Bat Survey

Church Lane Cottage, Church Lane, Aldham, IP7 6NP.

Project number:	Title:	Revision:	Issued:
REP23007	Bat Survey of Church Lane Cottage, Church Lane, Aldham, IP7 6NP.	Final	15 th June 2023

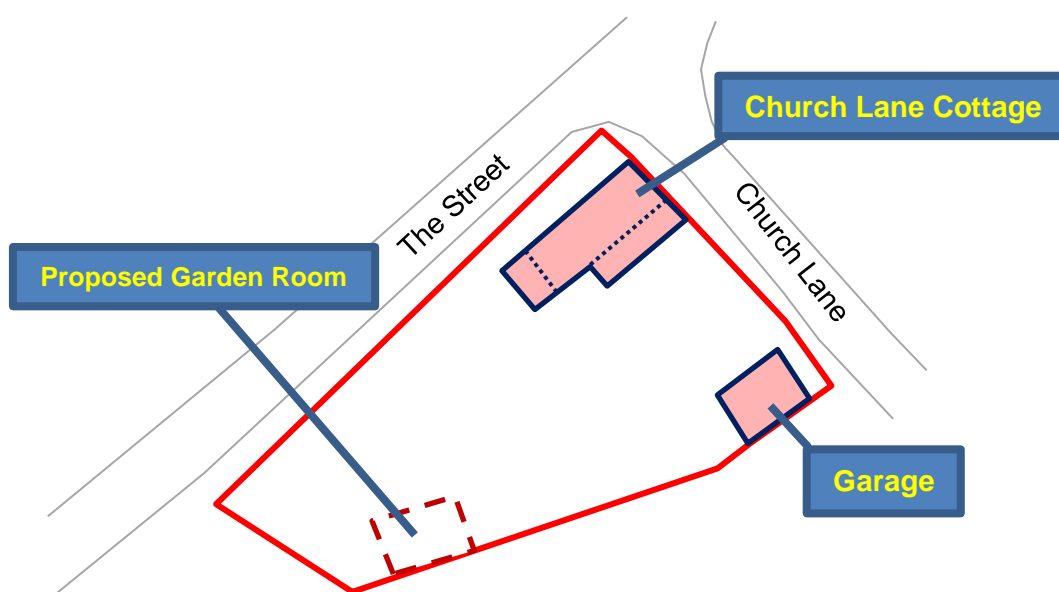
Figure 2.1: Location of the Cottage and site plan

The site comprises a detached residential property, detached garage, and a mature, maintained garden, mainly laid to lawn with planted shrubs and trees.

A planning application will be submitted to renovate and restore the property, including re-building the lean-to extensions (on the south-eastern and south-western elevations) largely within the footprint of the existing building. The existing garage would not be impacted and does not form part of the application. A new Garden Room is proposed on the south-western edge of the garden.

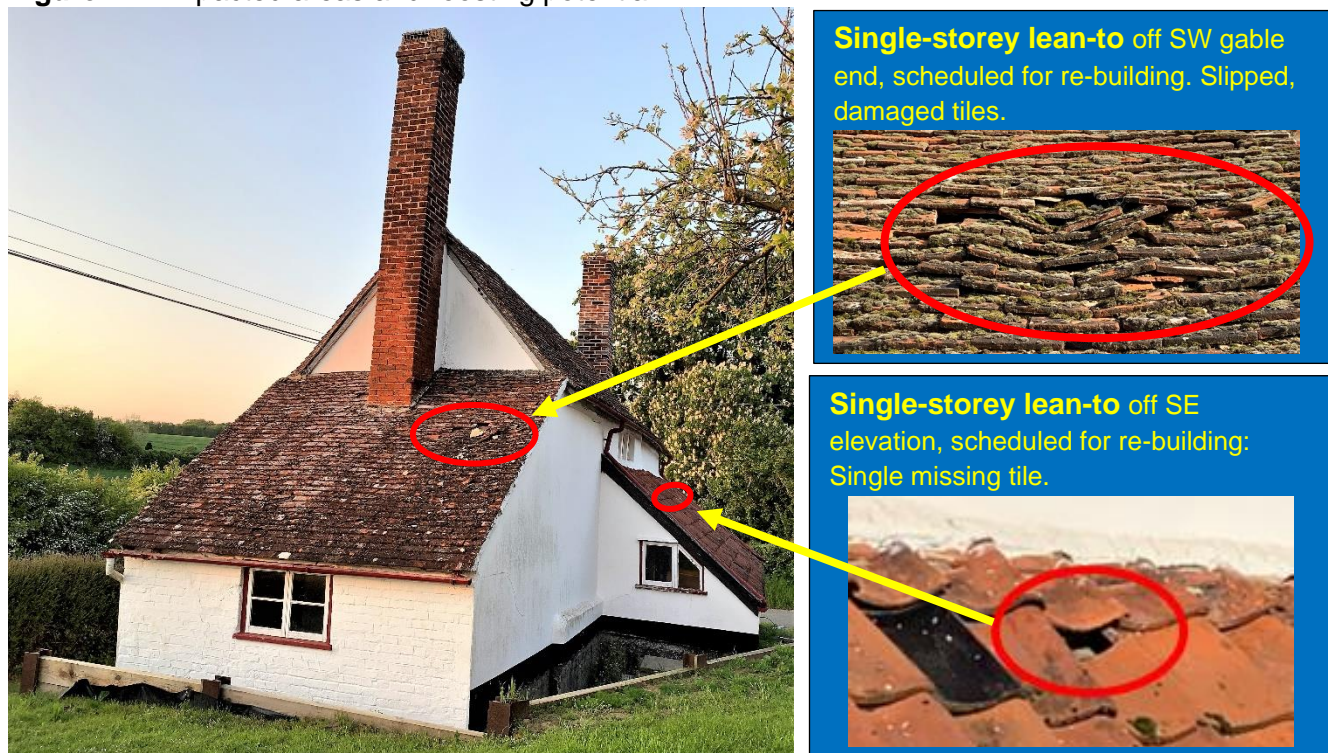
Figure 2.2: Impacted areas and roosting potential

A Preliminary Roost Assessment (PRA) of Church Lane Cottage carried out on 13th February 2023 identified features which could be used by roosting bats. The Cottage had low potential to support roosting bats in the cavity between roof lining and tiles on the south-eastern and north-western lean-to extensions where there were damaged and missing tiles. There was no evidence of bats having used the main Cottage loft-space, though there were potential access points (around external chimney).

Slipped and missing tiles on two lean-to sections of the Cottage which are scheduled for demolition/rebuild had low potential to support roosting bats and consequently, a single emergence (nocturnal) survey was required to comply with guidelines. The survey was carried out on 16th May 2023, to determine the status of roosting bats at the site and to inform a Listed Building/Planning Application to renovate the currently unoccupied property.

A single activity survey for bats was completed in May and there was no evidence of roosting bats in the Cottage, or immediate surrounding area. No further surveys are recommended. Demolition contractors should be made aware of the potential presence of protected species and carry out works with due diligence, contacting a suitably qualified ecologist for advice if any evidence of protected species is found during works.

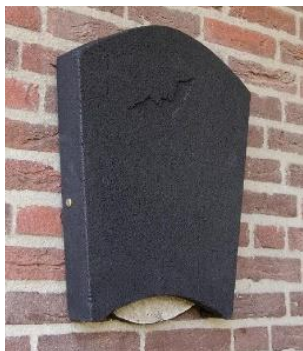
Beaumaris Bat Box

The box is made from durable WoodStone and has a lifetime warranty. Suitable for crevice roosting bats (e.g., pipistrelles) with a black exterior to absorb heat from the sun. WoodStone is strong and has good thermal insulation, reducing temperature fluctuations inside the box.

A Beaumaris bat box (Appendix B – or similar and approved) should be erected high on the south-western gable end, close to the apex on the southern side of the chimney (location shown in Appendix D).

Woodstone boxes are durable and long-lasting. The access hole is at the base so that the boxes are self-cleaning and do not require any maintenance. Bat boxes should be left in perpetuity, and only checked or moved by individuals licenced by Natural England to survey and handle bats.

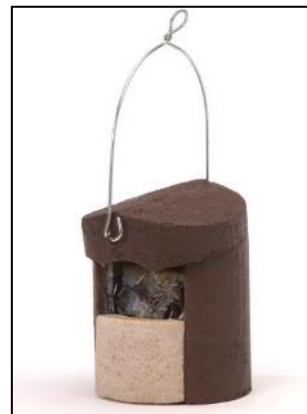
Schwegler 2H Open-fronted Bird Box

Should always be installed on the outside walls of houses, barns, garden sheds, etc. It is designed to be hung so that the entrance is to one side (at an angle of 90° to the wall). The front panel can be removed for cleaning. Install 2-4m high.

Song thrushes and spotted flycatchers use open-fronted nest-boxes: Schwegler 2H open-fronted nest boxes, or other specification to approved BTO-standards, will be installed in a retained mature tree on the north-western boundary of the site, to provide further nesting opportunities.

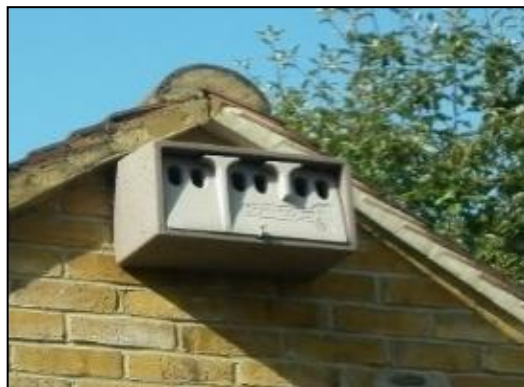
Schwegler 1SP Sparrow Terrace

This terrace provides nesting opportunities for three families. Made of wood-concrete mix, this terrace is durable, breathable and will last many decades. The terrace can be fixed on to the surface of a suitable wall or incorporated into the wall. Place the terrace two metres or more above the ground or install directly into the wall. Cleaning is advisable but not necessary. The front panel can be removed by turning the screw hook.

The BoCC red-listed house sparrow has been recorded locally and will readily use nesting boxes. Sparrow terraces, such as the Schwegler 1SP (see Appendix B), are suitable for buildings. A house sparrow terrace will be installed as high as possible on the south-western elevation of the new Garden Room, where there is close access to the vegetated garden boundary.

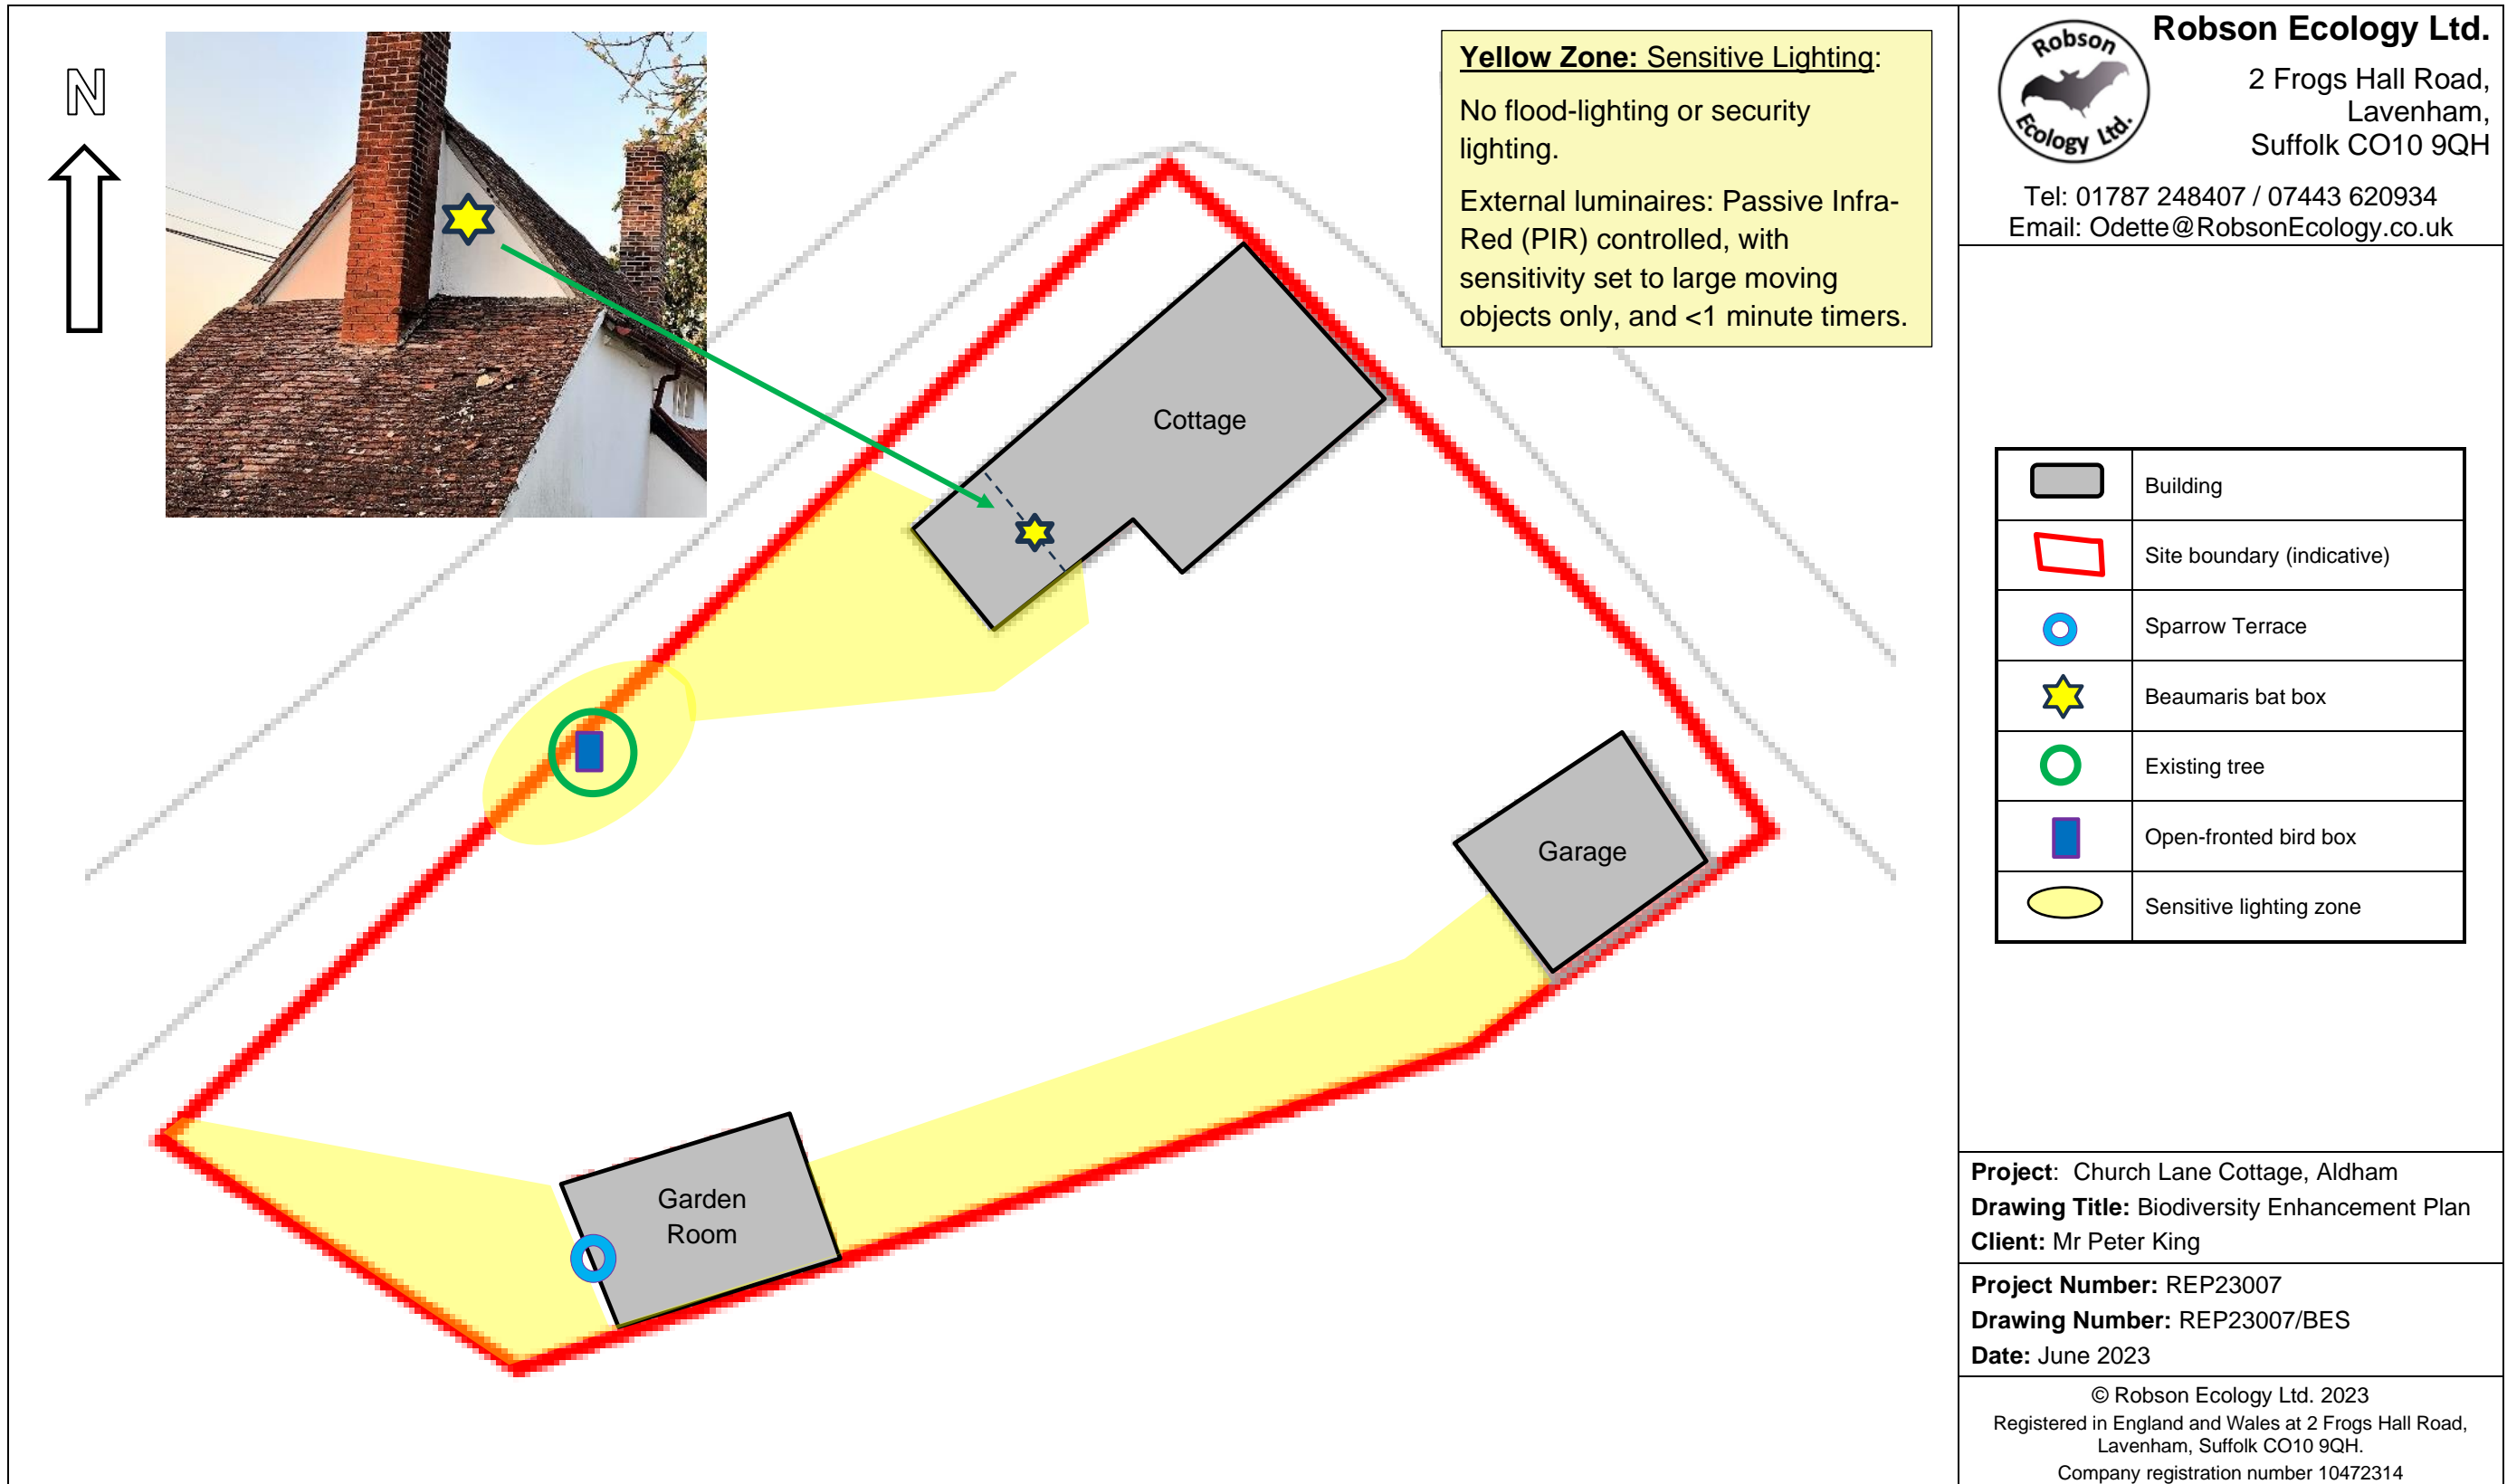
Appendix D: Biodiversity Enhancement Plan and Lighting Strategy

- The garden boundary to the east (tree line beyond closeboard fence) should be maintained as a dark corridor. No lighting should be directed towards this boundary, or the mature retained tree on the north-western (road-side) boundary.

- Lighting should be appropriately directed to avoid illuminating the retained trees, boundary vegetation, and enhancement habitat boxes.
- Construction works should only be undertaken during daylight hours and task lighting should not be used during the construction phase of the development.

A sensitive lighting scheme will maintain the foraging and commuting corridors around the garden/property (Section 3.3/Appendix D), and the site could be further enhanced by installing bat and bird boxes on retained trees and the renovated Cottage, as detailed in Section 4 and Appendix D.
