Home Farm House, Newbury Hill, Penton Mewsey, SP11 0RW

Bat Report

June 2022

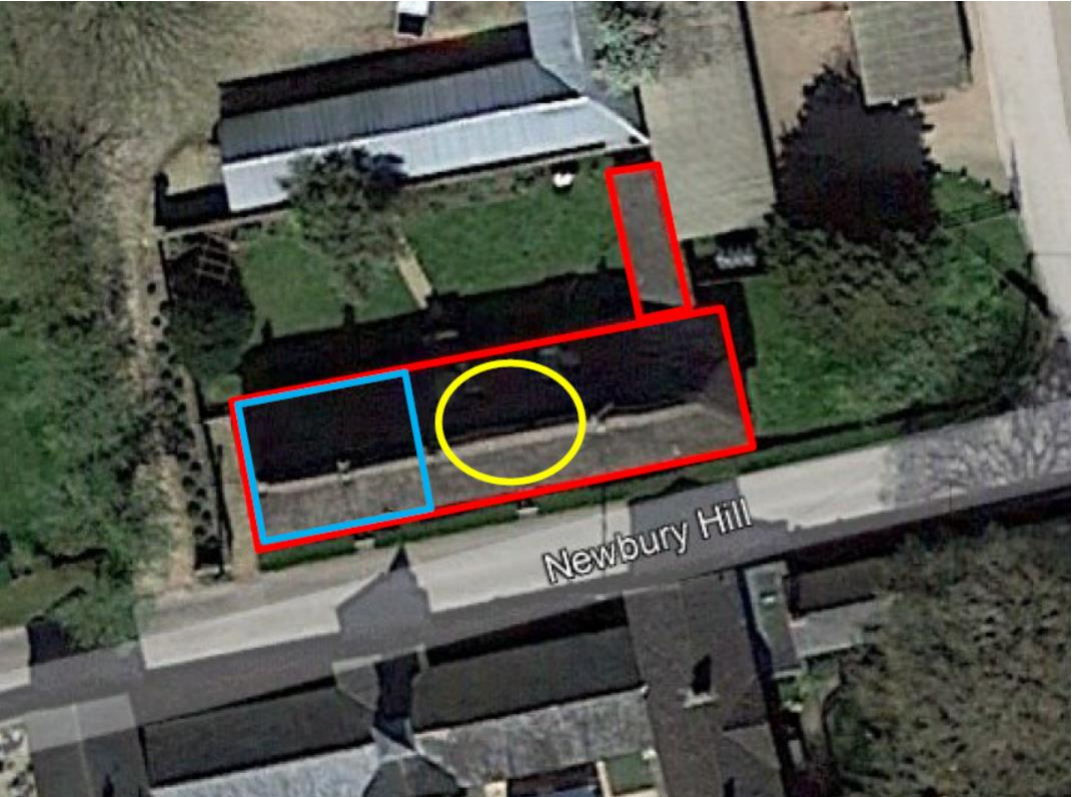
Appendix C: Internal Bat survey results

Location of bat evidence

Inaccessible loft void

- 4.5 The majority of the loft space and upper storey were accessible at the time of the survey by ESL Ltd. The upper storey of the house has plastered walls and ceiling with some of the beams exposed and painted over. Dormer windows into the hatch provide ample day light within this space. The floor in the upper storey has been only partially boarded, thus sections of the floor include exposed beams and fibre insulation.
- 4.6 The loft void has wooden rafters, wooden collar beams and a wooden ridge beam. No lining is present between the beams and the thatch. The elevations within the loft are bare brick. The loft floor has been boarded.
- 4.7 Evidence of bats, in the form of scattered droppings on the fibre insulation, was present within the void of the building.

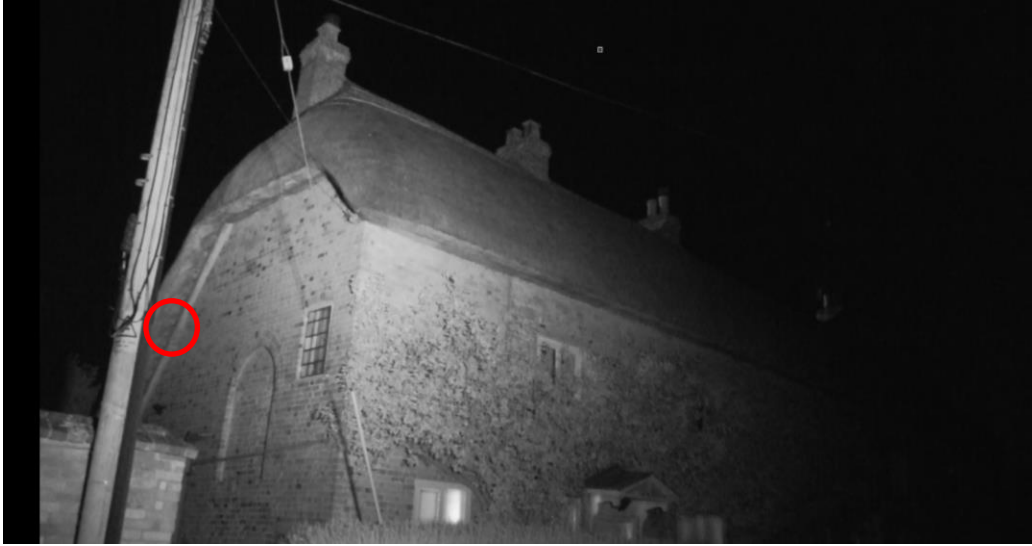
Louisa Jones, Southwest corner of the building – 5th May Dusk Common pipistrelle emergence at 20:59

20:58	Pipistrelle bat	Flew east to west along the road
20:59	Common pipistrelle	Emergence from the fascia board on the western gable end
20:59	Common pipistrelle	Flew east to west along the road

- 4.9 One common pipistrelle (*Pipistrellus pipistrellus*) was recorded emerging from the fascia board on the western elevation of the building at 20:59. Low levels of foraging activity by common and soprano pipistrelles were recorded, starting at 20:58 and continuing at irregular intervals during the survey until 21:59.
- 4.10 Two commuting pipistrelles were observed flying westwards over the building at 21:16. A Myotis bat was observed at 21:10 commuting east to west along the road. A noctule was heard not seen at 21:37, making a single pass and therefore possibly commuting over the site. Similarly a serotine was heard not seen making two passes, at 21:40 and at 21:44 respectively.
