The Beeches

The Street
Occold
Suffolk IP23 7PW

DESIGN AND HERITAGE STATEMENT FOR REPAIRS AND REPLACEMENT WINDOWS

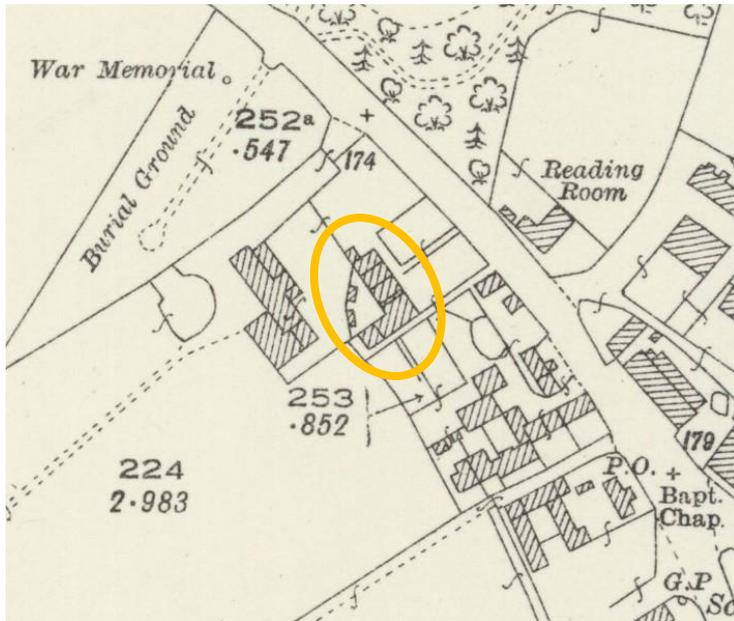
The image left shows an extract of the 1925 25 inch OS map, showing the site environs. The house is ringed.

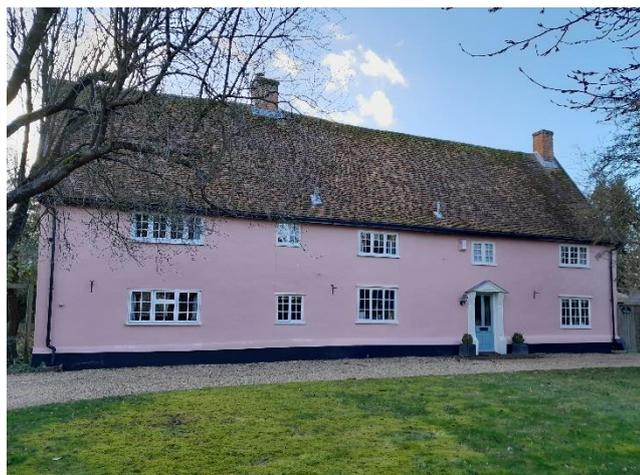
The house is grade II listed and is of two storeys with attics. It is timber framed and plastered with a gabled plain tile roof to the front and a pantile roof to the rear. It is a long range building, rectangular in plan. It is believed to have a C15th core. It has been much altered over time and was a series of attached cottages as late as the early to mid C20th. It was extensively renovated in the late C20th.

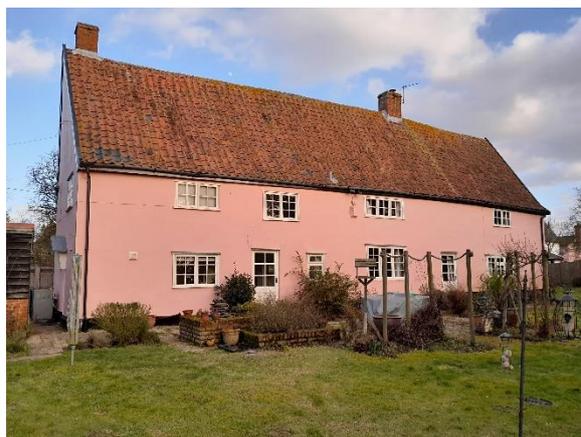
The image right shows the rear elevation.

The drawings identify the windows to be replaced. The entire range of windows to the rear elevation are of a modern stormproof pattern and many have vent sashes, all of which is inappropriate to a listed building. These are to be replaced as they deteriorate. There is also one ground floor window to the front, one ground floor south east gable window and one first floor north west gable window which are similar. The gable windows have extensive rot. One further window, a first floor window to the south east gable, which is a mid C20th three light window which requires replacement due to extensive rot and earlier repair.

Each of the windows will be replaced with a putty fronted single glazed flush casement to match the style of the earlier windows on the front of the property.

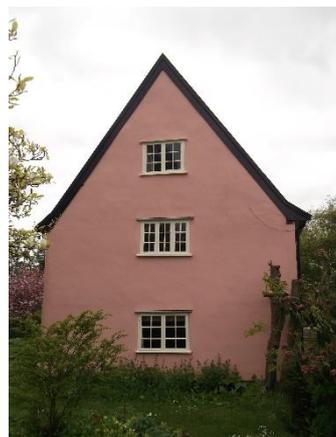
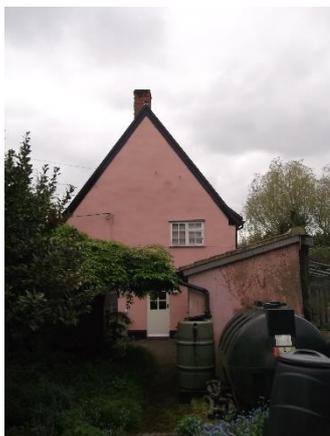
The images left show the two end elevations.

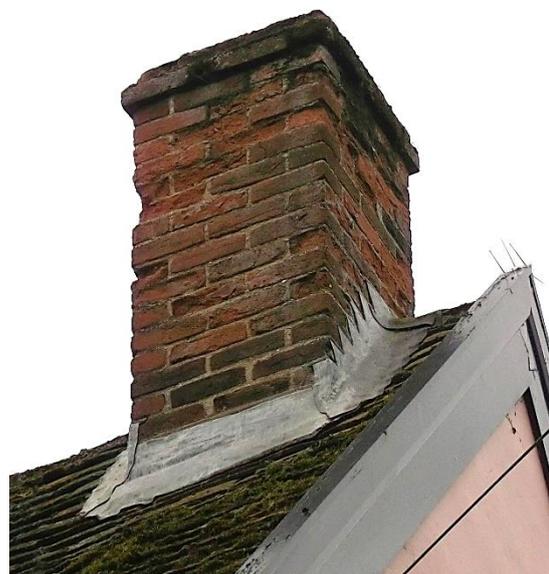
The image right shows the gable chimney condition.

The gable chimney is in a decayed condition with spalled bricks and perished pointing. There are approximately 15 courses which require rebuilding. The chimney brickwork appears to be late C19th or early C20th in origin. The flaunchings and mortar will be lime and the lead flashings will also be replaced.

- Carefully take down brickwork to roof pitch level and remove lead flashings.
- Rebuild chimney to exact same dimensions using matching red imperial bricks set in lime mortar.
- Remake mortar flaunchings to chimney head.
- Fit new code 4 lead flashings to pitch and ridge.
- Reinstate any dislodged tiles.

The rebuilding of the upper part of the gable chimney will not result in any visible change.

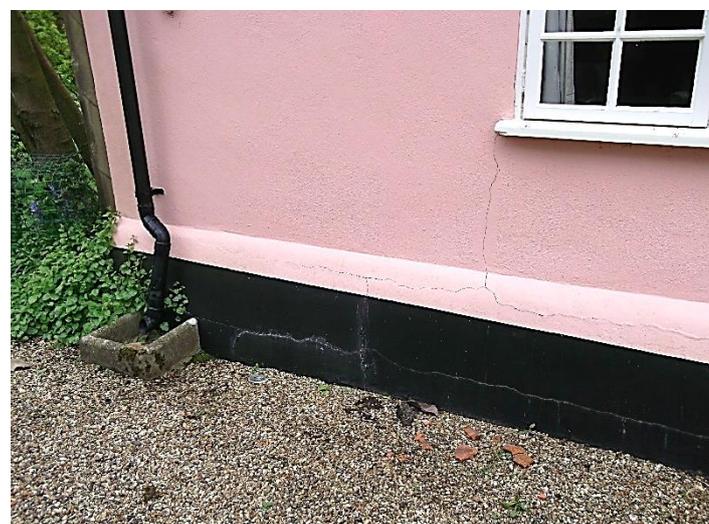
The image left shows typical cracking to the cementitious render.

The whole house is rendered in a hard cementitious render, which was presumably carried out in the late 1960's when the house was refurbished. This is cracked in several areas and is non breathable, which is not at all appropriate for a timber framed building. This is proposed for replacement with lime render on a split timber lath. The opportunity will also be taken to insulate the timber frame walls using sheeps wool, if the frame gaps allow. It is inevitable that the frame will require repair in some areas and this will be carried out using green oak in sections to match the existing timber, if required.

- Carefully remove all render from timber frame and brick plinth.
- Remove rainwater goods to be refixed later.
- Remove side door canopy and front door case/canopy to be refixed later.

- Reduce external ground levels to 150 below internal floor level, if required.
- Install a French drain around the perimeter to assist in drying out the plinth brickwork.

- Repair/rebuild rainwater gullies.
- Repoint plinth brickwork to lower courses if required where to be exposed, using lime mortar drawn slightly recessed and brushed. Assuming that the face of the bricks is suitable to be left exposed after the removal of the cement render.

- Carry out any repairs required to timber frame using matching sections of oak. Remake any peg joints and scarf any stud/wallplate repairs.
- Insulate between studs using sheeps wool insulation.

- Fix riven lath and render with Warmcote/Limecote finish. Render to stop at 150 above ground level.
- Decorate all external walls using limewash or a breathable mineral paint such as Keim.
