**Bat Inspection & Emergence Survey Report**  
**8A Church Street, Banwell**  
Guy Mitson  
June 2023  
IES/2023/030/Version 1.0

Job Number: IES/2023/030			Project Name: 8A Church Street, Banwell		
Revision Number	Description	Originator	Checked	Authorised	Date
001	Draft for Comment	MS	TT	TT	June 2023

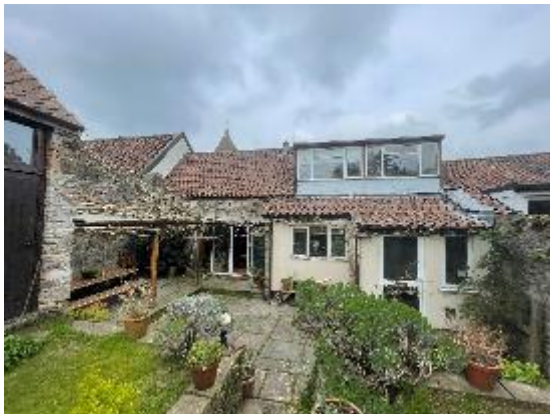
Plate 1: Eastern elevation

4.2.4 The building (Plate 1-2) is constructed of stone walls which are in good condition with no missing mortar. The pitched roof is constructed of clay, double roman roof tiles. There are several loose tiles creating gaps for access. On the eastern elevation, there is flat section of roof. There are gaps in the lead flashing at the corner of the flat roof (Plate 3), otherwise it is tight. There are no gaps on the ridgeline, between the wall and roof or in the soffit/barge boards. Wisteria is growing on the eastern roof, filling in any gaps (Plate 3). The windows are single glazed and are in good condition with no gaps.

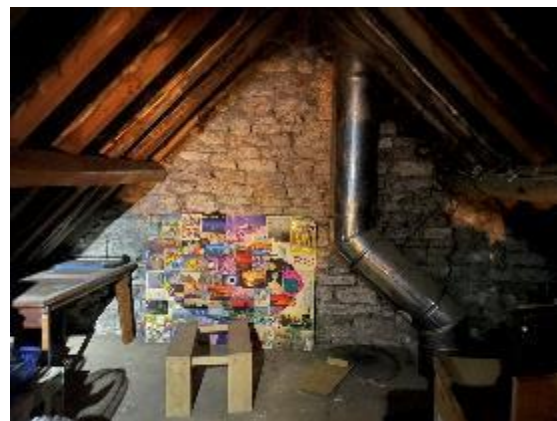
Plate 4: Internal roof space

4.2.5 The internal roof space is comprised of bituminous roof lining, with several gaps allowing in light (Plate 4-6). The roof space is very cobwebby and no free hanging bats were seen. There is evidence of rats using the roof space.

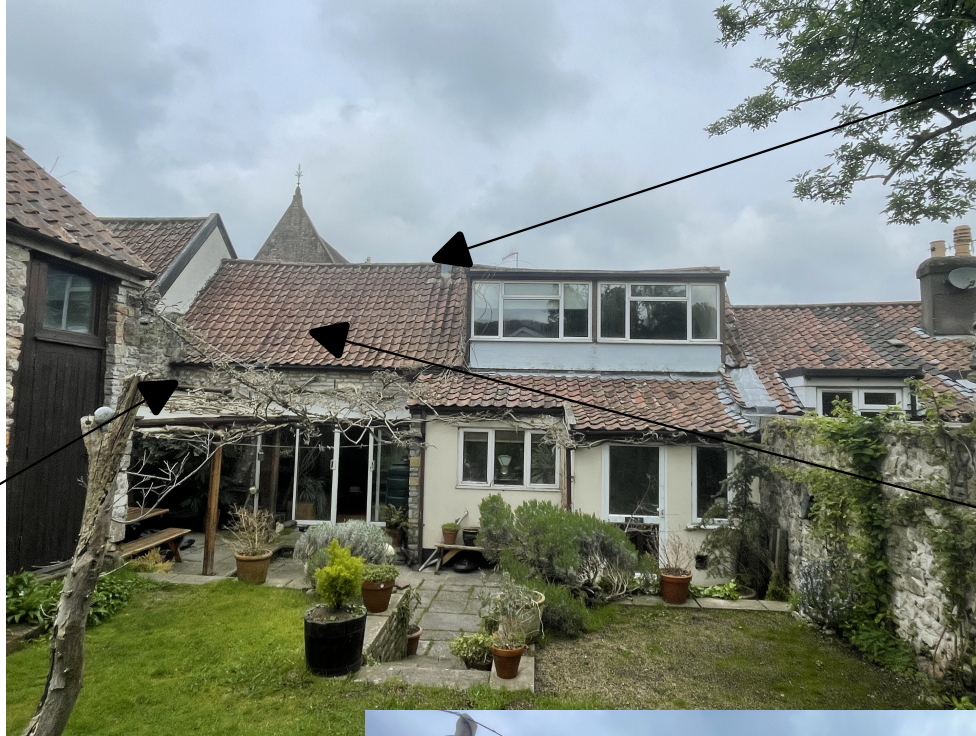
Figure 2: Internal and External Inspection

Wisteria is growing on the eastern roof, filling in any gaps

There are gaps in the lead flashing at the corner of the flat roof

Several loose roof tiles creating access gaps

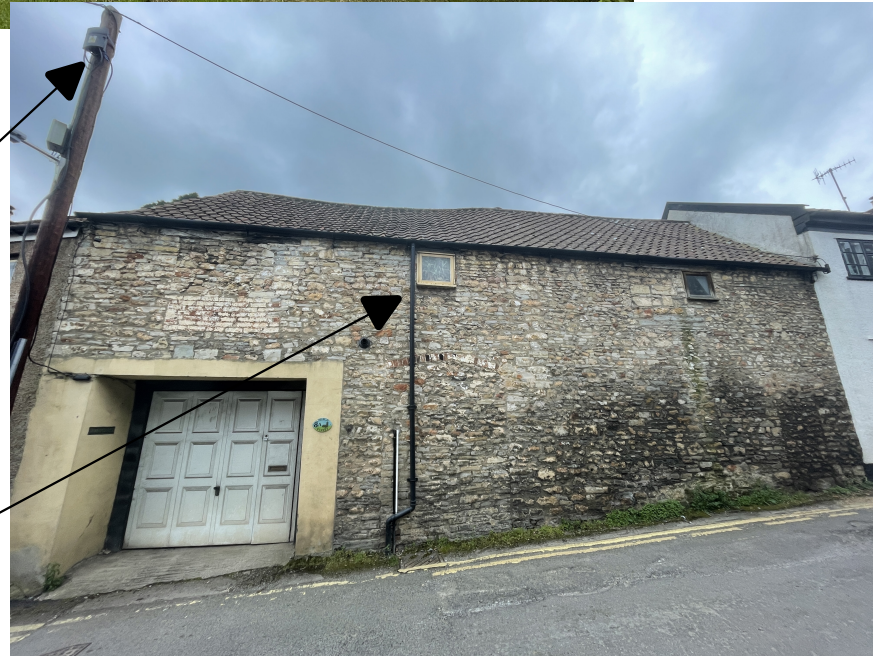
There is a street light directly next to the building on the western elevation

The windows are single glazed and are in good condition with no gaps

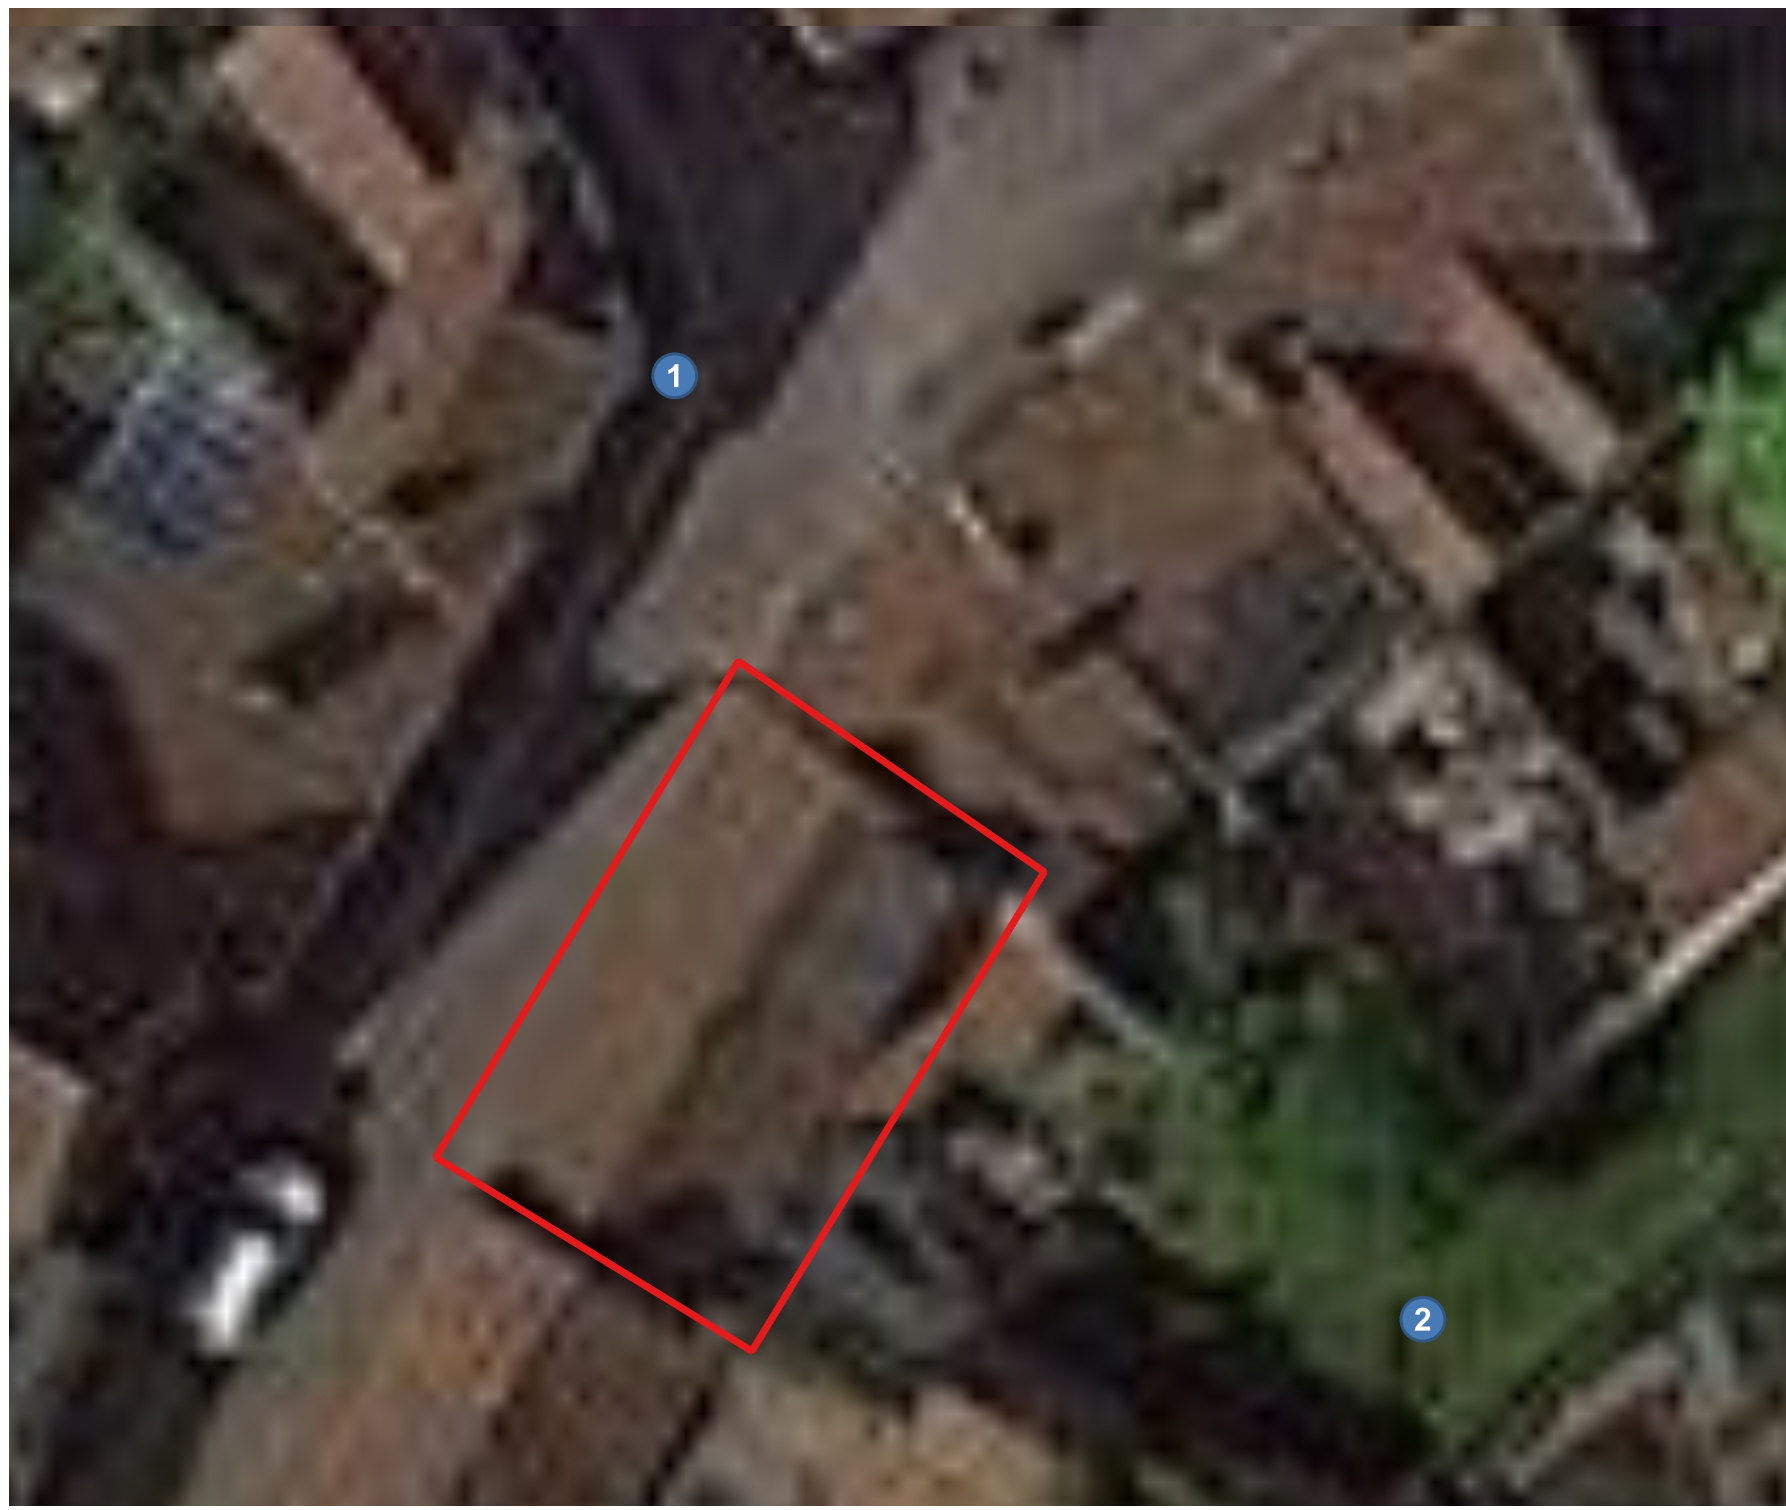
Figure 3: Emergence Survey

4.3.6 No bats were seen to emerge from the building. The site is used occasionally by common pipistrelle and soprano pipistrelle bats for commuting and foraging purposes.

4.3.10 No bats were seen to emerge from the building. The site is used occasionally by common pipistrelle, soprano pipistrelle, and nyctalid bats for commuting and foraging purposes.
