The Old Thatched Cottage, Monks Eleigh, Suffolk

Heritage Asset Assessment

March 2022

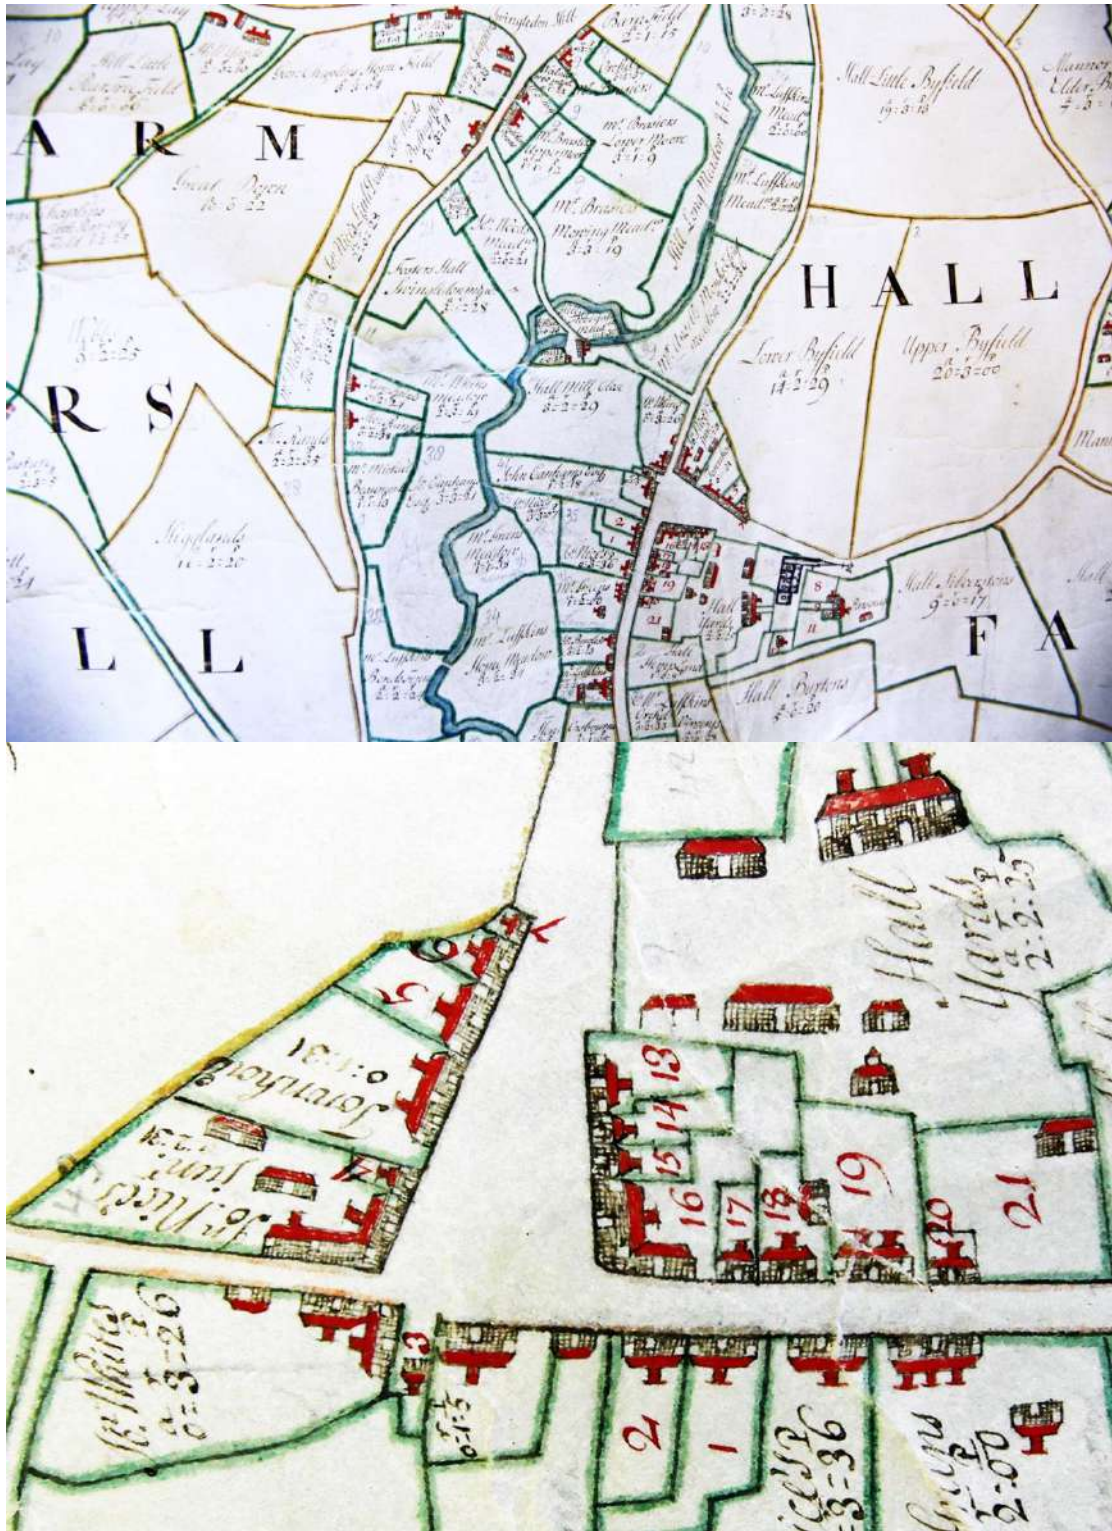
Figure 3

John Miller's 'Map of the Town and Parish of Monks Eleigh' drawn in 1724 (Suffolk Record Office FL607/1/3), with a detail of the village green below (reoriented to show north in the usual direction). The buildings are stylised but domestic houses are distinguished from farm buildings by the presence of chimneys. The site of Old Cottage was occupied by a small unheated barn or byre that was owned by John Canham of Mildenhall along with the field to the rear. The site of The Old Thatched Cottage is an empty plot between this building and a substantial detached house to the west.

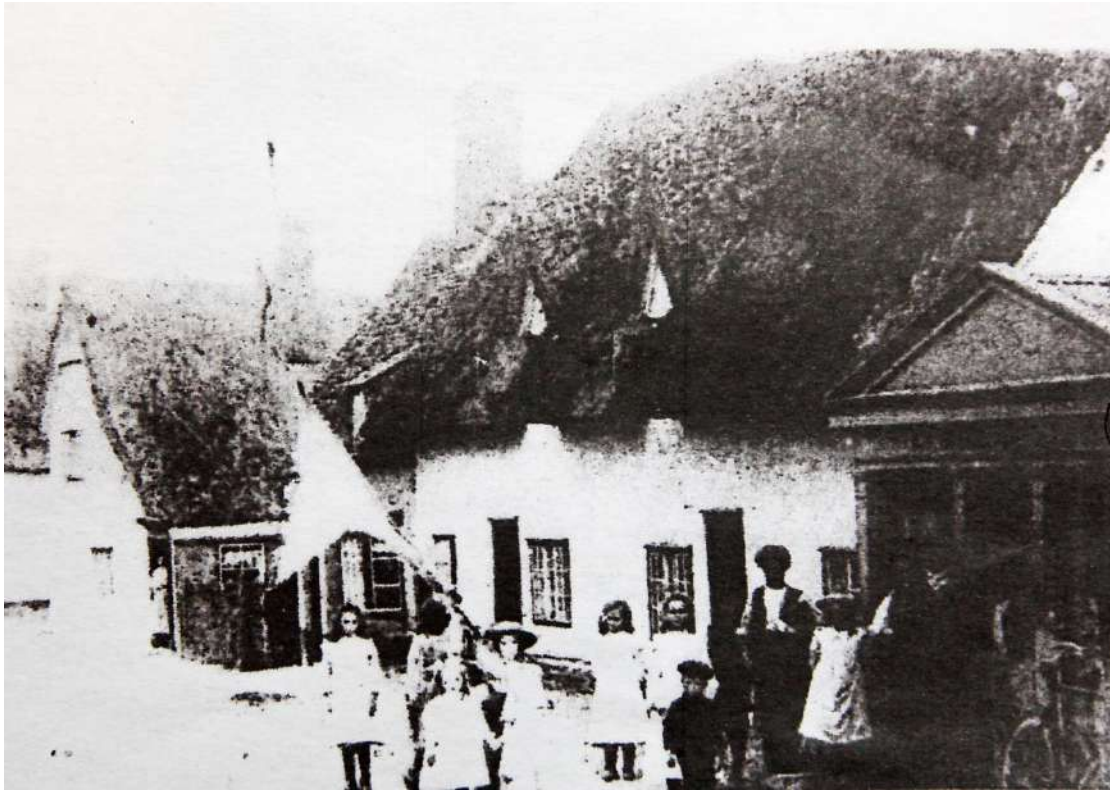
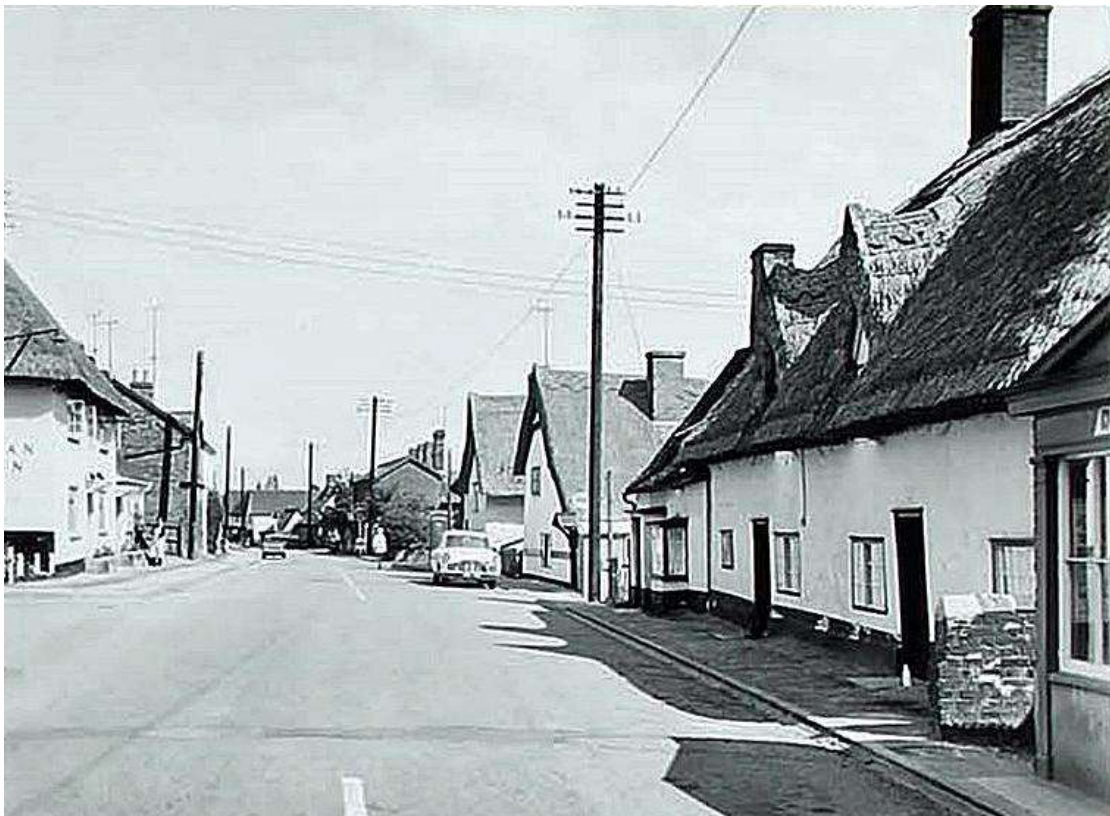
Figure 8

A photograph of the early-20th century in the possession of the current owners (top) and another of 1960 showing the property much as it remains today, with the unusual pedimented shop on the right. The end of a demolished brick boundary wall projecting onto the pavement is visible behind the shop but has since been demolished.

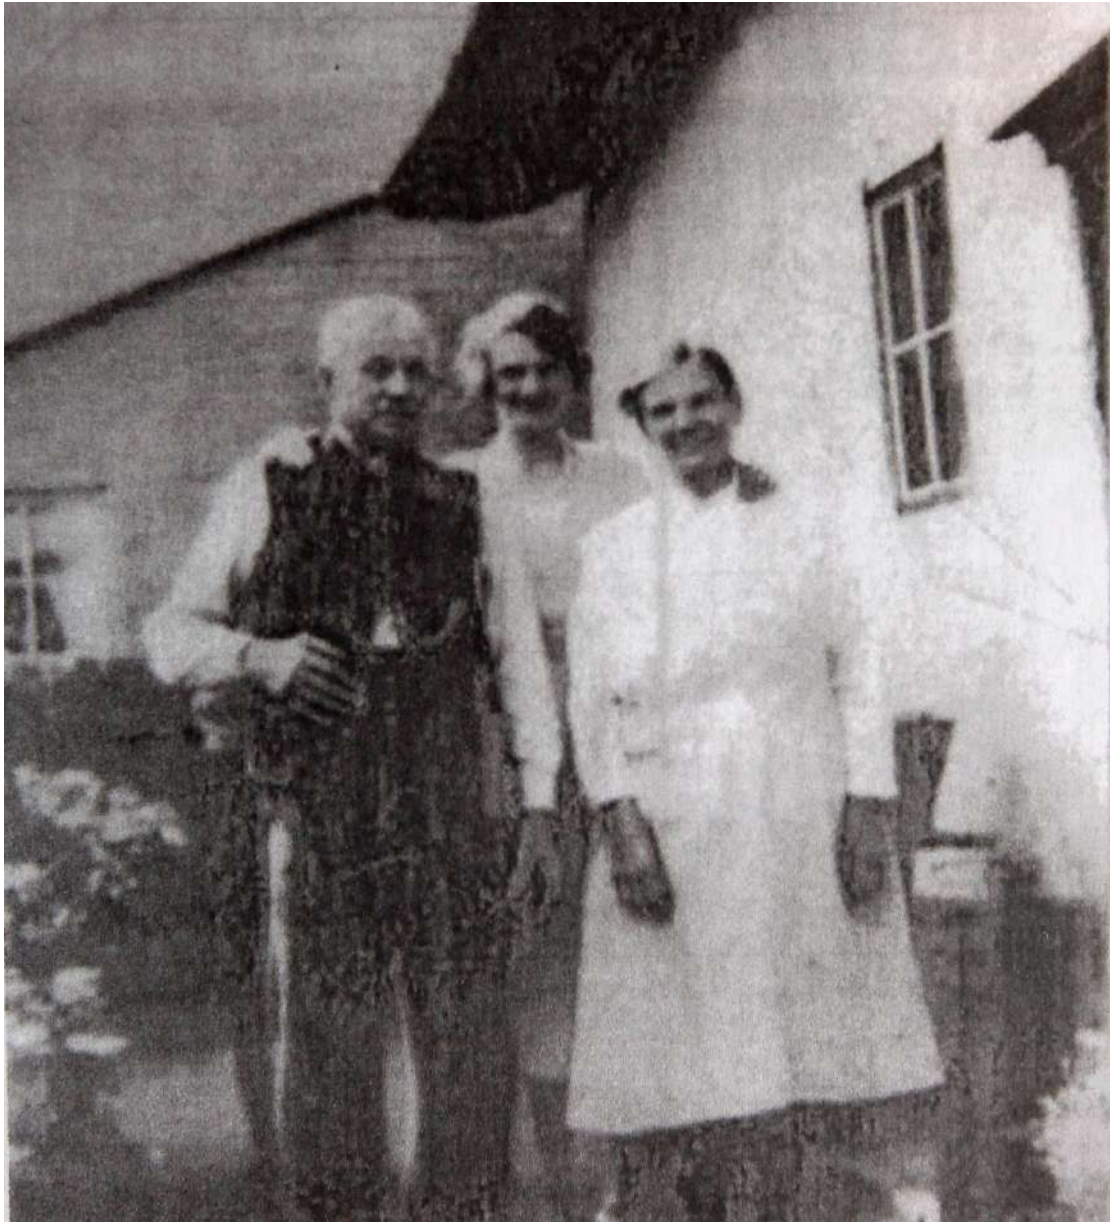
Figure 9

An early-20th century image in the owners' possession showing the western end of the back wall with the neighbouring brick cottage in the rear. The 19th century casement window alongside the door has since been replaced by a 'picture' window of the 1970s or 80s, but at this date the pantry adjoining the gable appears to have lacked a window in this elevation. The inserted additional window either replicated the example shown here or incorporated some of its components.

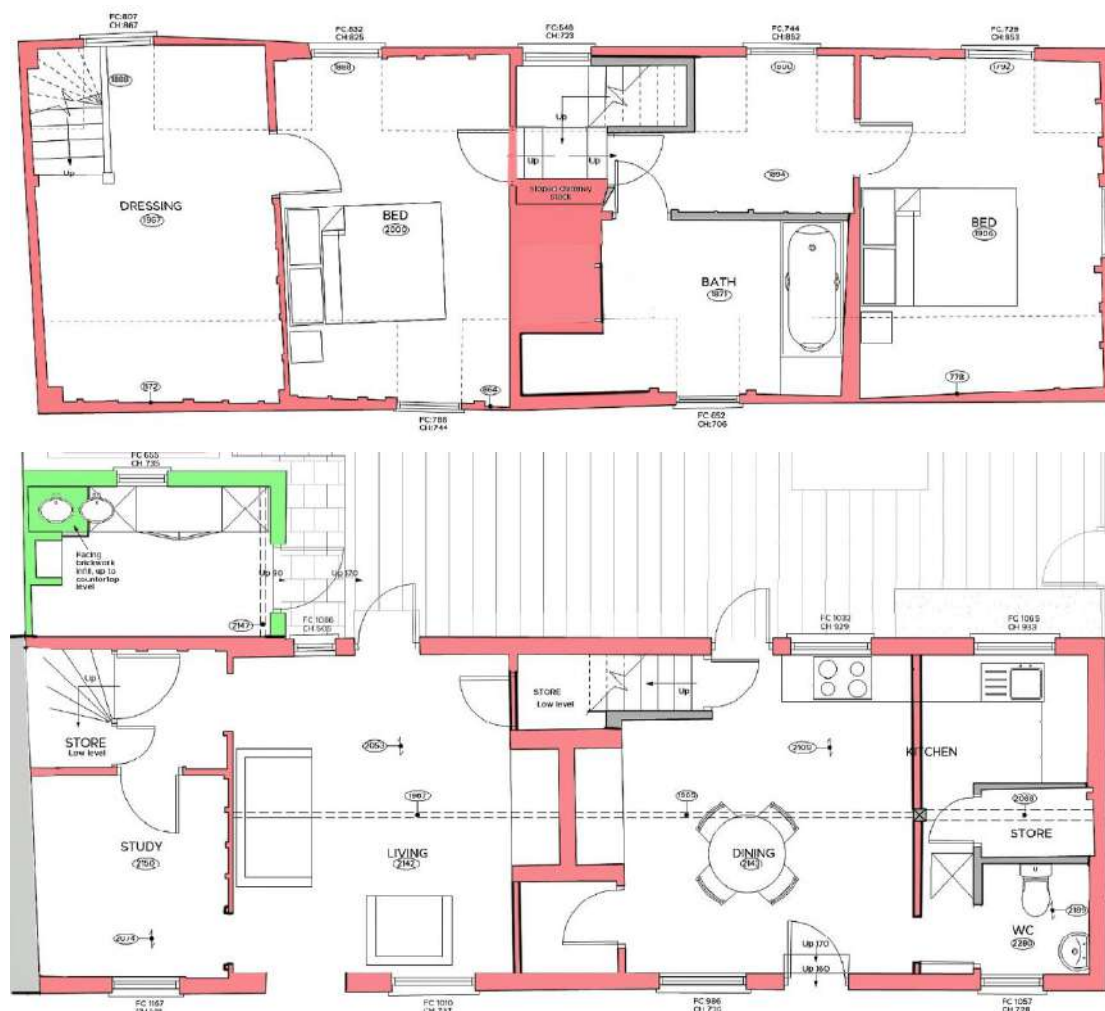
Figure 11

Ground and first-floor plans by Wincer Kievenaar adapted to show the original layout of the building in red and the mid-19th century lean-to extension in green. The structure lacked an eastern gable and simply abutted the formerly external gable of the neighbouring cottage. The exact configuration of the missing internal partition of the western cottage is conjectural as the two tenements were not identical: the stair of the western cottage appears to have adjoined the back of the central chimney while its counterpart lay in the building's south-eastern corner (where it still survives).

The building originally formed a pair of almost identical mirror-image tenements sharing a central chimney (figure 11). Each contained a hall that would have operated as a kitchen and general living area along with a small unheated pantry and two bedchambers on the upper storey. The bedchambers were of the same size but the halls were longer than the pantries at 3.5 and 2.5 m respectively (11.5 and 8.25 ft). Excluding the chimney, each cottage was therefore 6 m long (20 ft). Although modest, these proportions created a two-up/two down arrangement that offered more flexibility than many contemporary labourers' tenements with only one room on each floor. The eastern cottage is the best preserved, retaining its original staircase and internal partitions of slender studs as highlighted in red in figure 11 (illus. 11-13). The pantry now contains the modern study as labelled on the existing plans, and was initially connected to the hall by a blocked door just inside the front wall. The entrance to the hall is also blocked internally but its door survives externally approximately 1 m from the pantry door in order to avoid a clash. The front window lay towards the fireplace as might be expected. The pantry partition supports the junction between the ceilings of the two rooms, which are constructed differently. The hall ceiling consists of re-used rafters laid on edge that bear the scars of lath-and-plaster from their former lives and span the entire width of the external walls. They are supported at the centre of the building by a similarly narrow-sectioned pine principal joist in an unusual but undoubtedly original manner. The pantry ceiling, in contrast, consists of shorter joists tenoned to a re-used flat-sectioned axial joist. The ceilings of the western cottage are identical but its pantry partition has been removed and the two axial joists are supported by a recently inserted post (illus. 18). An attempt to clean the axial joist in the former hall has resulted in an abraded surface that appears modern, but the timber matches its counterpart to the east and is clearly original. The western pantry was either larger than that of its neighbour or possibly subdivided in some way as there is no evidence of a stair in the cottage's rear outer corner to reflect that of the eastern cottage (illus.

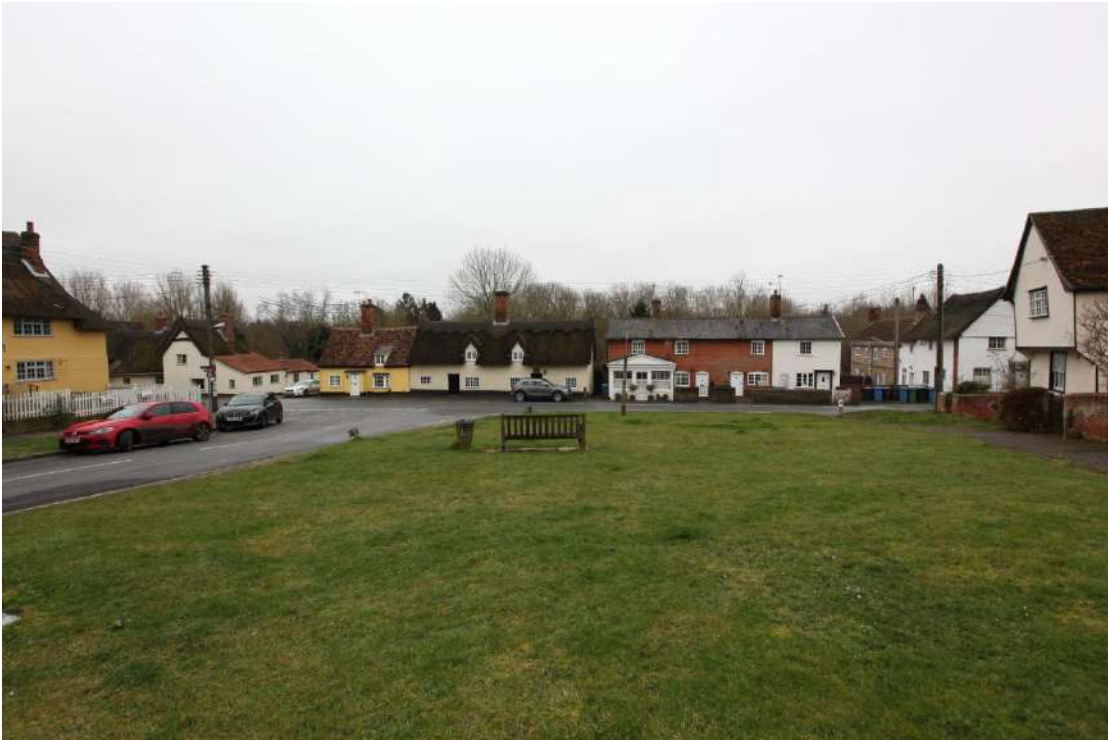
Illus. 1. A general view from the village green to the north. The property lies immediately opposite the road to the left and makes a significant contribution to this famously picturesque scene. The red-brick cottages on the right were in the same ownership in 1840 and share the same horizontal sash windows.

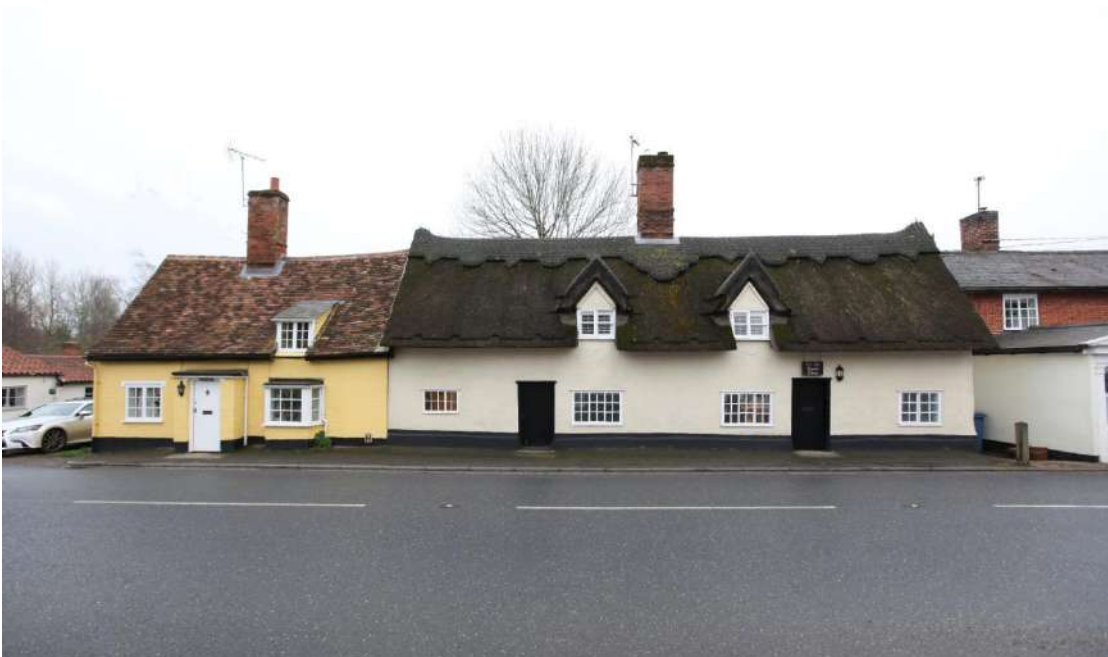
Illus. 2. The Old Thatched Cottage was built as two almost mirror-image tenements and retains its original symmetrical facade with twin entrance doors – although the door on the left is blocked. The property shares a single listing entry with its earlier tiled neighbour to the left. The unusual, projecting single-storied 19th century structure on the right is understood to have operated most recently as a tailor's shop.

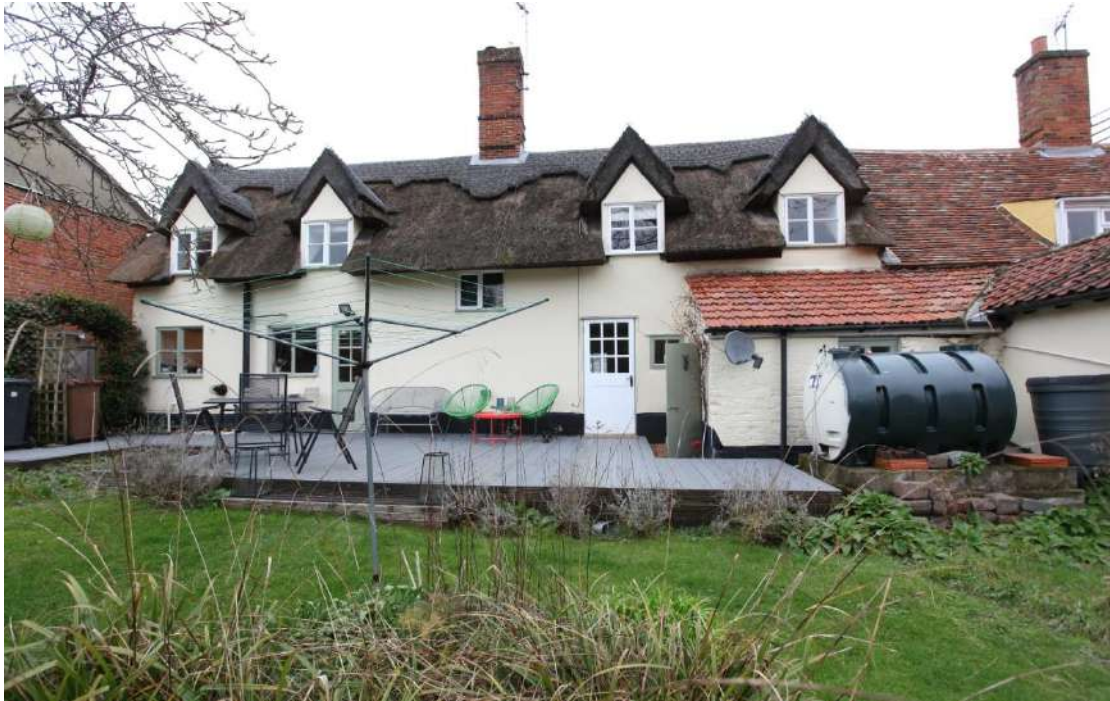
Illus. 3. The still largely symmetrical rear elevation with the brick and pantiled mid-19th century lean-to addition on the right. Built as a wash-house its original external chimney has been removed. The unusually narrow back door of the western cottage on the left was truncated to accommodate the modern stair behind the chimney, which is longer and therefore less steep than its predecessor. Figure 9 suggests the ground-floor window to the extreme left is a later insertion, but all four dormers are original.

A brick and pantiled shed was added to the back wall of the eastern cottage between its appearances on the 1840 tithe map and the 1885 Ordnance Survey (illus. 3-5). This retains a small original fireplace against its eastern gable, with a chimney now truncated below the roof, and an adjoining copper that is not integral to the fireplace and therefore a slightly later addition. An area of disturbance in the external southern wall adjacent to this copper suggests it once possessed a separate flue. The shed evidently formed a wash house for washing clothes and boiling water, and was probably shared by the two cottages in the same way as the rear garden (which lacked a partition). It has since been converted into a utility room and therefore still performs its original function.

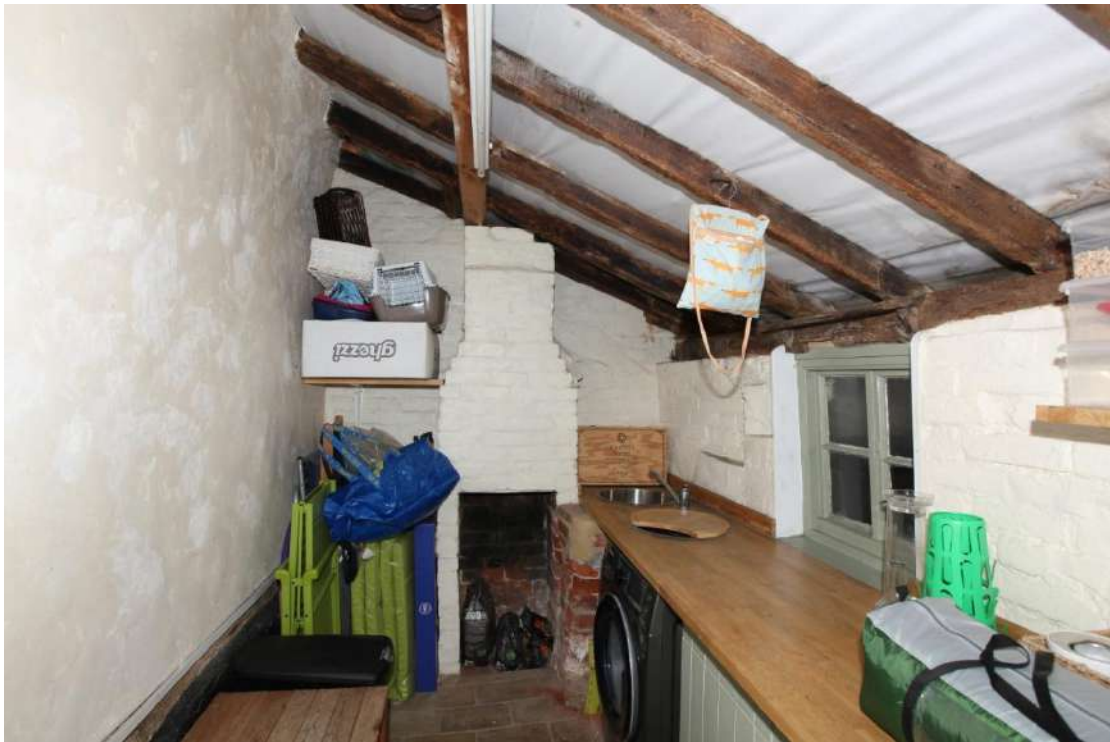
Illus. 4. The interior from its western entrance of the rear lean-to showing its narrow fireplace with a hot water copper to its right. The main chimney has been truncated below the roof and an area of disturbance in the brickwork to the right of the copper suggests it once possessed a separate flue of its own.

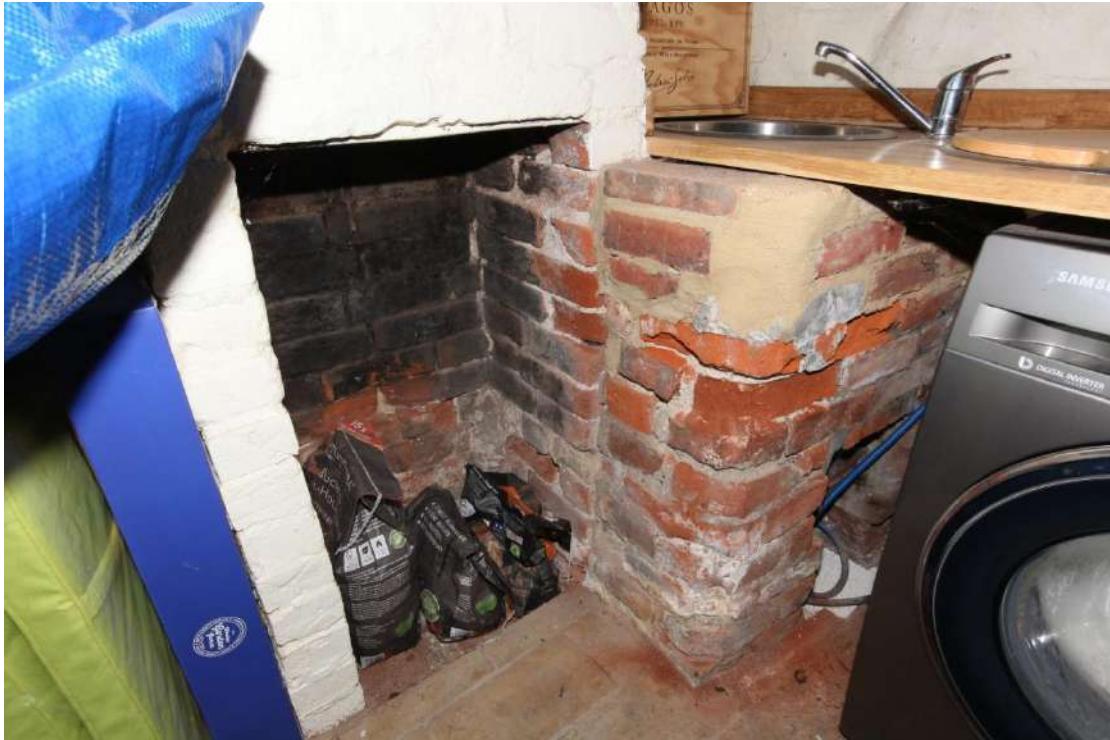
Illus. 5. A detail of the fireplace in illustration 4 with the stoke-hole of the brick copper base visible to the right. The copper was presumably a slightly later addition as its brickwork is not integral to that of the main chimney. The position of the copper itself is hidden by the modern work top but it is understood to have been removed.

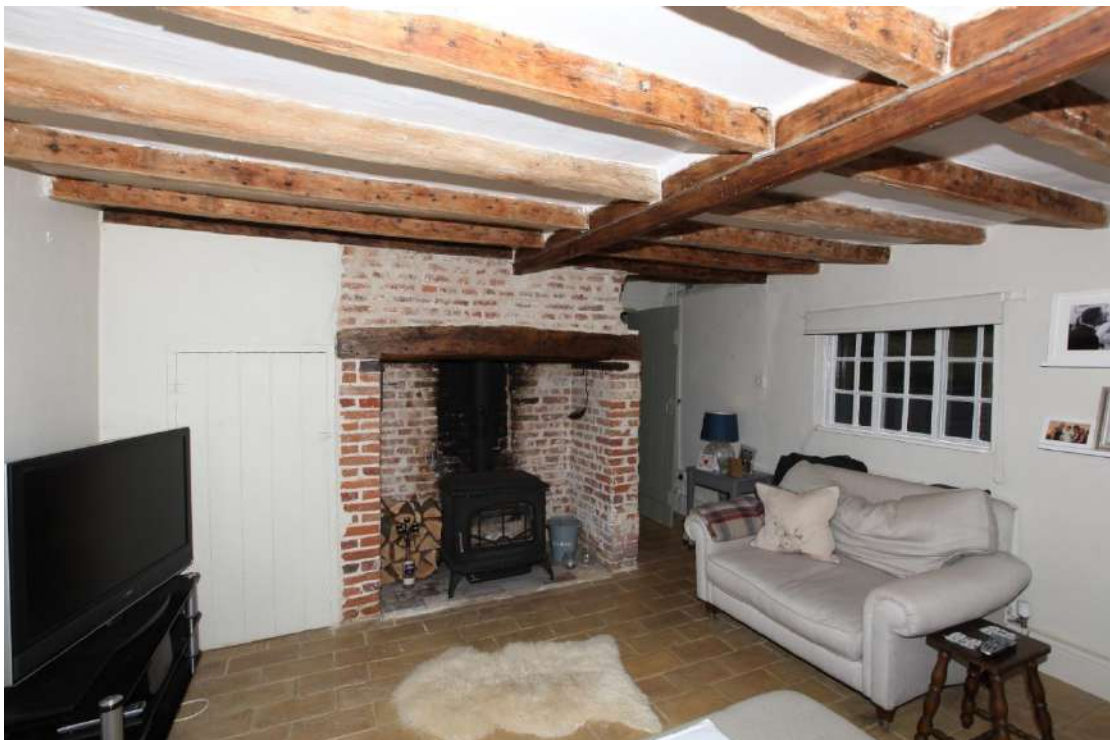
Illus. 6. The modern living room from the east. This represents the hall/kitchen of the eastern cottage and preserves its original cooking fireplace, which is identical to that of its western counterpart in illustration 15. This cottage appears to have been slightly smaller, with no access to the area alongside the central chimney –apart from the cupboard under the western cottage’s stair to the left.

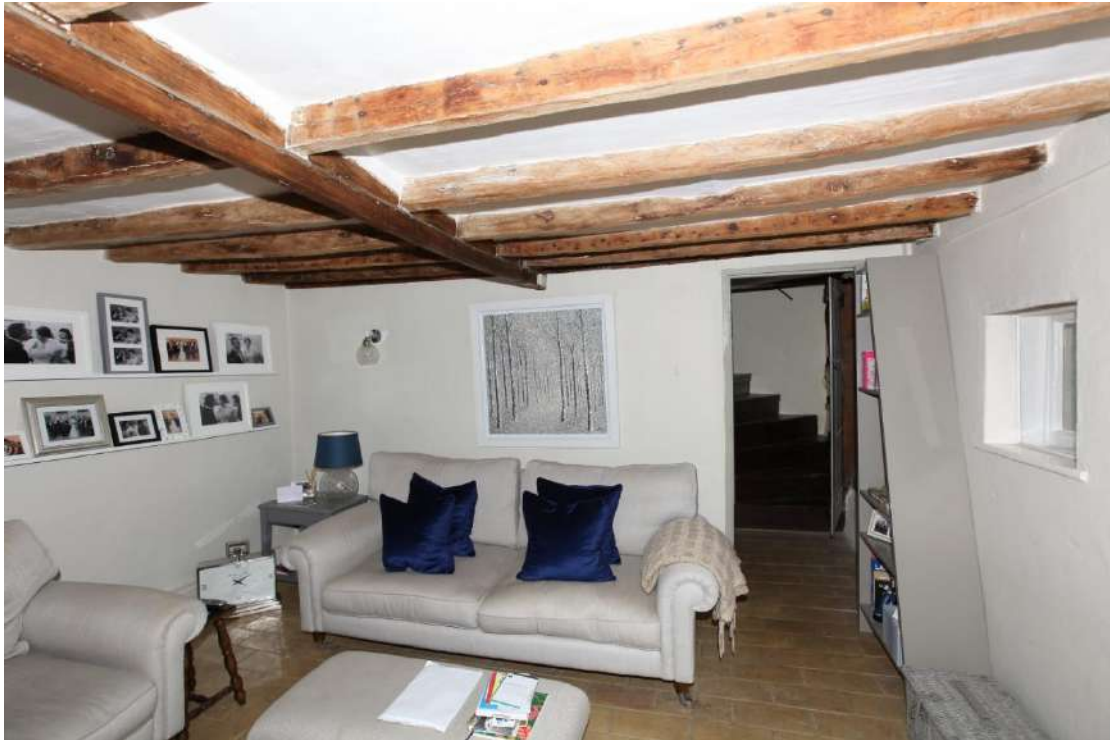
Illus. 7. The living room from the west showing the original partition of the pantry with a door to the corner stair on the right. The pantry door lay to the left but is now blocked (illus. 12), as is the front door in the northern facade to the extreme left.

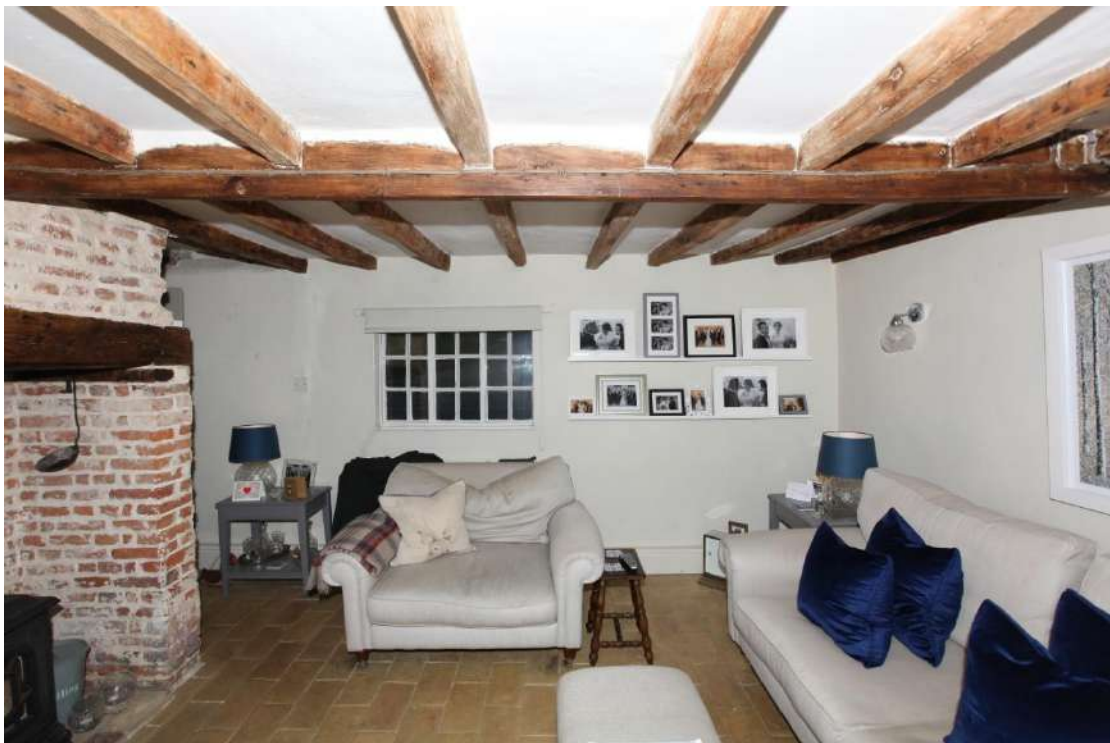
Illus. 8. The front wall of the well preserved eastern cottage showing the 3.5 m length of its principal room with the position of the blocked entrance door to the right of the window in illustration 9. The ceiling is original to the structure and unusually consists of re-used timbers with lath nails in their sides which span the walls and are lodged upon rather than tenoned to a central narrow-sectioned axial joist of pine.

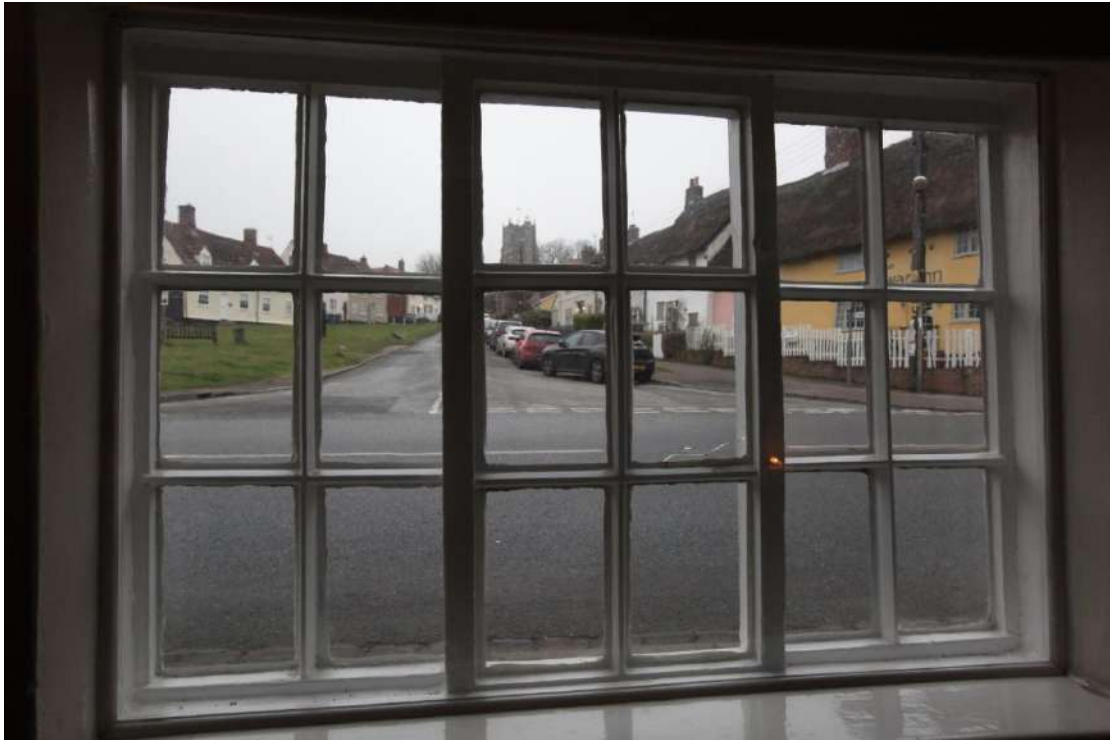
Illus. 9. A detail of the good 19th century horizontal sash window in the front wall of the eastern living room, with the famous view of the green beyond. These windows may well be contemporary with the building.

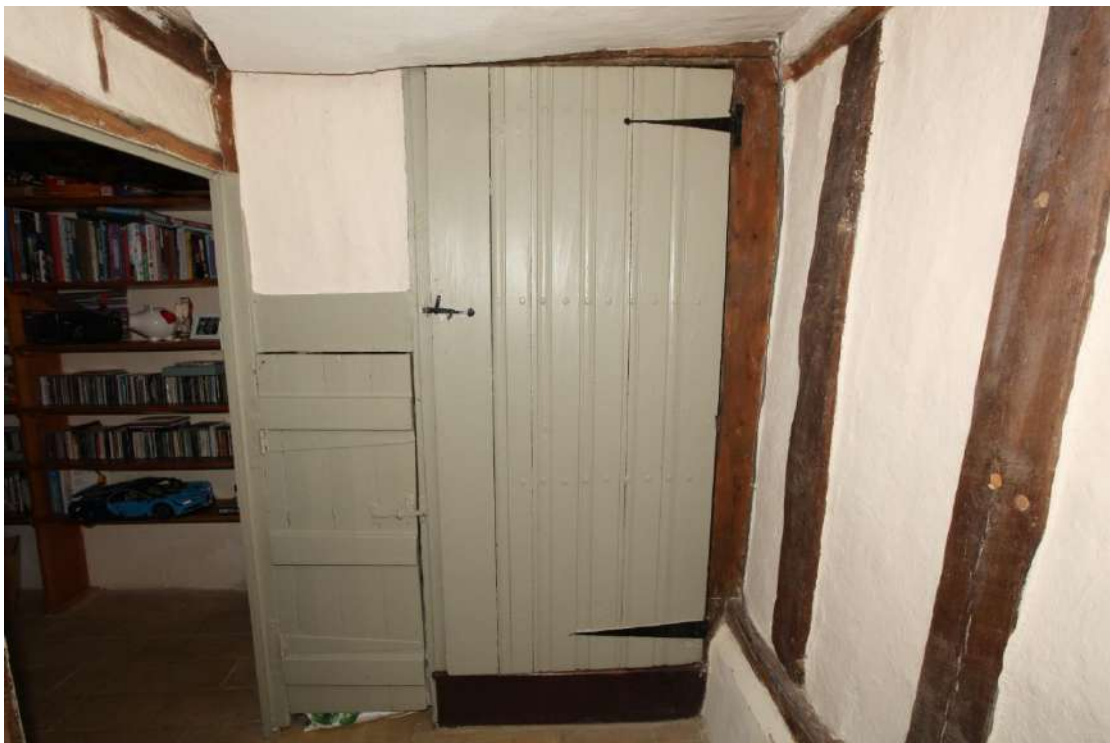
Illus. 10. The door to the original stair in the south-eastern corner of the building with the inserted entrance to the study on the left (originally a pantry). This door is a good 17th century example consisting of moulded planks, but was extended with a plain board on the left when it was re-used in its current position.

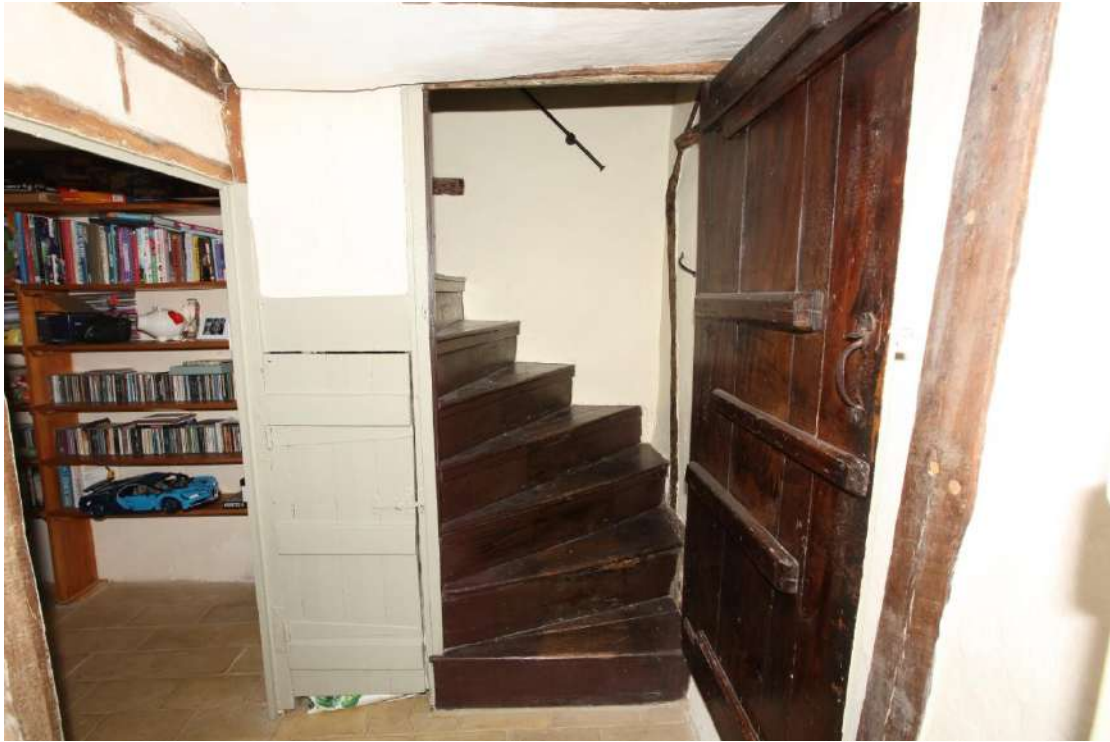
Illus. 11. The corner stair of the eastern cottage which appears to be entirely original to the building, with the re-used plank-and-batten door on the right. A similar stair lay behind the central chimney initially, but has since been rebuilt with a less precipitous incline.

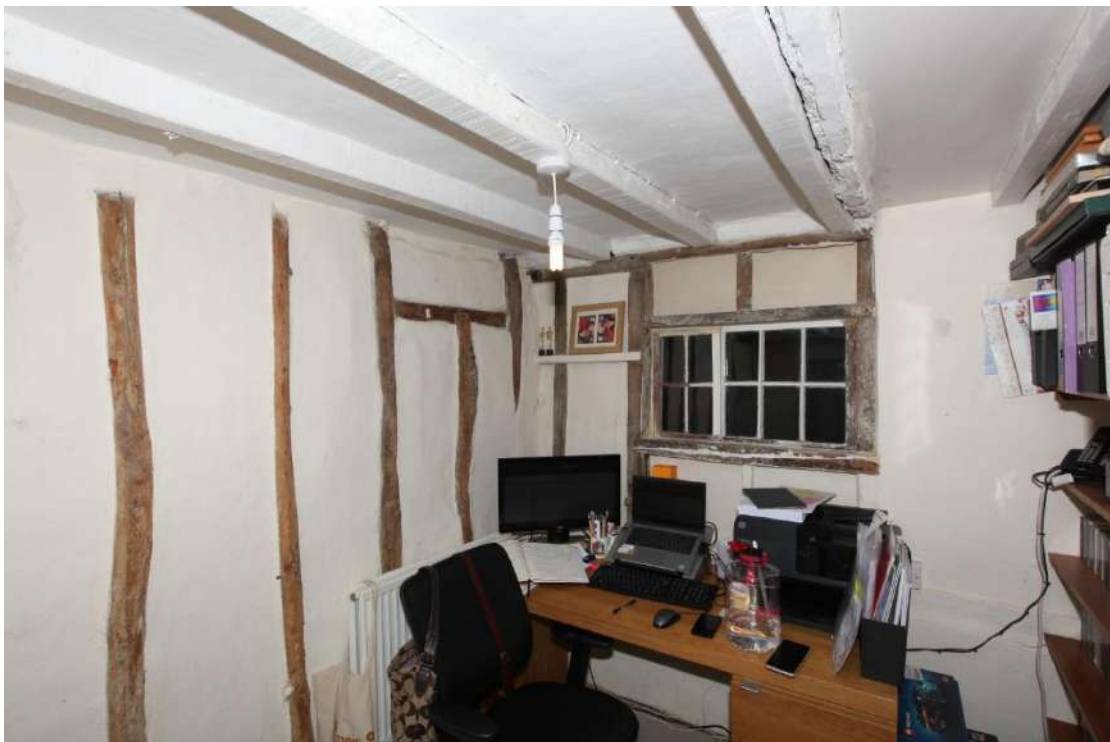
Illus. 12. The study in the north-eastern corner of the building, lit by another horizontal sash window that fits the original wall framing. This room would have operated as a pantry and general storage area, and was directly linked to the main room by the blocked door to the left of the window. This door was later blocked by a short stud nailed to the original door lintel.

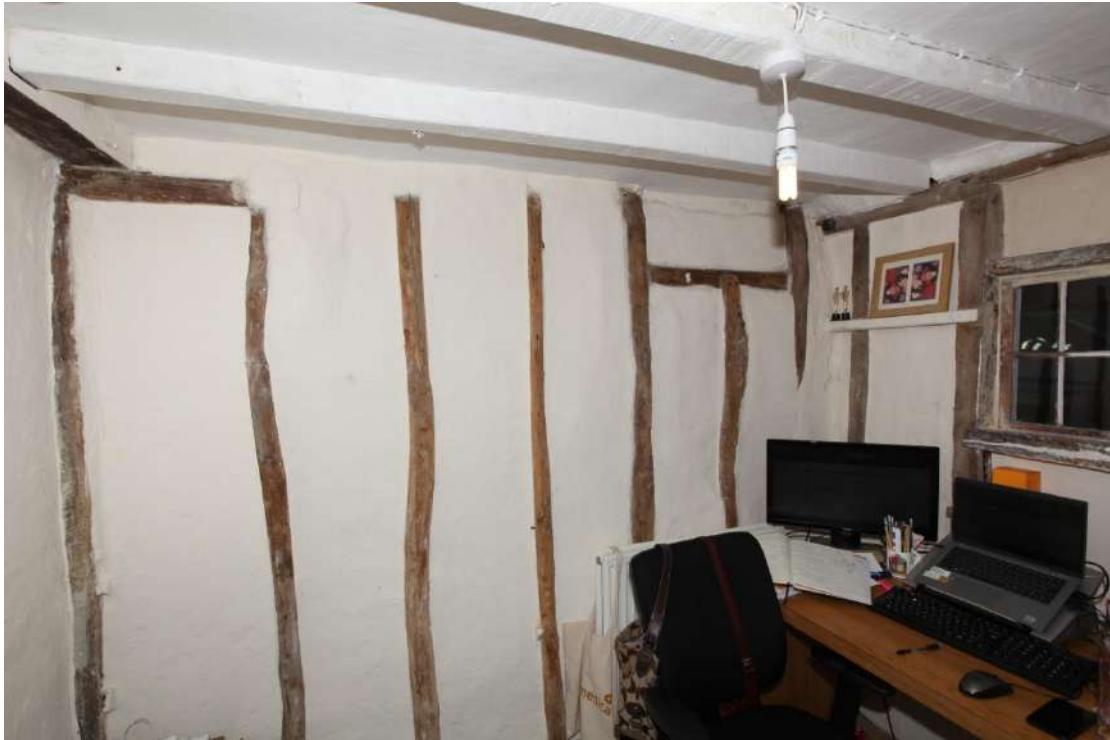
Illus. 13. The ground-floor partition to the west of the former pantry in illustration 12, with its blocked door on the right and the partition adjoining the stair lobby in illustrations 10-11 on the left. These are the only original internal walls to survive on the ground floor. The ceiling consists of common joists tenoned to a central axial joist on the left which is in turn supported by a short rail nailed to the studs. The same lintel presumably supports the narrow axial joist of the living room ceiling, which is constructed differently (with its joists resting on rather than tenoned to the axial joist).

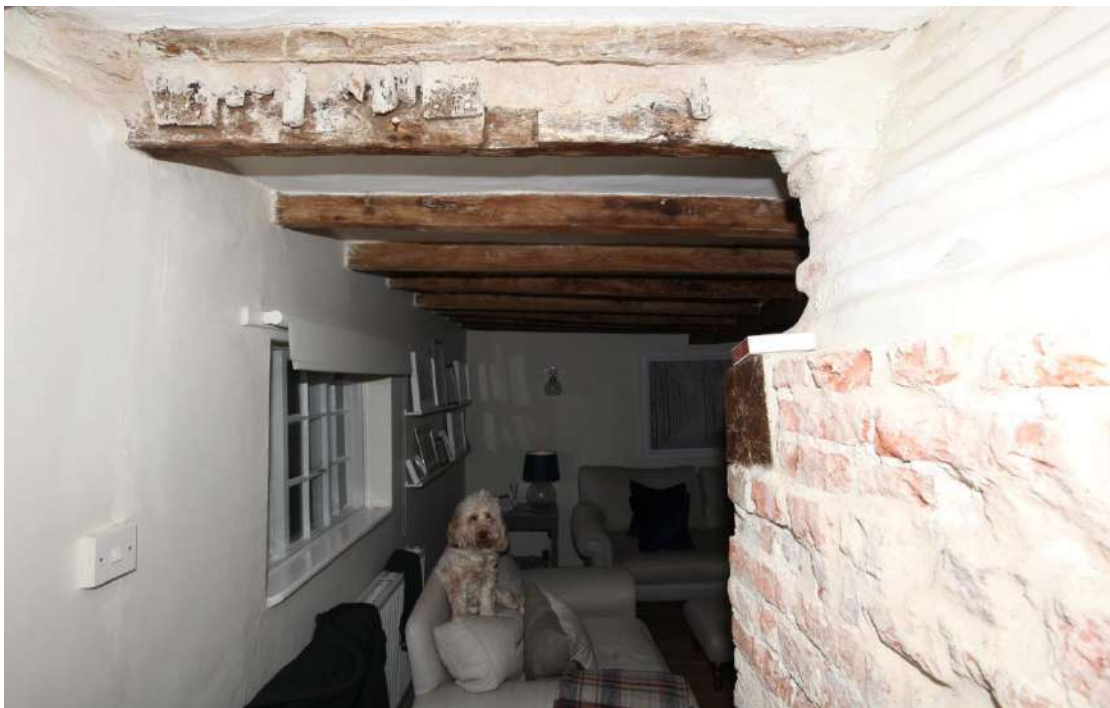
Illus. 14. A detail from the west of the nailed notches for the missing original partition studs between the two cottages, with the remains of wattle-and-daub infill above. The partition remains place on the first floor (to the left in illustration 22).

28). The western stair evidently lay behind the chimney where it remains today, albeit in a rebuilt and enlarged form that explains the narrow new glazed rear door at its foot. The western cottage also appears to have possessed the area in front of the chimney as the remains of the partition between the tenements can still be seen to the east (illus. 14).

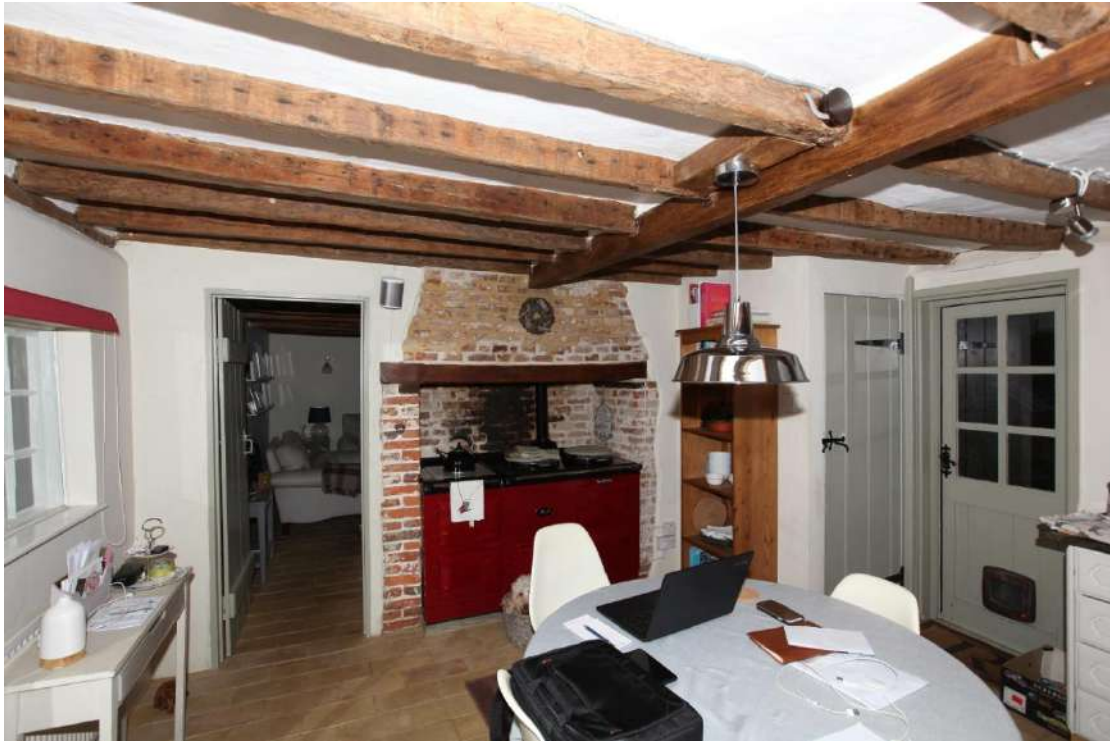
Illus. 15. The original fireplace in the hall/kitchen of the western cottage, matching its counterpart to the east. The unusual ceiling also matches, with re-used joists displaying the scars of lath-and-plaster on their sides. The cupboard-like projection on the right conceals the modern stair which occupies the same position as its predecessor but projects further into the room - hence the narrow width of the modern back door.

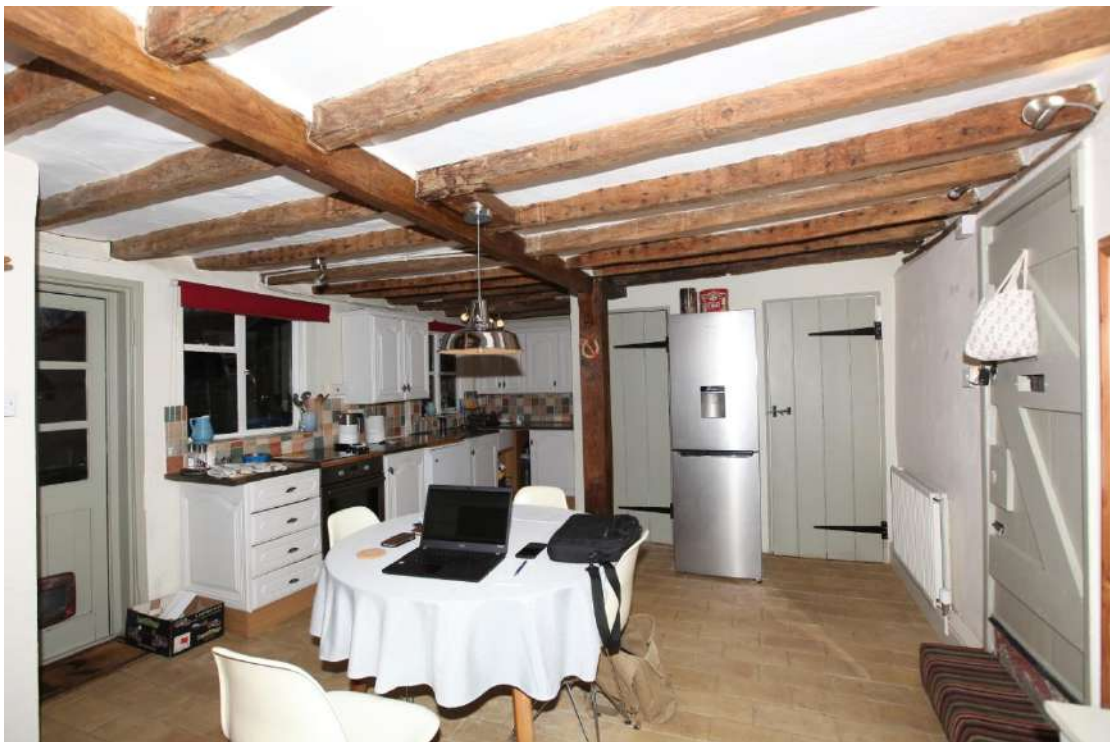
Illus. 16. The modern kitchen in the western cottage, with the original entrance door on the right. The vertical post marks the position of the missing partition between the hall and pantry – and the two ceiling structures. The present pantry and WC partitions in the rear are modern insertions of brick or block-work and plasterboard.

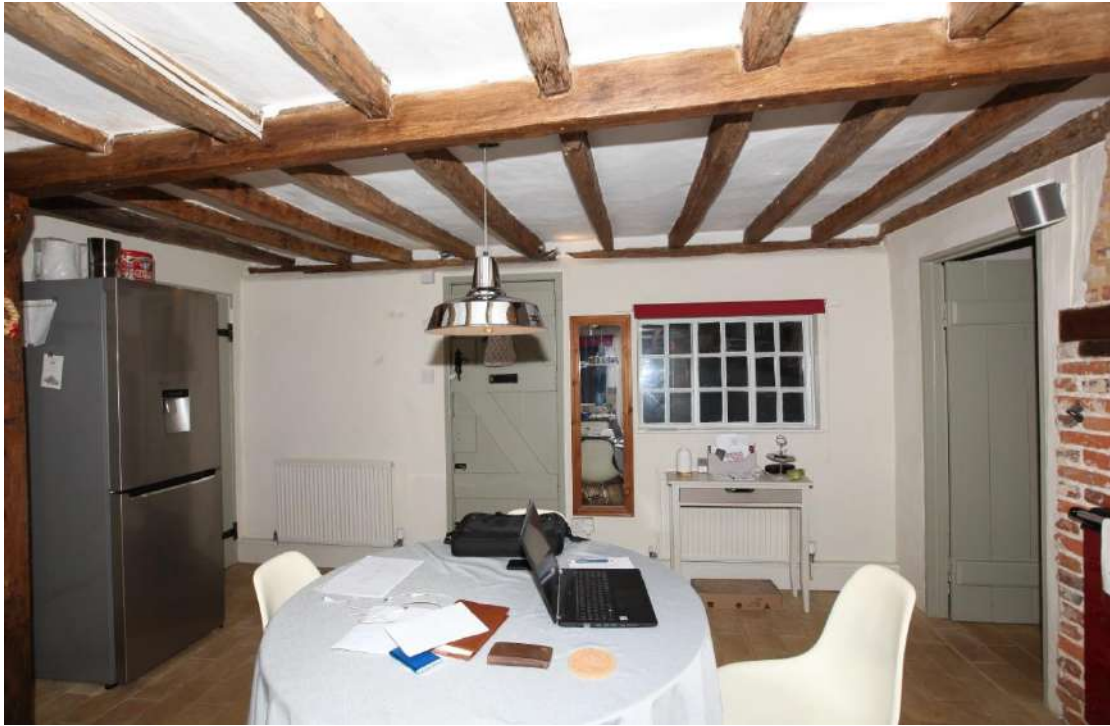
Illus. 17. The front wall of the western cottage showing its original entrance and window positions. The site of the missing western wall is indicated by the post on the left
