The Old Thatched Cottage, Monks Eleigh, Suffolk

Heritage Asset Assessment

March 2022

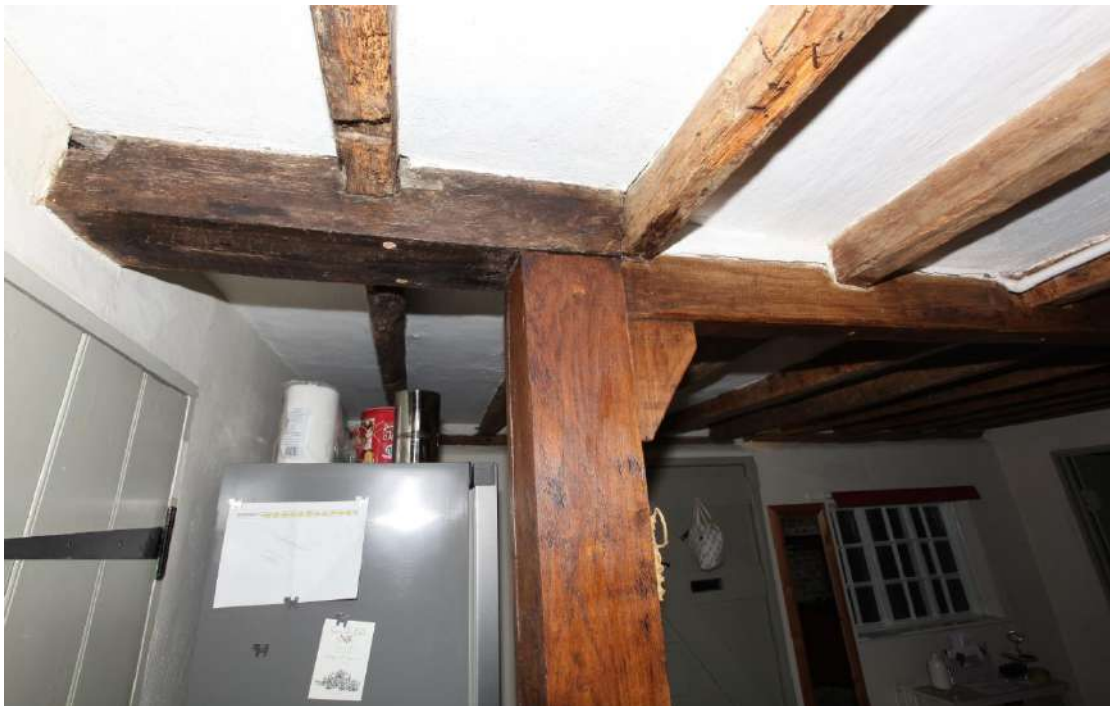
Illus. 18. A detail from the rear of the modern post which supports the two axial ceiling joists in the western cottage. The same task was originally performed by a studwork partition matching that in illustration 13, the notches of which are visible in the common joist immediately above. The common joists are all re-used, retaining nails, mortices and notches from their former lives, but those to the left are tenoned to a substantial axial joist while those on the right span the building and are supported by a narrow length of pine in the centre. The pine has been abraded and cleaned to the west of the chimney, producing a modern appearance, but preserves its original surface on the east.

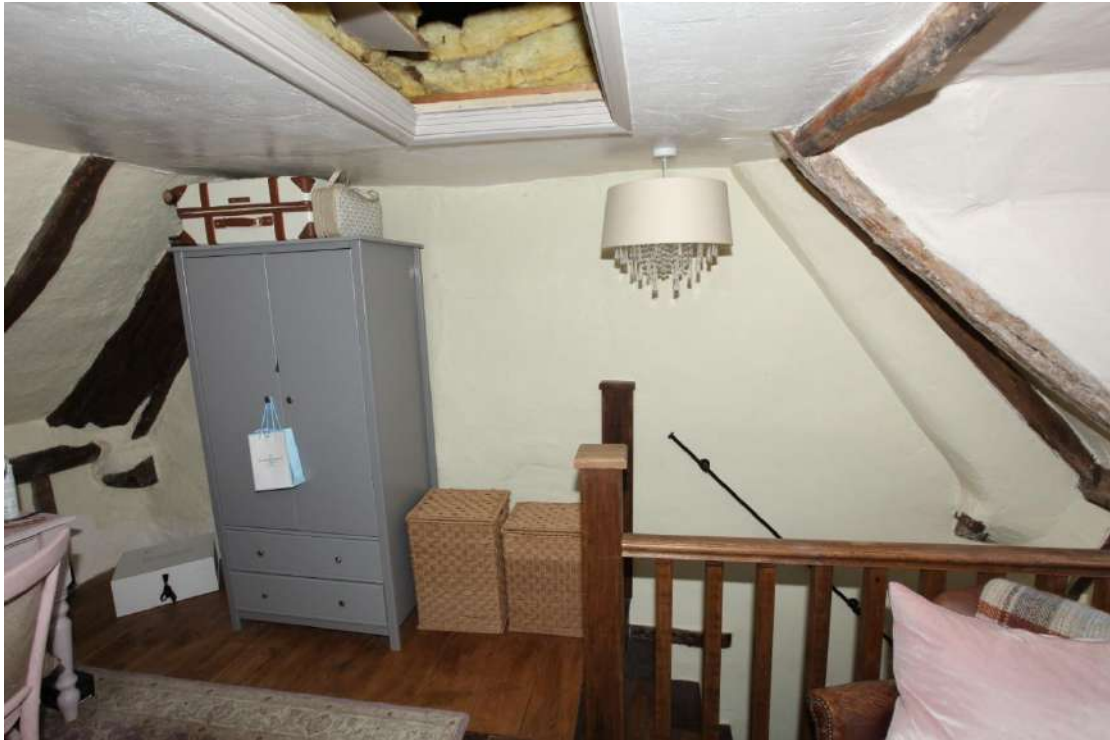
Illus. 19. The eastern internal gable of the structure on its upper storey. The timber-framed walls were simply built against the earlier cottage with no separate gable of their own. The projecting, weathered ends of the neighbouring building's roof-plates are clearly visible to left and right, having form an external wall prior to the addition of The Old Thatched Cottage.

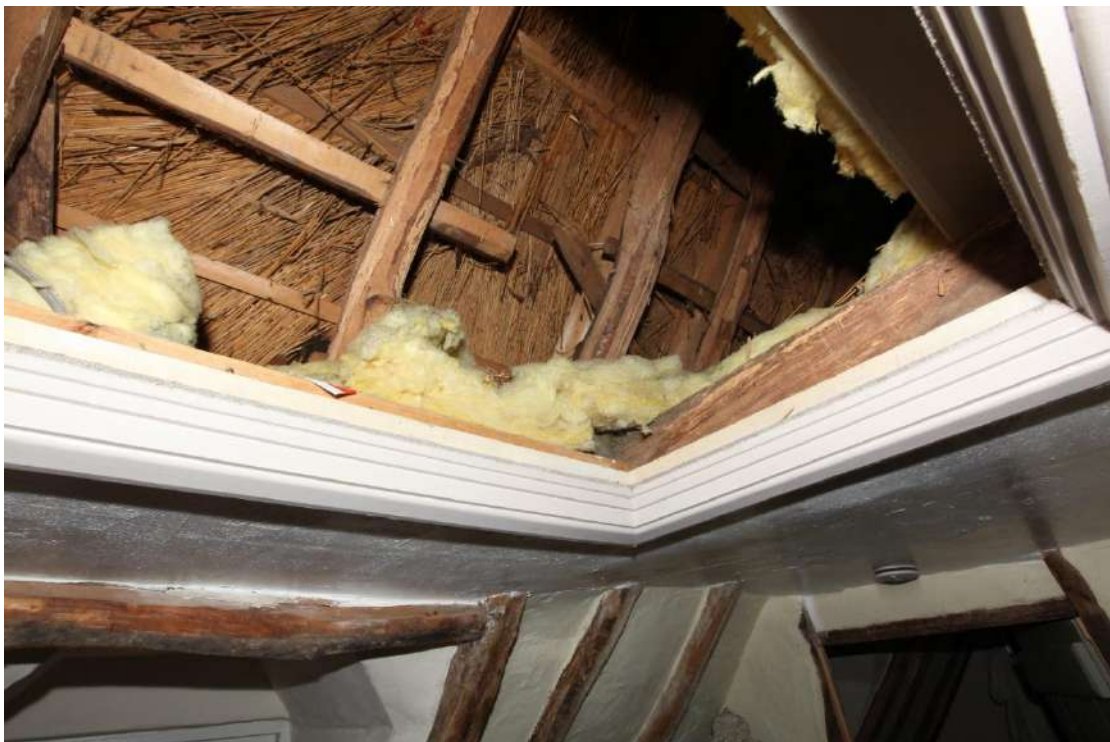
Illus. 20. The original clasped-purlin roof structure survives intact (as seen from the easternmost bedroom in illustration 19). In contrast to the external walls there is no evidence of re-used timber, but many of the rafters are unusually slender and new softwood rafters have been inserted alongside.

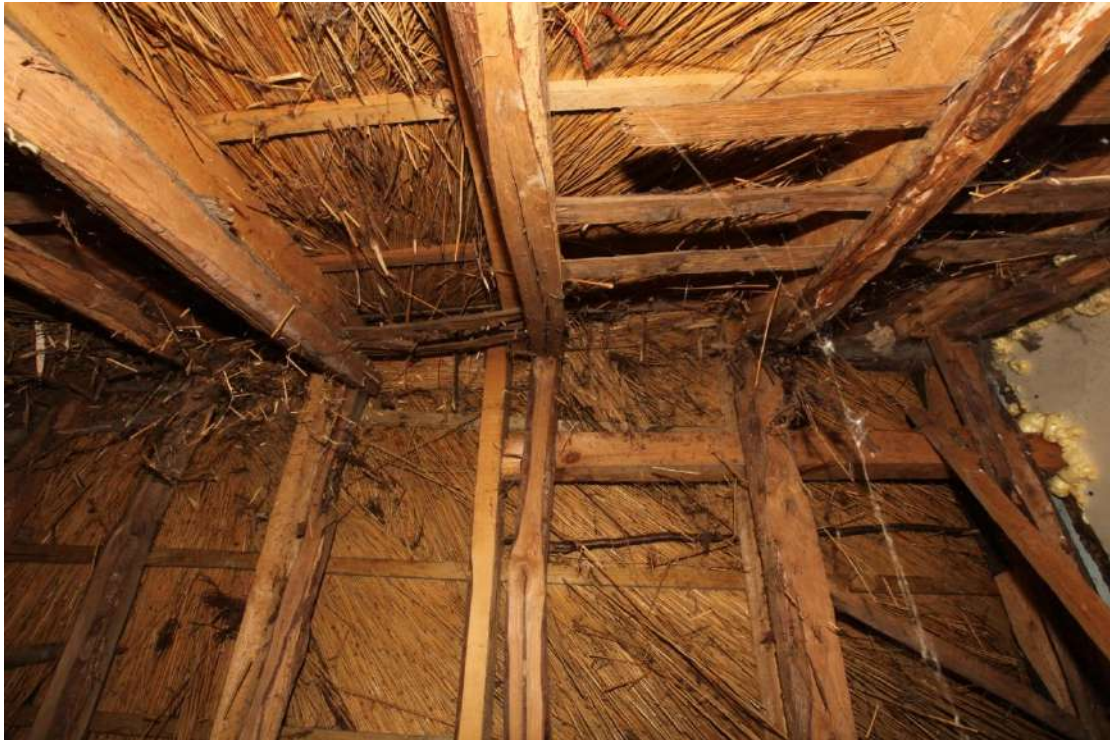
Illus. 21. A detail of the roof showing the plasterboard-clad eastern gable on the right. The size of the original rafters varies considerably, with some like those on the left no more than 2 inches square at the apex, but all are neatly pegged where they overlap.

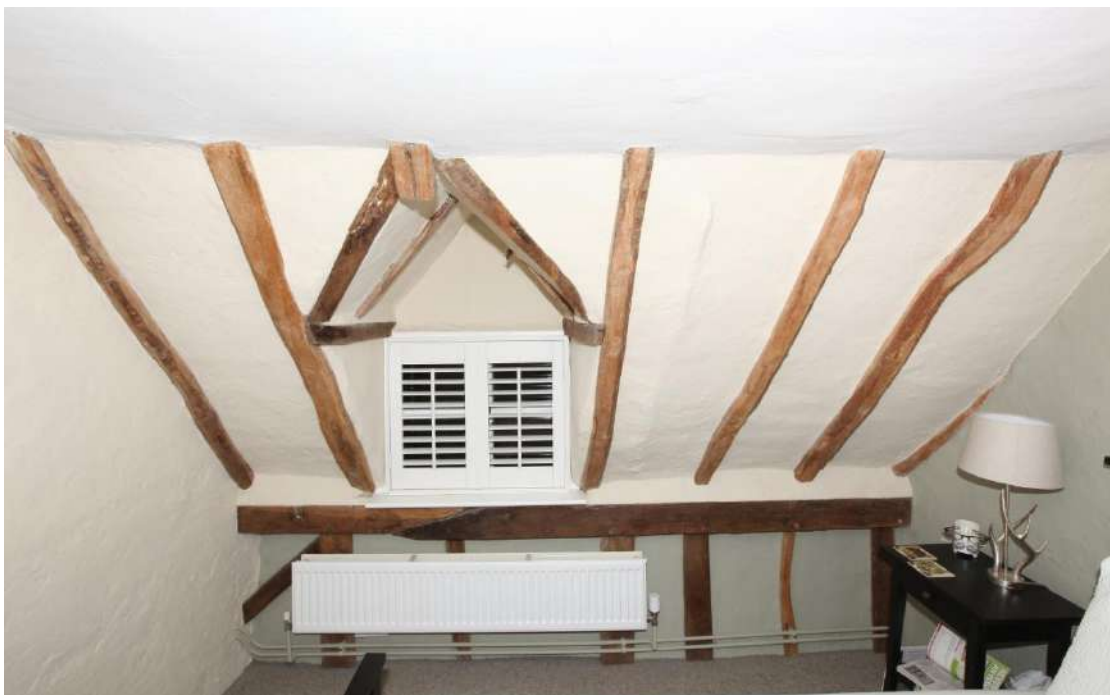
Illus. 22. The front (northern) wall of the bedroom above the living room in the eastern cottage with the original partition against the chimney and western cottage to the left. The rafters consist of slender branches with waney edges that retain much of their bark. The wall timbers, in contrast, are largely re-used from older structures and are more substantial, although some studs such as the thin example to the right are similar to the rafters (and are not re-used). The timbers of the six dormer windows all appear to be contemporary with the building.

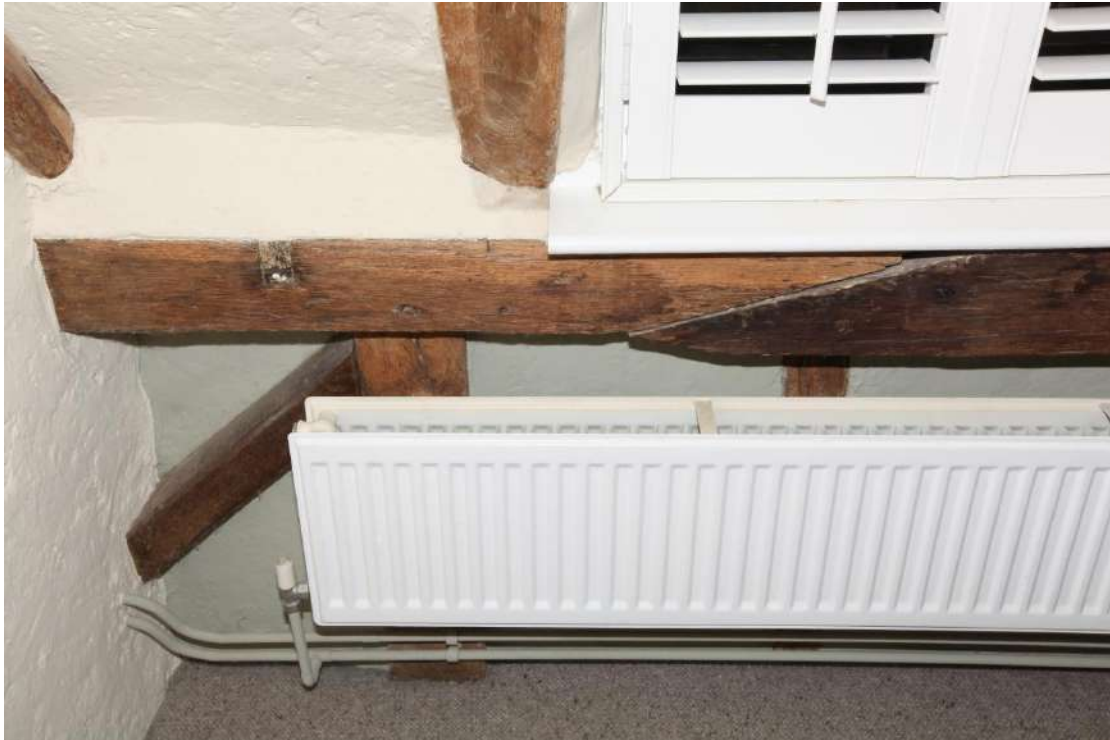
Illus. 23. A detail of the wall framing in illustration 20 showing a crude, diagonally splayed scarf joint with a re-used section of roof-plate on the left containing a dovetail joint for a tie-beam that is not matched in the opposite plate to the rear. The straight, diagonal primary braces interrupt the vertical studs and are nailed rather than pegged to the frame. These features all indicate a date towards the end of the framing tradition.

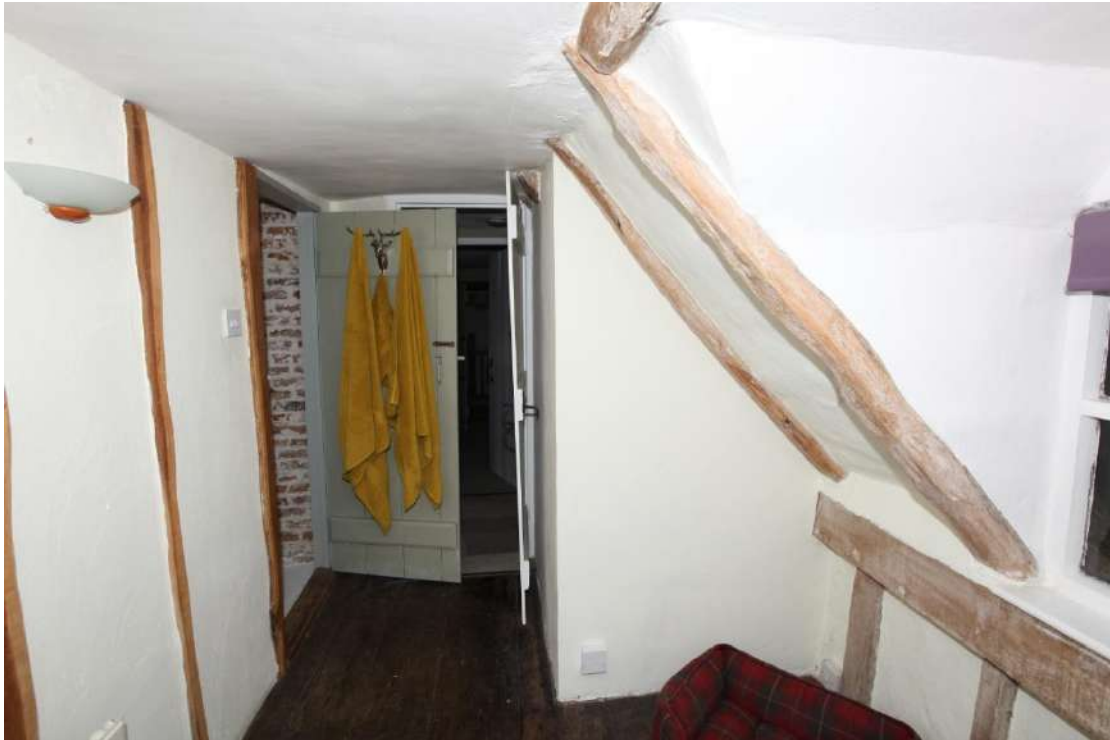
Illus. 25. The bedroom above the western hall/kitchen looking east towards the chimney and the partition enclosing the modern stair. The wall to the left is a modern insertion consisting of unpainted studs intended to replicate the originals and now forming the southern wall of a bathroom.

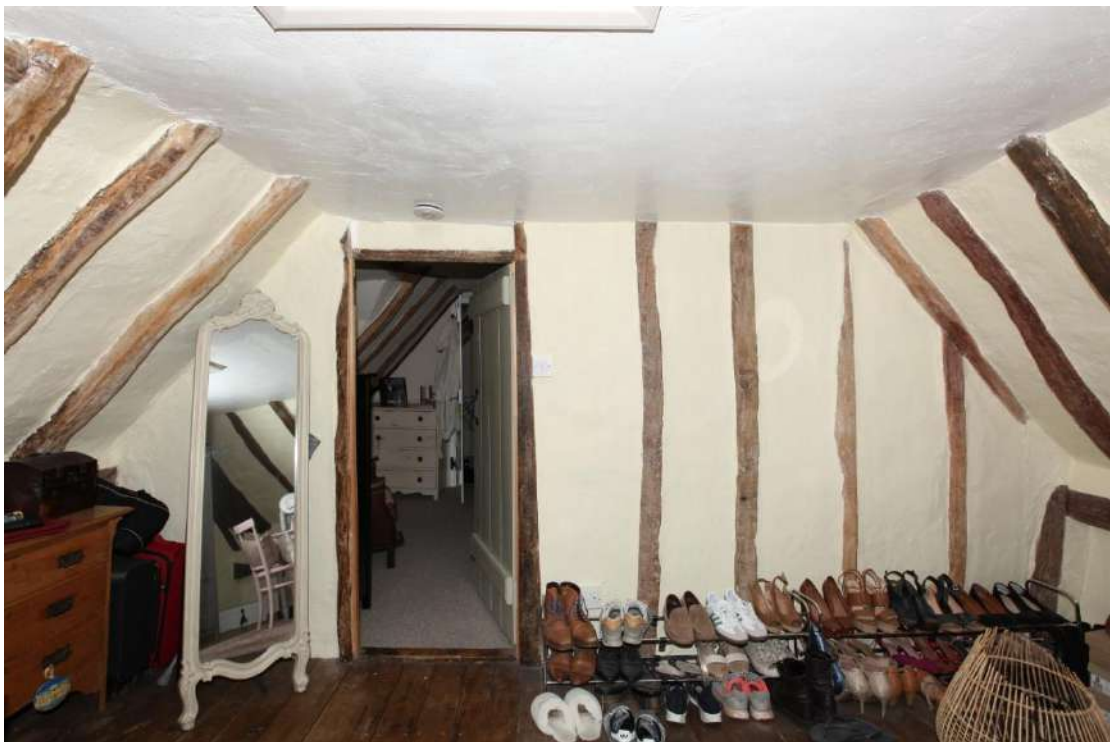
Illus. 26. The original partition of the eastern cottage, as seen from the east, showing its exposed studwork and the original connecting doorway to the western bedroom of the same cottage. The two first-floor partitions did not lie above the pantry walls on the lower storey but were placed centrally to create bedrooms of equal size.

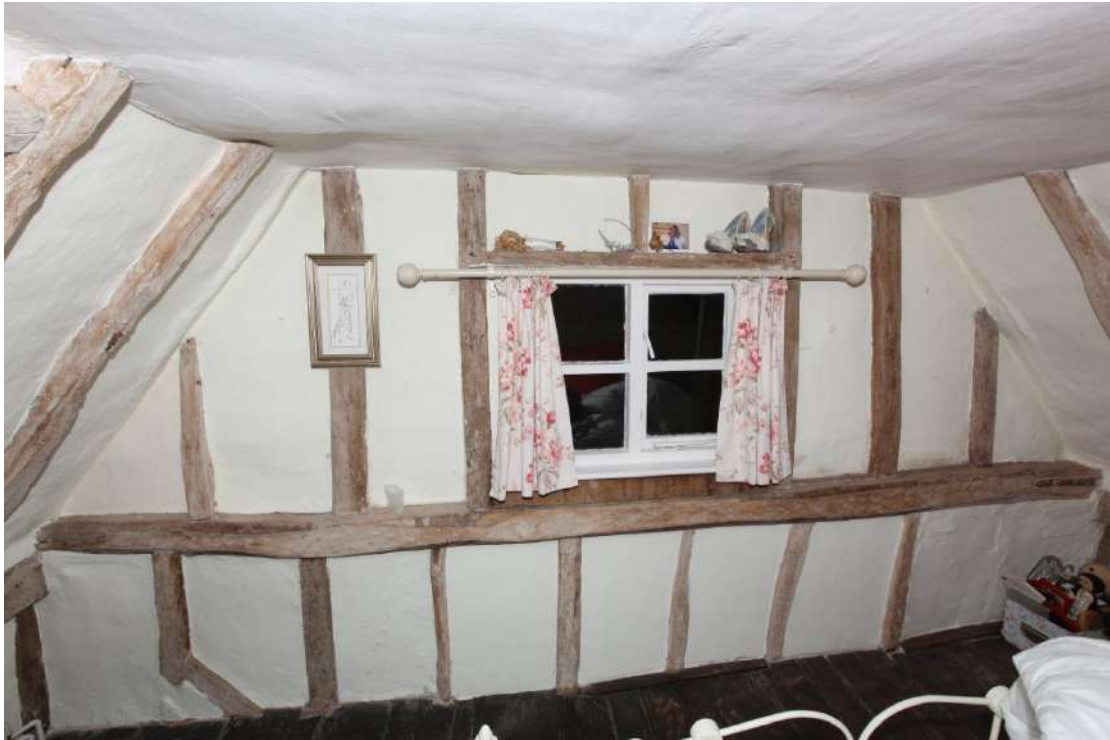
Illus. 27. The intact original studwork of the western gable with the top of a nailed diagonal primary brace visible to the left.
