Bat Roost Assessment

BE-1715-01B

Brigate Mill, Windmill Road, North Walsham,
Norfolk, NR28 9LT

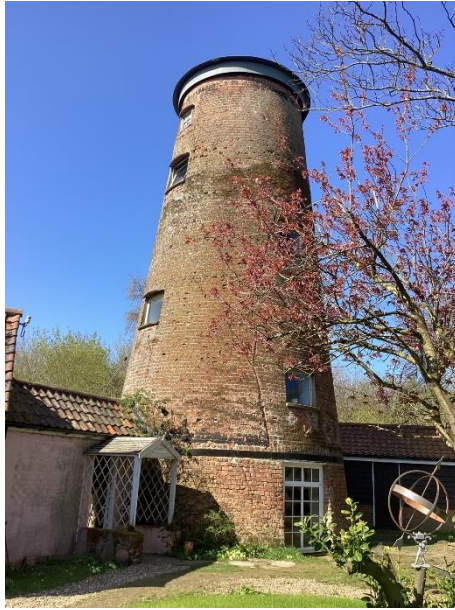
Plate 1: Building 1

Building 1 consisted of a three-storey mill, which had previously been converted into residential use but had internally fallen into a state of disrepair. The brickwork on the exterior of the building was good, with no visible gaps. The building had a metal roof. There were large gaps between the brickwork and the metal capping, where nesting jackdaws (*Coloeus monedula*) could be observed. The interior of the building was well-lit by windows on all floors. The interior of the roof had been boarded with plywood and was well-sealed, with no potential access points suitable for bats. Due to the absence of any potential access points for bats, Building 1 was considered to have negligible potential for roosting bats.

2. Works to Building 1 must either avoid the bird nesting season (1st March – 31st August) or be carried out within this period only if a further survey by a suitably qualified ecologist has confirmed that nesting birds are absent.

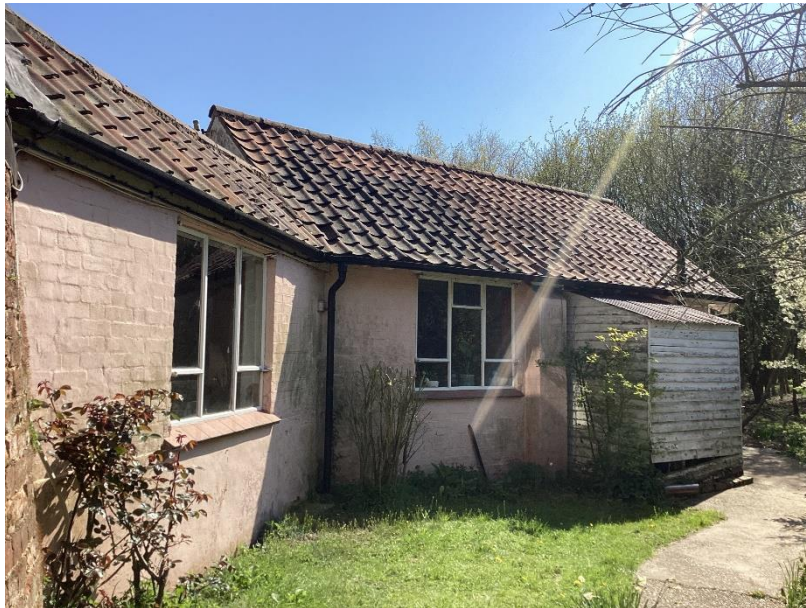
Plate 4: Building 2, south aspect

Building 2 consisted of a single storey outbuilding with a pitched pantile roof, connected to Building 1 by a smaller pitched roof. The brickwork was painted, with no visible gaps. There were no soffits or fascia boards below the eaves. The ridge tiles appeared well-sealed, although there were numerous gaps under the roof tiles on both aspects which could provide opportunities for cavity roosting bats. Weatherboarding at the gable ends was well-sealed. An inspection of the roof void found it to be approximately 1.2m high. The interior of the roof tiles was lined with straw and the interior of the roof void was highly cluttered with cobwebs. No signs of roosting bats were identified. It was evident that bats weren't using the roof void, however due to the presence of lifted tiles on the exterior of the building, Building 2 was considered to have low potential for roosting bats.

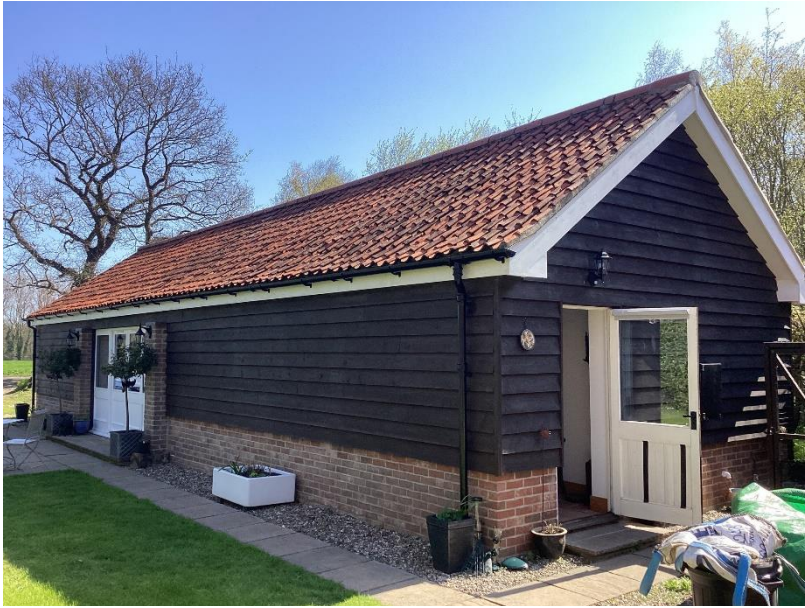
Plate 7: Building 3, south and west aspects

Building 3 consisted of a single storey residential building with a pitched roof. The building was constructed of brick and clad in timber, which was well-sealed. Soffit boxes on all aspects were in good condition, with no visible gaps. There were several gaps under the pantiles on both aspects of the roof. The interior of the building consisted of two rooms. The main living room and bedroom to the north was open to the roof and well-lit inside. To the south was a bathroom, above which was a small roof void. The roof void had breezeblock gables and was lined with bituminous roofing felt, which was well-sealed and with no evidence of bats. It was evident that bats weren't using the roof void, however due to the presence of lifted tiles on the exterior of the building, Building 3 is considered to have low potential for roosting bats.

3. No works are to be carried out to the roof of Building 3. If any works are required to the roof, a further activity survey must be carried out to determine presence/absence of bats. If bats are found to be present, a Natural England EPSML will be required.

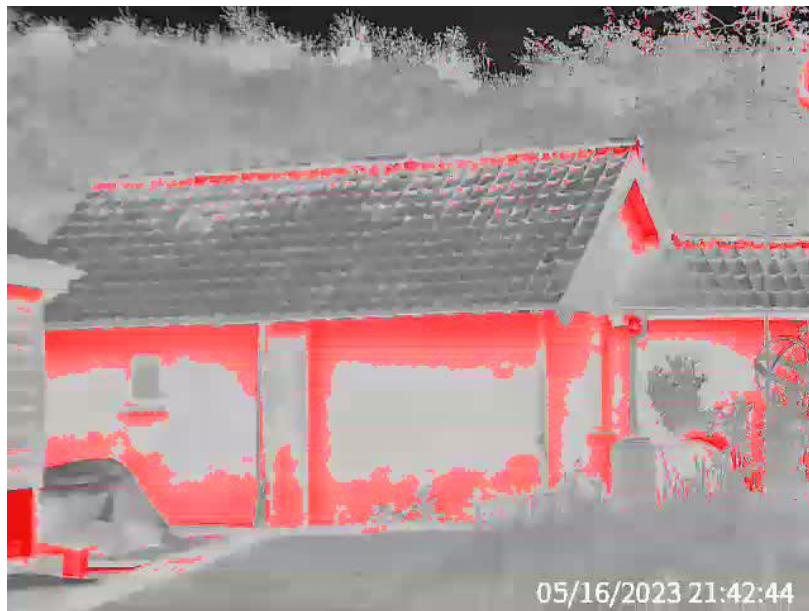
Plate 10: Building 2, still from thermal imaging footage

No bats were observed emerging from or re-entering Building 2 during the first activity survey. Bat species, including common pipistrelle, soprano pipistrelle, Nathusius' pipistrelle (*Pipistrellus nathusii*) and noctule (*Nyctalus noctula*) were observed commuting and foraging over the site. The first bat was recorded at 20:52, eight minutes after sunset. Following this, bats could be heard within the woodland to the south of the site and could be viewed commuting along the treeline to the north of the site throughout the survey. With the exception of this, activity within the site boundary was relatively low, confined to several passes to the north of the buildings.

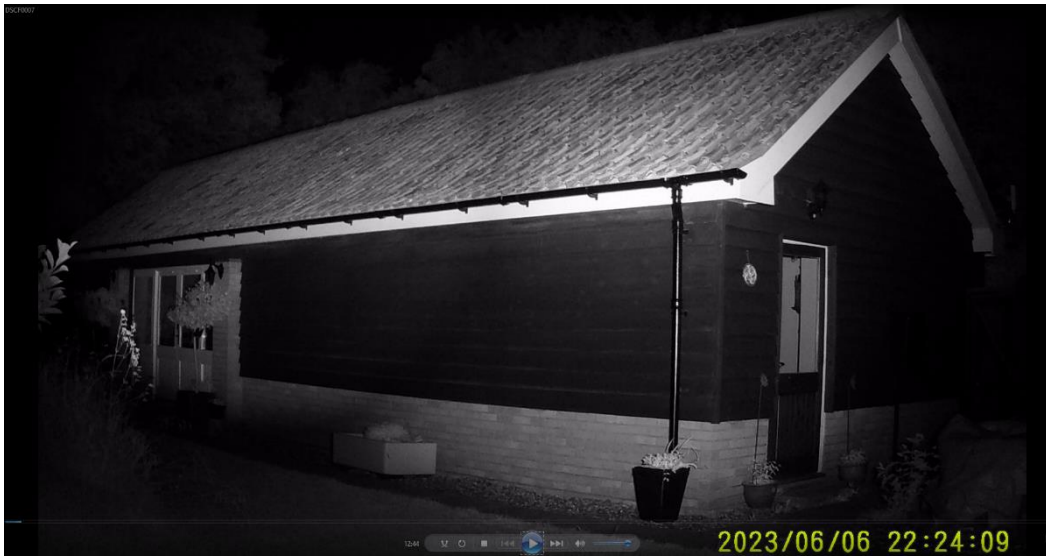
Plate 10: Building 3, still from infrared footage

No bats were observed emerging from or re-entering Building 3 during the second activity survey. Bat species, including serotine, common pipistrelle, soprano pipistrelle and noctule were observed commuting and foraging over the site, predominantly along the tree line at the south boundary (with the exception of noctule and serotine, which were audio records only). The first bat was recorded at 21:34, 21 minutes after sunset.

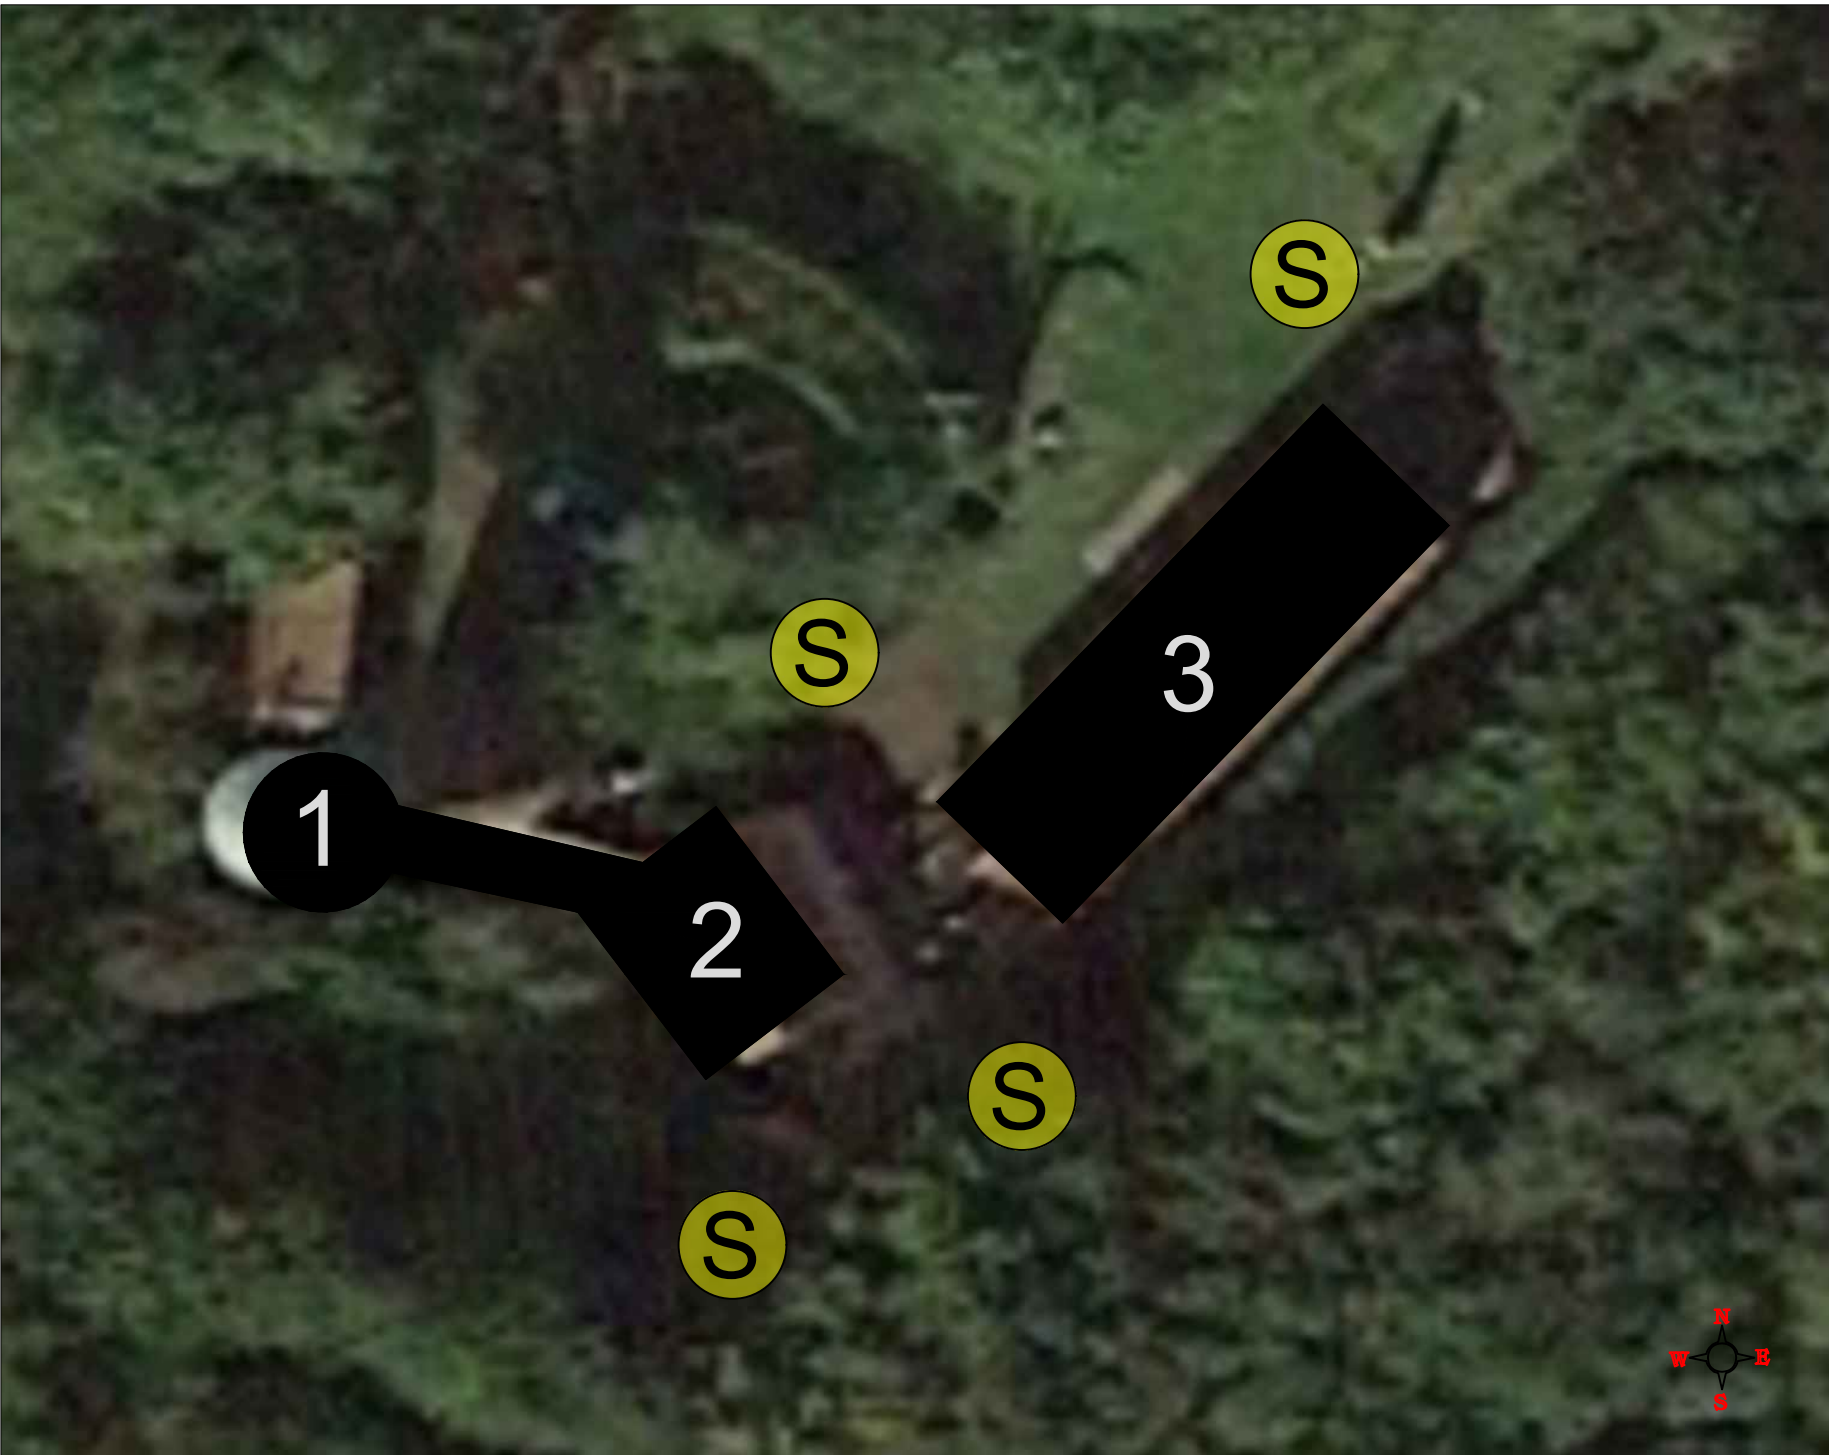
Drawing title:	Bat Survey Plan
Project:	Briggate Mill
Drawn by:	David Watts
Date:	07/06/2023
Scale:	1:200 @ A4

Table 2.2, below, shows a summary of the survey details. Surveyor locations are shown in *Appendix 2: Survey Plan*.
