Bat Survey and Mitigation Strategy

**Park Farm, Worlds End Lane, Buxhall
Stowmarket, IP14 3EB.**

Survey Commissioned by:	Mr Paul Canham
Project Number:	REP23005
Report issued:	6 th July 2023
Date of surveys:	Emergence surveys: 17 th May, 9 th June, and 25 th June 2023 Static Monitoring: 17 th May to 9 th June 2023
Project Ecologist:	Odette Robson BSc (Hons) PhD MCIEEM

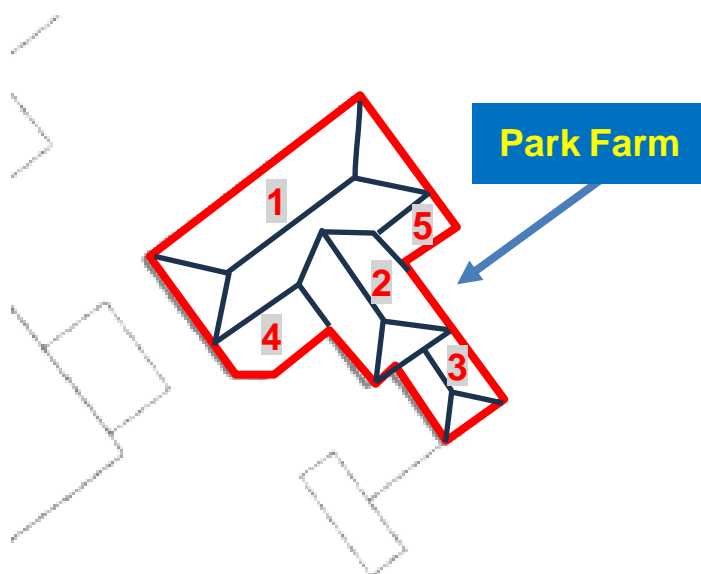
Figure 3.1: Park Farmhouse – roof section numbering.

A preliminary roost assessment was carried out at the property, including the loft, on 15th February 2023. Descriptions in Table 3.1 refer to numbers/locations shown in Figure 3.1 below.

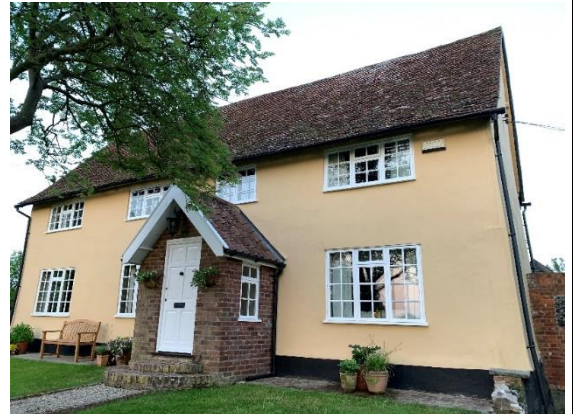
1) Main (Original) House - External.

An C17 two-storey timber-framed gabled house, externally rendered, with a clay peg-tiled roof and end chimney stack to the north-east gable. Roof tiles were largely intact, but lifting and slipped in places, particularly along the ridge.

Extended on the south-eastern elevation.

Glazed windows were intact and well-sealed into their surrounds.

The Farmhouse roof is currently in a poor state and re-roofing is necessary to maintain the property and prevent future leaking/damage to the historic building.

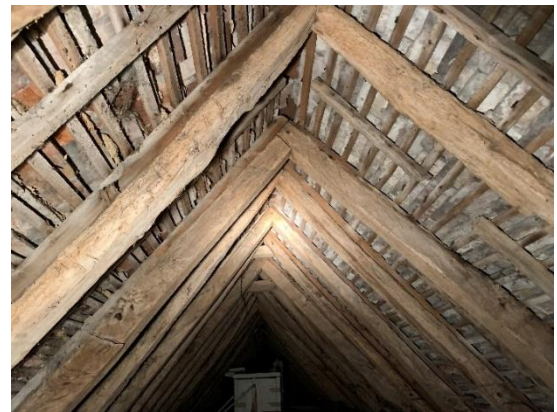
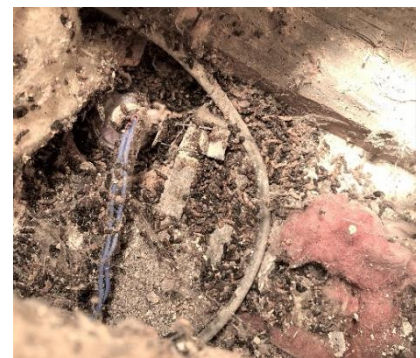
1) Main (Original) House - Internal

Internally, the loft was heavily cobwebbed below the ridge to the northern end, but clear at the ridge to the southern end. Old timbers with no ridge-beam. A number of slipped and lifting tiles caused draughty internal conditions. Most of the void was not lined, with tiles laid directly to roof timbers and daylight showing in places. Part bitumen felt lining on the south-eastern roof slope (northern end). An internal water tank obstructed flight, though the loft was largely uncluttered by roof timbers/trusses and open. Approximately 3m height and lagging insulation throughout.

Approximately 200 medium-sized droppings (likely brown long-eared) were located in a discrete accumulation under the ridge beam, with a further 100 scattered throughout the loft, consistent with internal flight or occasional roosting. The droppings were of mixed age and likely to have accumulated over a number of years: Some droppings were very old, grey and desiccated; others were relatively fresh and likely to have been from the most recent active season.

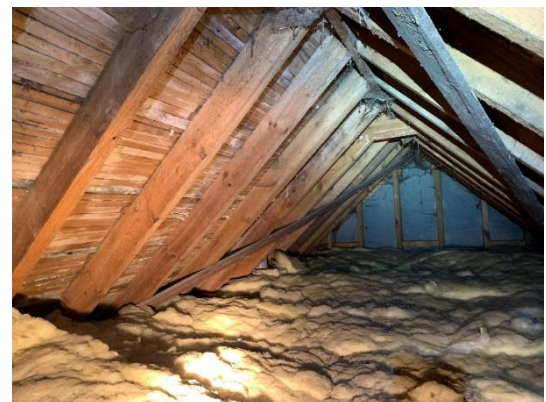
2) Two-Storey Extension

Pan-tiled Victorian extension with double-pitch roof: Roof and ridge tiles well-sealed and intact.

Internally, the loft void interconnects with the main/original roof void. Narrow void (approximately 1m height), with no crevices between roof timbers - lath and plaster roof lining. Lagging insulation. No signs of bats using the void, and no potential egress/access points due to sealed roof lining.

Not scheduled for re-roofing.

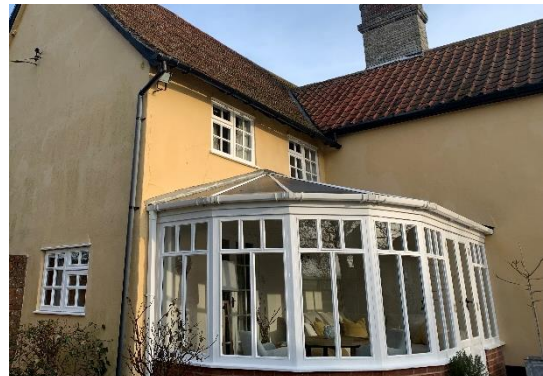
4) Conservatory

Attached to the walls of TN1 and TN2.

Negligible potential to support roosting bats, and will not be impacted (directly or indirectly) by the proposed re-roofing of main roof (1).

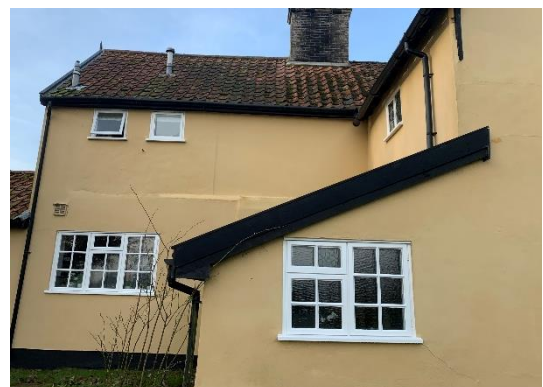
5) Single-storey lean-to extension

Mono-pitched roof. This roof void was not inspected as it will not be impacted (directly or indirectly) by the proposed re-roofing of void #1.

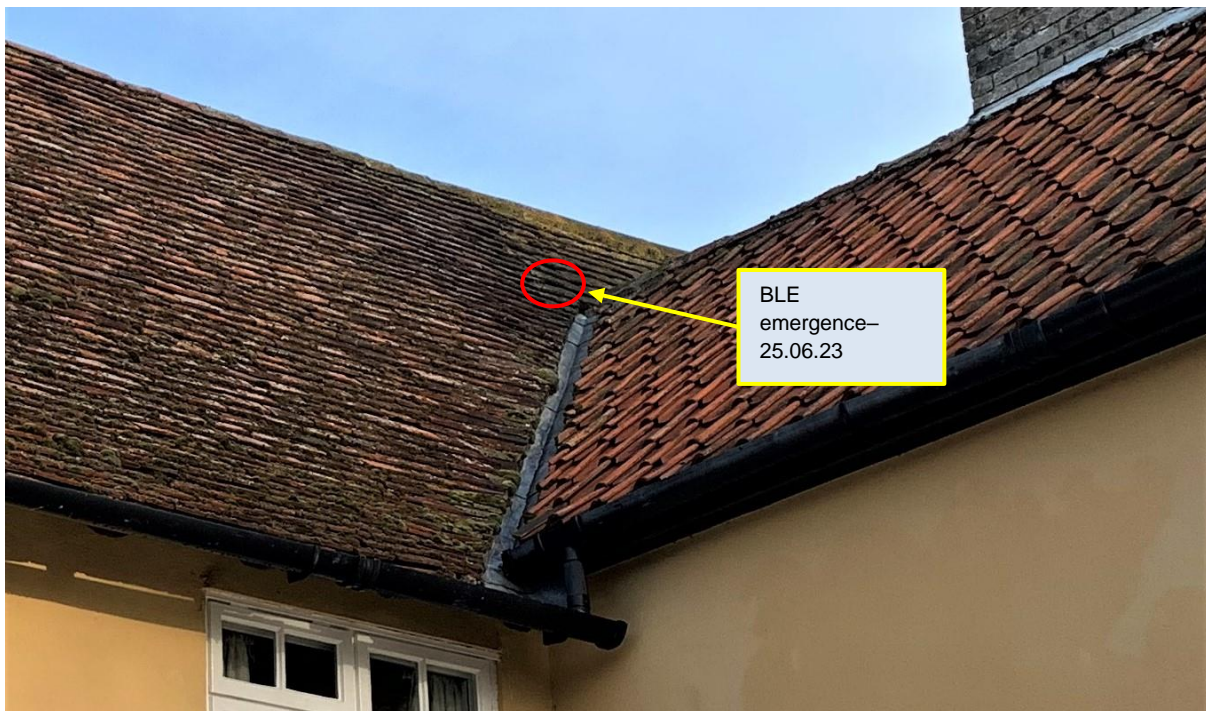
A single brown long-eared bat emerged from the south-east facing slope of the main (original) House roof at 89 minutes after sunset – flying to the south-west and around the SW-facing gable end.

Plate 3.6: Emergence point on south-eastern slope of main roof – brown long-eared on 25/06/23.

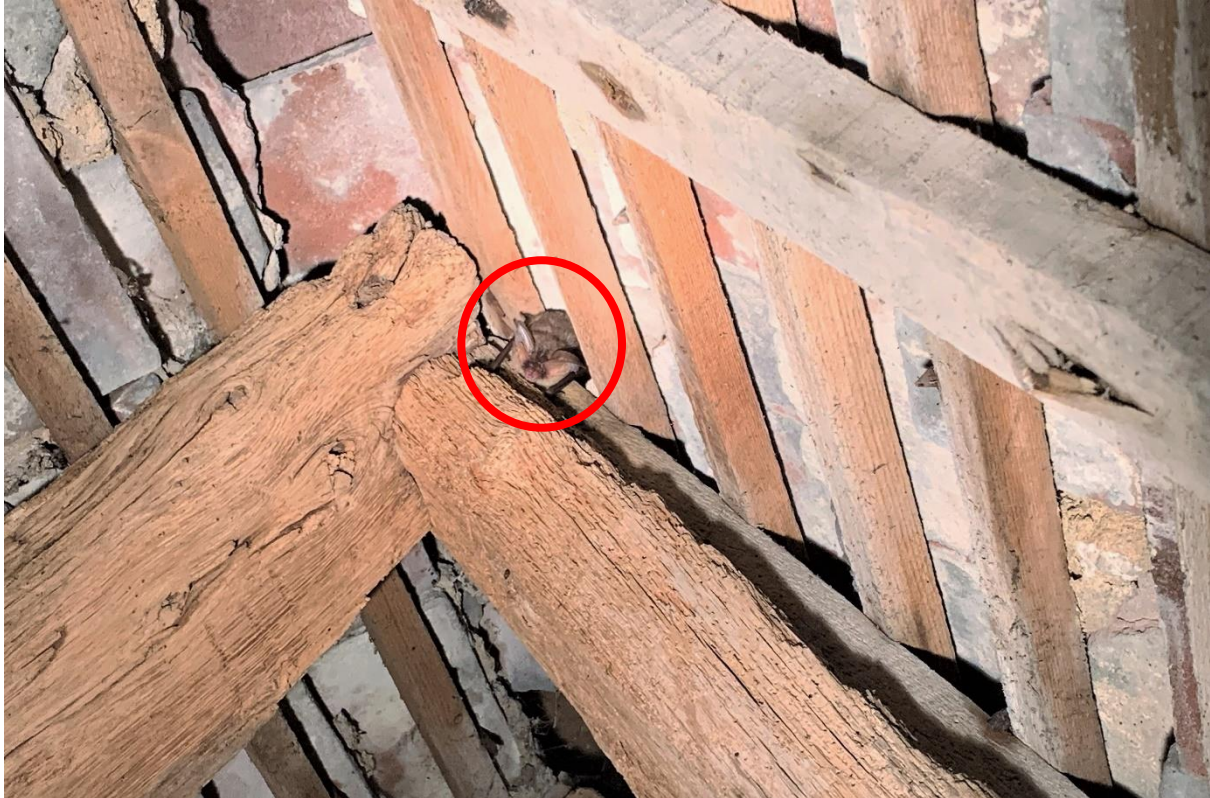
A single brown long-eared bat was roosting close to the ridge in the loft during a pre-survey inspection. Very low number (<10) of fresh droppings beneath roost location.

Plate 3.7: Roosting brown long-eared bat (main roof) – 25th June 2023.

The loft-void will be reinstated and remain as a bat roost on completion of the re-roofing. The roof timbers will not be changed, however, a roofing membrane (bat-safe/bitumen felt) will be used, modifying the internal roosting conditions.

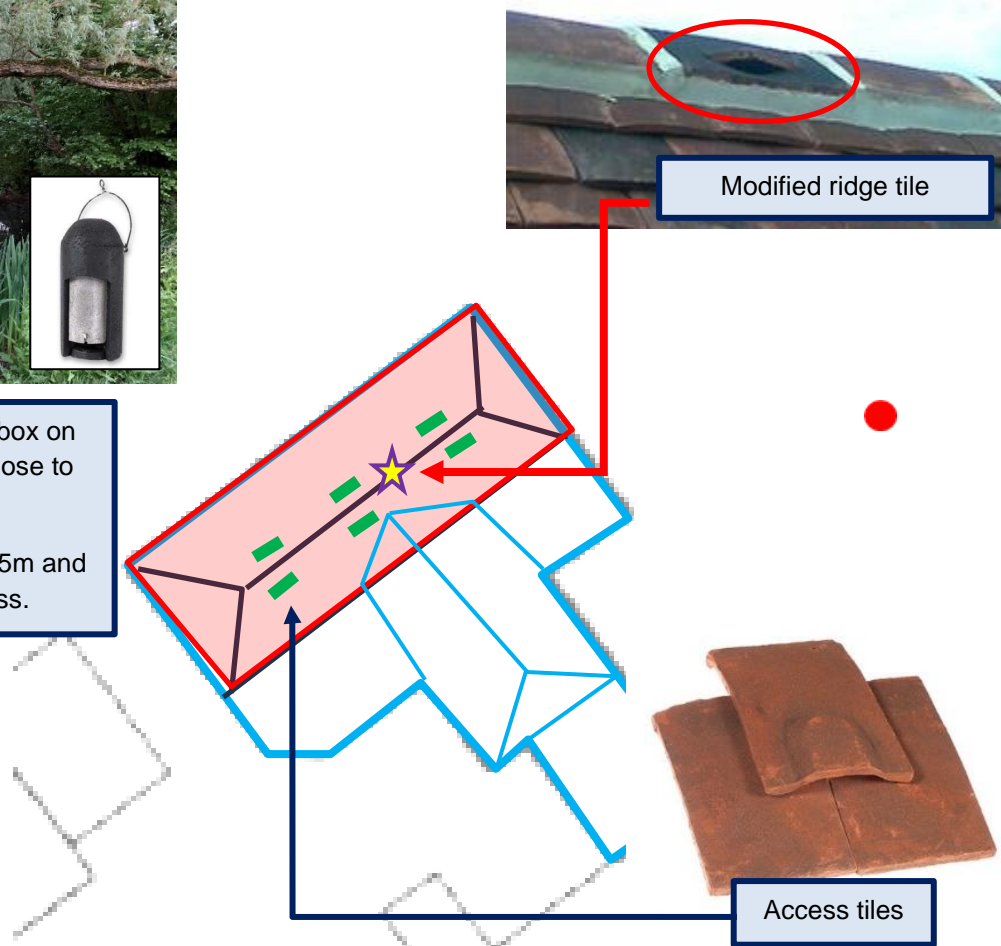
Schwegler 2FN (x1) bat box on mature tree in garden (close to pond and House)
Facing SW or SE; above 5m and with open flight access.

Schwegler boxes are built using wood-concrete; an exceedingly durable, rot-proof and breathable natural material designed to mimic the properties of natural nest sites.
