PRELIMINARY ECOLOGICAL APPRAISAL

St Marys House
Church Street
Bentworth
GU34 5RD

Revision 2: 13TH DECEMBER 2022

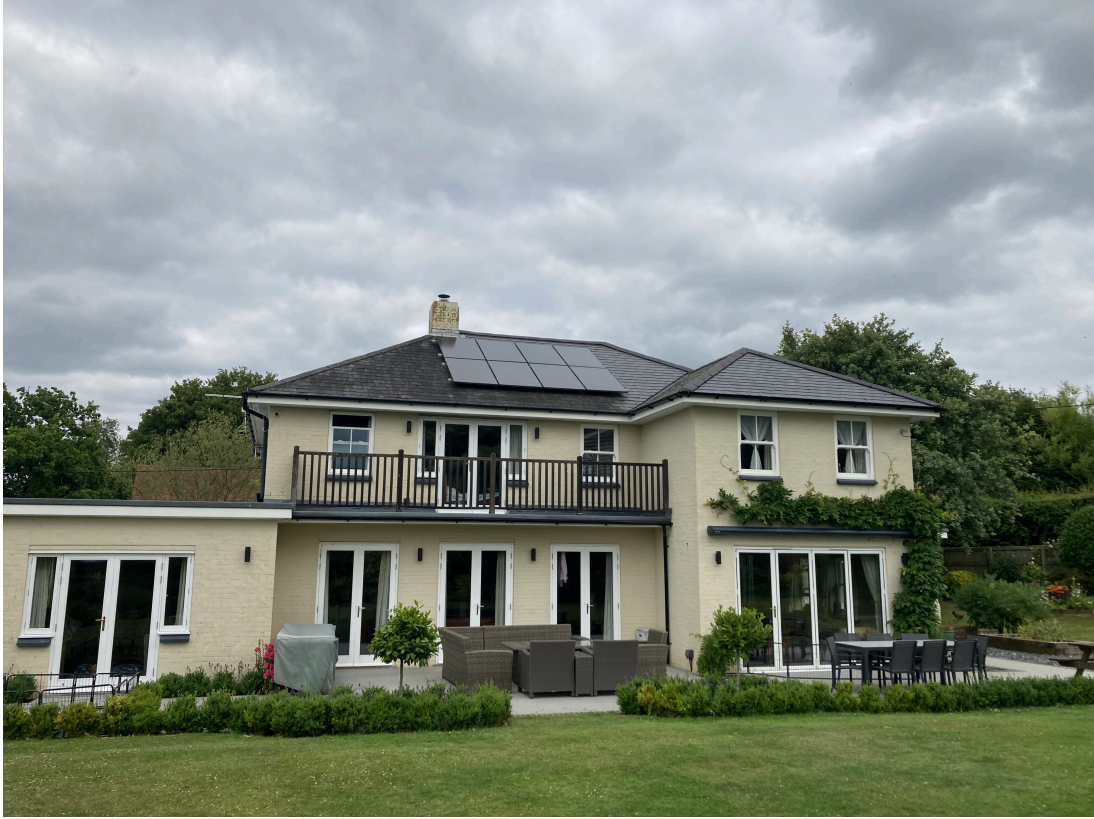
- 3.4. The house is a two storey residential property of brick construction with a multiple pitched hipped roof clad in slate. A single storey flat roof extension is present on the northern side. The windows, doors and soffits are of uPVC construction and are in good condition with no gaps (Photographs 1 and 2).
- 3.5. Internally the roof space is lined with sarking boards and breathable membrane with no gaps visible (Photograph 3).

Photograph 1: Eastern side of building.

- 3.6. The house is well sealed with no gaps suitable for roosting bats visible. The majority of the roof is clad in slate tiles which are tightly fitted. The ridge tiles are clay and are tightly bonded to the roof. No evidence of bat activity was recorded either inside or on the external building surfaces.
- 3.7. In accordance with previously cited guidelines (Collins, 2016) the building was assessed as being of **negligible suitability** to support roosting bats.
- 3.8. The house is situated within a garden which contains several mature trees, and which is connected to suitable adjacent habitats. This area is considered suitable for foraging and commuting bats. However; it should be noted that the garden is not affected by the proposals. The proposed extensions will extend onto existing hard landscaping only.

4.1. No evidence of bat activity was recorded during the preliminary roost inspection. In addition, no gaps suitable for roosting bats were recorded on the building and the building is assessed as having negligible suitability to support roosting bats.

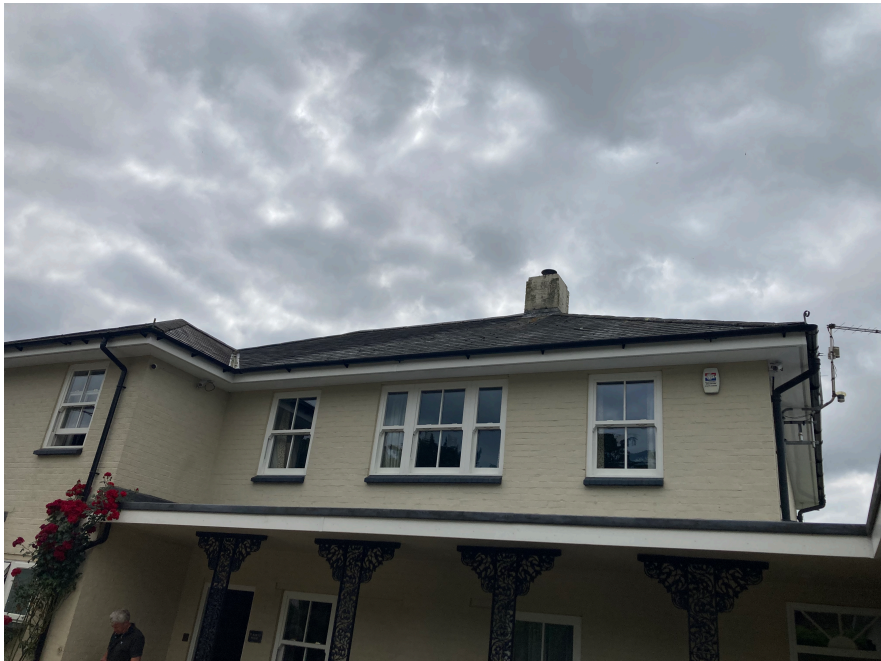
Photograph 2: Western side of house.

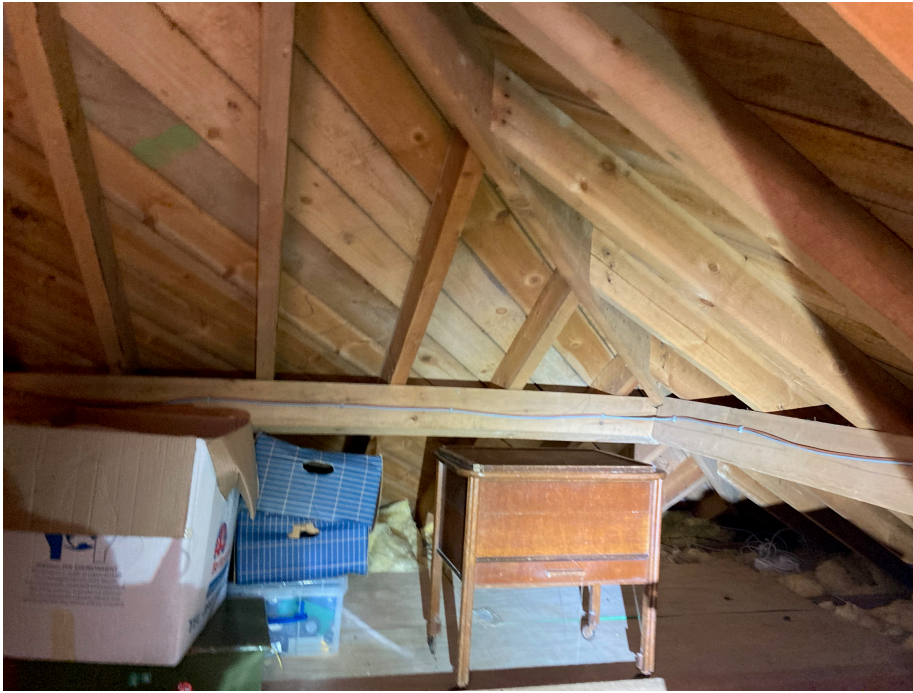
Photograph 3: Internal view of roof space.
