**Building at Spooners**

**The Heath**

**Woolpit**

## **Nocturnal Bat Survey Report**

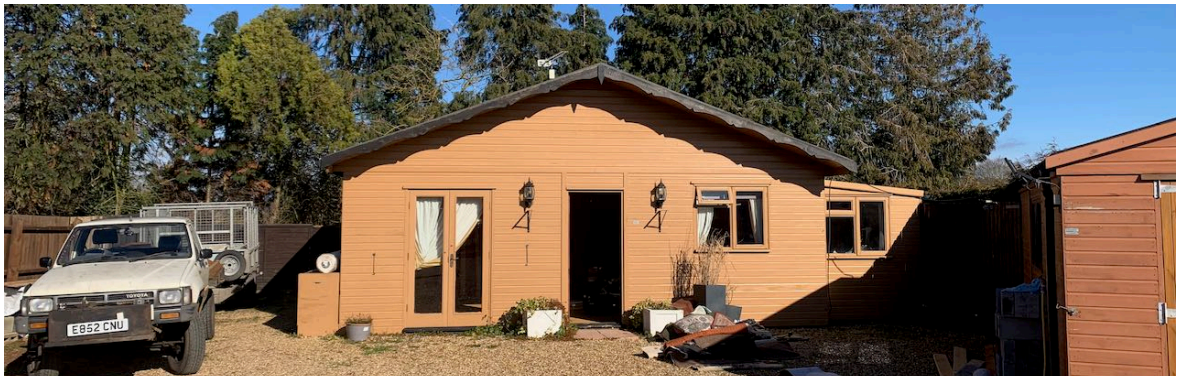
**Photograph 1.** Bungalow – south aspect

BiOME Consulting Ltd was appointed by Anglia Design LLP (in February 2023) to undertake a Preliminary Roost Assessment (PRA)<sup>1</sup> in relation to proposed demolition of a bungalow and associated garage located at Spooners, The Heath, Woolpit, Suffolk (*'the site'*) (TL985615) (Photograph 1, Figures 1 & 2).

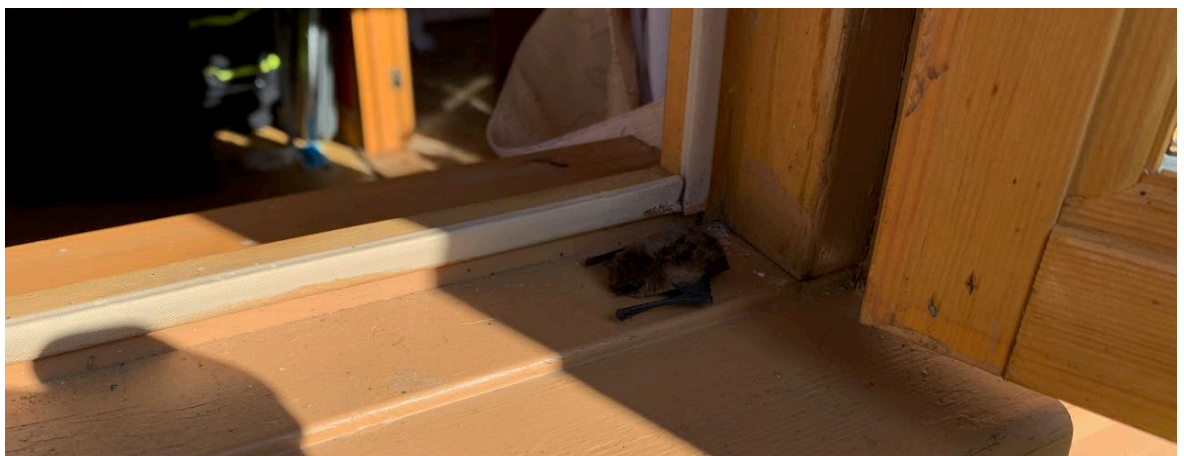
**Photograph 2. Deceased Common Pipistrelle**

This survey recorded a deceased Common Pipistrelle on a window ledge of the bungalow, below what was considered to be an occasionally used day roost of likely a single bat within the window frame/broken vent (**Photographs 2 & 3**). No other bat evidence or Potential Roost Features (PRFs) were recorded in association with the bungalow. Consequently, a minimum of two nocturnal emergence/return to roost surveys of the bungalow were recommended to provide further information on the status of roosting bats within the bungalow. The nocturnal survey work has now been completed and forms the basis of this report.

The confirmation of a bat roost within the bungalow to be demolished means that a licence from Natural England will be required to enable the proposed works to proceed lawfully. Given the identified roost is of low conservation status, the site can be registered under the Bat Mitigation Class Licence (BMCL) scheme through a Registered Consultant (RC). Following submission of appropriate forms, the application takes up to ten working days to be assessed by Natural England.

Works in the area of the roost will need to be supervised by an RC (or accredited agent). Prior to works commencing, the RC would provide a 'toolbox talk' to those contractors on site in which details of e.g. best working practices and what to do in the event of discovering a bat will be discussed.

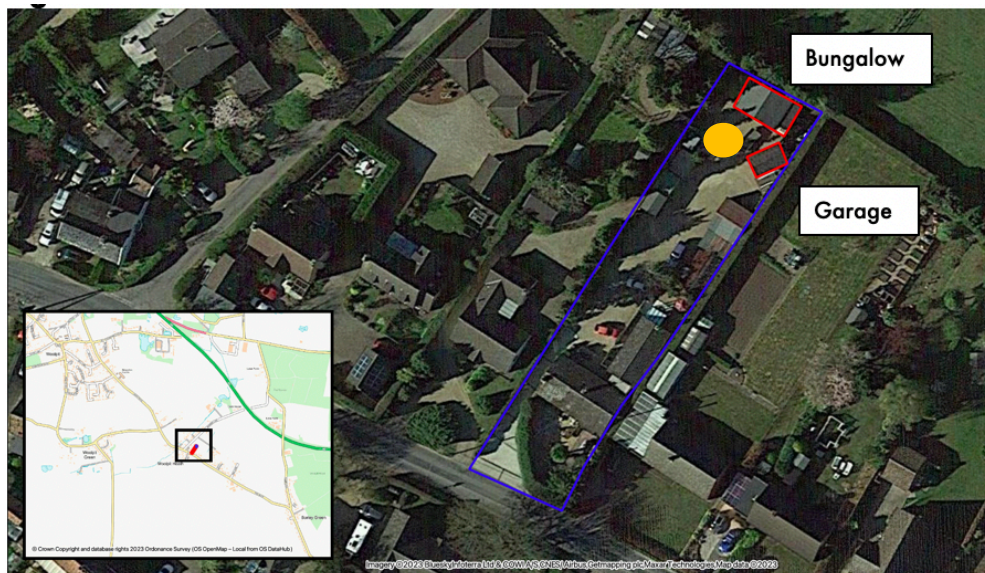
Figure 3. Surveyor Location

Two nocturnal bat surveys of the building were completed in line with good practice guidance<sup>6</sup> to assess the presence/likely absence of roosting bats in the building. To ensure coverage of all potential bat access points/roost features, each survey was completed by a single surveyor located watching the front elevation of the bungalow (Figure 3 – orange oval).
