Peel Environmental Management (UK) Limited  
and North Selby Mine Waste Limited

Former North Selby Mine Site, New Road,  
Escrick, York

Proposed Anaerobic Digestion and  
Horticultural Glasshouse Facility

Geo-Environmental Desk Study

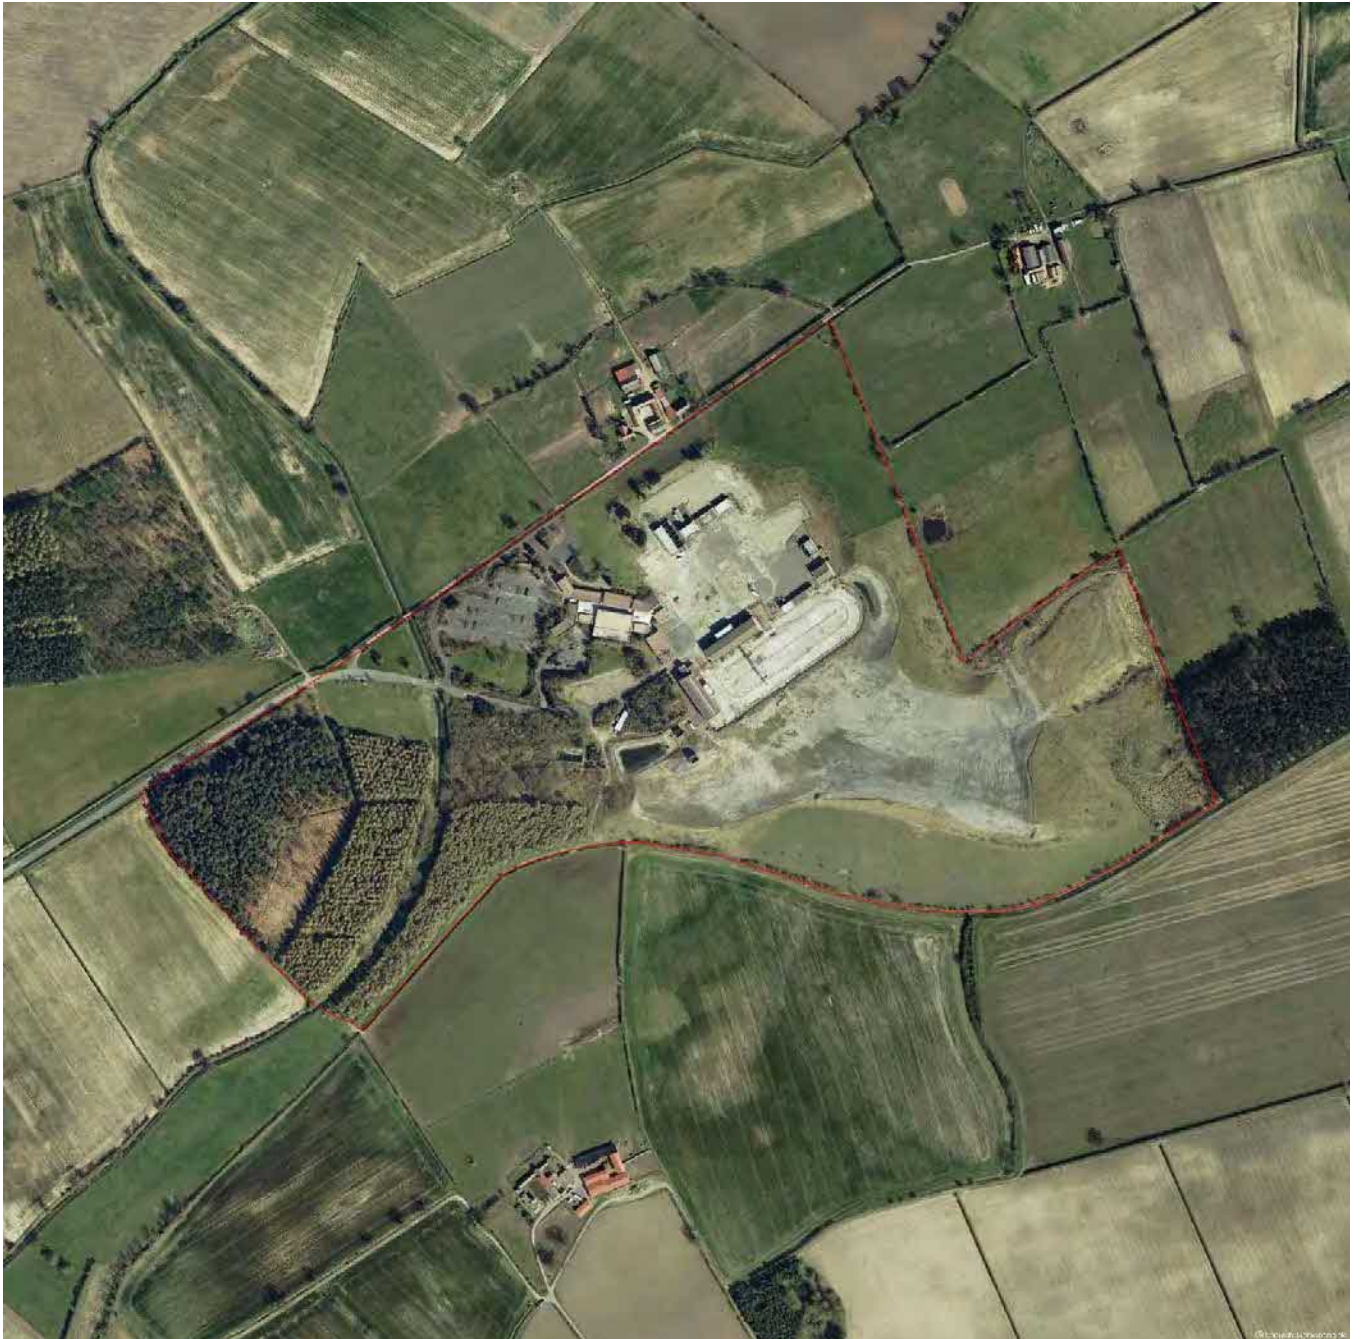
Figure 1: Aerial Photo of the site and surrounding area.

The general site setting is in a relative flat, low lying agricultural area, part of the Yale of York. The general topographic elevation of the area is 6 to 10m AOD. The fields in the immediate vicinity were observed to be used for Equine pasture.

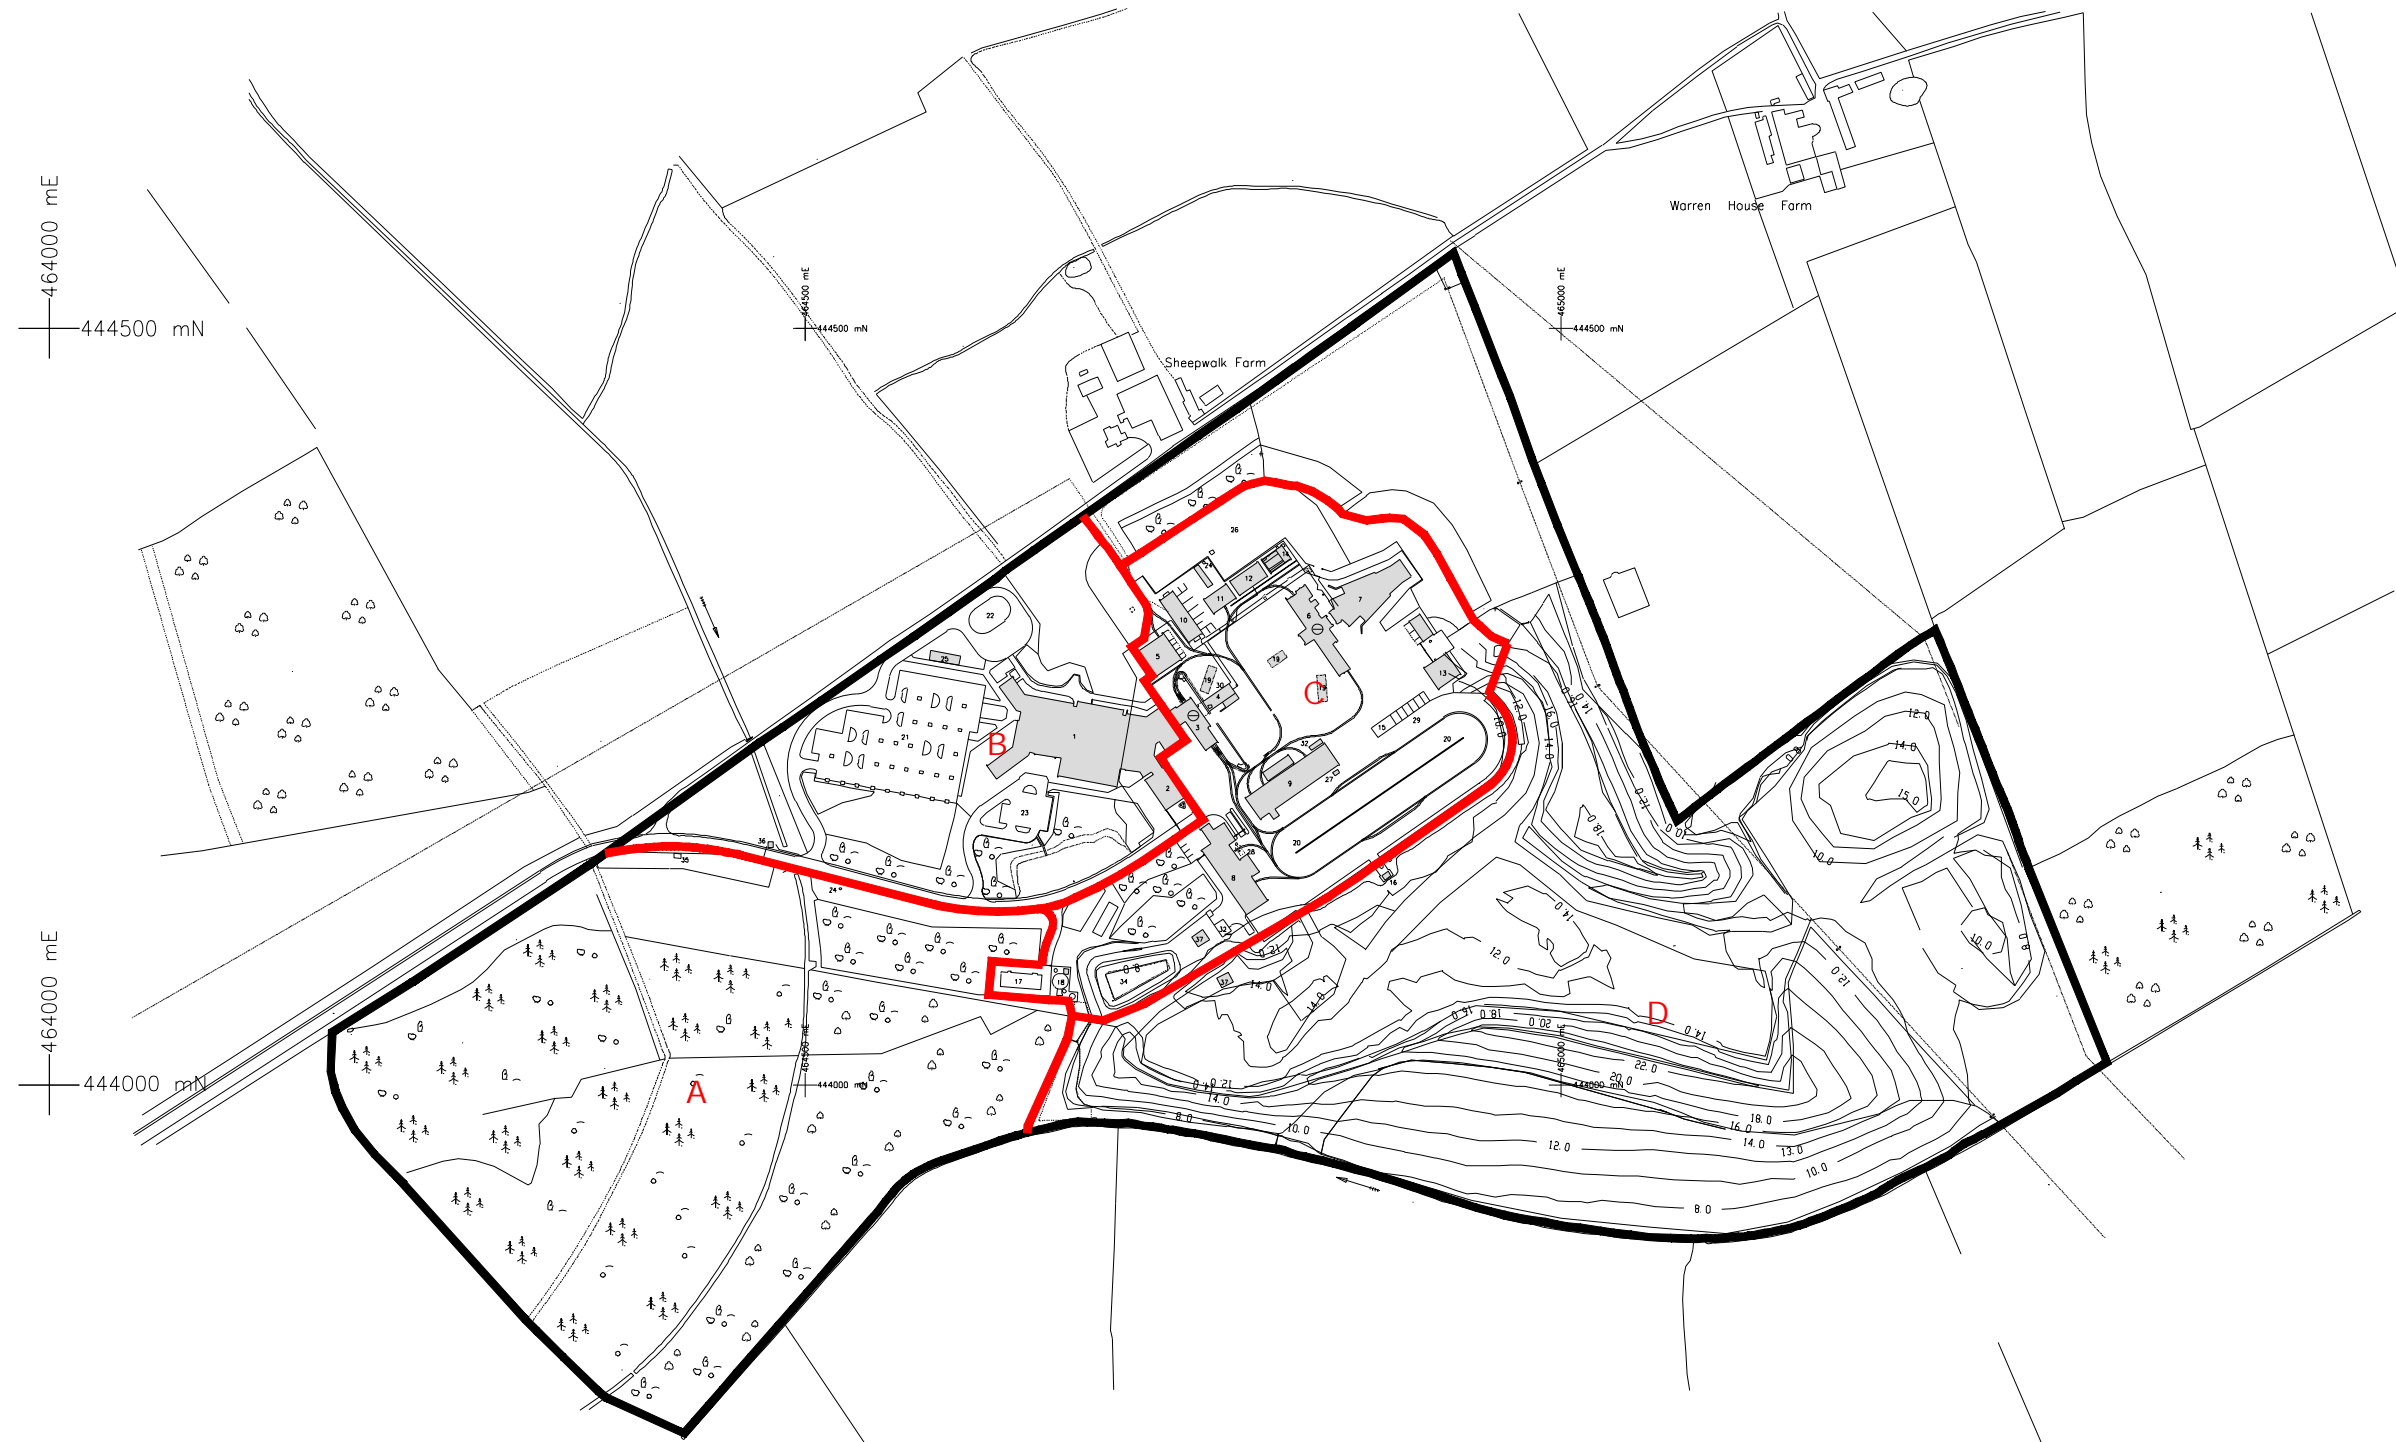
- MINING SITE BOUNDARY
- INTERNAL BOUNDARY
- A WOODLAND TO THE WEST
- B AMENITY MAIN BUILDING & PARKING
- C MAIN SITE INCLUDING SHAFTS
- D BUND / MADE GROUND TO THE SOUTH & EAST

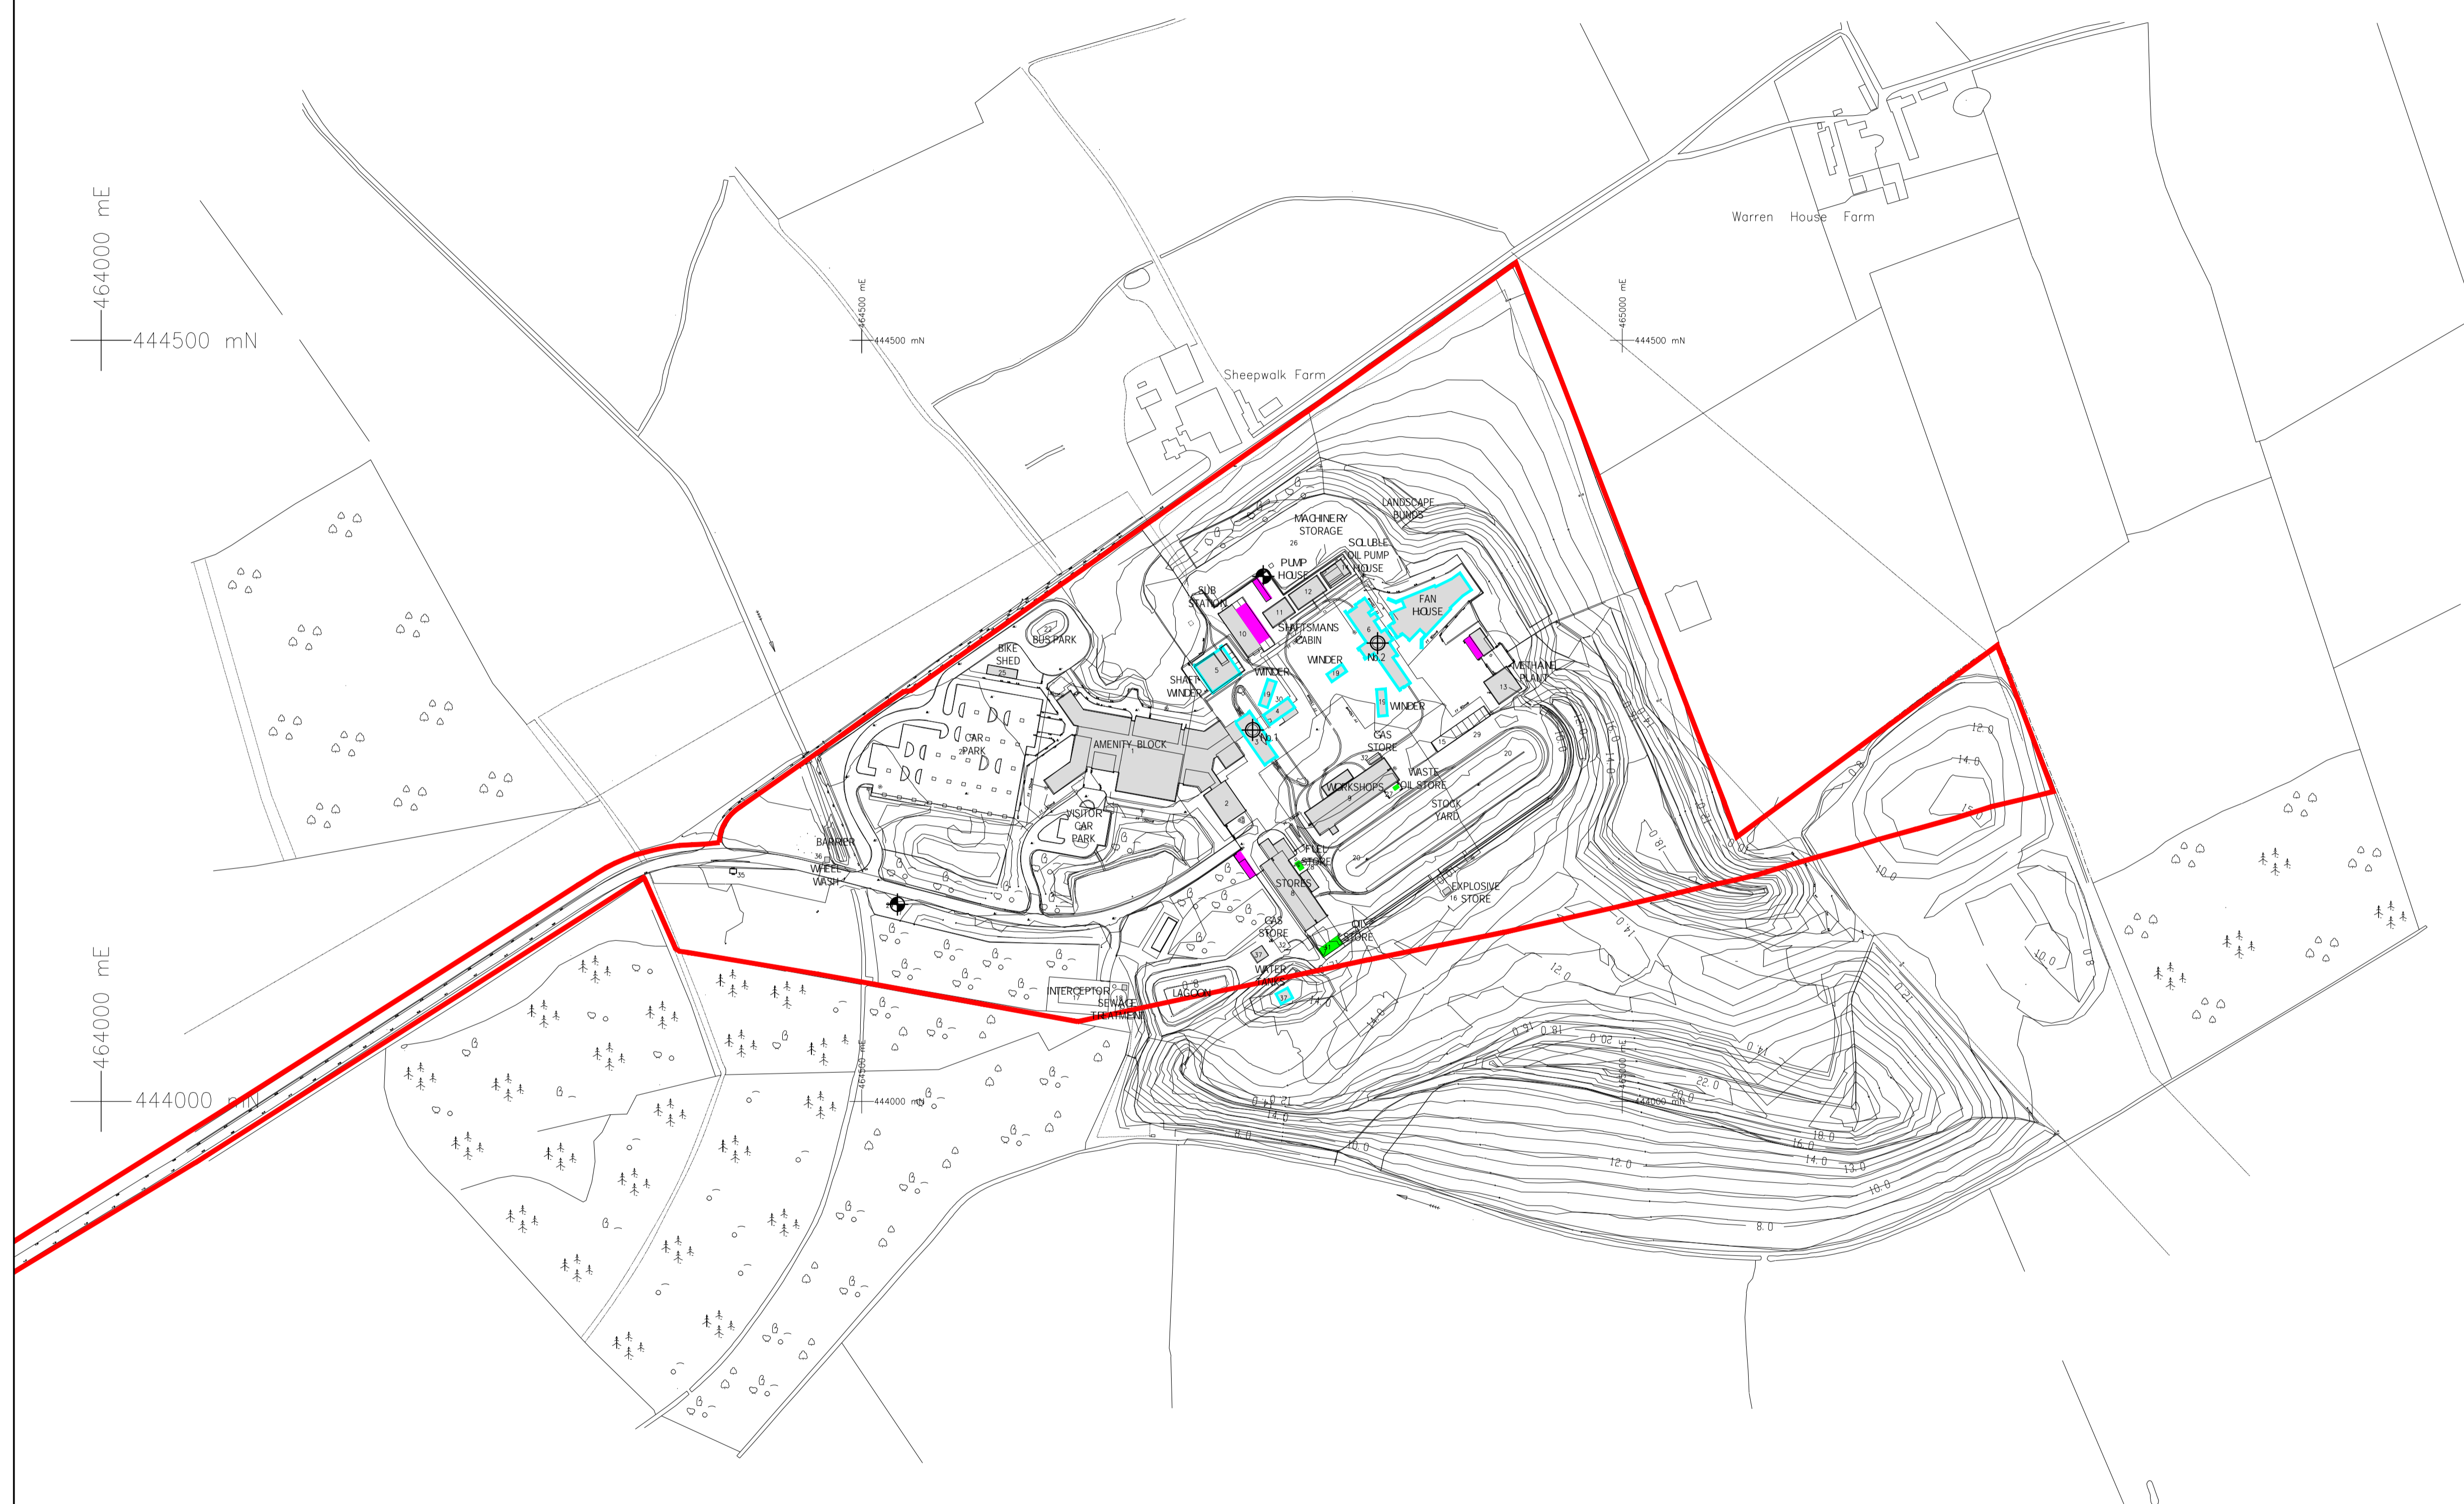
There are a number of 33kV transformers with auxiliaries on site located next to the Sub-station (10), methane plant (13), and by the stores (8). There is also a building housing electrical Capacitors north of Building 11. No oil staining relating to transformer oil was observed.

- KEY**
- APPLICATION BOUNDARY
  - EXISTING BUILDINGS
  - DEMOLISHED BUILDINGS
  - BOREHOLE
  - SHAFT
- POTENTIAL SOURCES OF CONTAMINATION**
- ELECTRICAL (TRANSFORMER OIL)
  - HYDROCARBONS

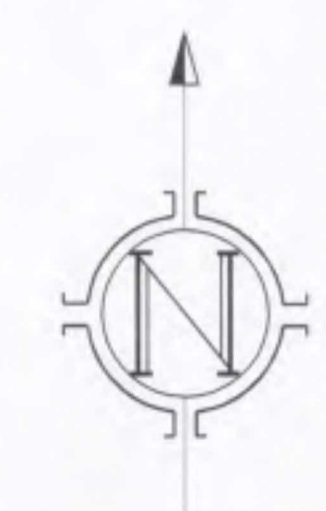
- 1 AMENITY BLOCK
- 2 BOILER HOUSE
- 3 No.1 SHAFT
- 4 AIR DRIFT
- 5 No.1 SHAFT WINDER
- 6 No.2 SHAFT
- 7 TAIL HOUSE
- 8 STORES
- 9 WORKSHOPS
- 10 SUB STATION
- 11 SHIFTMENS CABIN
- 12 PROCESS WATER TANKS & PUMPHOUSE
- 13 METHANE PLANT
- 14 SOLUBLE OIL PUMP HOUSE
- 15 CEMENT STORE & AGGREGATE BUNKERS
- 16 EXPLOSIVE STORE
- 17 OIL & GRIT INTERCEPTOR
- 18 SEWAGE TREATMENT PLANT
- 19 EMERGENCY WINDER SITES
- 20 STOCKYARD
- 21 MAIN CAR PARK
- 22 BUS PARK
- 23 VISITORS CAR PARK
- 24 PROCESS WATER BOREHOLE
- 25 BICYCLE SHED
- 26 MACHINERY STORAGE
- 27 WASTE OIL STORAGE
- 28 FUEL STORE
- 29 WASTE MATERIALS STORAGE
- 30 COMPRESSORS
- 31 OIL STORE
- 32 GAS STORE
- 33 CONTRACTORS OFFICES
- 34 LAGOON
- 35 WHEELWASH
- 36 BARRIER
- 37 WATER TANK

- FOULWATER
- METHANE DRAINAGE
- MINEWATER DRAINAGE
- SURFACE WATER
- FIREFIGHTING
- PROCESS WATER
- TOWN WATER
- CABLE IN GROUND
- CABLE IN DUCT
