# Preliminary Ecological Assessment Bat Roost Survey

10 Feering Road Coggeshall Essex

Report Approved 9<sup>th</sup> August 2021

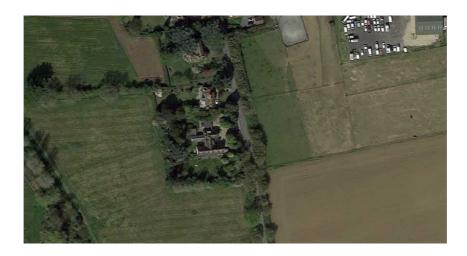
Photograph 1

- 6.12 Those trees identified for removal are:
  - Group 1 and Group 2
  - Individual trees T14--24, T26-T28 inclusive
- 6.13 Groups 1 and 2 are mature ornamental conifers to the front of the site, they are healthy vigorous trees (Photographs 1 and 2), with no PRF's.

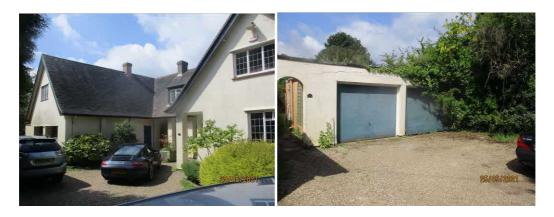
Photograph 2

3.3 The detached main building and garages are located towards the front of the plot with a hard standing gravel drive (Photographs 2 and 3).

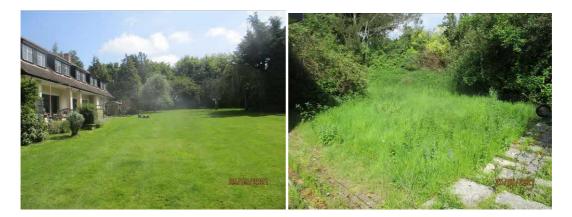
Photograph 5

- 3.5 To the left flank of the property is a wide open amenity lawned area that extends to the rear. It is a managed short sward with little floristic diversity or conservation value (Photograph 5).
- 3.6 To the right flank to the rear of the garages is a patio area with a small amenity lawn and shrub borders. The amenity lawn has not been mown/managd to the same extent as that to the left flank (Photograph 6). Although a longer sward has grown there is no successional development that would at the moment increase the sites biodiversity value.

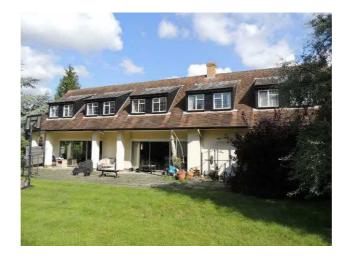
7.3 The survey building is a detached property with a tile and felted roof and pale, rendered walls. The building is aligned N-S with 'wings' at the northern and southern ends. The survey found that much of the roof volume was taken up by living accommodation, with five dormers to the south and one to the north, east and west. The remaining roof void had a shallow pitch with a floor to ridge height of c. 1.2m, dimensions that are usually unsuitable for roof-dwelling species of bats that prefer a large, open volume in which to fly prior to emergence. No evidence of their presence was found on the floor of the loft, along the internal eaves of the building or on items stored in the loft. Externally, there was a tight seal to the eaves and gables, and also to the roof tiles. Two dormers had a small area of tile cladding that had a tight seal, whereas the others had tongue and grove cladding that had no cavities that might be occupied by bats. There was also no evidence such as staining or droppings on the pale walls where the presence of bats would have been readily apparent.

Southern elevation. Note dormers

7.4 There is no evidence of any existing or past bat roost in any of the buildings on this site.
