Bat Assessment at Curates House, The Green, Hartest, Suffolk. IP29 4DH

On Behalf Of:

Mr & Mrs Pask

July 2023

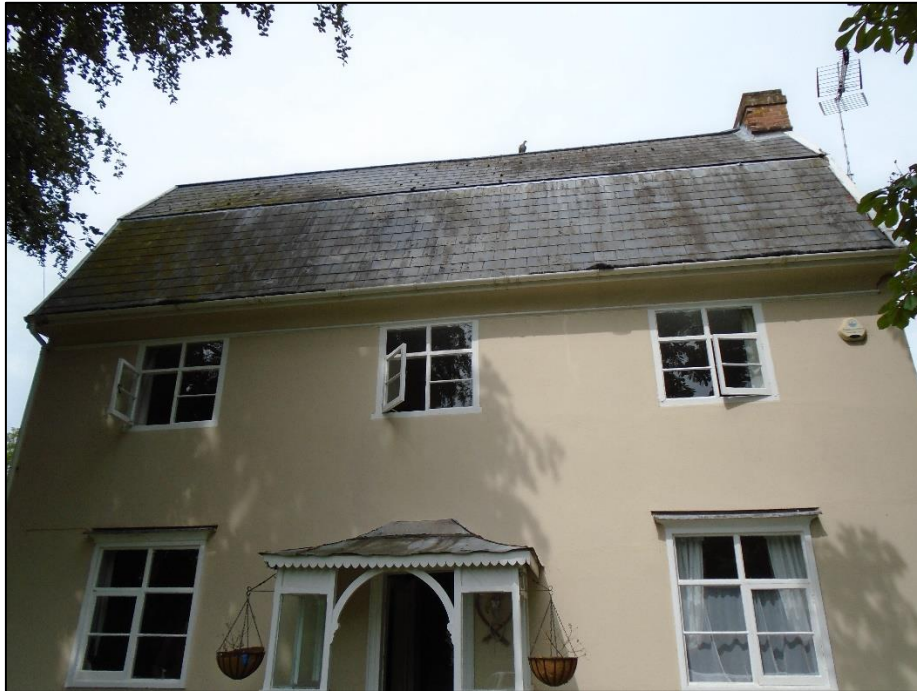
- 3.3.1 No signs or evidence of bats or bat activity were found in the loft or associated with the proposed construction zone. Opportunities for roosting on the eastern elevation where the dormer windows are proposed were considered negligible with the roof tiles and soffits tightly fitting.

Photograph 1: Eastern elevation proposed for the new dormer windows at Curates House.

- Roof tiles should be removed by hand during works. If at any point during construction, bats or evidence of bat activity (droppings etc.) are found, works should stop and an Ecologist called for advice.

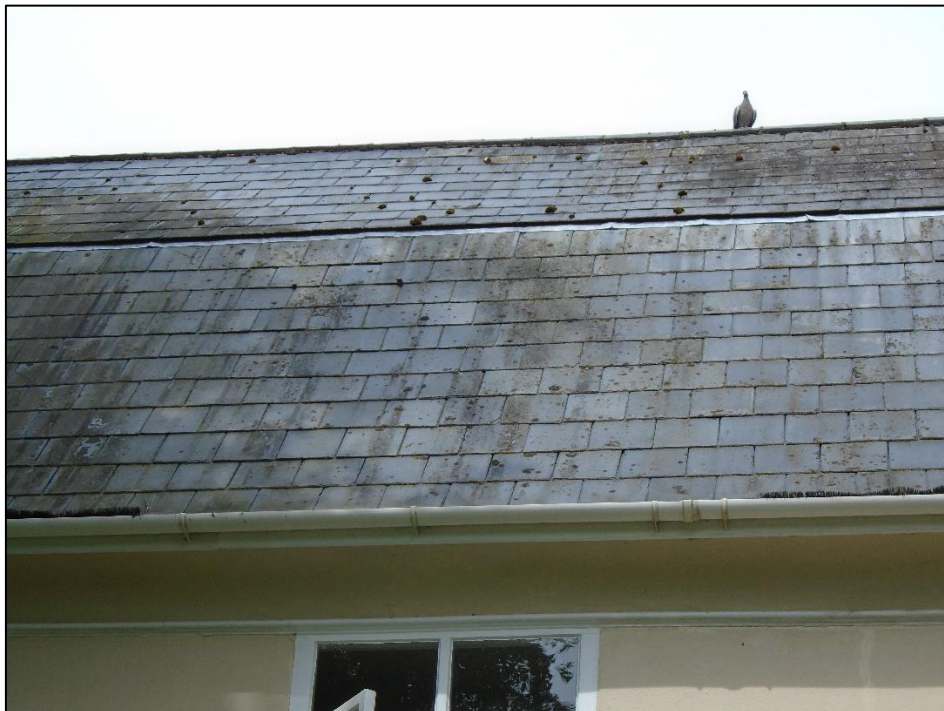
- 0.5 No signs or evidence of bats or bat activity were found in the loft or externally associated with the proposed construction zone. Opportunities for roosting were considered negligible with the roof tiles and soffits tightly fitting. Gutter guards were present blocking access for bats or birds under the first row of tiles.

Photograph 2: Close up of the eastern elevation at Curates House.

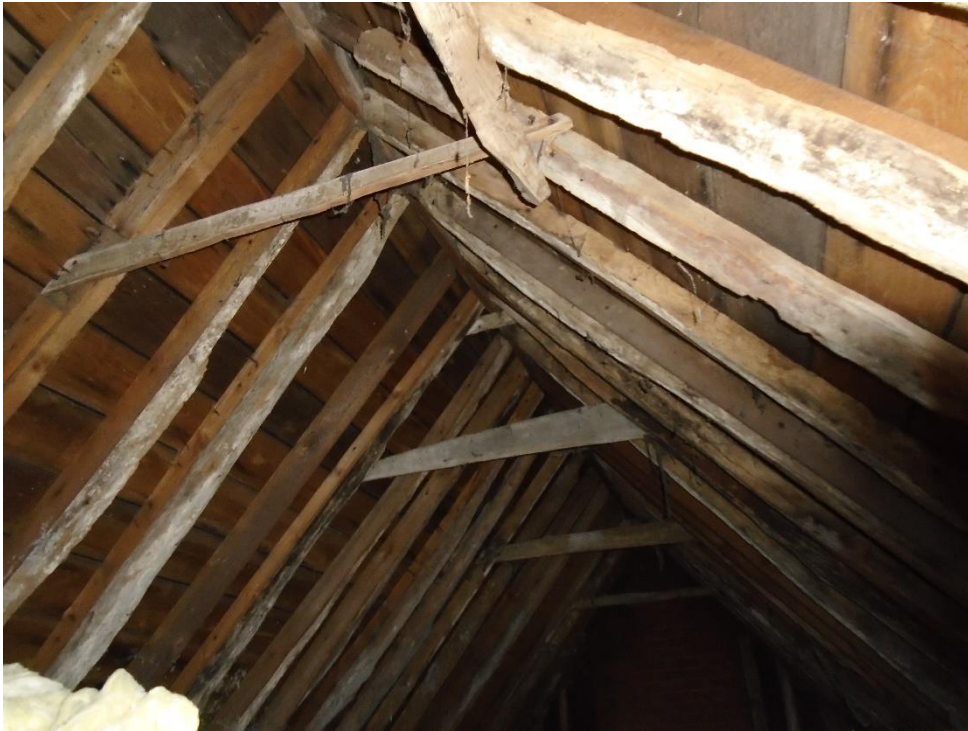
- 0.3 The site and proposed construction zone includes: a three-storey, period dwelling with a pitched (Dutch-style), slate tiled roof. A small loft space is present, though reduced due to the second floor. Thick insulation was present in the loft blocking the soffits.

Photograph 3: Inside the loft at Curates House.
