2.8 Existing Buildings - North & South Elevations

2.9 Existing Buildings - East & West Elevations

3.1 Historic mapping

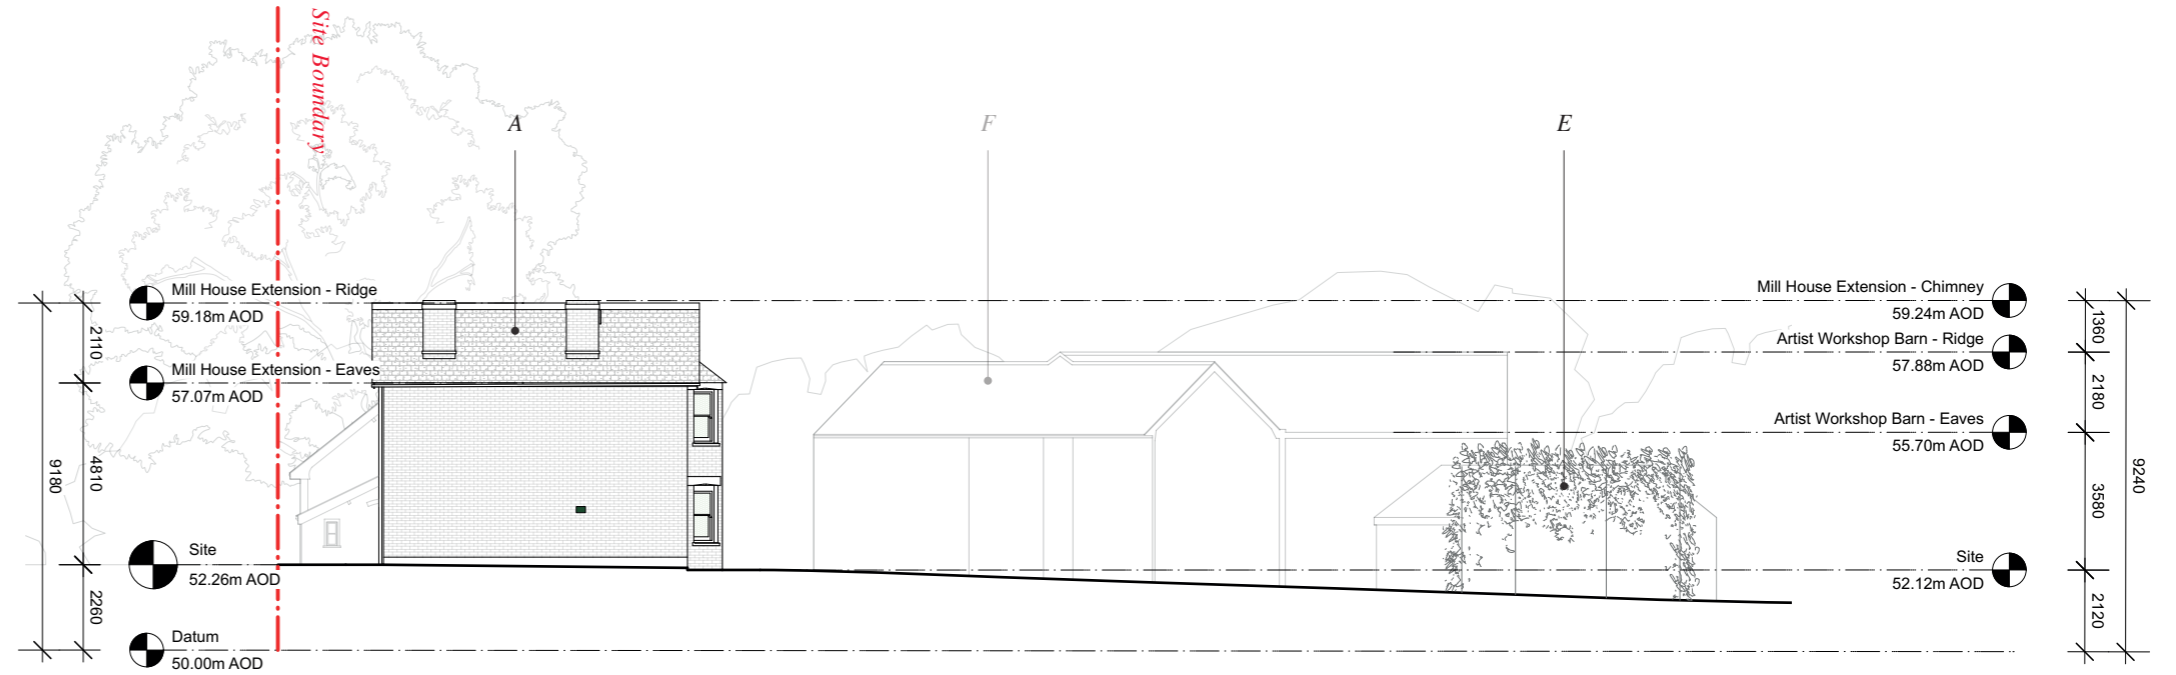
- Key**
- A. Mill House - north-wing extension
 - B. Mill House - original form
 - C. Mill House - south-wing extension
 - D. Retained barn - music room and storage
 - E. Remains of the Wind Mill
 - F. Mill Buildings - workshop and storage

Opposite: Top: north elevation as existing, Bottom: south elevation as existing (Scale 1:200)

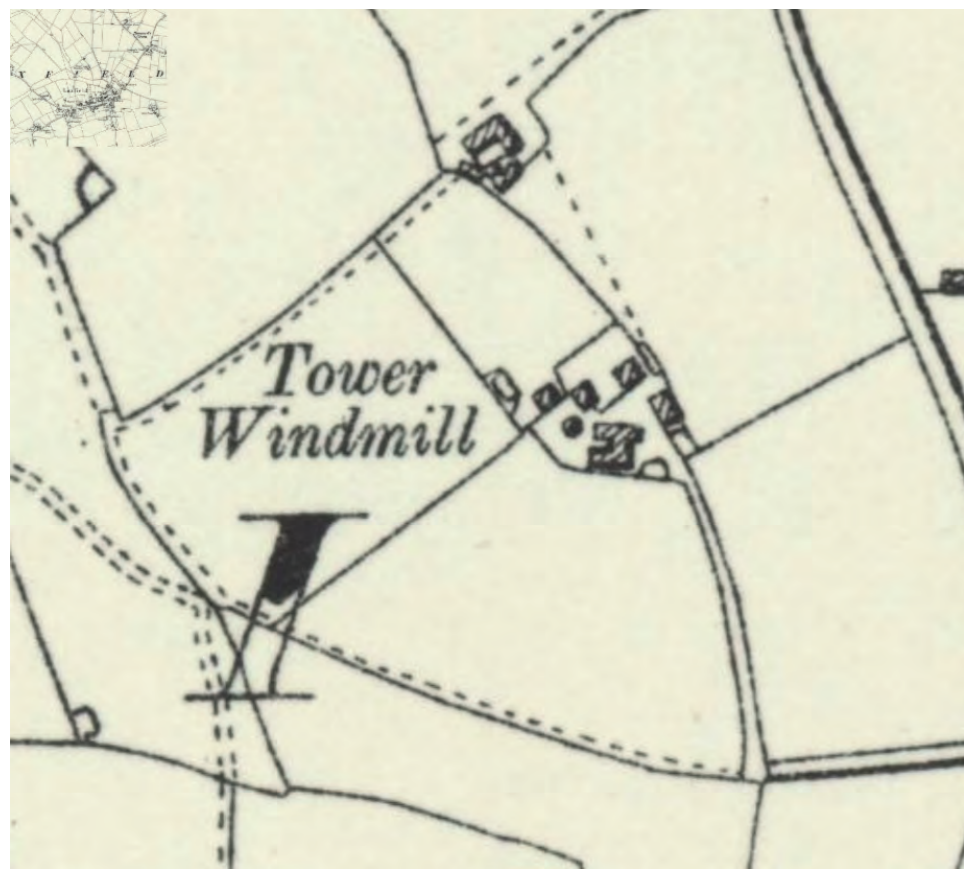
On the map dated 1903 (*shown below*) we can see that the site was historically much denser around the tower windmill. The maps provide evidence that the outbuildings dotted around the site have changed over time to perform different uses and functions.

Above: Historic map of the Laxfield Mill site in 1903 showing additional dwellings / massings surrounding the tower windmill.
Opposite: Historic map of Laxfield, dated 1884.

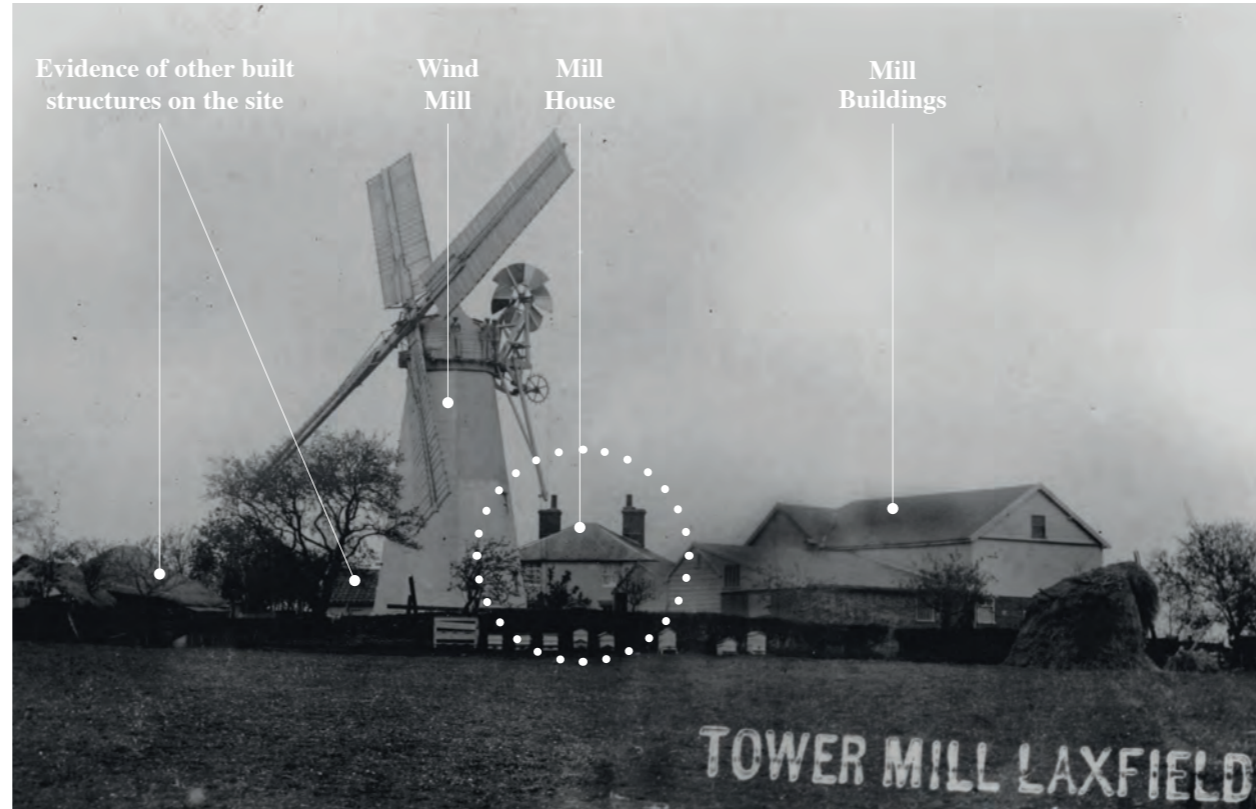
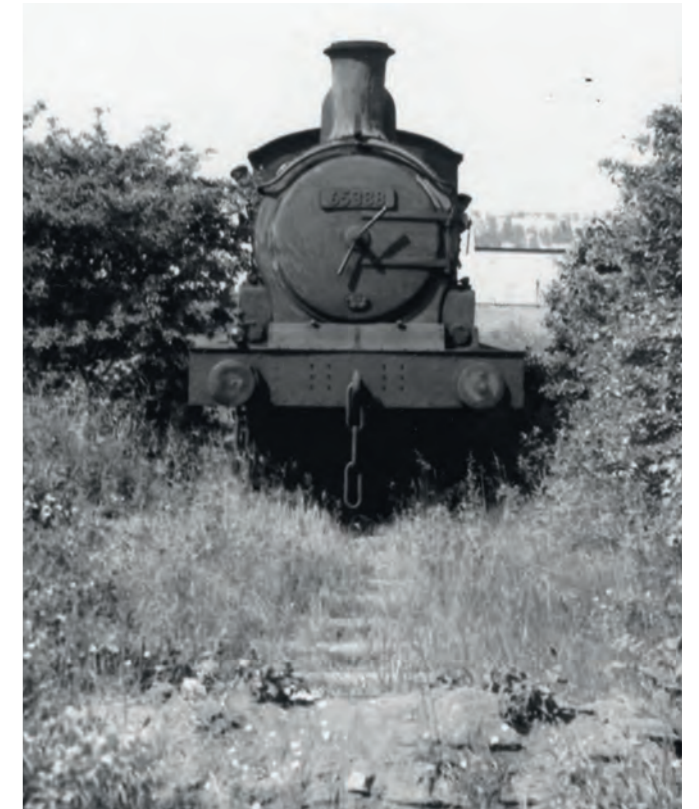
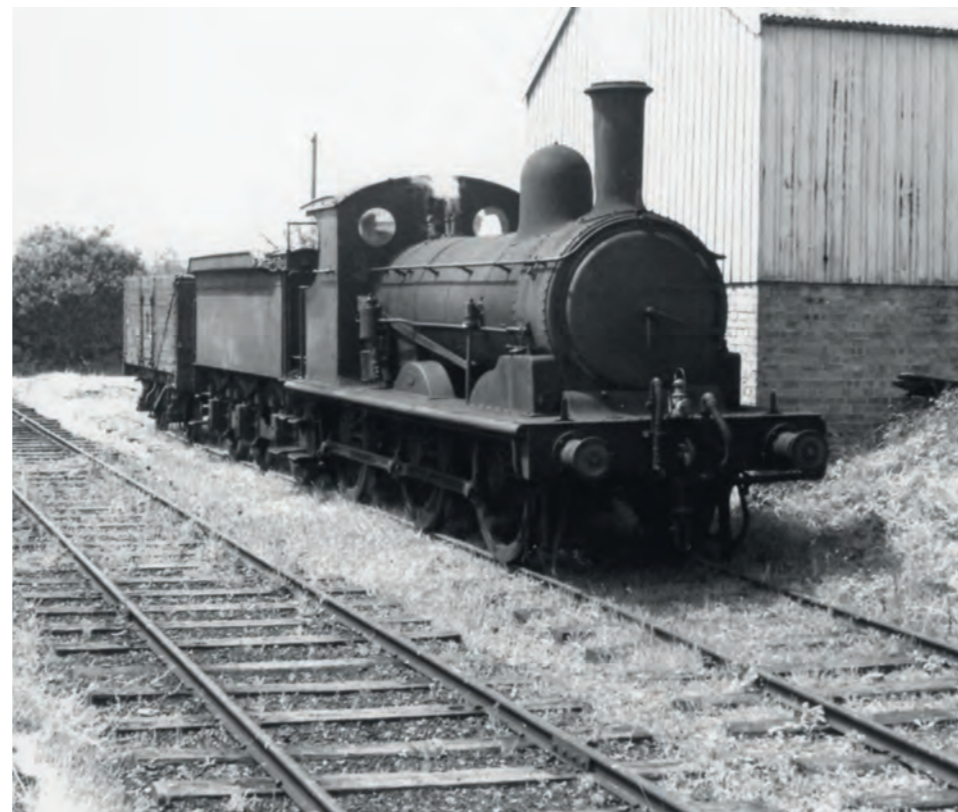
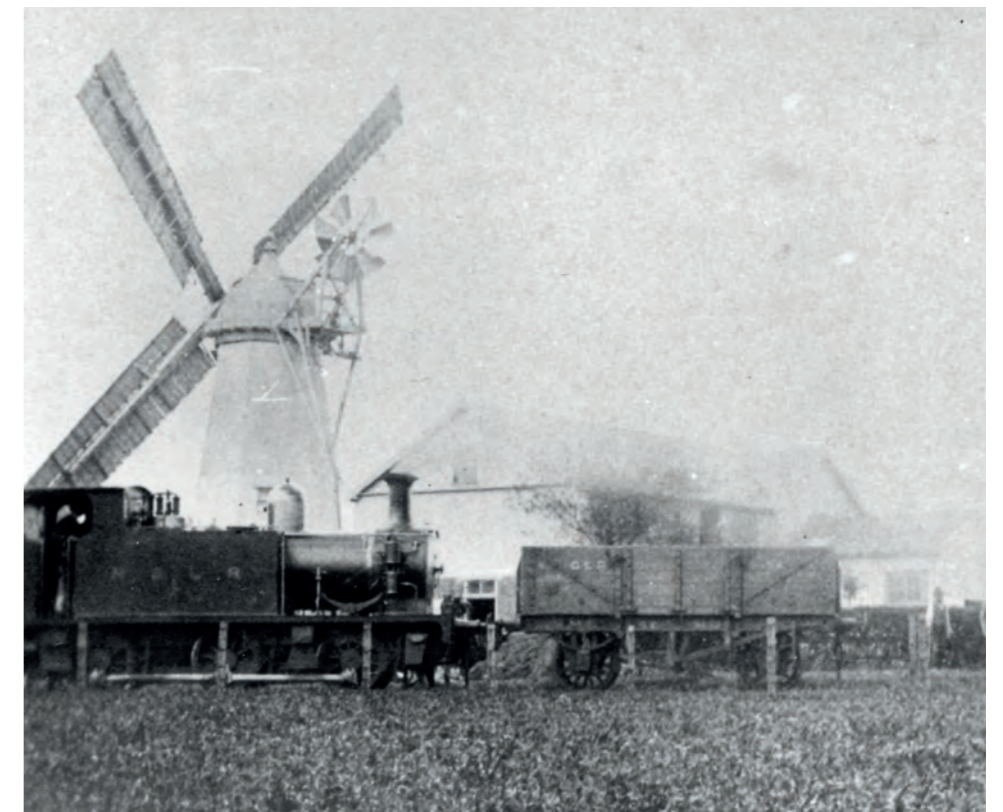
The historic photographs show the Mill House site as a working mill. They also show the Mill House in its original form without the 20th century extensions to the north and south. In the place of the extensions is a traditional Georgian hipped roof with two large chimneys. The front door was centred on the cottage to allow for efficient access to the wind mill.

Opposite: Historic photographs of tower windmill, Mill House cottage, and the Mid-Suffolk light railway (images provided by client).

The historic site photographs also suggest the site was historically significantly more dense, with multiple additional built structures.

The site was also a station stop on the Mid-Suffolk Light Railway, which opened in 1908. The line ran between Haughley and Laxfield. The Laxfield Mill (also known as Goram’s Mill) marks the location where construction funds ran out and the railway closed in 1952.
