## Statement of Historic Significance

Name: PRESTON COTTAGE

COLEBROOKE SX 79 NE 5/80 - Preston Cottage

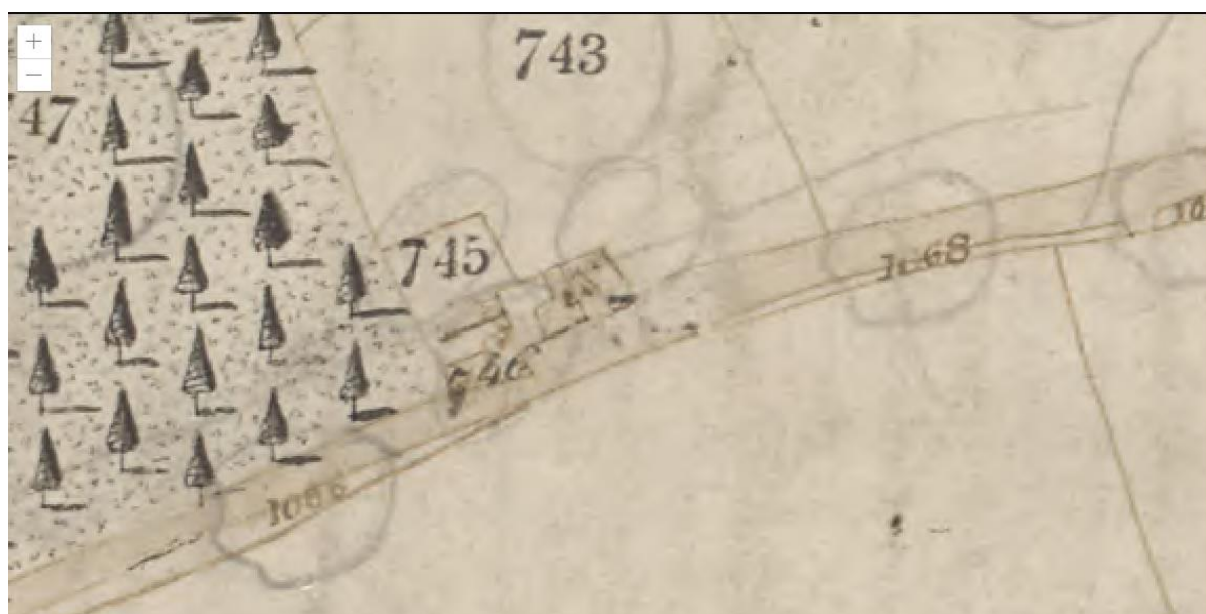
Tithe Map 1836/7

Tithe mapping 1836/7 indicates the building existant at this time with the plots in and around the building suggesting the existence of two dwellings. This theory is supported by the existence of a door size recess to the RHS front of the building.

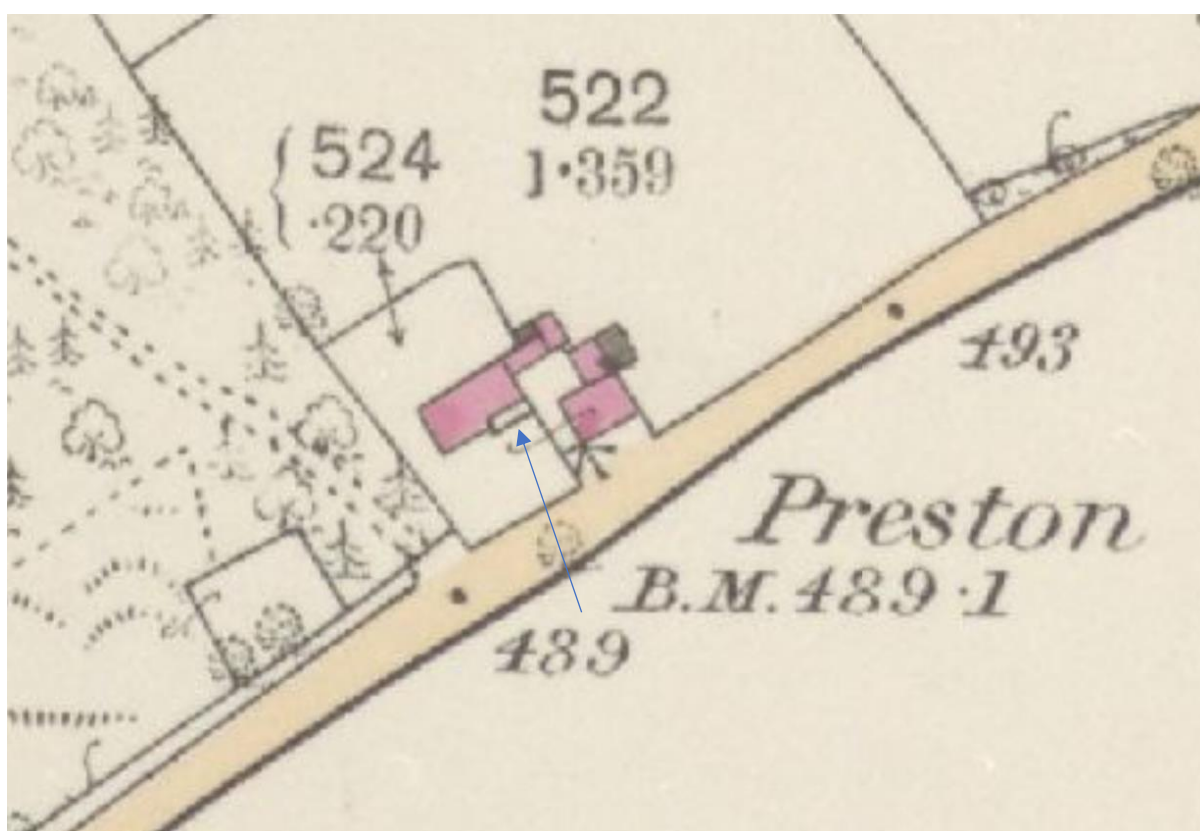
The first feature shows evidence of a building running the length of the rear of the building (approximating to the depth of the existing extension) and extending to the RHS rear ( northeast ) to form a courtyard linking the existing building to the building to the Northeast which was used as a donkey shed. (See Pages 4 & 6)

The other feature is the step on the front of the building dedicated in the images below with a protruding feature. This is mirrored on other 1888 mappings.

O/S Survey Map 1888 buildings indicated in Pink; unknown feature indicated with arrow

The 1888 O/S map is well drawn and distinct. When overlaid onto the site survey and other mapping, this appears to show two features of interest.

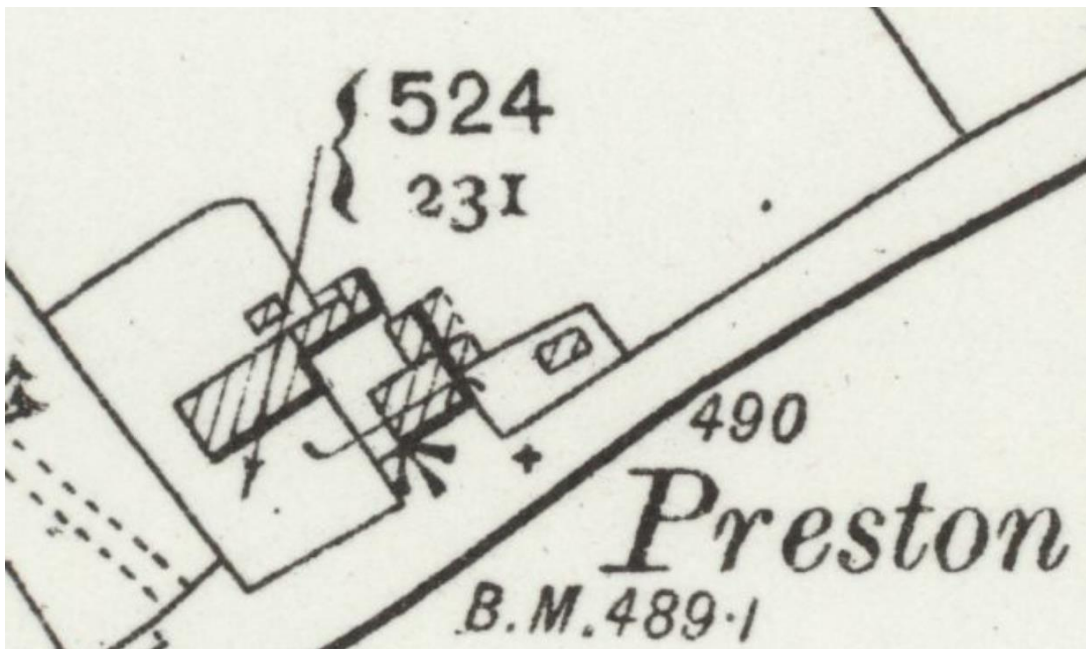
By 1905 the mapping no longer shows the feature to the front of the building and shows another building to the north of the existing building. It is possible that this building is the same as that seen on later drawings through to 1962.

1905 O/S mapping

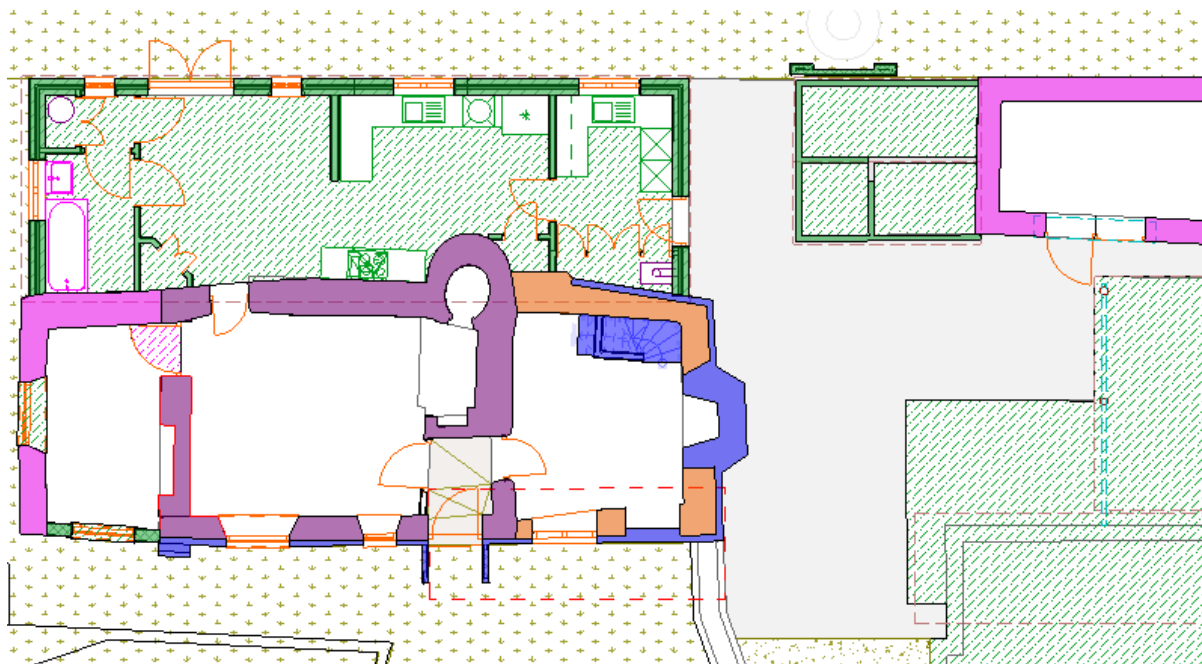
The current building appears to have evolved over the years. The central part of the building range containing the fireplace and bread oven appears to form the original building, shown in dark purple in the image below. The main beam in this space is of high-quality oak and is installed in the traditional way across the building resting on the window lintel on the front elevation. This part of the building, both ground and first floor, appears to be consistent with traditional 17<sup>th</sup> century construction.

As the part of the building to the left in shown in pink is of slightly different construction, we believe this was constructed after the original building and would appear to have been an open fronted store building as the wall closest to the road is of significantly later construction than the rest of the building. In addition, there is evidence suggesting that the current door opening is not original and other openings between the original building and this part of the building were in existence where the alcove is now. The current door and the alcove do not match in size and shape, and we therefore are unconvinced that this door is the original one for this room. The construction would again appear consistent with traditional 17<sup>th</sup> century construction so could be contemporaneous with the original building.

The room to the RHS on the plan below, shaded in orange, appears to be of a later date than the main room. The historic mapping indicates a step in the front wall in the 1880s. We believe that it is possible that this part of the building was originally a separate dwelling with a doorway to the RHS of the front elevation where there is an alcove in the room. Other evidence supporting the theory that this is a later addition is the construction of the first floor. This is of differing construction to the adjacent room. The main beam supporting the floor is of lower quality and along the room as opposed to across the space. The fireplace in this space appears to be of brick construction, again indicating a later date 18<sup>th</sup>/19<sup>th</sup> Century perhaps. The change in floor level across the hallway is also an indicator of divergent construction dates.

GF Plan as existing – with indicative phasing

- Probable original construction 17th /18th century
- Probable contemporary with the original structure or slightly later 18th century ?
- This part of the building has been added to the original structure as the type of timber and the construction methodology particularly to the First floor varies from that of the original in addition the roof timbers to the two parts of the dwelling are not contiguous. It is possible that this part of the building formed an independant dwelling as the recess to the front RHS of the dwelling is indicative of a door opening. The mapping of 1888 shows the front of the building as stepped.Overlaying the mapping using the boundary lanes and building as datums indicates the this part of the building was in existence 1838 to 1888 but it is unlikely this was in its present form in its present form.

- Construction possibly dating from early 20th c porch constructed of imperial bricks laid on edge. Buttrressing likely to be brick construction and it would appear that the front and RHS wall have been refaced as unlike other parts of the building the face of the walls are straight and vertical. The fireplace in this room is a later style. It is possible that the cottage was altered and upgraded in the early 20th c Whilst some of the estate books survive1903-1910; 1911-1919 we have yet to establish any reference to this in the archive.

- Older doorway 17th C? not in original location.
- 21st Century Construction Walls
- 21st Century Construction general

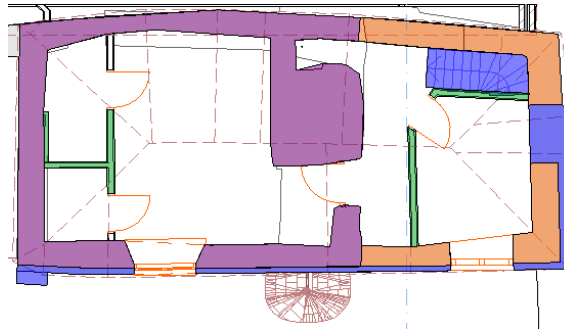
FF Plan as existing – with indicative phasing
