PHASE 3 SITE REMEDIATION STRATEGY

SITE: THE CHALET
HOMEFIELD
CROFTHANDY
ST. DAY
REDRUTH
CORNWALL
TR16 5JB

Our Ref: A1150 - P3/JW

Date: 19th April 2017

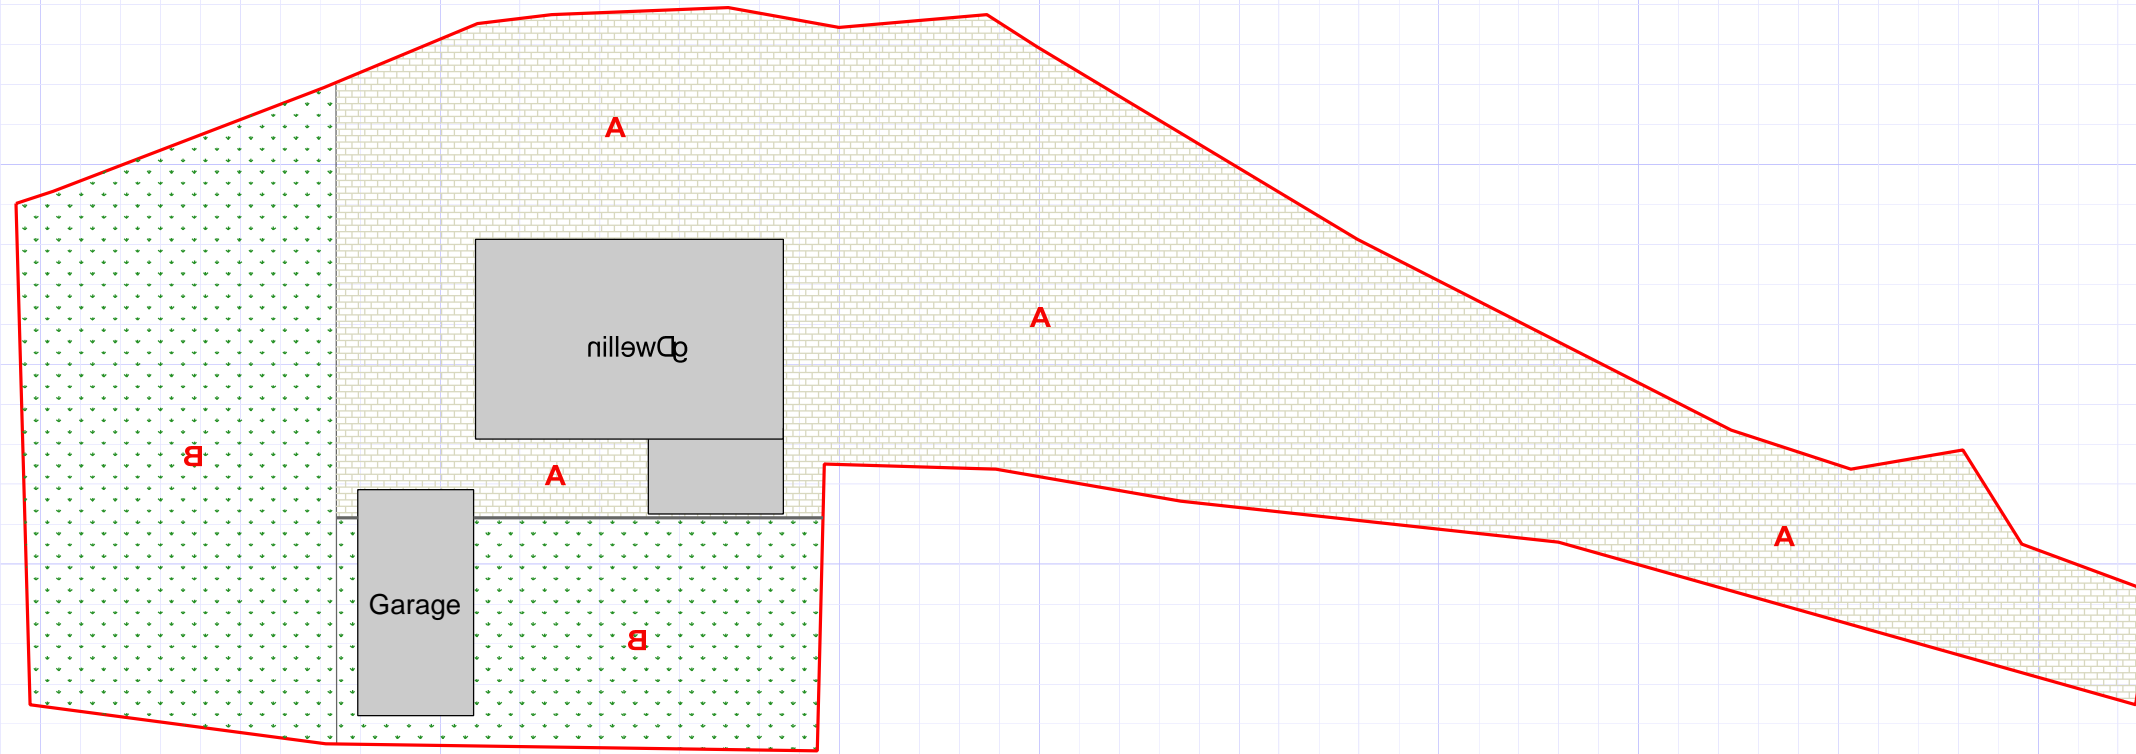
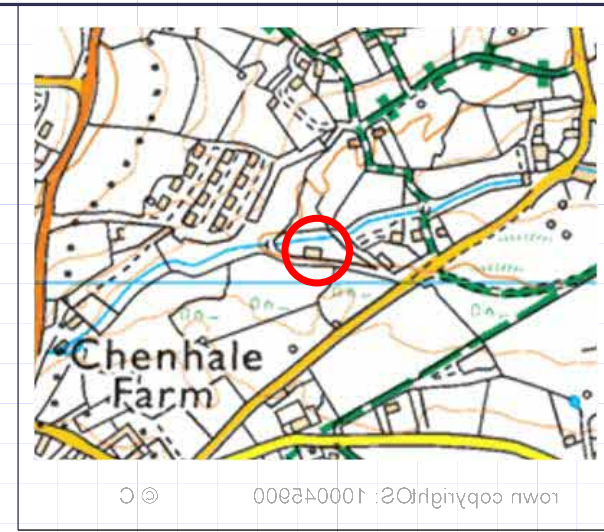
Annex 1: Plan

Zone A: Remediation zone (brick pattern)

Zone B: Remediation zone (green dotted pattern)

Please refer to Annex 1 Site Plan at the rear of this report for the site remediation scheme references selected for the development.

The remediation scheme outlines remedial methods that can be utilised for the safe development of the specified site areas (see Annex 1: Site Plan). Upon completion of the remedial works, a Phase 4 verification report will need to be undertaken to finalise the works and to satisfy the local authorities that the site is safe for end-users. This will involve liaising with the appointed site supervisor for documentary evidence of the remediation process.
