Date: 15<sup>th</sup> September 2022  
Our Ref: A1150/P4/SV  
Planning Ref: PA15/10999

## **SITE VERIFICATION & COMPLETION REPORT**

**The Chalet, Homefield, Crofthandy, St. Day, Redruth, Cornwall.**

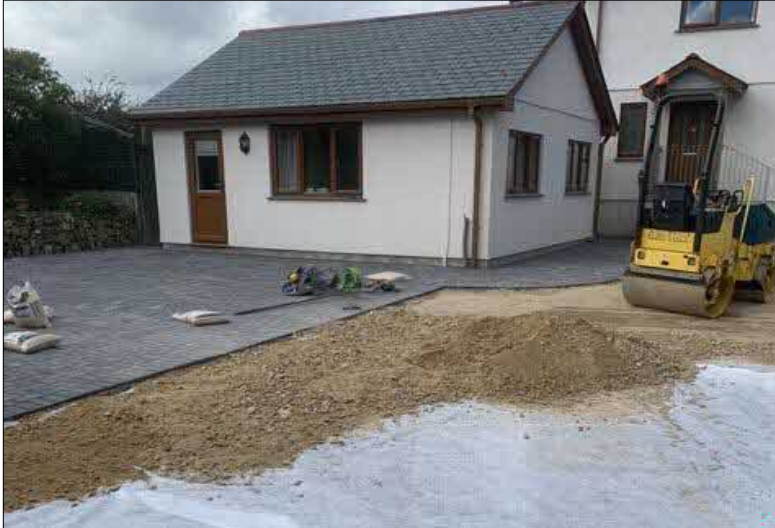
Photograph 1.

View: southwest

Remedial works:

Geotextile ground cover underlying hardcore/803 break layer being utilised within the driveway area of the site, with cemented brick paviours being installed for the parking bays.

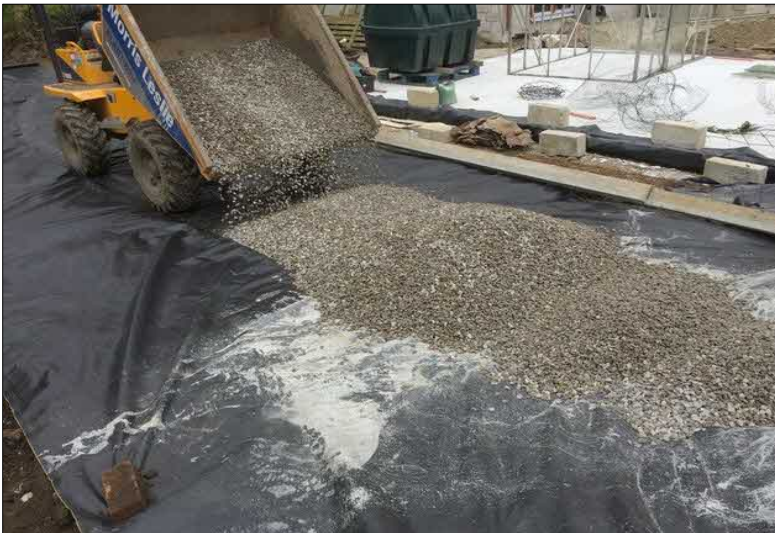
Photograph 2.

View: northeast

Remedial works:

Remedial works within the garden amenity areas of the site, with geotextile ground cover being overlain by gravel filtration layer prior to the installation of a secondary course of geotextile and clean certified topsoil.

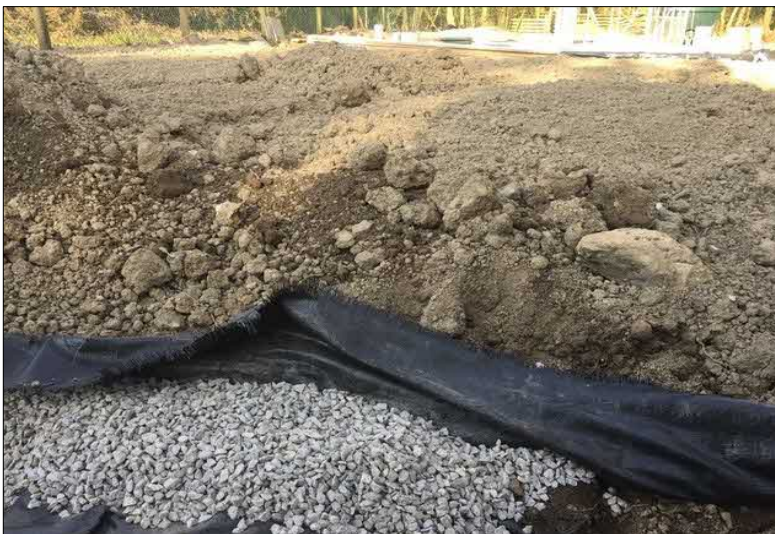
Photograph 3.

View: northeast

Remedial works:

Continuation of remedial works within the garden amenity areas, showing two courses of geotextile ground cover, gravel filtration layer and 0.50m depth of clean certified topsoil.

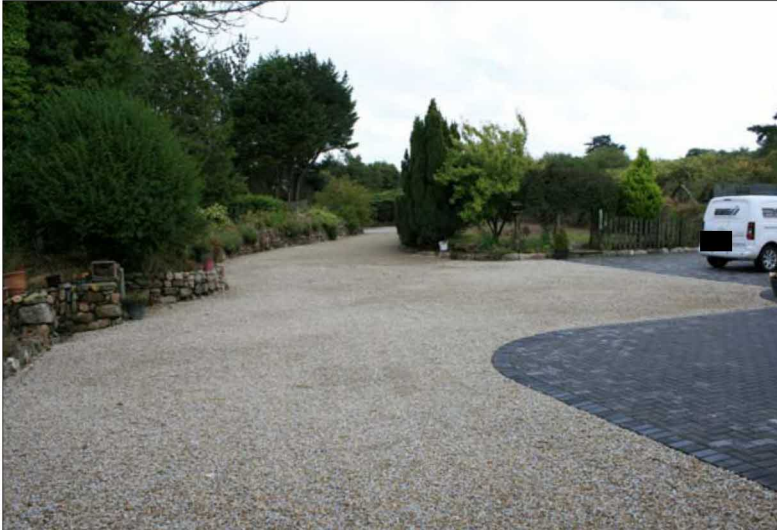
**Photograph 4.**

View: east

Completion works:

Looking toward the driveway and parking bays of the site following the installation of gravel surfacing and brick paviments.

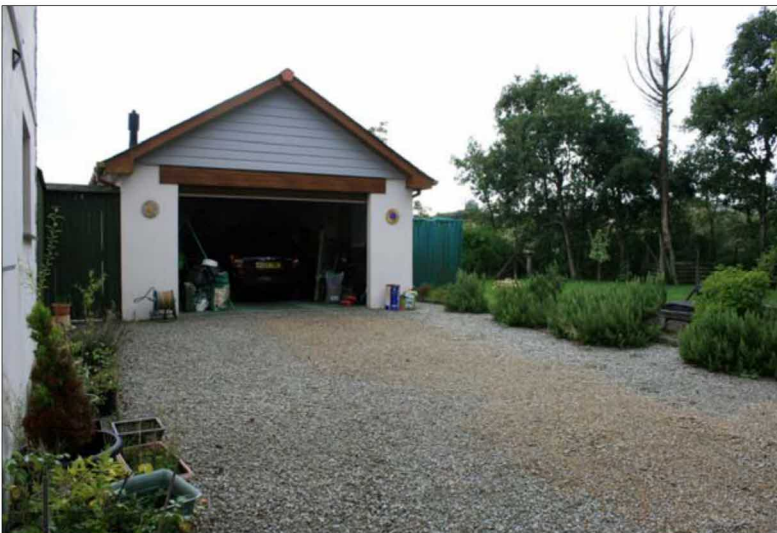
**Photograph 5.**

View: south

Completion works:

View of the driveway and rear garden located within the western extent of the site.

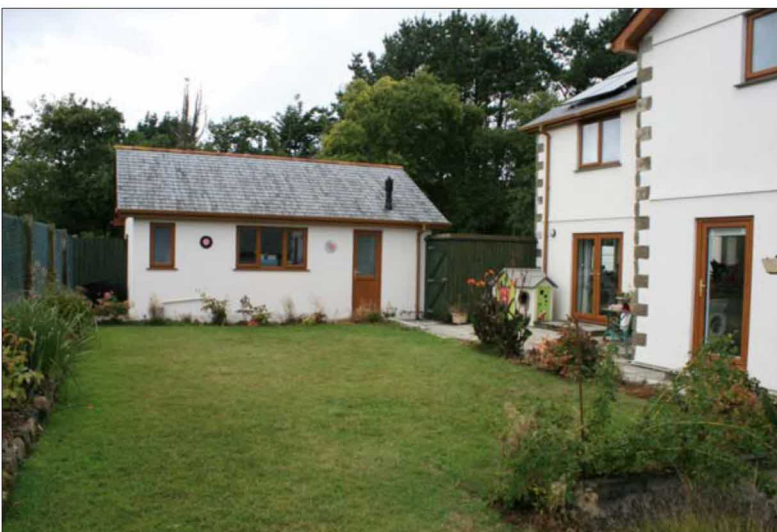
**Photograph 6.**

View: west-northwest

Completion works:

Looking to the garden amenity area located within the southern section of the site
