Protected Species
Survey

Church Barn, Morston

Prepared by
Glaven Ecology

June 2023

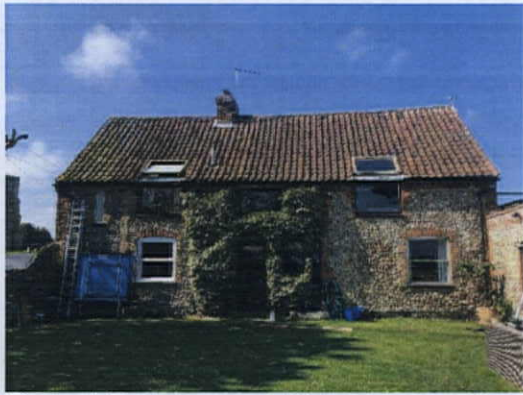
5.2.4 The house was of typical north Norfolk flint and brick construction with pantile roof (Figures 1-3). There was a separate outbuilding attached to the east (Figures 4-6) which was used as a storage and laundry area.

Figure 1: Eastern aspect of house

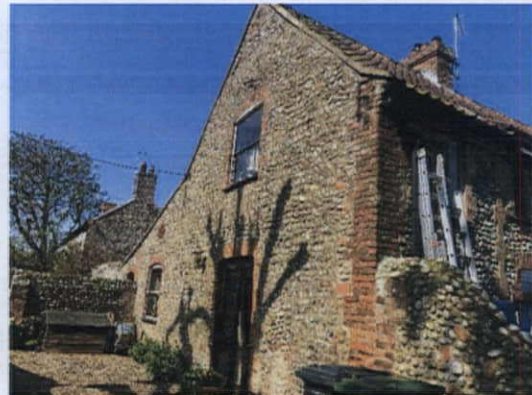
Figure 2: Southern elevation of house

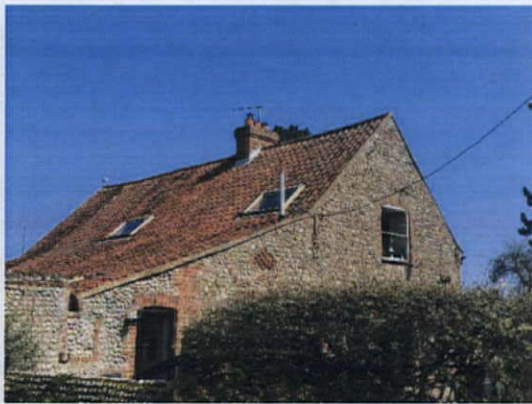
Figure 3: Western and southern aspects of house

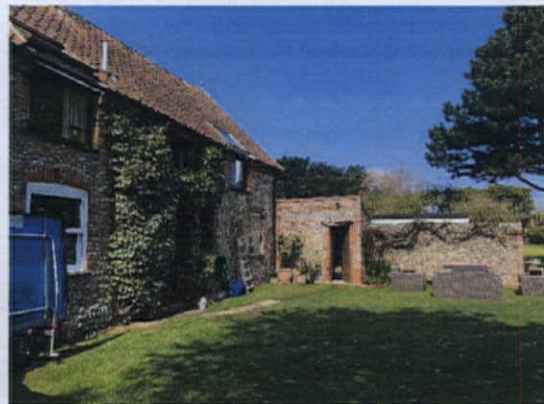
Figure 4: Outbuilding to the east

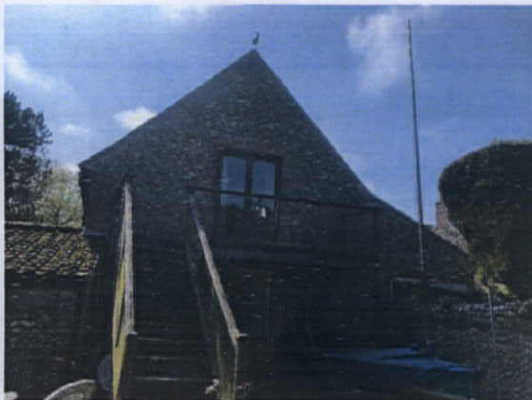
Figure 5: Northern aspect of house

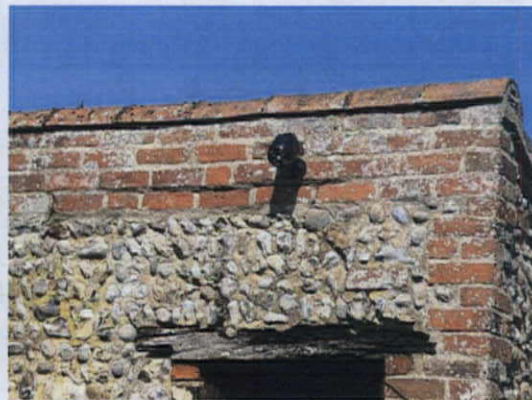
5.2.9 The outbuilding had a low, single-pitch pantile roof with some rotting of the lintel above the door.

Figure 6: Lintel of outbuilding to the east

5.2.19 The house and outbuilding were assessed as having **low suitability** to support roosting bats, with the main roosting opportunities being under lifted flashing on the house or the rotting lintel of the outbuilding.

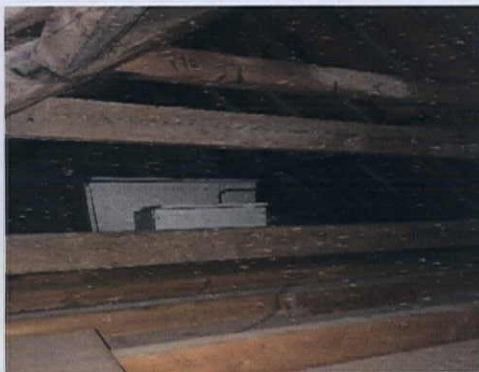
5.2.11 The roof void was small and shallow (Figure 7). There was a mix of traditional and machine cut beams and a boarded floor.

5.2.12 There was insulation between the roof beams which was held in place with plastic sheeting. The roof space was open and empty and very densely cobwebbed.

Figure 7: House roof void

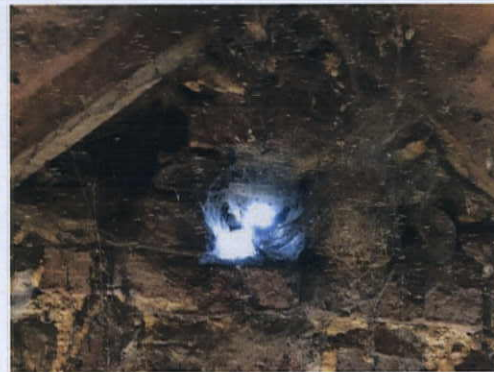
5.2.13 There was an airbrick on the southern gable where daylight was evident, and some gaps around the flints but this was densely cobwebbed (Figure 8).

Figure 8: House - Southern gable end

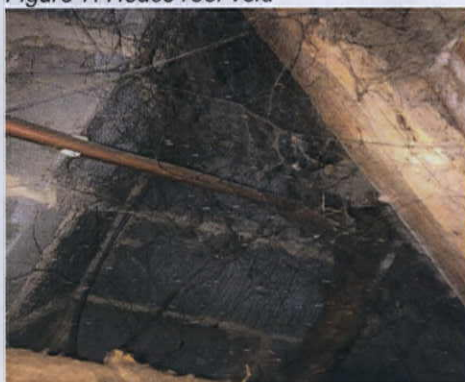
5.2.14 A small patch of daylight was evident around the eastern side of the chimney, however this was also densely cobwebbed (Figure 9).

Figure 9: Dense cobwebbing around chimney

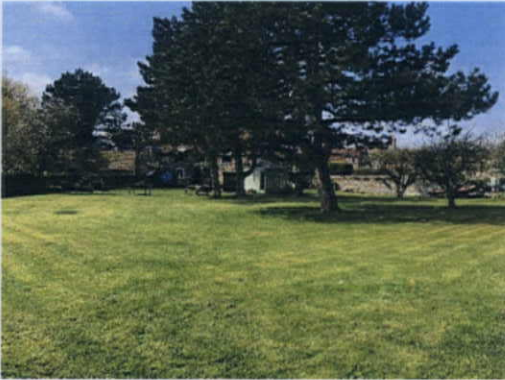
5.2.20 The three pine trees all had relatively thin trunks with flaking bark but no visible holes or dead branches evident from the ground and were assessed as having low suitability to support roosting bats (Figure 11).

Figure 11: Pine trees

7.3.1 The pine tree to be removed should be removed by soft felling, where each limb is slowly lowered to the ground and any cavities or flaking bark inspected for bats before discarding.
