New Earswick, York

Heritage Statement

June 2023

RB Heritage Ltd have been commissioned by BSB Architecture Ltd to undertake a heritage statement on behalf of the Joseph Rowntree Housing Trust in support of several listed building consent applications for a replacement roof project at New Earswick, York.

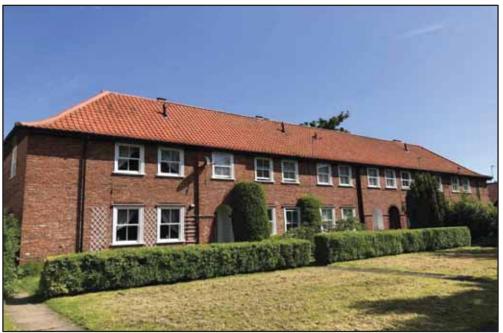
Plate 1: 14-18 Sycamore Place, front elevation

6.7 The terrace comprises red brick in running bond with soldier bond above the 4-pane white sash windows. There are black plastic rainwater goods throughout. The roof is likely original, therefore considerably past its lifespan. The external condition of the roof is poor due to gaps in some valleys and some easterly ridge caps missing and broken.

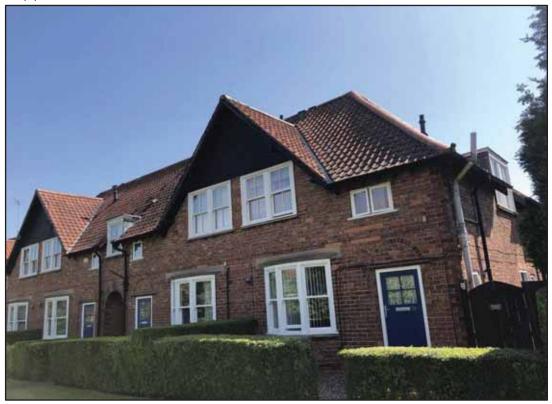
Plate 3: 74-80 Chestnut Grove, front elevation

6.9 The terrace comprises red brick in running bond with some bricks having been replaced. There are black and white plastic rainwater goods throughout. The roof is likely original, therefore considerably past its lifespan. The external condition of the roof is poor due to missing flashing in areas, particularly along some dormer windows. The rear of the properties shows missing ridge caps, flashing missing on valleys, rotting fascias and evidence of mould/algae build up.

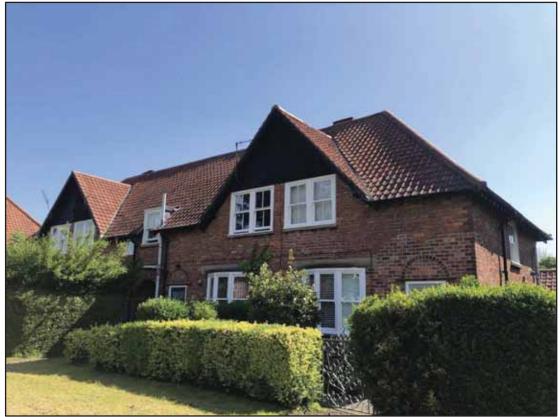
Plate 9: 90-96 Chestnut Grove, front elevation

- 6.11 The terrace comprises red brick in running bond with some bricks having been replaced. There are black and white plastic rainwater goods throughout. The roof is likely original, therefore considerably past its lifespan. The external condition of the roof is poor due to missing flashing in areas, particularly along some dormer windows. The rear of the properties shows missing/broken ridge caps, flashing missing on valleys, rotting fascias and evidence of mould/algae build up. There is also evidence that the mortar on the north facing ridge caps of 104 was replaced at some point.
- 6.12 65-83 Chestnut Grove is a row of Grade II listed properties consisting of four, two and four residential dwellings. The Historic England listing describes 65-71 as follows:

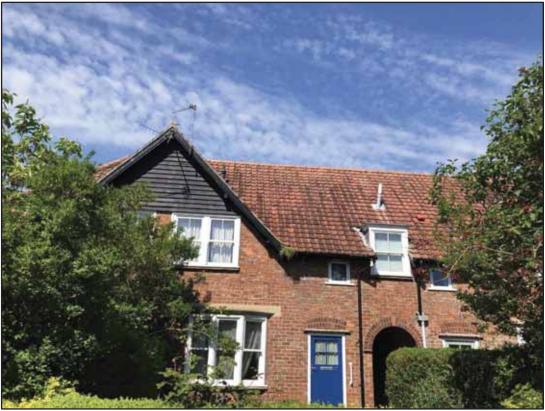
Plate 14: 65-71 Chestnut Grove, front elevation

6.13 The terrace comprises red brick in running bond with some bricks having been replaced. There are black and white plastic rainwater goods throughout. The roof is likely original, therefore considerably past its lifespan. The external condition of the roof is poor due to missing flashing in areas, particularly along some dormer windows, loose ridge caps, vegetation damage and evidence of mould/algae build up.

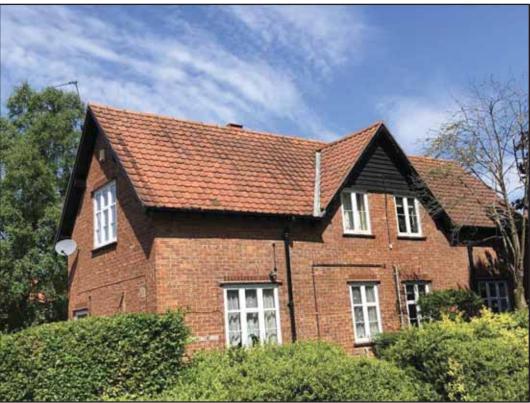
Plate 17: 73-75 Chestnut Grove, front elevation

6.15 The buildings are of red brick in running bond. There are black plastic rainwater goods throughout. The roof is likely original, therefore considerably past its lifespan. The external condition of the roof is poor due to missing/broken flashing in areas, loose ridge caps, rotting fascias and evidence of mould/algae build up.

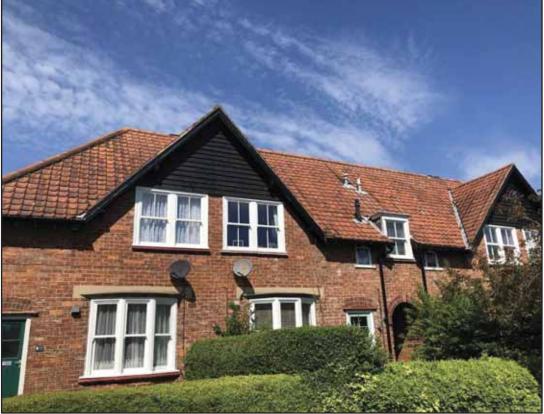
Plate 19: 77-83 Chestnut Grove, front elevation

6.17 These buildings comprise red brick in running bond with some bricks having been replaced and/or mortar replaced. There are black and white plastic rainwater goods throughout. The roofs are likely original, therefore considerably past their lifespan. The external condition of the roof is poor due to missing flashing in areas, particularly along some dormer windows. There are also missing/broken ridge caps, flashing missing on valleys, rotting/damaged fascias and evidence of mould/algae build up.

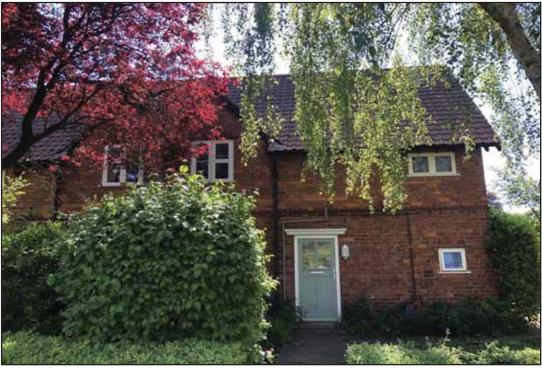
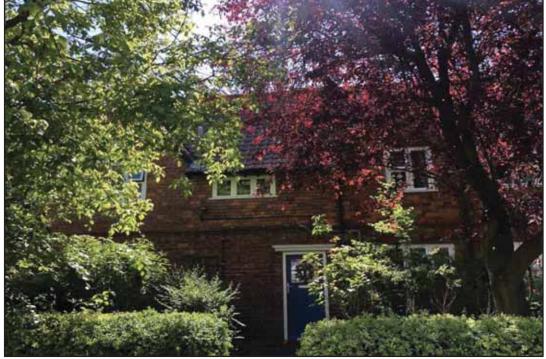
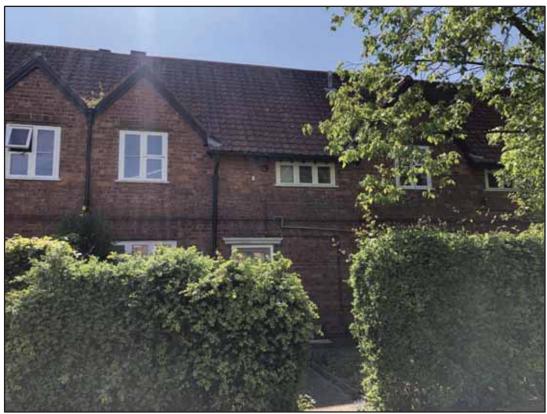
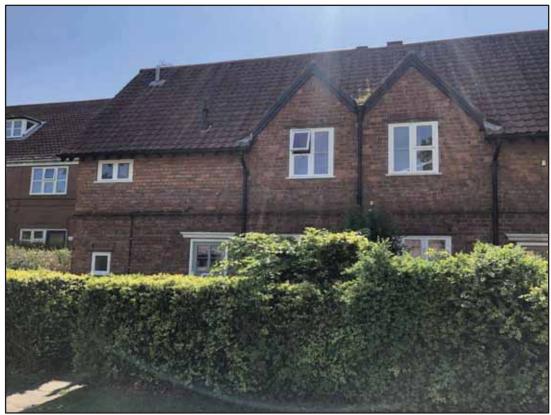
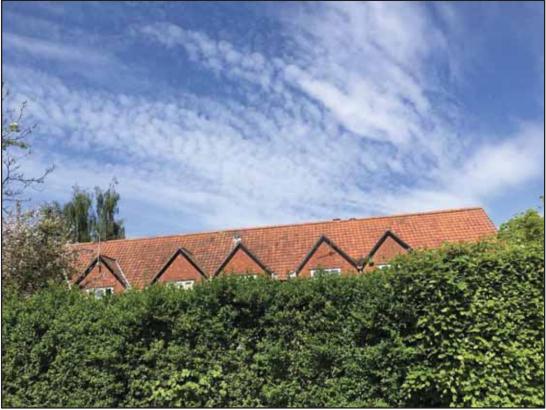
- 6.19 These buildings comprise red brick in English garden wall bond with some bricks having been replaced and/or mortar replaced in areas. There are black plastic rainwater goods throughout. The roofs are likely original, therefore considerably past their lifespan. The external condition of the roof is fair/poor with areas of missing flashing, evidence of evidence of mould/algae build up and some missing/broken ridge caps.
- 6.20 58-72 Chestnut Grove comprises one terrace of four dwellings and two sets of four semi-detached cottages. All the buildings are Grade II listed. The Historic England listing describes 58-64 as follows:

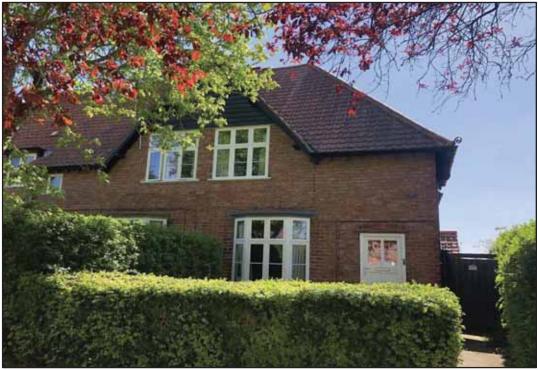
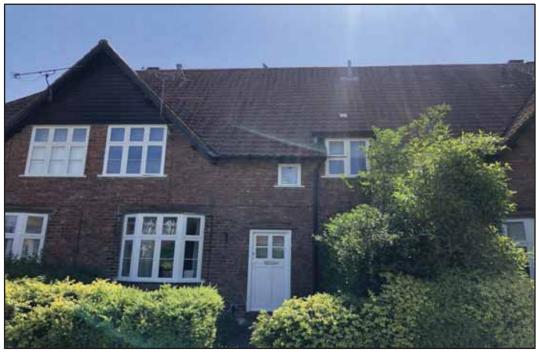
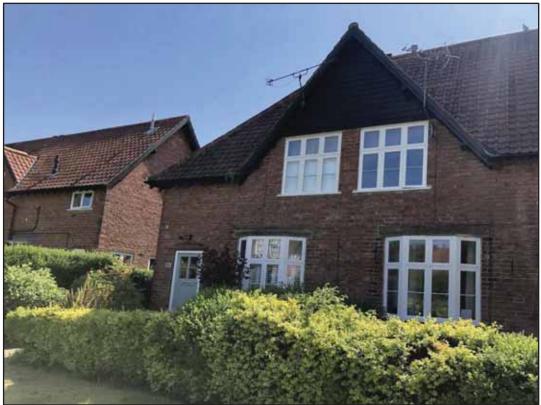
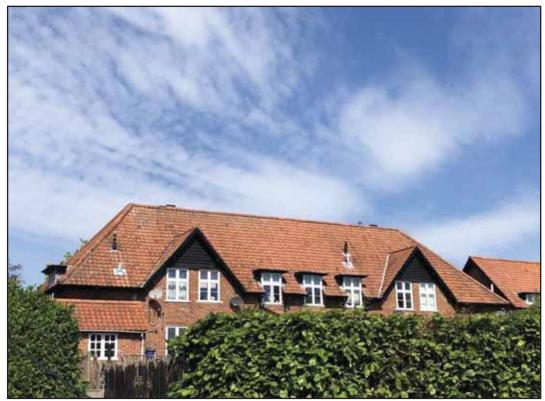
- 6.21 These buildings comprise red brick in running bond with some bricks having been replaced and/or mortar replaced. There are black and white plastic rainwater goods throughout. The roofs are likely original, therefore considerably past their lifespan. The external condition of the roof is poor due to missing/damaged flashing in areas, particularly along some dormer windows. There is also flashing missing on valleys and evidence of mould/algae build up.
- 6.22 66 and 68 are described in the Historic England listing as follows:

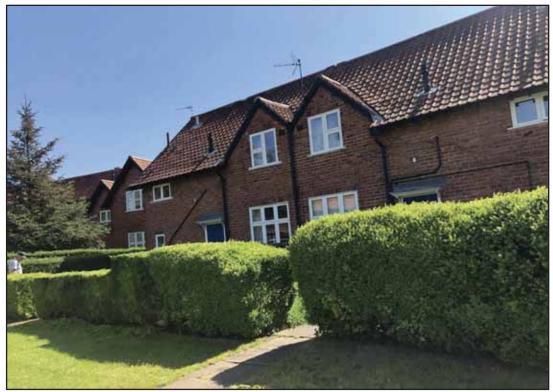
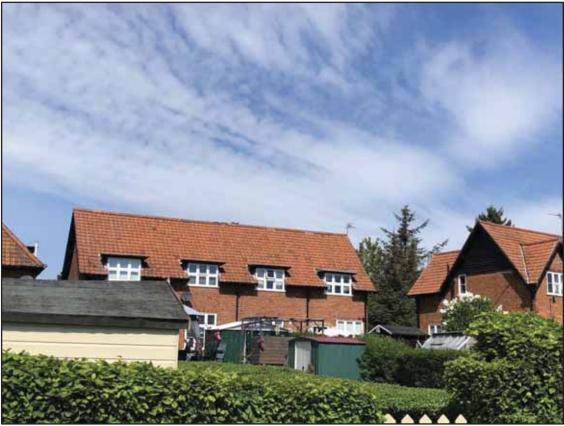
- 6.23 These buildings comprise red brick in running bond with some bricks having been replaced and/or mortar replaced. There are black plastic rainwater goods throughout. The roofs are likely original, therefore considerably past their lifespan. The external condition of the roof is poor/fair due to missing/damaged flashing in areas. There is also evidence of mould/algae build up.
- 6.24 70 and 72 are described in the Historic England listing as follows:

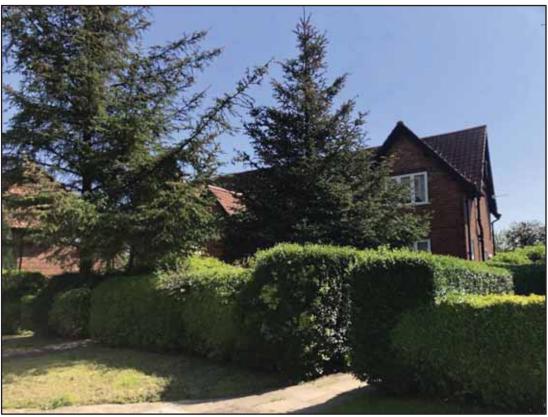
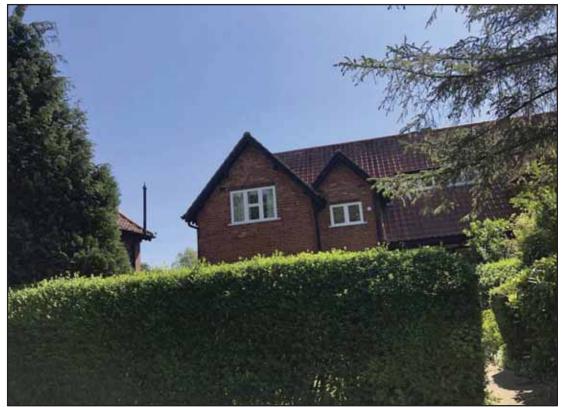
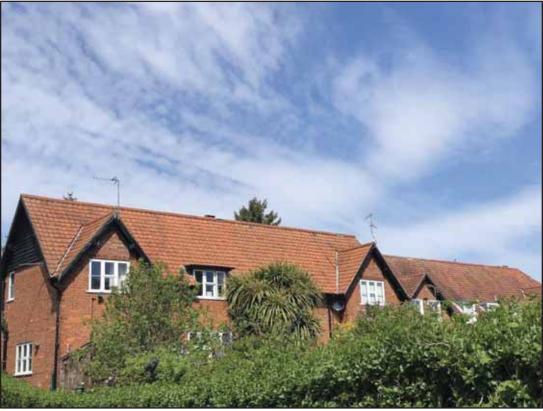
6.25 These buildings comprise red brick in running bond with some bricks having been replaced and/or mortar replaced. There is also evidence of efflorescence in areas. There are black plastic rainwater goods throughout. The roofs are likely original, therefore considerably past their lifespan. The external condition of the roof is poor due to missing/damaged flashing in areas particularly along some dormer windows. The fascias are damaged/rotting and a ridge cap has been replaced previously. There is also evidence of mould/algae build up.

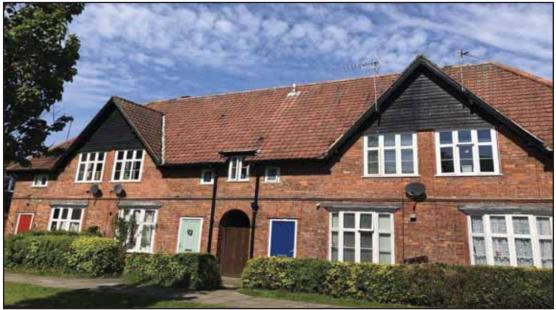
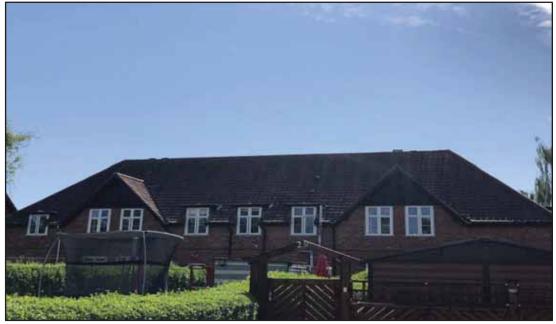
- 6.27 These buildings comprise red brick in English garden wall bond with some bricks having been damaged by efflorescence/historic leaks. There are black and white plastic rainwater goods throughout. The roof is likely original, therefore considerably past its lifespan. The external condition of the roof is poor due to damaged flashing in areas particularly along some dormer windows and some areas of fascias are damaged. There is also evidence of mould/algae build up.
- 6.28 37 51 are described in the Historic England listing as follows:

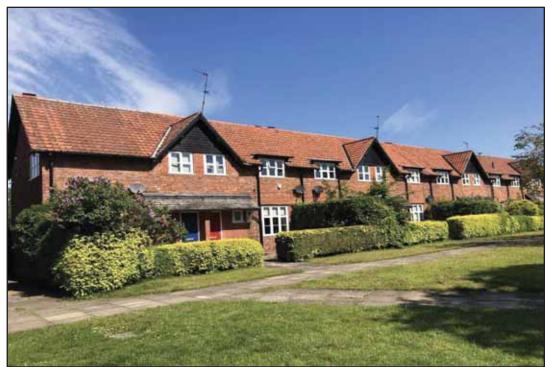
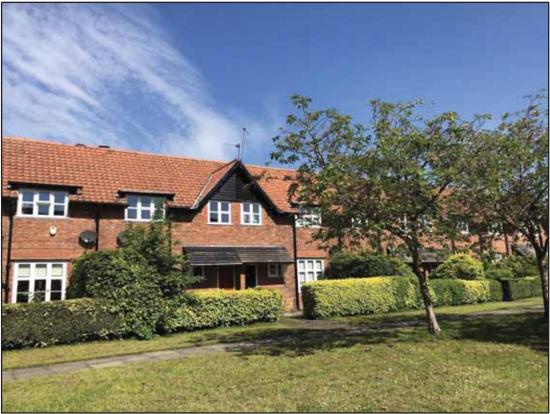
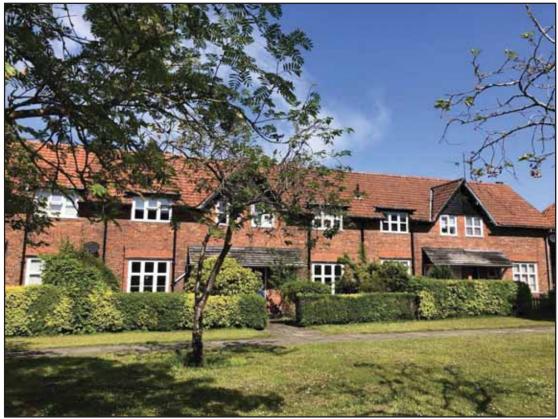
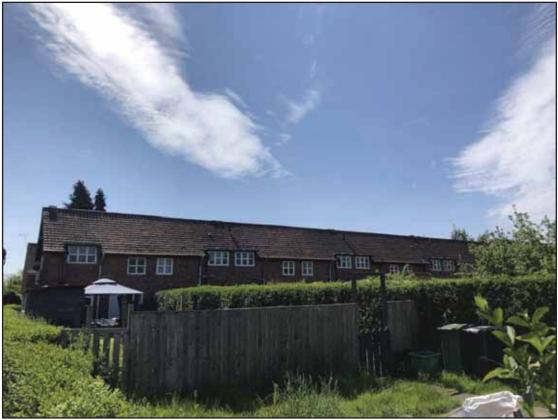
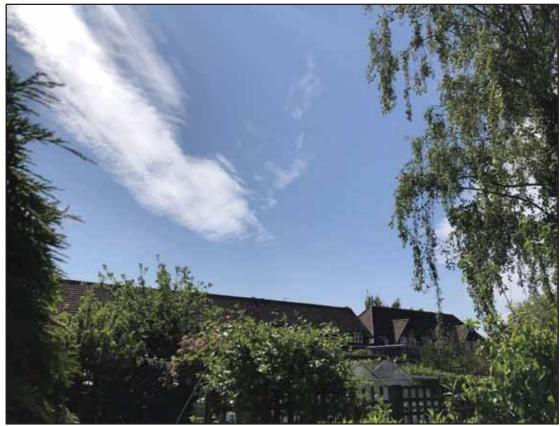
- 6.29 These buildings comprise red brick in English garden wall bond with some bricks having been replaced. There are black and white plastic rainwater goods throughout. The roof is likely original, therefore considerably past its lifespan. The external condition of the roof is poor due to damaged/missing flashing in areas particularly along some dormer windows and the canopy over the front doors, damaged/missing fascias, loose ridge tiles, and gaps in the mortar. There is also evidence of mould/algae build up.
- 6.30 53 59 Chestnut Grove is terrace comprised of 2 pairs of Grade II listed cottages. The Historic England listing describes both terraces as follows:

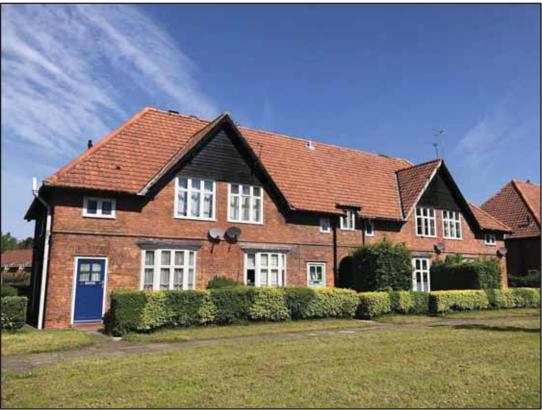
Plate 46: 53-59 Chestnut Grove, front elevation

6.31 These buildings comprise red brick in English garden wall bond with some mortar repairs evident. There are black and white plastic rainwater goods throughout. The roof is likely original, therefore considerably past its lifespan. The external condition of the roof is poor due to damaged/rotting fascias, loose ridge tiles, and gaps in the mortar. There is also evidence of mould/algae build up.

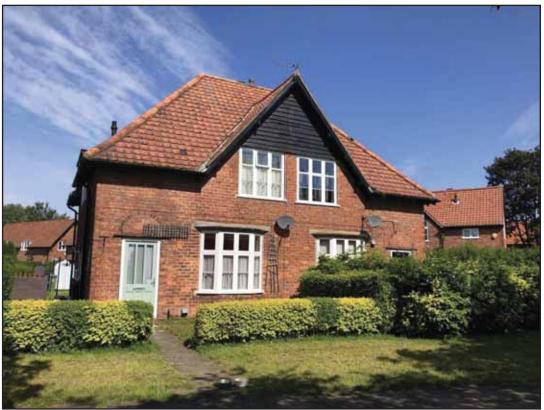
Plate 49: 61-63 Chestnut Grove, front elevation

6.33 These buildings comprise red brick in running bond with some mortar repairs and brick replacement evident. There are black plastic rainwater goods throughout. The roof is likely original, therefore considerably past its lifespan. The external condition of the roof is poor due to damaged valley flashing, loose and broken ridge tiles, and gaps in the mortar. There is also evidence of mould/algae build up.

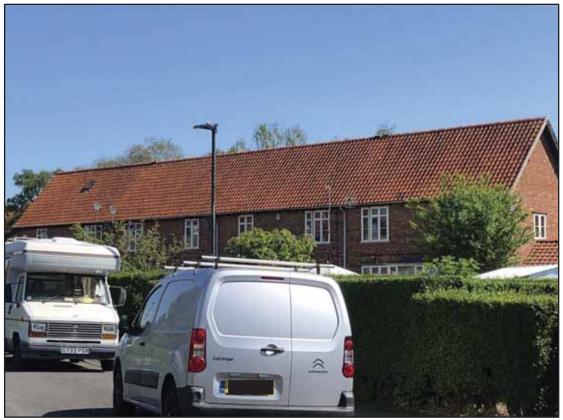
Plate 53: 1-7 Chestnut Grove, rear elevation

- 6.35 These buildings comprise red brick in English garden wall bond with some mortar repairs and brick replacement evident. There are black and white plastic rainwater goods throughout. The roof is likely original, therefore considerably past its lifespan. The external condition of the roof is poor due to damaged/missing flashing, loose ridge tiles, and gaps in the mortar. There is also evidence of mould/algae build up.
- 6.36 The Historic England listing describes 9-15 as follows:

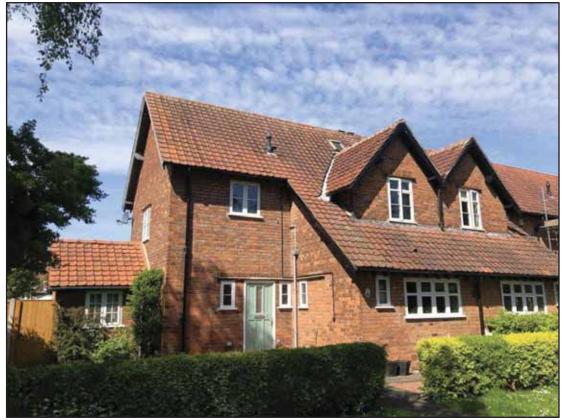
Plate 54: 9-15 Chestnut Grove, front elevation

6.37 These buildings comprise red brick in English garden wall bond with some mortar repairs and brick replacement evident. There are black plastic rainwater goods throughout. The roof is likely original, therefore considerably past its lifespan. The external condition of the roof is fair/poor due to damaged valley flashing, loose ridge tiles, and gaps in the mortar. There is also evidence of mould/algae build up.

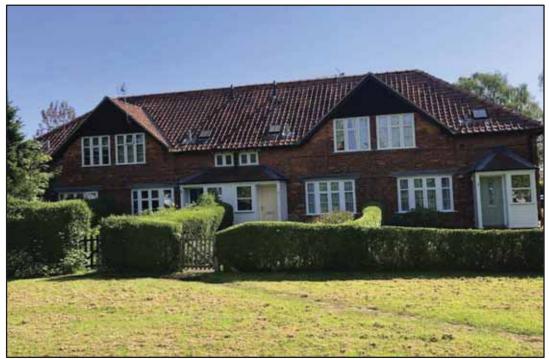
Plate 57: 1-4 Hawthorn Terrace, front elevation

- 6.39 These buildings comprise red brick in English garden wall bond with some mortar repairs and brick replacement evident around windows in particular. There are black plastic rainwater goods throughout. The roof is likely original, therefore considerably past its lifespan. The porch roof appears to be a more modern addition. The rear elevation clearly shows where there have been historic roof tile replacements. The external condition of the roof is fair/poor due to damaged valley flashing, loose ridge tiles, and gaps in the mortar. There is also evidence of mould/algae build up.
- 6.40 The Historic England listing describes 5-8 as follows:

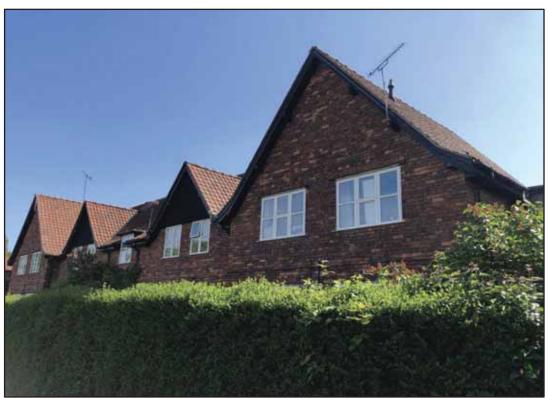
Plate 61: 9-12 Hawthorn Terrace, front elevation

6.43 These buildings comprise red brick in English garden wall bond with some mortar repairs evident. There are black plastic rainwater goods throughout. The roof is likely original, therefore considerably past its lifespan. The porch roof appears to be a more modern addition. The rear elevation clearly shows where there have been historic roof tile replacements. The external condition of the roof is poor due to damaged/missing valley flashing, loose ridge tiles which have resulted in insensitive repair, and gaps in the mortar. The facias are also damaged/missing in some areas. There is also evidence of mould/algae build up.

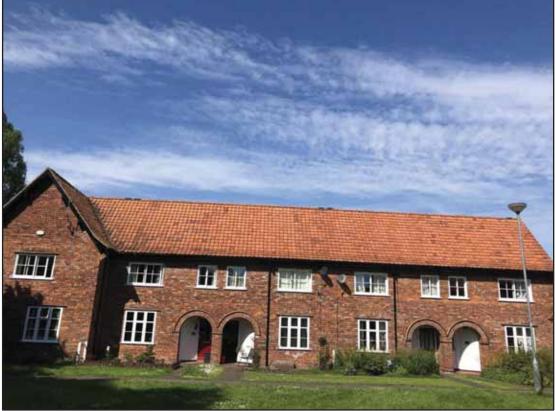
Plate 65: 1-5 lvy Place, front elevation

- 6.45 These buildings comprise red brick in English garden wall bond with some mortar repairs and efflorescence evident. There are black plastic rainwater goods throughout. The roof is likely original, therefore considerably past its lifespan. The front elevation shows evidence of historic roof tile replacements. The external condition of the roof is poor due to damaged/missing valley flashing, loose ridge tiles, and gaps in the mortar. There is also evidence of mould/algae build up.
- 6.46 The Historic England listing describes 6-12 as follows:

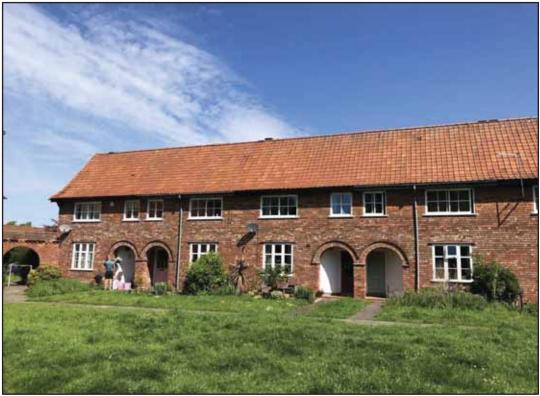
Plate 67: 6-12 Ivy Place, front elevation

- 6.47 These buildings comprise red brick in English garden wall bond with some mortar repairs and replacement bricks. There are black and white plastic rainwater goods throughout. The roof is likely original, therefore considerably past its lifespan. The external condition of the roof is poor due to gaps in flashing, loose ridge tiles, and gaps in the mortar. The fascias also are damaged/rotting. There is evidence of mould/algae build up.
- 6.48 The Historic England listing describes 13 15 as follows:

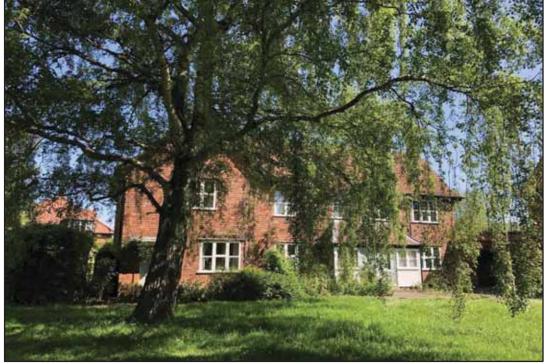
Plate 69: 13-15 Ivy Place, front elevation

- 6.49 These buildings comprise red brick in English garden wall bond with some mortar repairs evident. There are black plastic rainwater goods throughout. The roof is likely original, therefore considerably past its lifespan. The external condition of the roof is fair/poor due to gaps in flashing, loose ridge tiles, and gaps in the mortar. There is also evidence of mould/algae build up.
- 6.50 The Historic England listing describes 16 20 as follows:

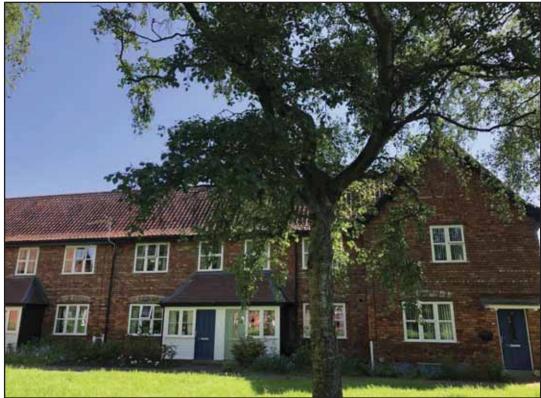
Plate 71: 16-20 Ivy Place, front elevation

6.51 These buildings comprise red brick in English garden wall bond with some mortar repairs and replacement bricks evident. There are black plastic rainwater goods throughout and projecting porch roofs which appear to be modern additions. The roof is likely original, therefore considerably past its lifespan. The external condition of the roof is poor due to damaged/missing flashing, loose ridge tiles, and gaps in the mortar. There is also evidence of mould/algae build up.
