Appendix D Pre-planning Enquiry Response

HEMPLAND PRIMARY
SCHOOL,
YORK

for
Department for Education

Appendix G Drawings

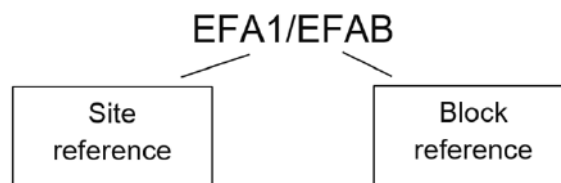
Figure 1: Location field naming convention

The relevant site and block reference. Site references contain a unique number; block references (with the exception of 'Ancillary blocks') are labelled A-Z. The example below refers to block 'B' of site '1'.
