Middlemarch was commissioned by ISG to undertake bat surveys at Hempland Primary School located off Whitby Avenue in York. These surveys are required to inform a planning application associated with the proposed demolition of the existing school building and the construction of a new school on the same site. Two initial bat surveys were commissioned by Spatial Initiative on the site in August and September 2022 and a third survey was subsequently commissioned by ISG and carried out by Middlemarch in June 2023, this report covers the findings of all three surveys.

Middlemarch was commissioned by ISG to undertake bat surveys at Hempland Primary School located off Whitby Avenue in York. These surveys are required to inform a planning application associated with the proposed demolition of the existing school building and the construction of a new school on the same site.

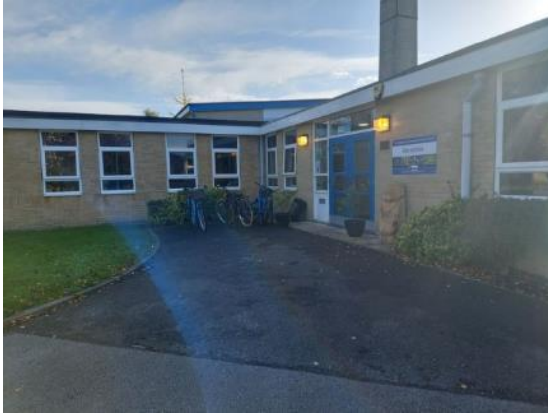
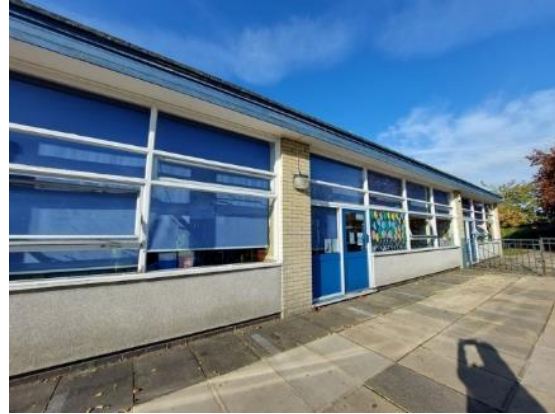
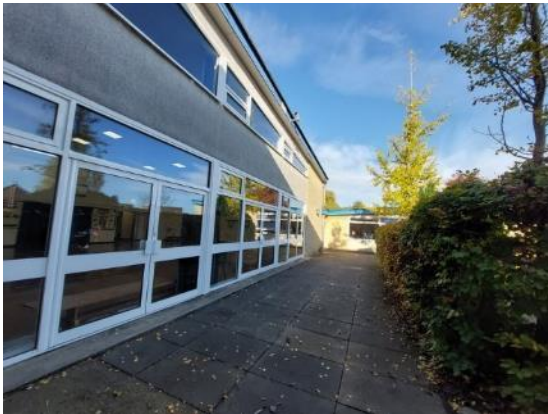
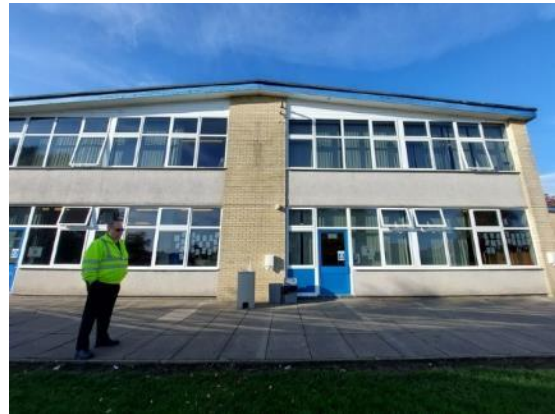
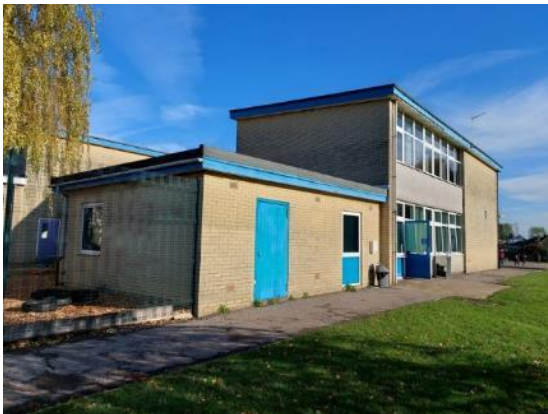
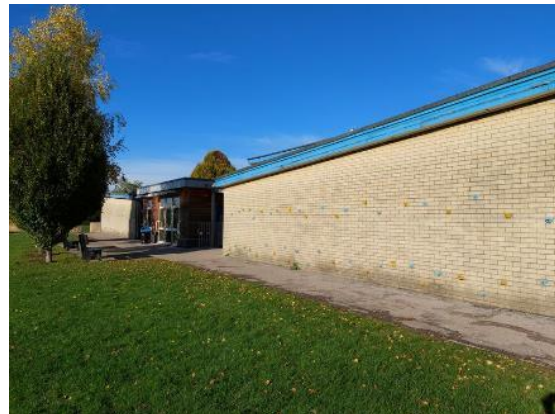
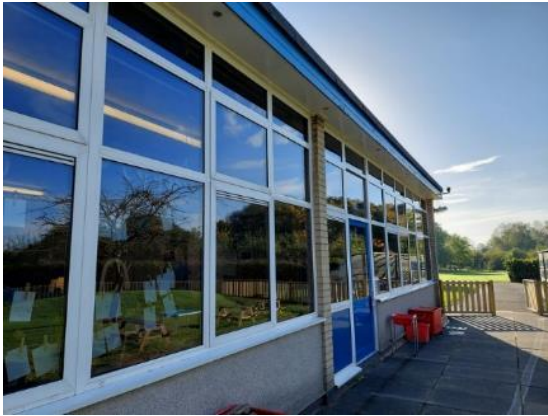
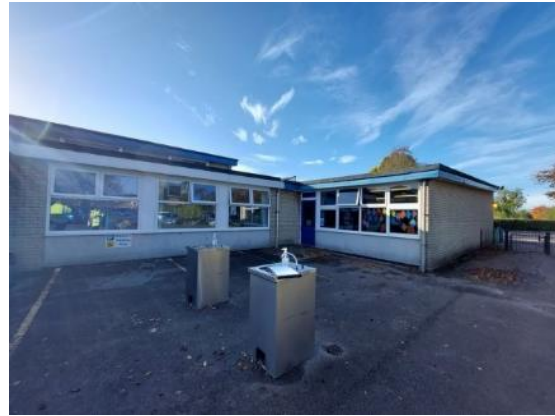
The Main School Building comprised several sections which varied from single-storey to two-storeys in height (Plates 4.1 to 4.8). It was constructed from brick with concrete rendering present in some sections. The roofs were all flat, except for the pitched section at the southern end of the eastern elevation, and they were all covered in bitumen felt. The soffits around the main entrance had been replaced with uPVC boards, but the rest of the building had wooden soffits with wooden fascia boards. A number of windows were present around the building. These were set in uPVC frames, which were tightly fitted with no gaps.

**Plate 4.1: Main entrance,
central section of northern elevation**

**Plate 4.2: Northern end
of eastern elevation**

**Plate 4.3: Central section
of eastern elevation**

Plate 4.4: Southern end of eastern elevation

Plate 4.5: Eastern end of southern elevation

**Plate 4.6: Western end
of southern elevation**

Plate 4.7: Southern end of western elevation

Plate 4.8: Western end of northern elevation

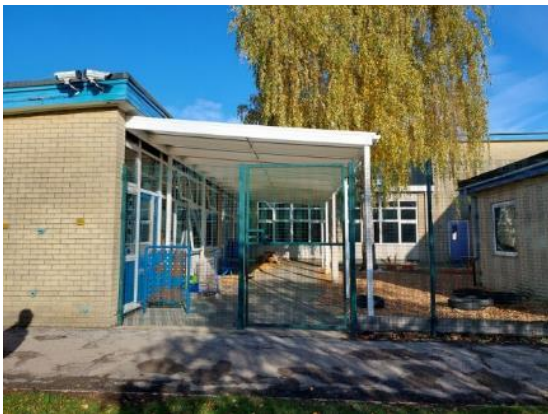
Plate 4.9: Courtyard in central section of southern elevation

A small, covered courtyard was present midway along the southern elevation of the Main School Building. The canopy in this area was constructed from clear plastic sheeting supported by a metal frame (Plate 4.9). At the northern end of the western elevation, there was a wooden framed canopy with a curved roof (Plate 4.10). No gaps were present where the canopies joined the Main School Building.

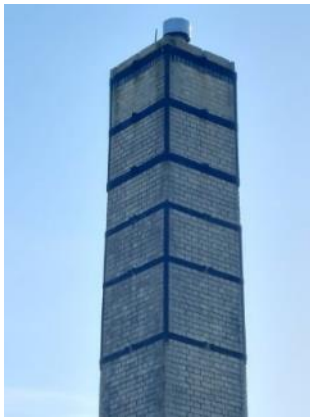
There was a tall brick chimney rising from the centre of the building (Plate 4.11). This appeared to be in good condition when viewed from the ground using binoculars.

Plate 4.11: Tall chimney in centre of building

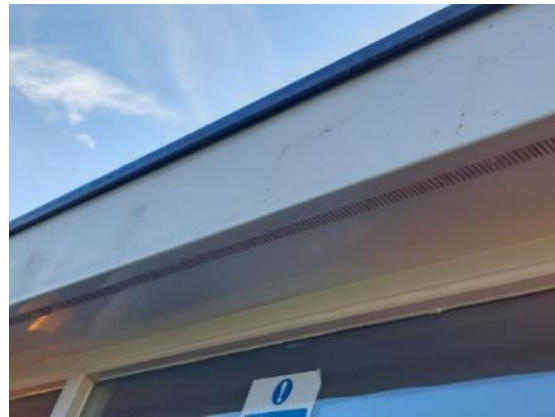
- Gaps under roof edging (Plates 4.12 and 4.13);
- Damaged fascia boards (Plates 4.14 to 4.16);
- Damaged soffits (Plates 4.17 and 4.18);
- Missing vent cover leading into soffit box (Plate 4.19);
- Lifted lead flashing (Plate 4.20);
- Holes in brickwork (Plate 4.21); and,
- Gaps around windowsills.

Due to their height and location, many of the features listed above could not be fully inspected. Where accessible, features were checked and found to be clear of cobwebs and debris, possibly indicating recent use by bats or birds. No evidence of bats was recorded.

Plate 4.12: Gaps under roof edge

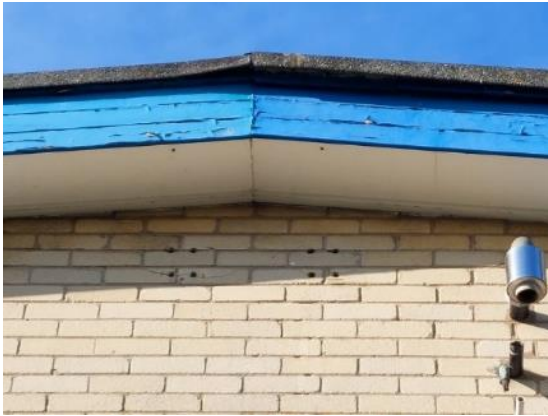
Plate 4.13: Gaps under roof edge

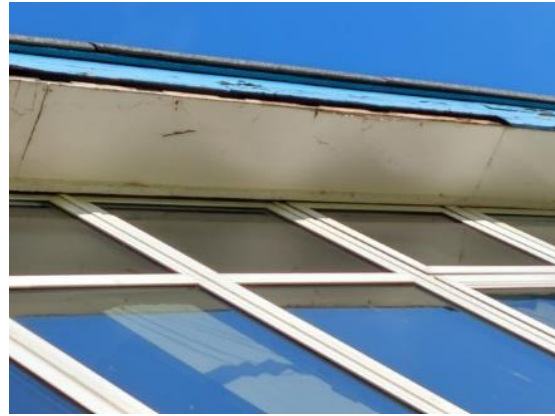
Plate 4.14: Damaged fascia boards

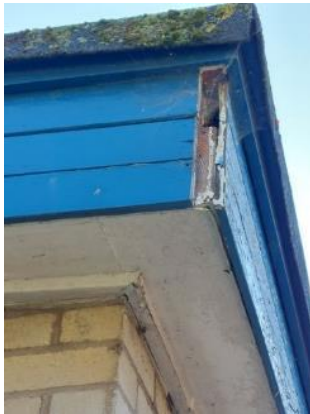
Plate 4.15: Damaged fascia boards

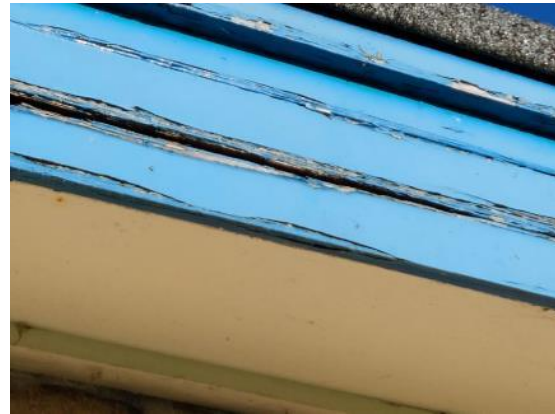
Plate 4.16: Gap in fascia board

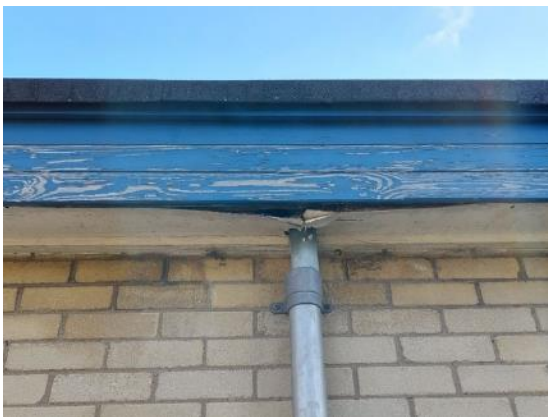
Plate 4.17: Damaged soffit

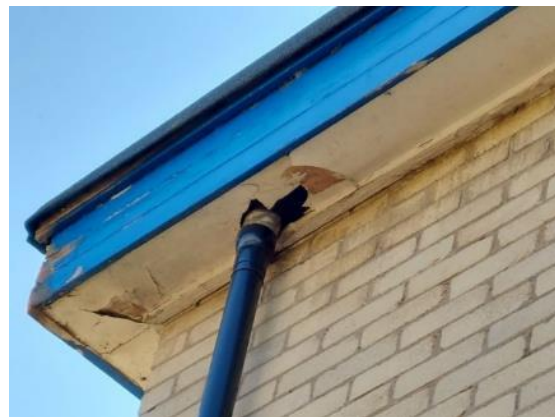
Plate 4.18: Damaged soffit

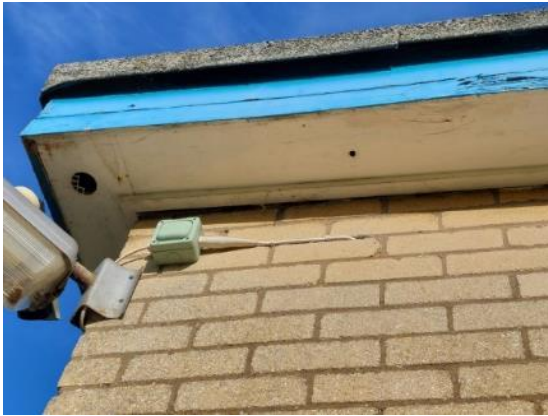
Plate 4.19: Missing vent cover

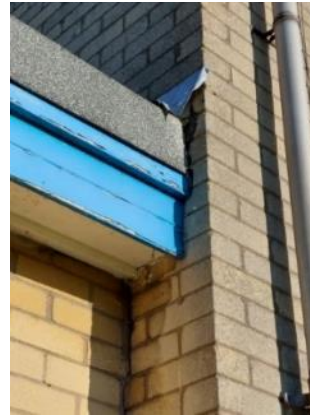
Plate 4.20: Lifted lead flashing

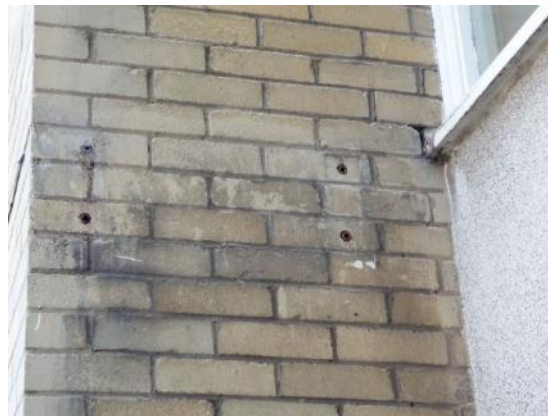
Plate 4.21: Holes in brickwork and gap around windowsill

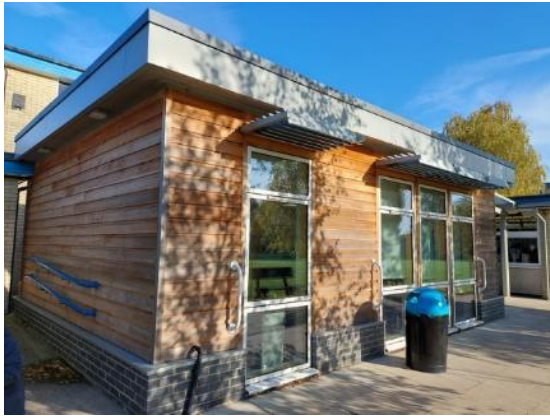
This was a modern addition to the original school building, consisting of a single-storey, standalone block located to the south of the Main School Building (Plate 4.22). It had a brick base with wooden cladding on the walls, and a flat roof covered in metal sheeting. There were wide, metal soffits all around the building, the windows and doors were set in uPVC frames. The building was well-sealed with no potential ingress points or roosting features present.

Plate 4.22: Southern elevation

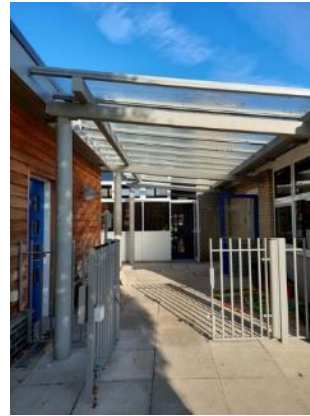
A canopy connected the eastern elevation of the Caddell Centre to the Main School Building, forming a small covered courtyard between the two buildings (Plate 4.23). The canopy was constructed from clear plastic sheeting supported by a metal frame. No gaps were present where the canopy joined the two buildings.

Plate 4.23: Canopy connecting the eastern elevation to the Main School Building

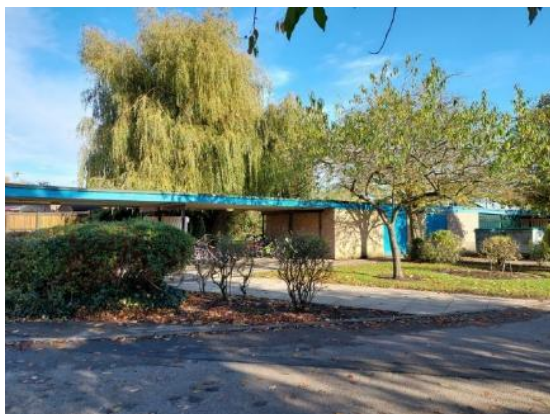
A Bike Shed/Storage Building was present to the north of the Main School Building. This comprised a single-storey building with a flat roof covered in bitumen felt (Plate 4.24). The central section housed a storage room, which was constructed from brick and had wooden doors along the southern elevation (Plate 4.25). The brickwork was in good condition with no cracks or crevices present. The wooden doors were also in good condition and tightly fitted with no gaps. At the eastern and western ends of the building, there was a bike shed and storage area which were open sided (Plate 4.26). Wooden fascia boards were present along the entire length of the building. These were intact and tightly fitted with no gaps.

Plate 4.24: Northern elevation

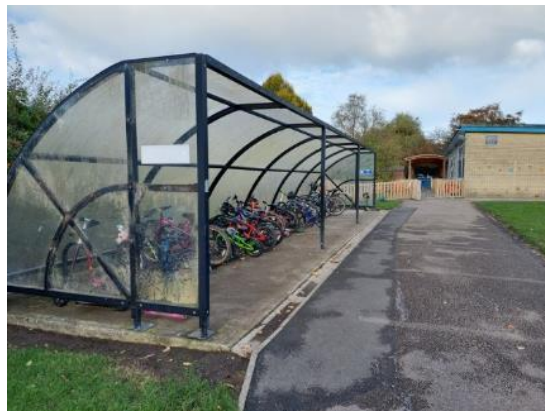
A Bike Shelter was present to the south-west of the Main School Building. This was constructed from a metal frame with clear plastic sheets (Plate 4.27). It held no potential roosting features for bats.

Plate 4.27: Bike Shelter
