**HEMPLAND PRIMARY
SCHOOL,
YORK**

Project Number PC218325

April 2022

Preliminary Ground Investigation Report with
Interpretive Chapter
for

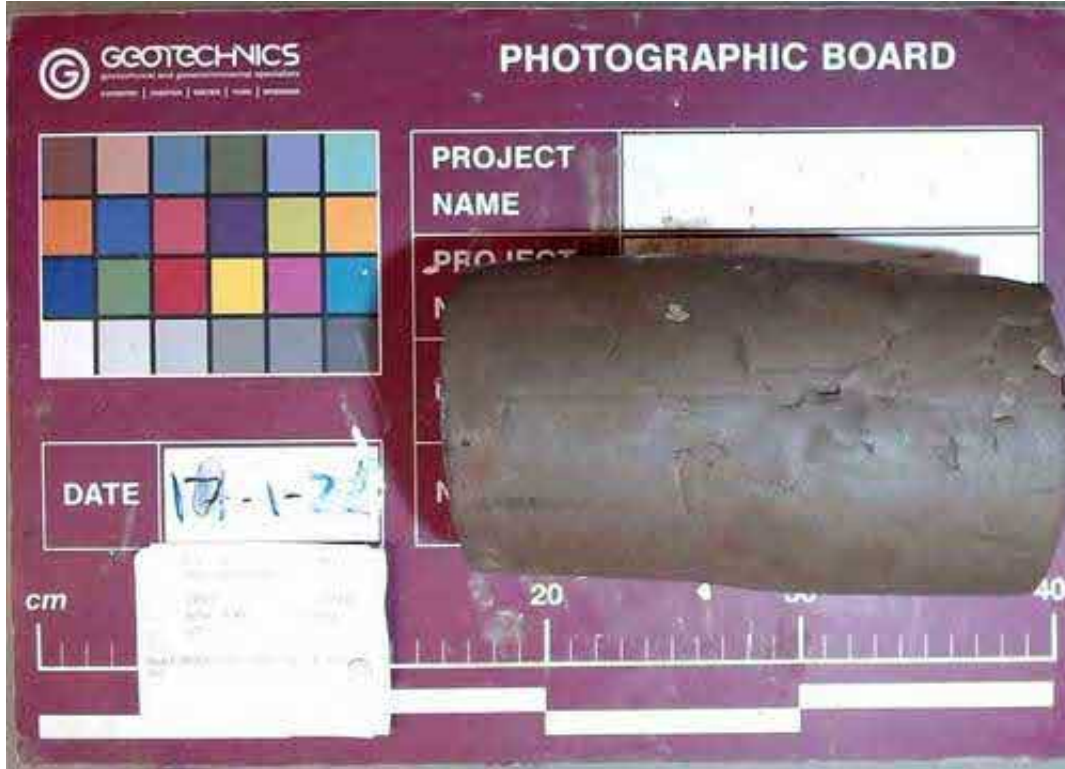
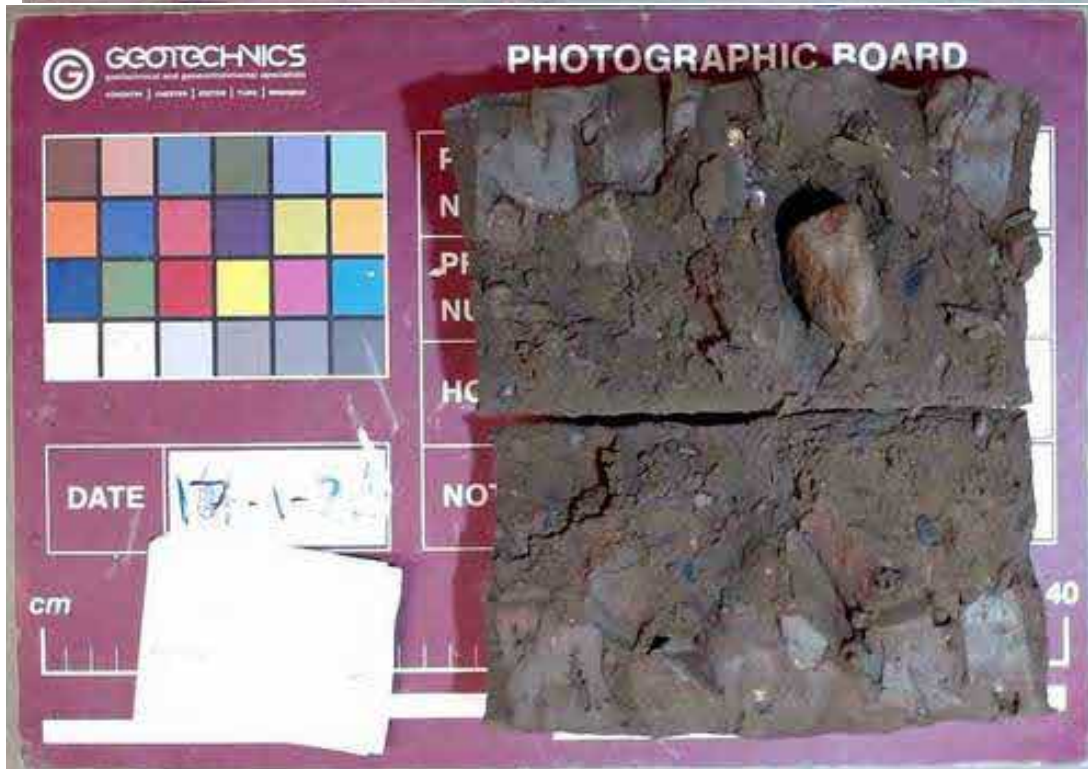
Hole CP01
Sample Depth 4.00-4.45m
Sample Type UT
Sample Ref C77757

Stage 1	Stage 2	Stage 3	Strain %	Corrected Deviator Stress kN/m ²	Strain %	Corrected Deviator Stress kN/m ²
Test Type	Single Stage						
Sample Condition	Undisturbed						
Orientation of sample	Vertical						
Initial Diameter (mm)	104.71			0.2	35.5	10.0	330.2
Initial Length (mm)	210.92			0.5	71.0	10.4	326.5
Initial Water Content (%)	11.3			0.7	99.0	10.9	321.7
Initial Bulk Density (Mg/m ³)	2.19			0.9	125.1	11.4	319.1
Initial Dry Density (Mg/m ³)	1.97			1.4	168.5	11.9	314.0
Particle Density (Mg/m ³)	2.65 Assumed			1.9	197.7	12.3	308.7
Cell Pressure (kPa)	100			2.4	222.3	12.8	304.1
'Specimen Height' at start of Shearing Stage (mm)	210.85			2.8	242.0	13.3	298.1
Membrane Thickness/Correction (mm/kPa)	1 / 0.0000			3.3	257.1	13.7	289.7
Rate of Strain (%/min)	1.9			3.8	270.4	14.2	281.8
Corrected Deviator Stress (kPa)	334			4.3	282.6	14.7	273.0
Undrained Shear Strength (kPa)	167			4.7	291.8	15.2	263.7
Strain at Failure (%)	9.0			5.2	302.6	15.6	253.4

Failure Zone Water Content (%)	13.4			5.7	308.7	16.1	244.4
Water Content (after test) (%)				6.2	313.5	16.6	235.2
Mode of Failure	Intermediate			6.6	319.9	17.1	226.0

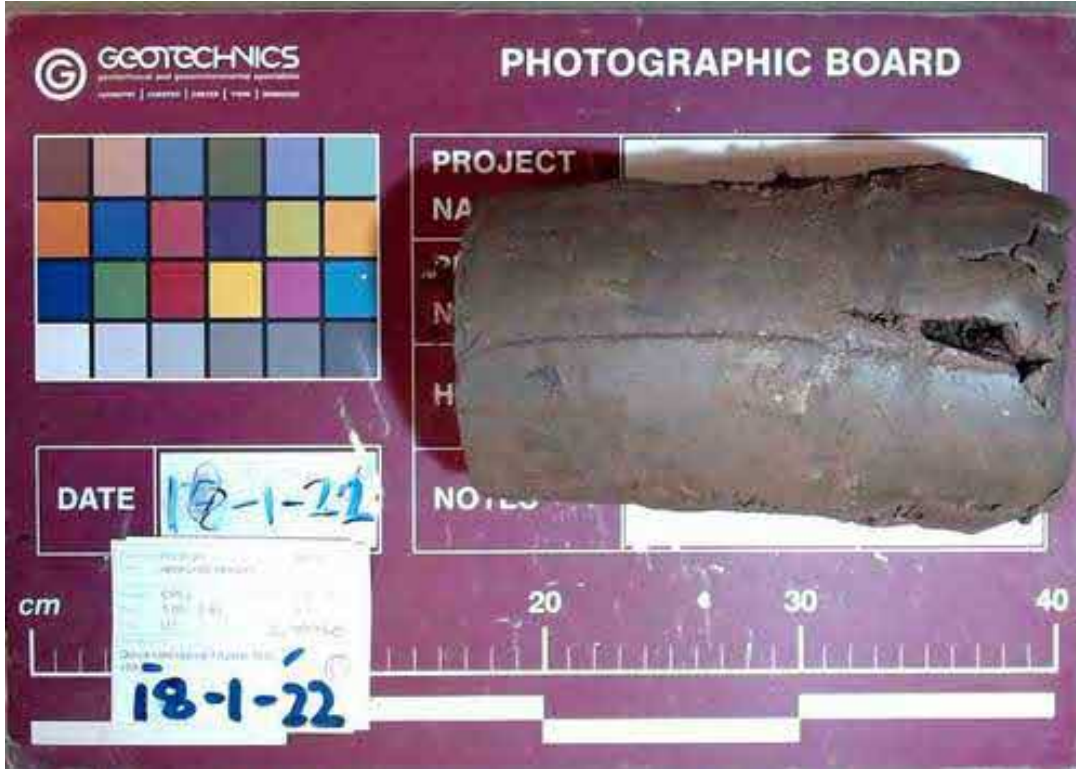
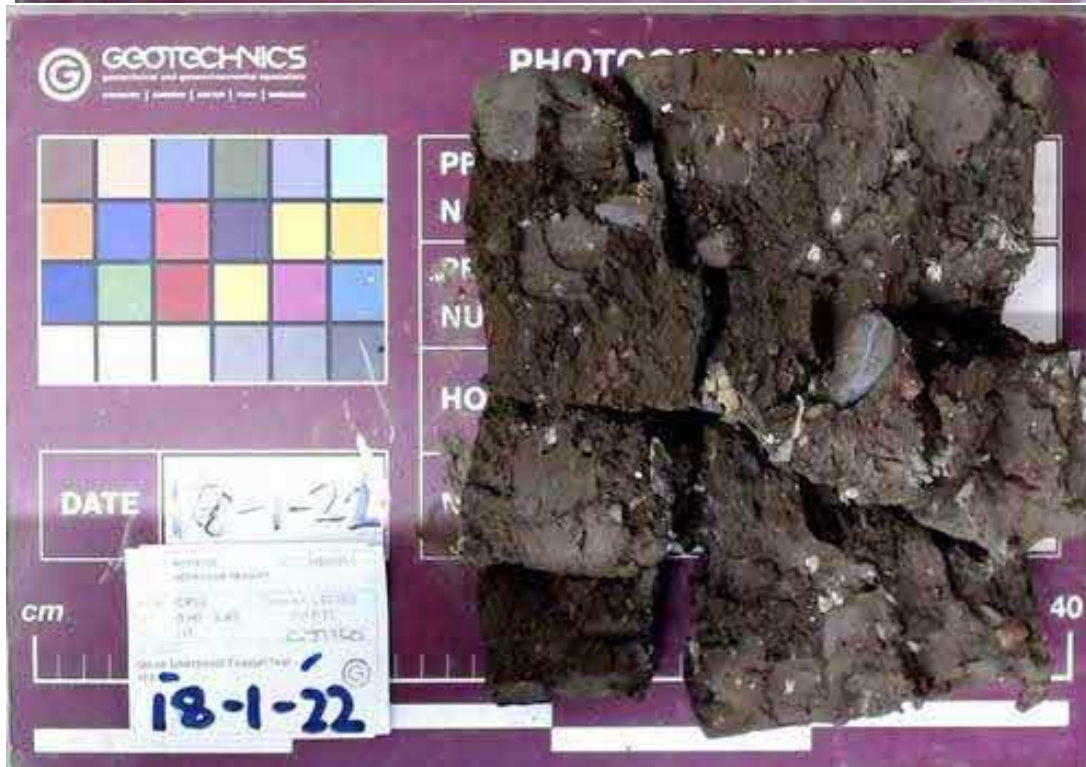
Hole: CP02
Sample Depth: 5.00-5.45m
Sample Type: UT
Sample Ref: C77760

Stage 1	Stage 2	Stage 3	Strain %	Corrected Deviator Stress kN/m ²	Strain %	Corrected Deviator Stress kN/m ²
Test Type	Single Stage						
Sample Condition	Undisturbed						
Orientation of sample	Vertical						
Initial Diameter (mm)	103.69			0.2	38.7	10.0	226.9
Initial Length (mm)	210.44			0.5	51.6	10.5	230.4
Initial Water Content (%)	14.3			0.7	63.0	10.9	232.7
Initial Bulk Density (Mg/m ³)	2.25			1.0	74.5	11.4	235.4
Initial Dry Density (Mg/m ³)	1.97			1.4	93.0	11.9	238.7
Particle Density (Mg/m ³)	2.65 Assumed			1.9	106.3	12.4	241.6
Cell Pressure (kPa)	40			2.4	120.6	12.8	244.5
'Specimen Height' at start of Shearing Stage (mm)	210.42			2.9	131.7	13.3	247.3
Membrane Thickness/Correction (mm/kPa)	100 / 0.0000			3.3	141.6	13.8	249.4
Rate of Strain (%/min)	1.9			3.8	151.4	14.3	250.8
Corrected Deviator Stress (kPa)	259			4.3	161.0	14.7	252.3
Undrained Shear Strength (kPa)	129			4.8	168.4	15.2	252.8
Strain at Failure (%)	19 (excess)			5.2	174.7	15.7	252.3

Failure Zone Water Content (%)				5.7	181.3	16.2	252.6
Water Content (after test) (%)	13.6			6.2	187.9	16.6	254.0
Mode of Failure	Plastic			6.7	193.2	17.1	255.1

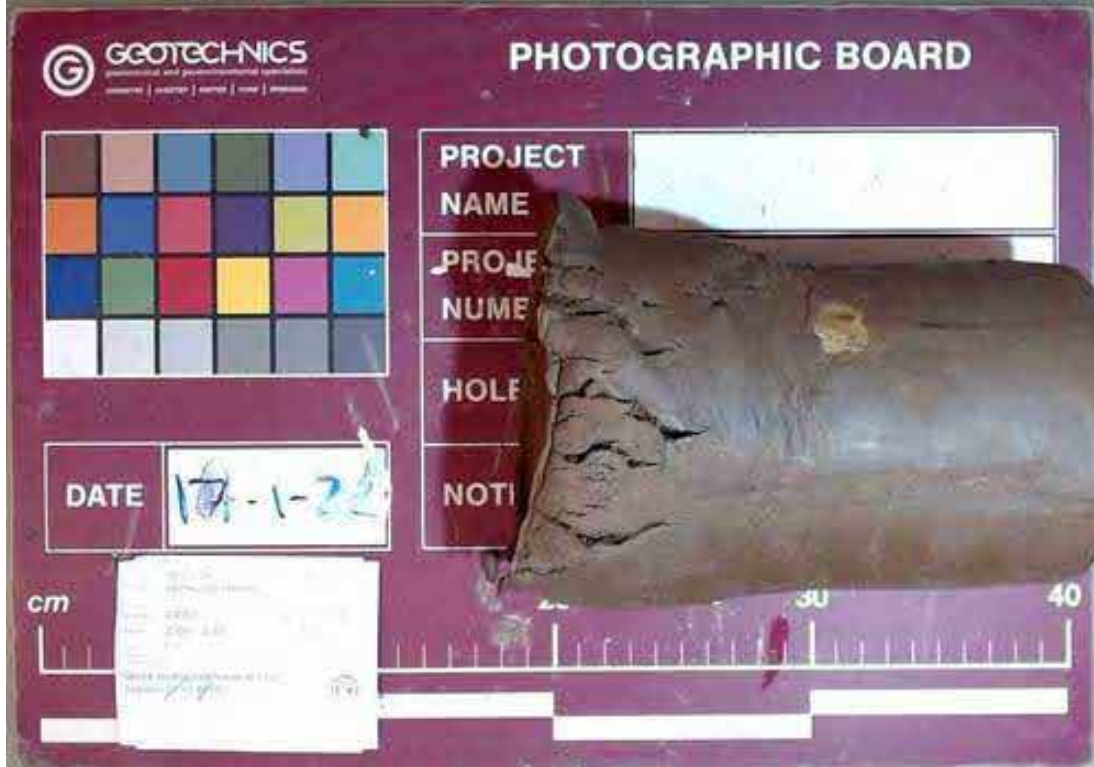
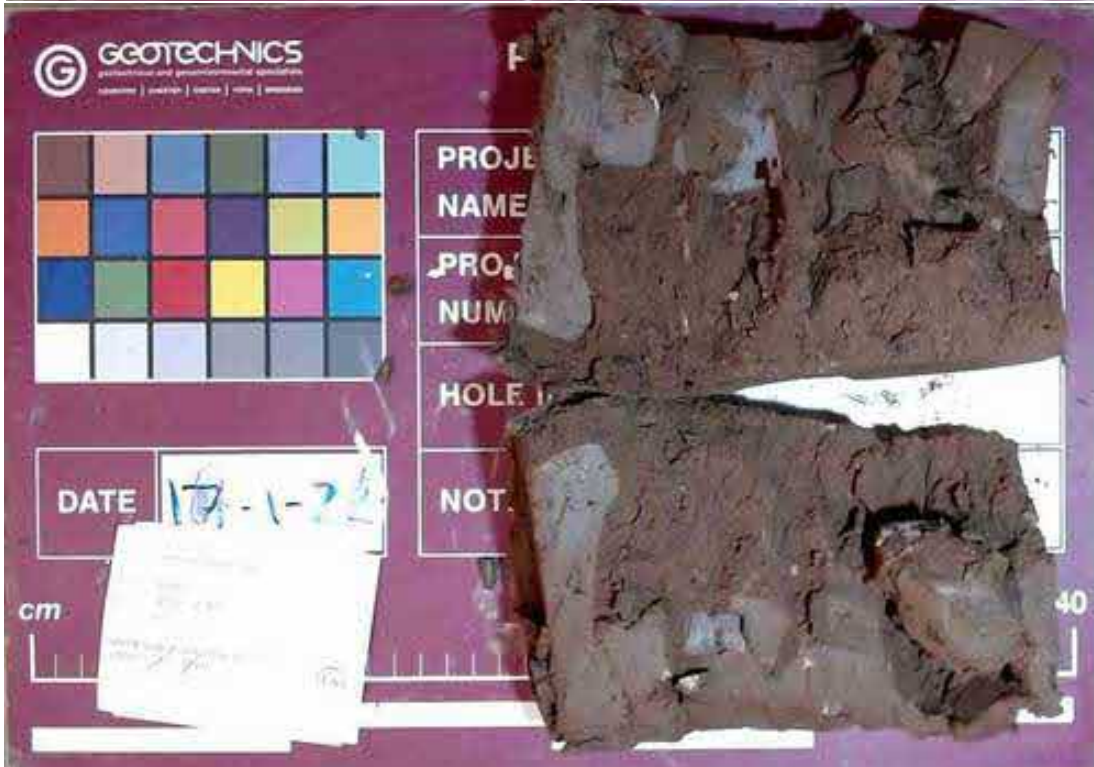
Hole CP03
Sample Depth 2.00-2.45m
Sample Type UT
Sample Ref C77755

Stage 1	Stage 2	Stage 3	Strain %	Corrected Deviator Stress kN/m ²	Strain %	Corrected Deviator Stress kN/m ²
Test Type	Single Stage						
Sample Condition	Undisturbed						
Orientation of sample	Vertical						
Initial Diameter (mm)	102.59			0.2	37.5	10.0	205.0
Initial Length (mm)	210.38			0.5	53.8	10.5	206.3
Initial Water Content (%)	12.0			0.7	66.3	10.9	206.7
Initial Bulk Density (Mg/m ³)	2.23			1.0	74.1	11.4	208.0
Initial Dry Density (Mg/m ³)	1.99			1.4	90.4	11.9	210.5
Particle Density (Mg/m ³)	2.65 Assumed			1.9	106.7	12.4	212.0
Cell Pressure (kPa)	120			2.4	121.6	12.8	211.9
'Specimen Height' at start of Shearing Stage (mm)	210.30			2.9	134.1	13.3	211.8
Membrane Thickness/Correction (mm/kPa)	100 / 0.0000			3.3	146.3	13.8	212.9
Rate of Strain (%/min)	1.9			3.8	156.2	14.3	214.5
Corrected Deviator Stress (kPa)	230			4.3	164.9	14.7	215.6
Undrained Shear Strength (kPa)	115			4.8	170.3	15.2	215.5
Strain at Failure (%)	20 (excess)			5.2	175.6	15.7	215.8

Failure Zone Water Content (%)				5.7	181.1	16.2	217.1
Water Content (after test) (%)	12.0			6.2	185.5	16.6	217.2
Mode of Failure	Plastic			6.7	189.8	17.1	218.0

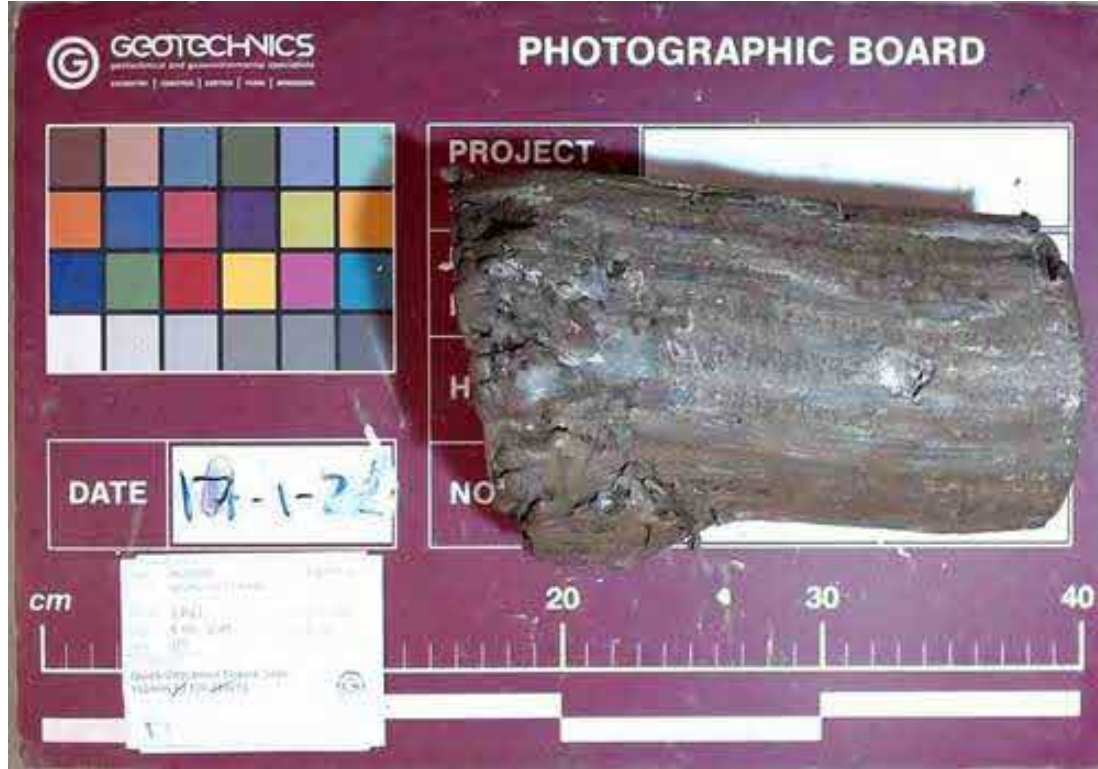
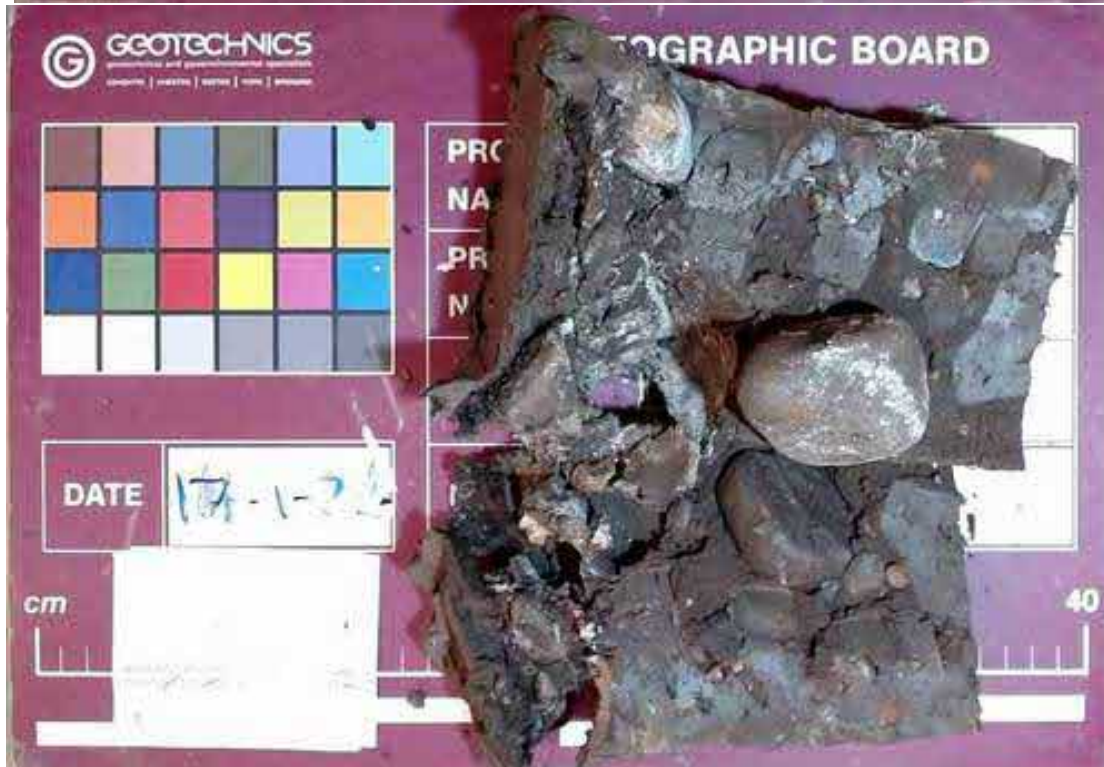
Hole CP03
Sample Depth 6.00-6.45m
Sample Type UT
Sample Ref C77754

Stage 1	Stage 2	Stage 3	Strain %	Corrected Deviator Stress kN/m ²	Strain %	Corrected Deviator Stress kN/m ²
Test Type	Single Stage						
Sample Condition	Undisturbed						
Orientation of sample	Vertical						
Initial Diameter (mm)							
Initial Length (mm)							
Initial Water Content (%)							
Initial Bulk Density (Mg/m ³)							
Initial Dry Density (Mg/m ³)							
Particle Density (Mg/m ³)	2.65 Assumed						
Cell Pressure (kPa)	120						
'Specimen Height' at start of Shearing Stage (mm)							
Membrane Thickness/Correction (mm/kPa)	0 / 0.0000						
Rate of Strain (%/min)	2.0						
Corrected Deviator Stress (kPa)							
Undrained Shear Strength (kPa)							
Strain at Failure (%)							
Failure Zone Water Content (%)							
Water Content (after test) (%)							
Mode of Failure

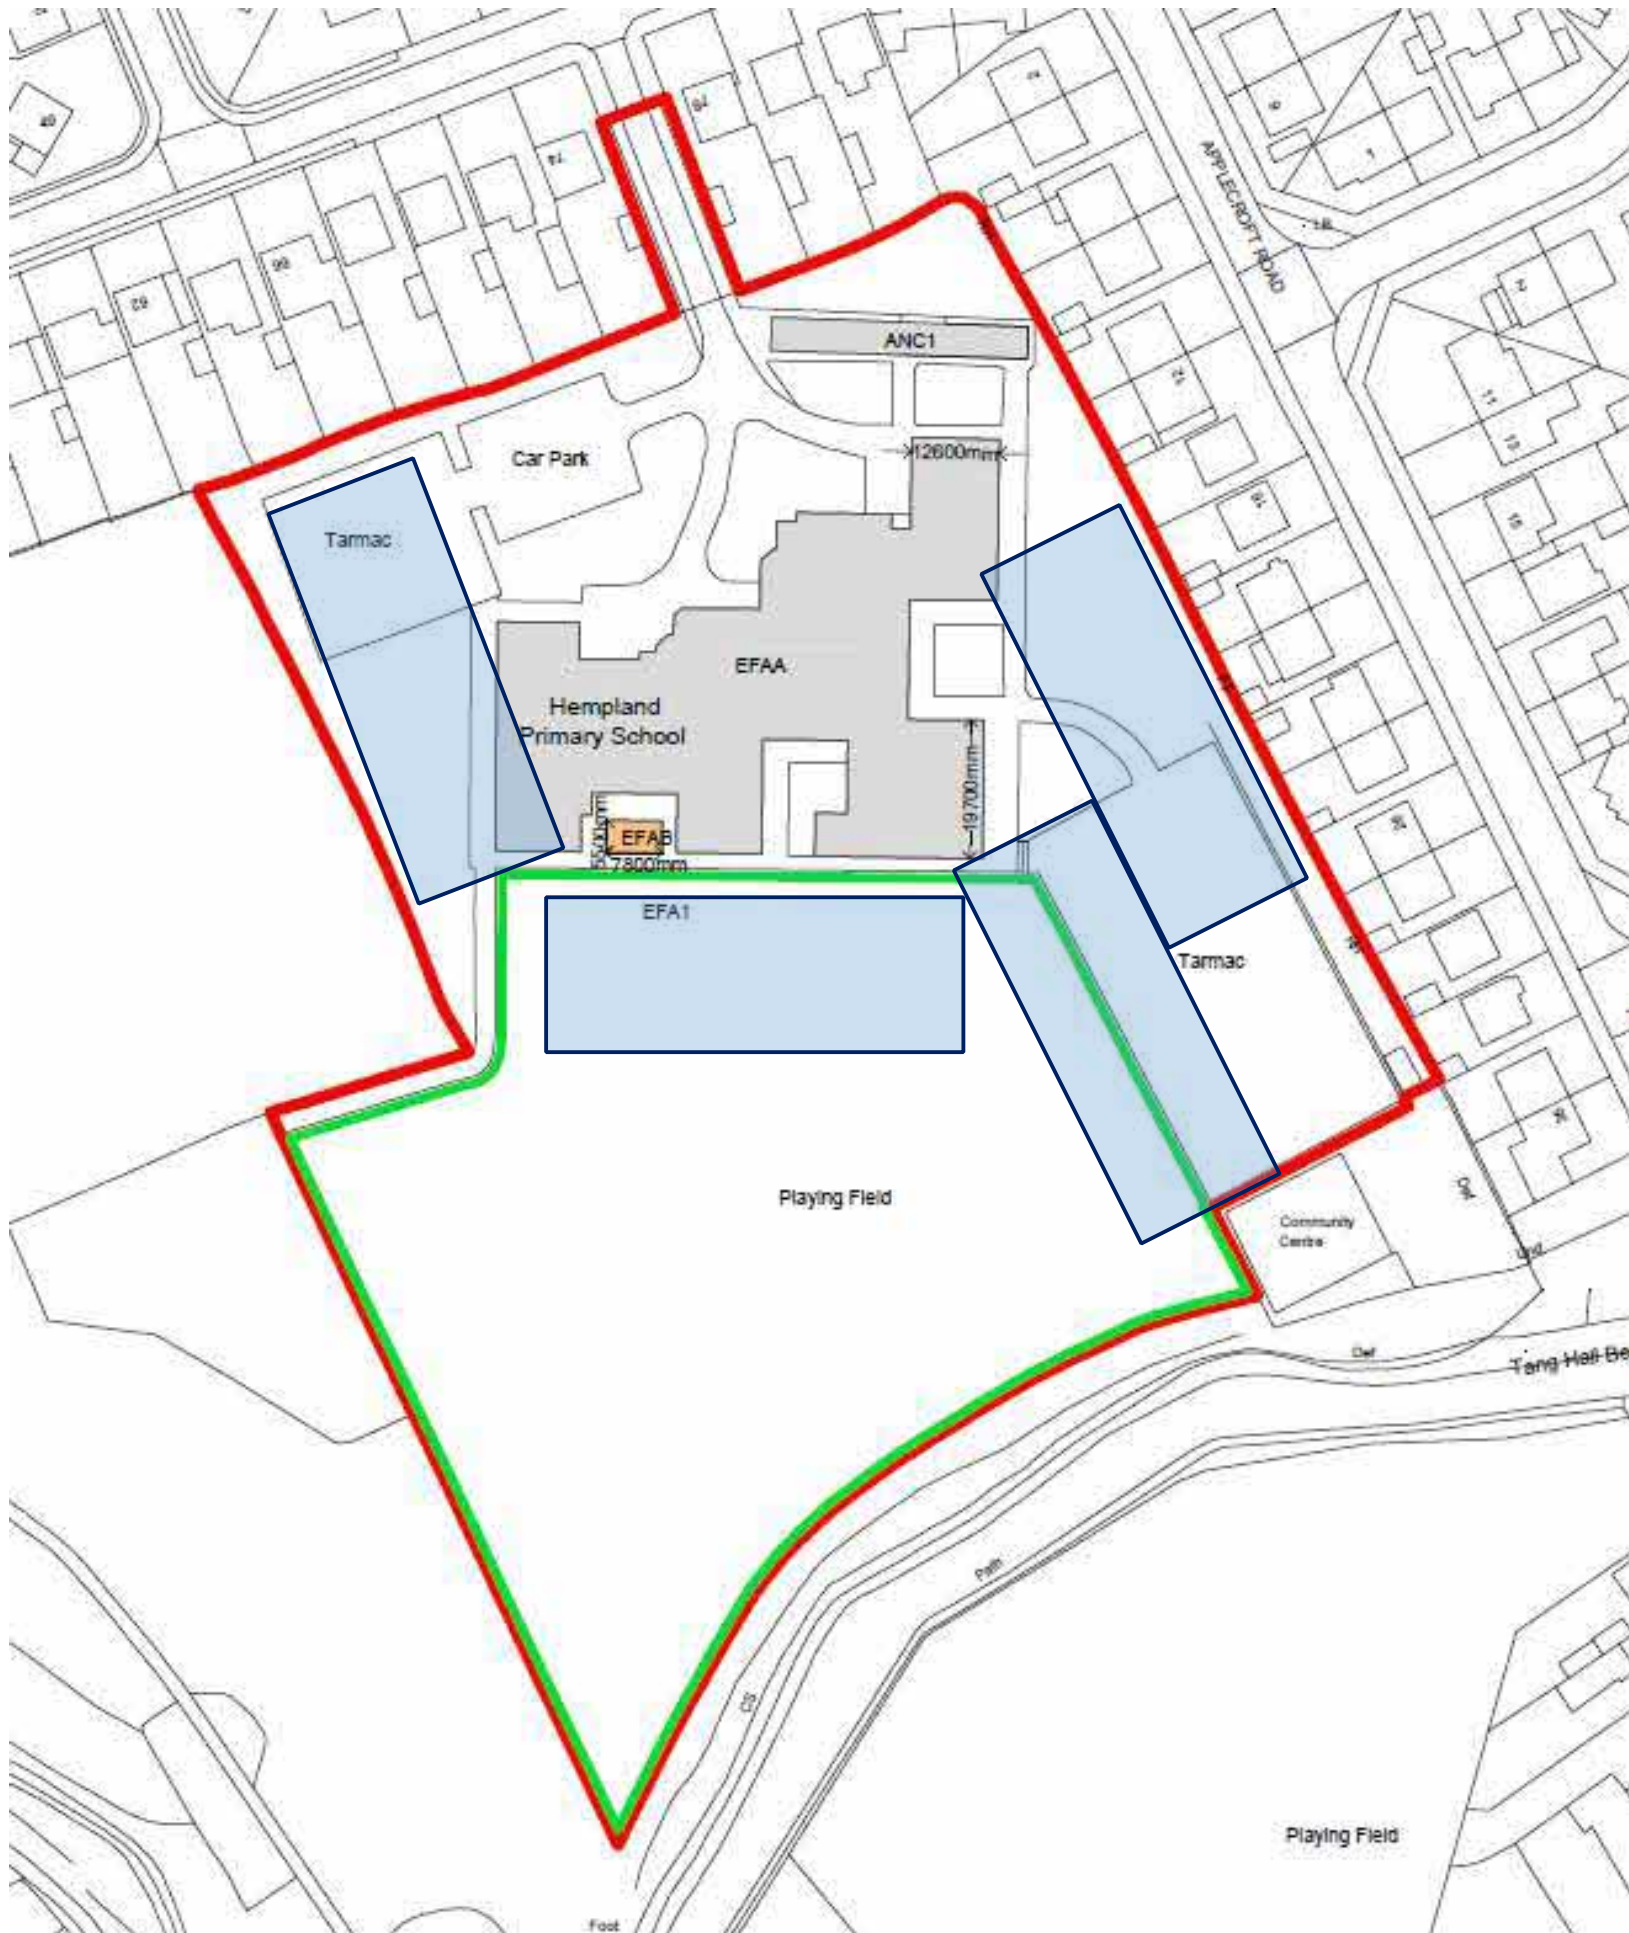
Proposed Layout Plan

■ Possible location of redevelopment
