Bat emergence and re-entry surveys, and remote monitoring

No. 8 Bank Street, St Columb Major

July 2016

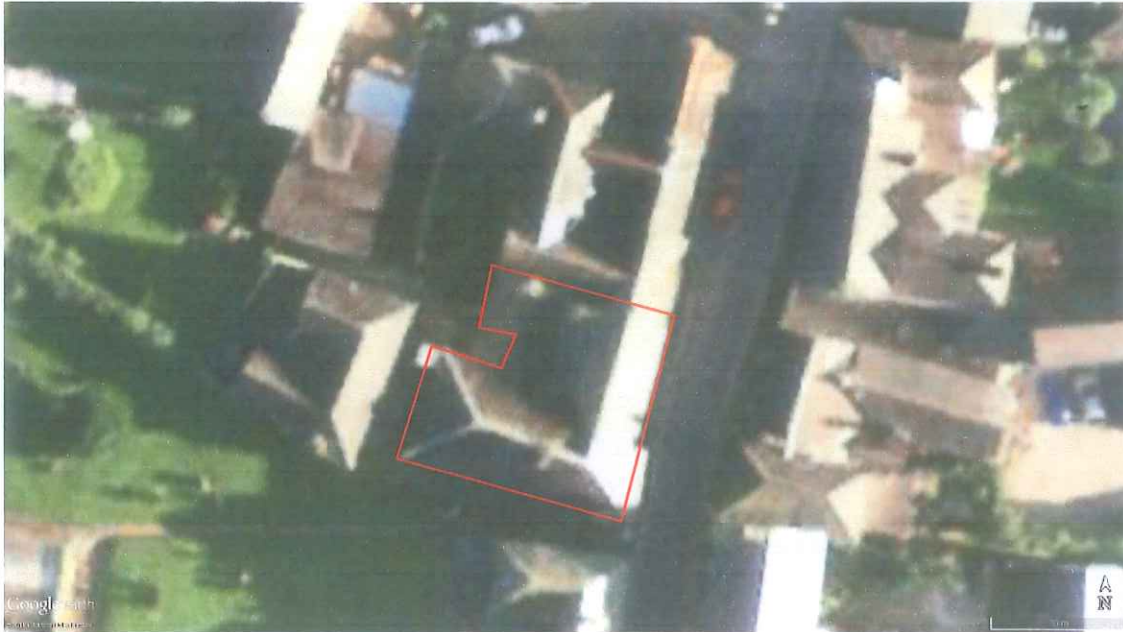
Plan 2. The built structure considered within this report.

It is proposed that the roof on No 8 Bank Street (Plan 2) will be replaced.

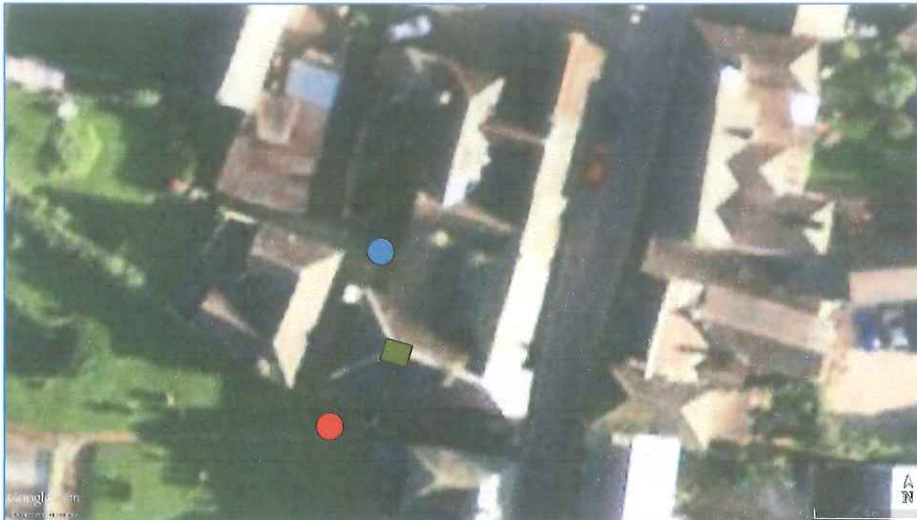
Plan 3. Location of surveyors. Colin Hicks/Yolande Knight were at the red position and Michael Sanders at the blue position. The remote monitor location is shown in green. No surveyors were located to the east of the building as this is an extremely well-lit street within the town with little in the way of potential access points for bats.

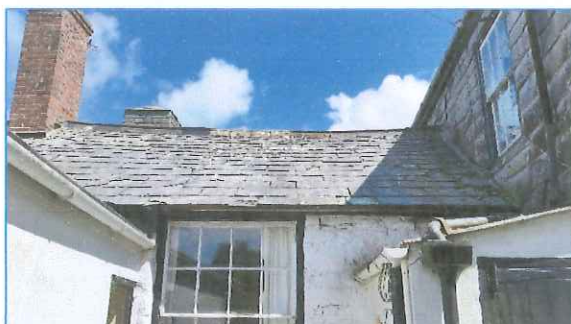
The western aspect of No 8 showing one of the two smaller roofs

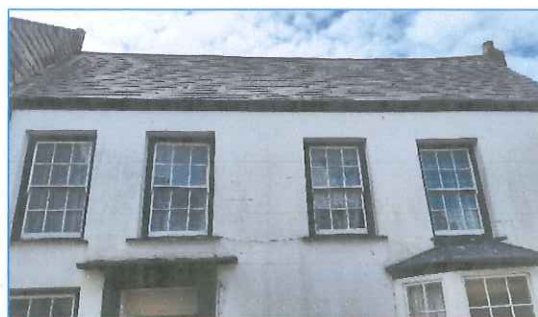
Eastern aspect as seen from Bank Street showing the other small roof

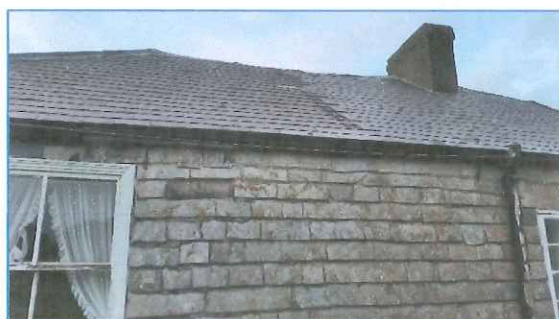
Larger hipped roof on the southern side of the building

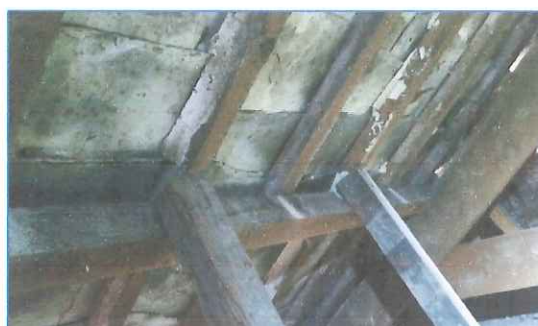
Other voids associated with No 8 were much smaller, extremely cobwebby and cluttered, whilst the slate roofs were unlined. No bats or signs of bats were found associated with the other roof voids, and they have little potential due to their low nature.

Most of the slate roofs were unlined to the inside

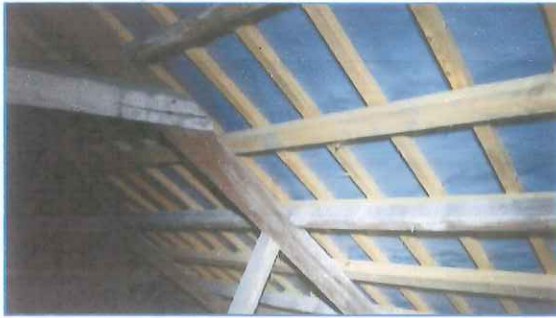
The northern pitch of the southern roof was lined with a breathable membrane

The roof will be underlined with bitumen IF felt. Recent research has shown that modern breathable membranes can be harmful to bats and **must not be used** within a bat roost (bats have been found dead in some roosts after having become entangled in the fibres of the membrane).

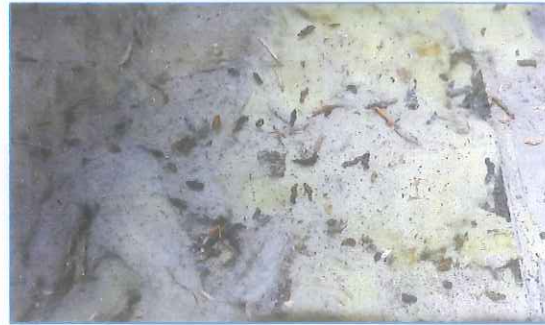
Accumulation of Long-eared bat droppings in the roof void beneath the southern roof

A single Brown Long-eared bat has roosted within the southern roof void of No 8 Bank Street. It is also likely that this bat has fed here on sheltering moths, as evidenced by an accumulation of Yellow Underwing wings close to the chimney. This bat, although seen to be present when deploying the remote detector on 5th July, prior to the emergence survey, was not seen to leave or re-enter the building, and was not recorded within this roof void during 14 days of remote monitoring. Since this bat will 'warm up' within a roof void prior to emergence, it is very likely that during the survey period it was only present within this void on 5th July. It will have exited the roof void via a number of large gaps to the rear (west) of the house, and its exit may have been missed during the emergence survey due to it being very dark in this area of the building, with a lot of Common Pipistrelle activity concealing any ultrasonic calls it may have made.

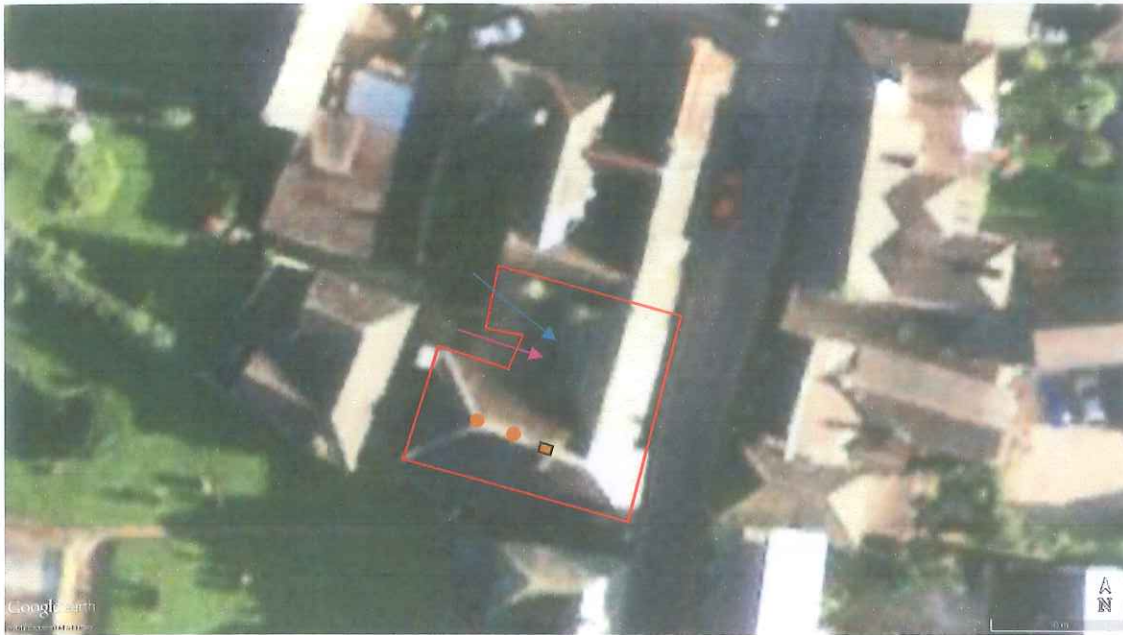
Prior to the survey, the remote detector was deployed into the southern roof void. Whilst placing the detector, a Long-eared bat was found clinging to the chimney (Plan 4). This bat was taken in hand and identified as a male Brown Long-eared bat.

During the survey, a Natterer's was seen to enter one of the two smaller roofs, probably at the eaves, at 04:52, followed by a Common Pipistrelle at 05:03 (Plan 4).

Plan 4. Google Earth image annotated to illustrate the results of the preliminary visual assessment for bats along with the emergence and re-entry surveys

- Brown dots – Accumulations of Brown Long-eared droppings
- Brown square – Brown Long-eared roosting on chimney inside roof void and accumulation of Yellow Underwing wings
- Magenta arrow – Common Pipistrelle re-entry location
- Blue arrow – Natterer's re-entry location

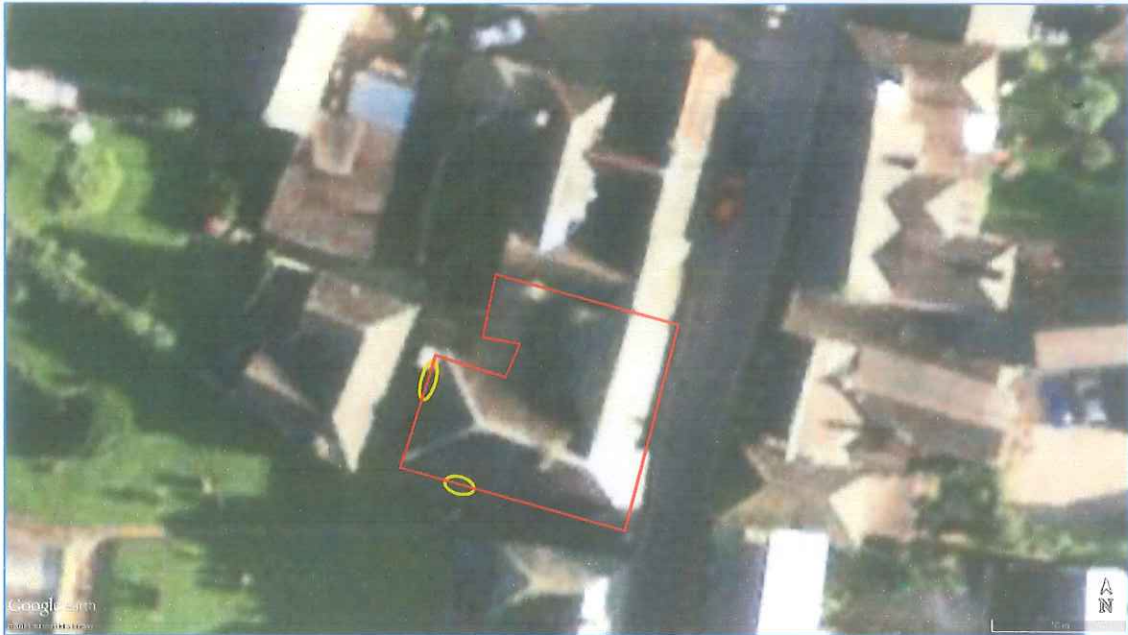
Plan 5. Google Earth image annotated in yellow to illustrate the locations of existing gaps allowing Brown Long-eared access into the southern roof void. The gaps will be retained when the roof is replaced.

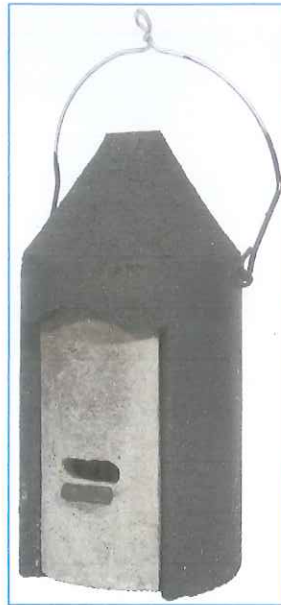
Schwegler 2F standard bat box

The 2F is the standard and most popular bat box and is ideal as a starter box to see if there are bats in your area or to provide much needed secure roosting space. It has been designed as a summer roosting space for bats and has a simple entrance hole at the front. The Schwegler 2F has a removable front panel and can be converted in to a bird nest box using a replacement 1B front panel if there is no evidence of bat activity after a couple of years. The 2F is manufactured from long-lasting Woodcrete, which is a blend of wood, concrete and clay which will not rot, leak, crack or warp, and will last for at least 20 - 25 years, making it suitable for long-term mitigation projects. Woodcrete is breathable and maintains a stable temperature inside the box and the 2F is painted black to absorb warmth. It also provides a good rough surface for bats to cling on to and climb. The 2F bat box can be sited in trees or on buildings and is best positioned at a height of between 3 to 6 metres. Bat boxes should ideally be sited in open sunny positions and in groups of 3 to 5 boxes facing different directions to provide a variety of micro-habitats. Please note that once bats have inhabited a roost site they may only be disturbed by licensed bat workers.

Height 33 cm x diameter 16 cm. Weight: 4 kg.
