# Design, Access & Heritage Statement

## Conversion of outbuilding west of 8 Bank Street, St Columb Major

30th June 2023

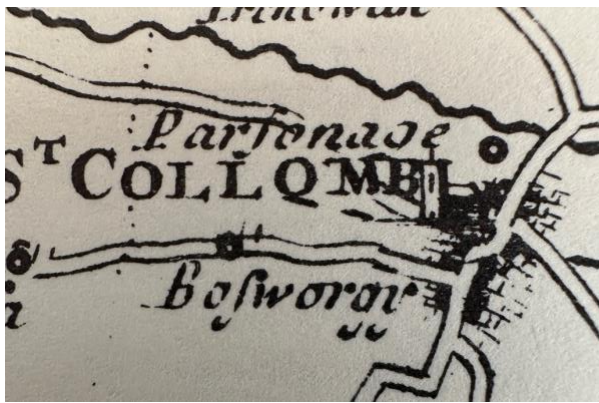
Fig 1: 1811 OS Drawing

The 1811 OS drawing (fig 1) shows the layout of St Columb with the church to the north west of the town. Development is shown along Bank Street and it is likely that some development was in place to 8 Bank Street at this time including parts of the existing house. It is possible that parts of the outbuilding were also constructed although the map does not provide adequate detail to draw any conclusions.

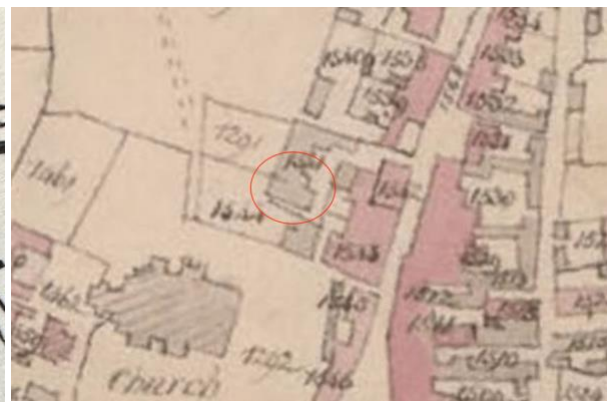
Fig 2: 1840 Tithe Map

The 1840 tithe map (fig 2) shows an approximate footprint of the outbuilding similar to what is found today, although with the portion to the north east corner missing. The apportionment to the 1840 tithe map indicates gardens owned by the Glebe at plot 1291. Associated apportionments for the surrounding plots were not available at the time of research, although were presumably also part of Glebe land given their location adjacent to the church.

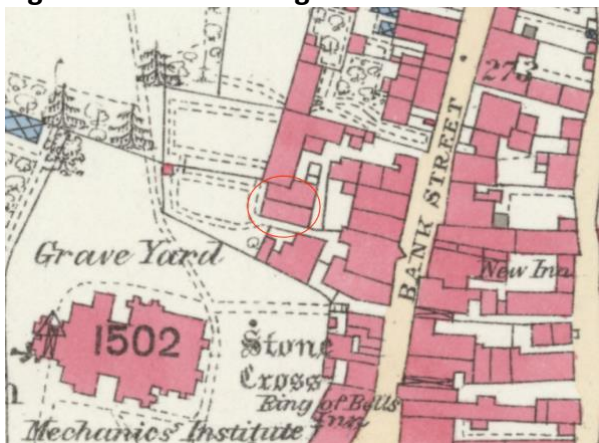
Fig 3: 1878 Ordnance Survey Map

By 1878 in the ordnance survey map (fig 3), the existing situation is largely replicated with the footprint of the outbuilding showing and divided into two sections as per the existing situation. This continues into the 1895 OS map, although a further covered area to the east appears. There is little evidence of this today and it is assumed to represent a temporary structure.

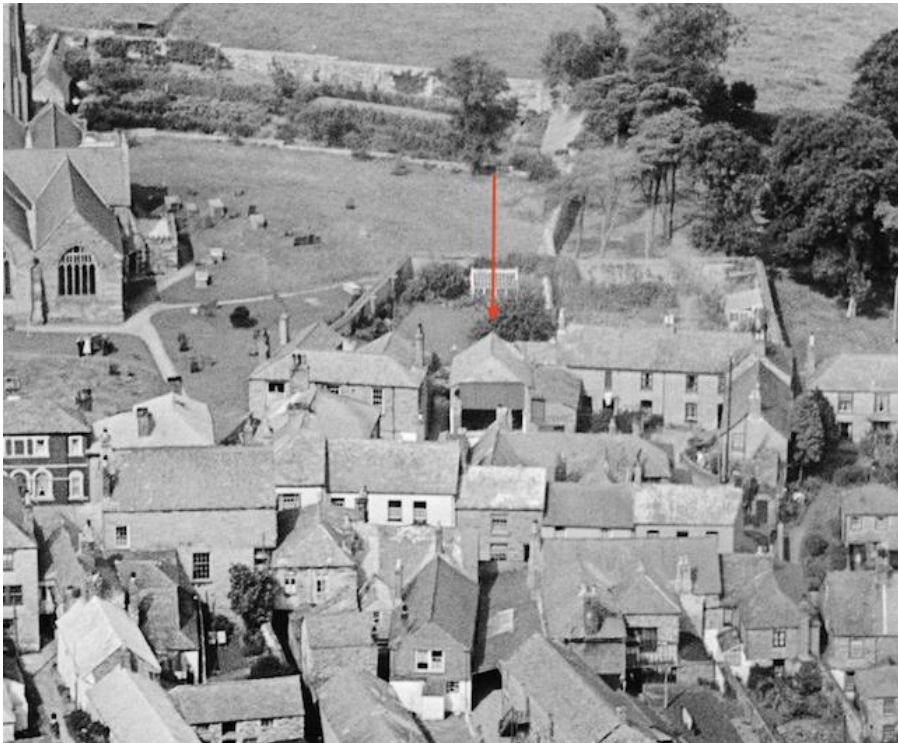
**Fig 7: Britain From Above 1932 photograph showing the outbuilding**

The Britain From Above 1932 photograph gives a likely indication of the original form of the outbuilding at the rear of 8 Bank St. This indicates a taller building in proportion with the surrounding 2 storey dwellings. The roof pitch is steep than what is found today and appears to be slated in natural slate as per the vernacular style.

Consideration has been given to raising the roof height as per the original building shown in figure 7 on the 1932 image. This would also allow the use of slate, being the vernacular roofing material. However this may have a detrimental effect on surrounding housing by blocking light and decreasing views. It has therefore been agreed to retain the existing roof height and pitch.

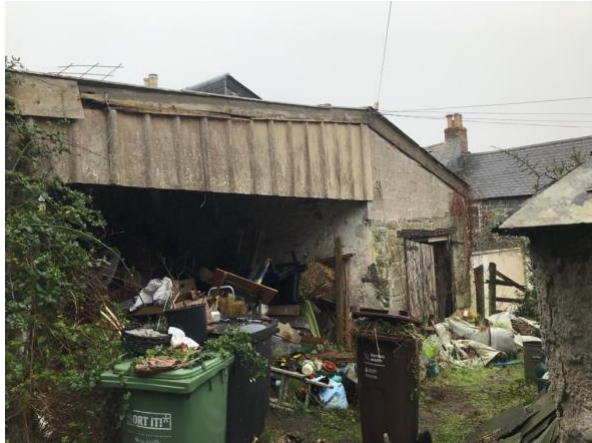
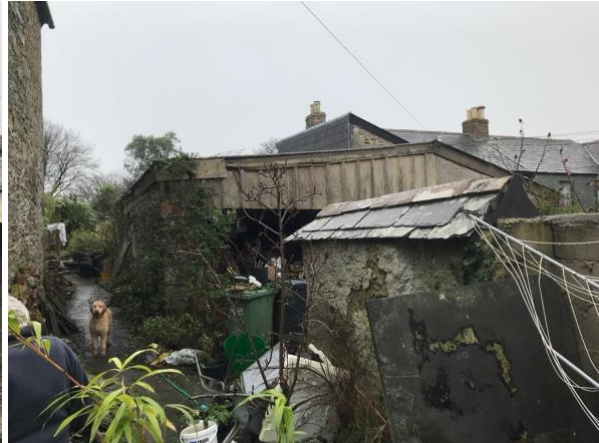
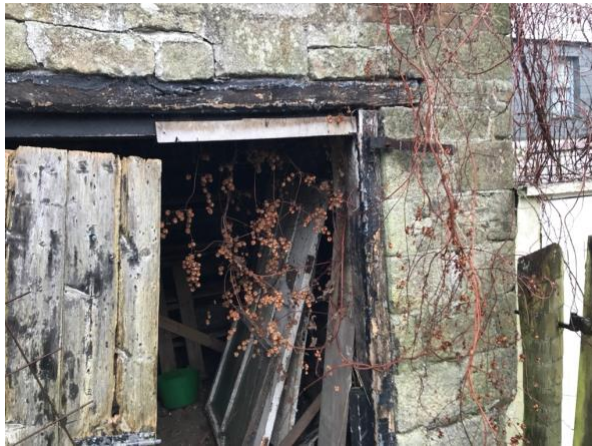
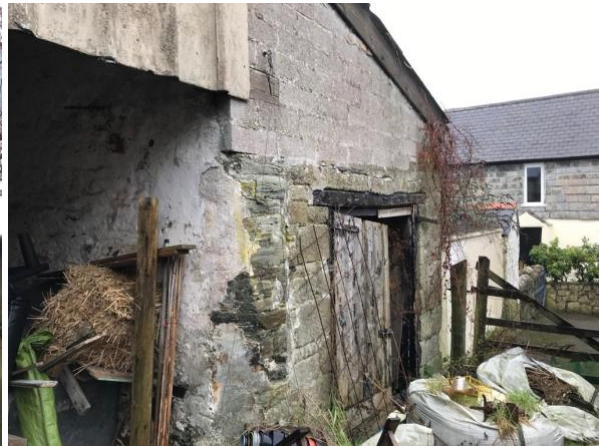
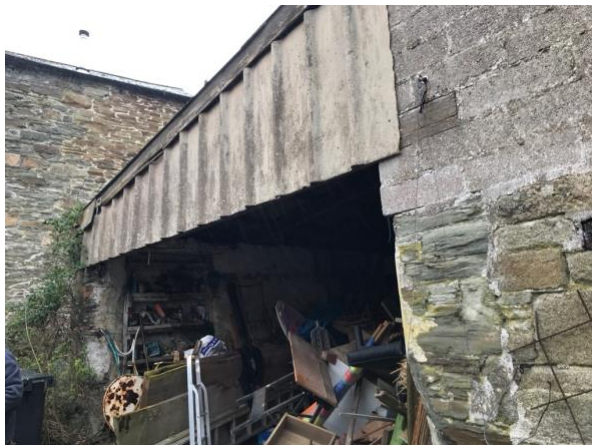
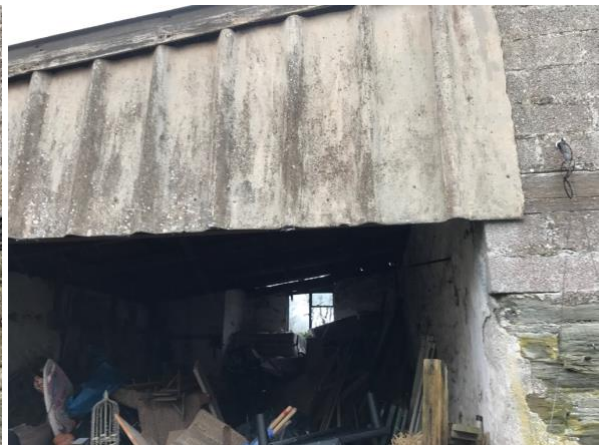
The existing outbuilding has a shallow asymmetric pitched roof with a ridge running east to west and covered in asbestos cement sheeting. This is built over a timber rafter and purlin structure supported by the masonry walls, with a wall running beneath the ridge. Walls comprise sections of natural stone which have been largely altered and adjusted. This includes infilling with sections of concrete block there is also a section clad with asbestos cement above the main entrance to the east.

**Fig 8: East elevation**

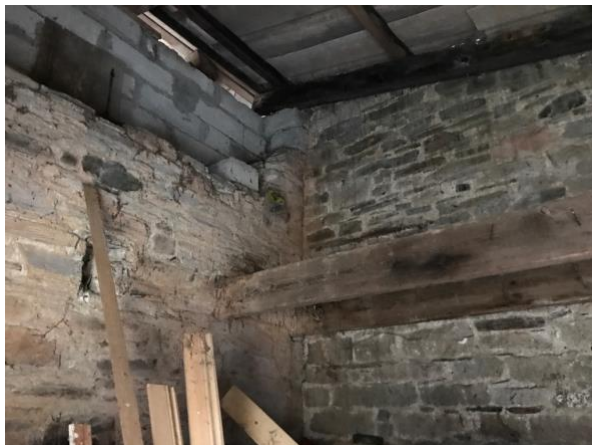
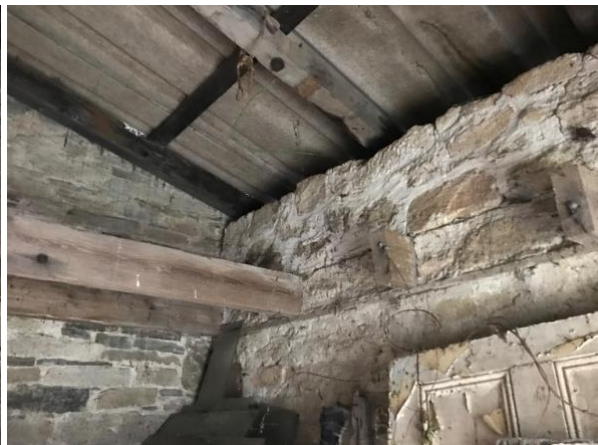
The north east store has double timber doors. This shows signs of having previously had an intermediate floor with joist ends visible within the walls. The upper floor would now be unusable due to the lower pitched roof provided. The main workshop has an open front and the WC enclosure at the south-western corner is formed in concrete block. The western elevation is largely built in concrete block with a single steel crittall window. This gives way to stone at the boundary where the neighbouring building 18 Bank Street has a two-storey section with monopitch roof.

**Fig 8: Interior north east**
