# Preliminary Bat Roost Assessment for Mr Shering

Martinique, East Martin, Fordingbridge,  
Hampshire, SP6 3JS

12TH JULY 2021

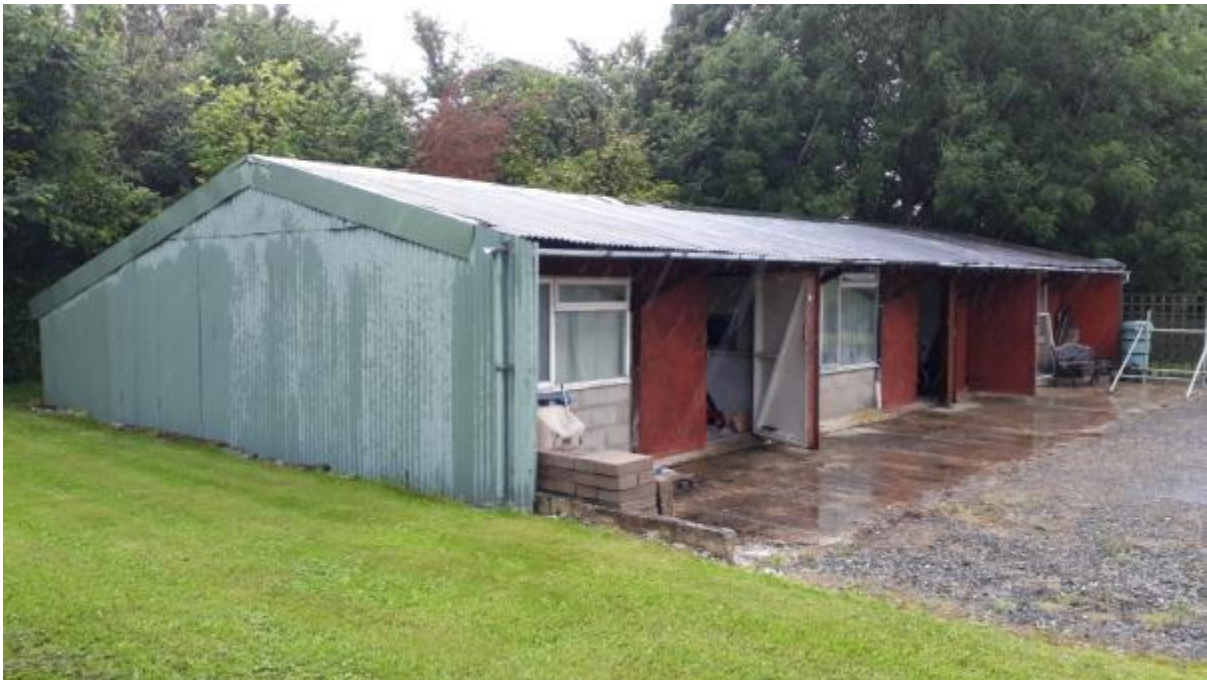
Fig. 3 'Barn 1'

‘Barn 1’ - The building is a single skin construction of blockwork and wooden panelling with a single skin of corrugated iron roofing. No evidence of use by bats or birds was observed.

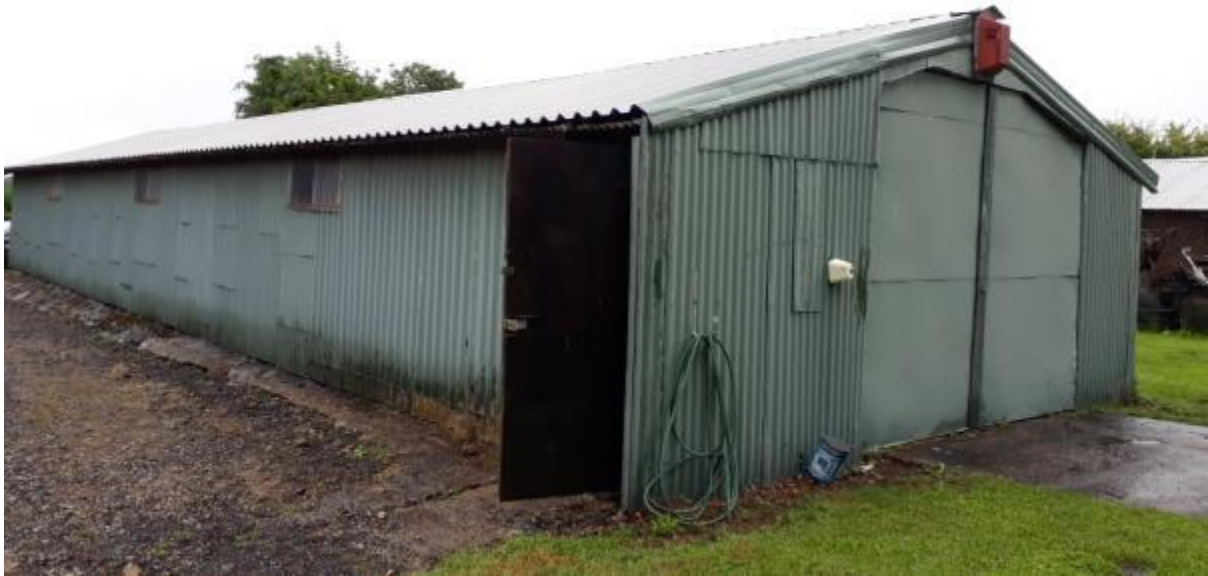
Fig. 5 'Barn 2'

'Barn 2' – The building is a single skin of corrugated iron overlaying wooden panelled walls with an asbestos roof overlain with corrugated iron. ~6 bat dropping were observed on the corrugated iron wall panelling on the SE side of the building. No evidence of use by birds was observed.

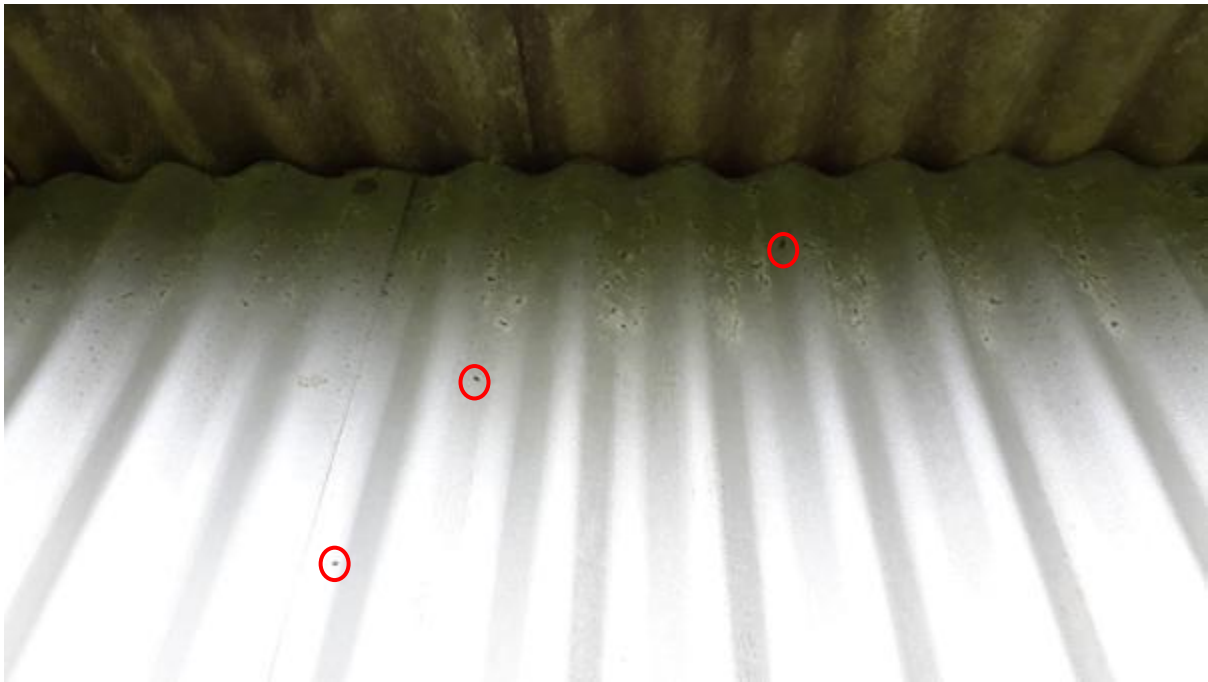
Fig. 7 SE side of 'Barn 2' with bat droppings evident

17. As such, a precautionary approach to any works is recommended and if at any stage bats or evidence of bat use is observed, works should stop immediately and advice be sought from Joanna Ramsay Horbury or Natural England (via the contract with the Bat Conservation Trust) on 0845 1300 228.

18. Provision of potential bat roosting features could be included in the proposed works on site with the installation of bat boxes on mature trees around the site or on external walls of buildings and consideration of bat tiles and bat bricks in any new features. Consideration of phasing the project could be given.

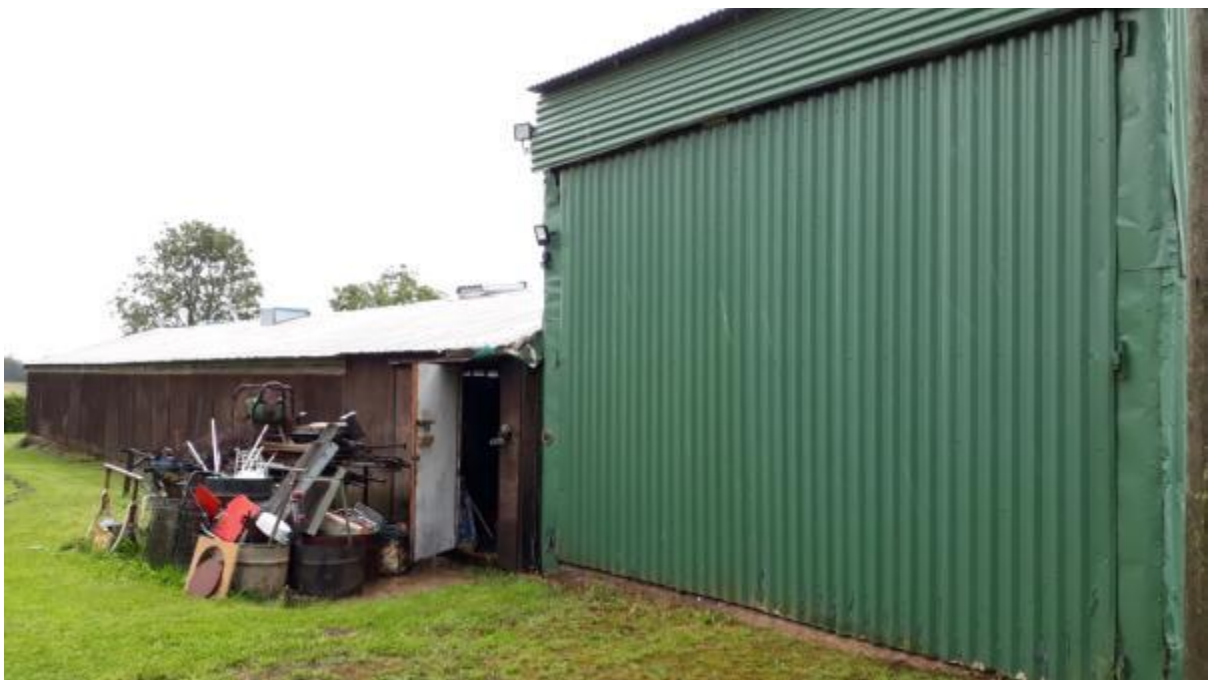
Fig. 8 'Barn 3'

'Barn 3' – The building is made up of two sections; a single storey wooden panelled section with corrugated iron roof which has vented sections remaining from its use as a chicken shed (these are now blocked off); and a double height corrugated iron section at the SW end. No evidence of use by bats or birds was observed.

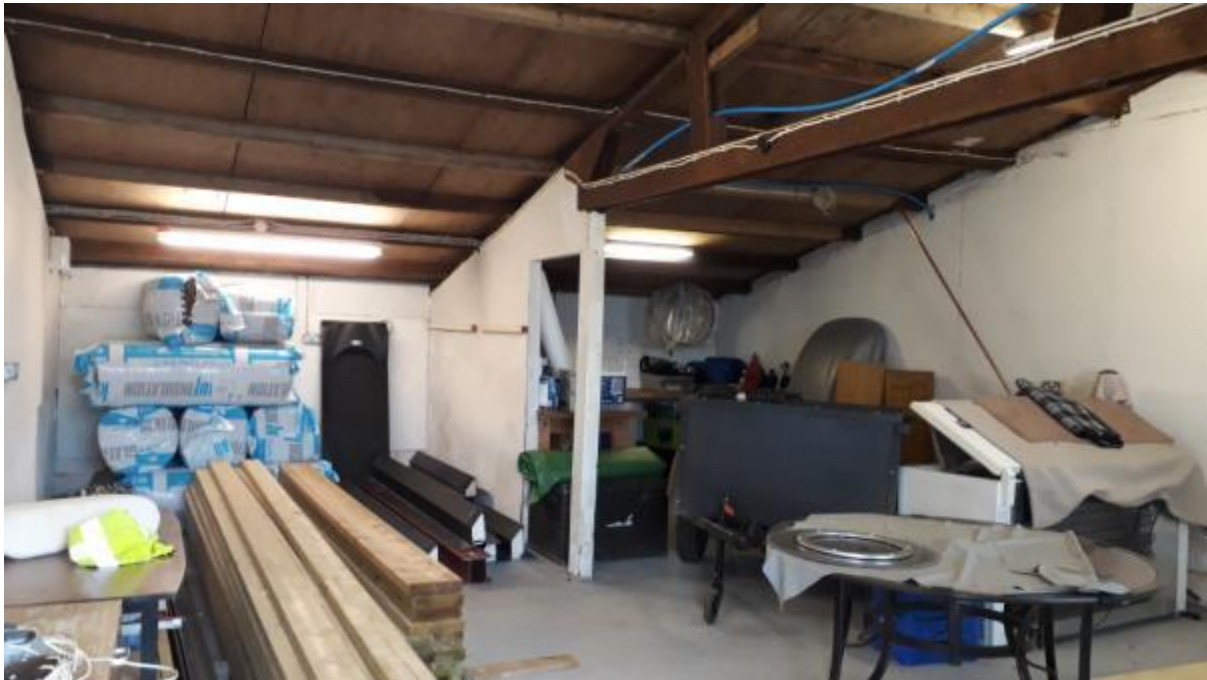
Fig. 11 First and most north easterly section of 'Barn 1'

Internal inspection: 'Barn 1' - The internal space is split into three storage areas and is boarded throughout but has no insulation. Multiple gaps were evident. No evidence of use by birds was observed in any of the three sections. From NE to SW; in the first section ~6 droppings of a small bat, most likely pipistrelle sp., were observed; in the second section no evidence of bats was observed; in the third section ~3 droppings of a small bat, most likely pipistrelle sp., were observed.

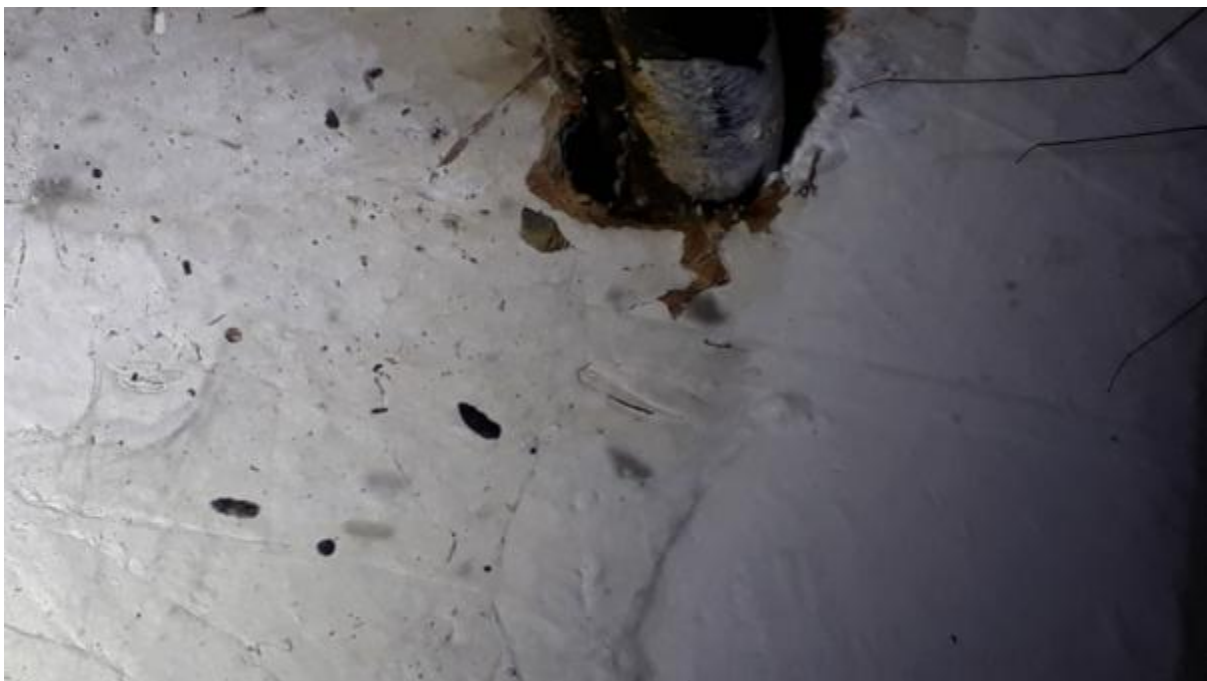
Fig. 12 Bat droppings in first section of 'Barn 1'

15. It was possible to access all parts of the buildings and no specialist equipment was necessary to undertake the visual inspection. Some evidence of bat use in the form of droppings was established in all storage buildings. However, the buildings are considered to offer low suitability for bat use given the lack of insulation and single skin corrugated iron construction which renders them vulnerable to extremes of heat and cold. Use is likely to be opportunistic for individual bats.

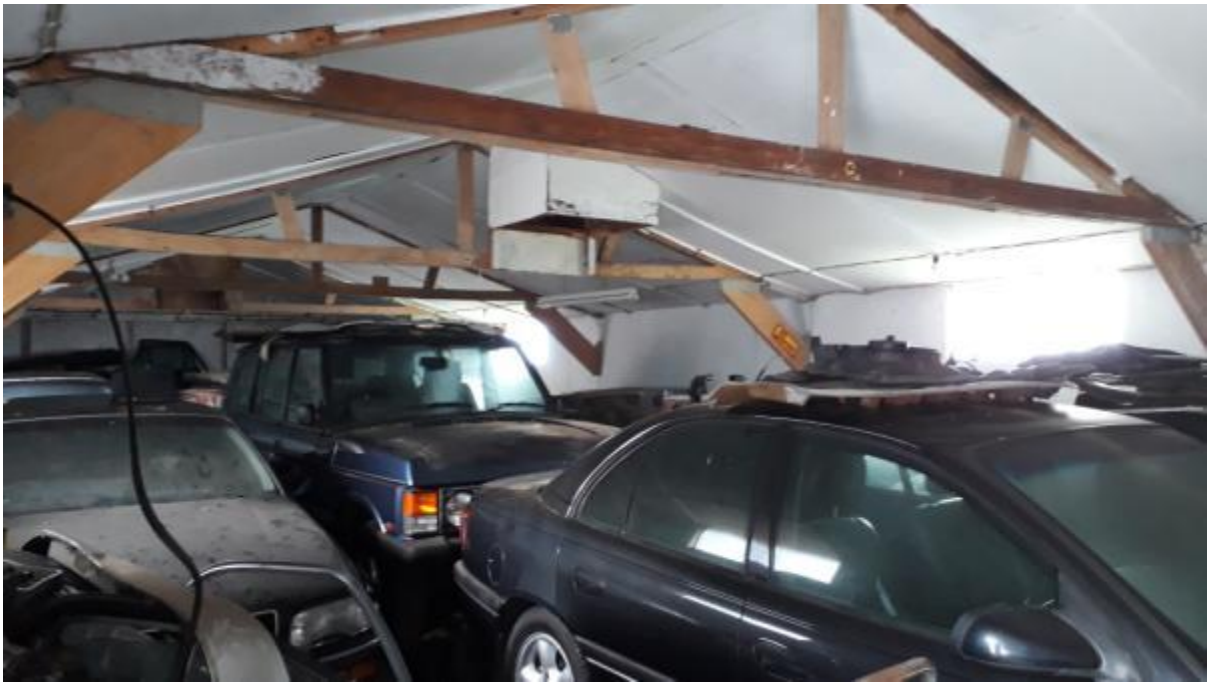
Fig. 15 'Barn 2'

'Barn 2' – The internal space is boarded throughout and has no insulation. ~3 droppings of a small bat, most likely pipistrelle sp., were observed. Evidence of activity by a squirrel, in the form of paw prints in dust, was also observed. No evidence of use by birds was observed.

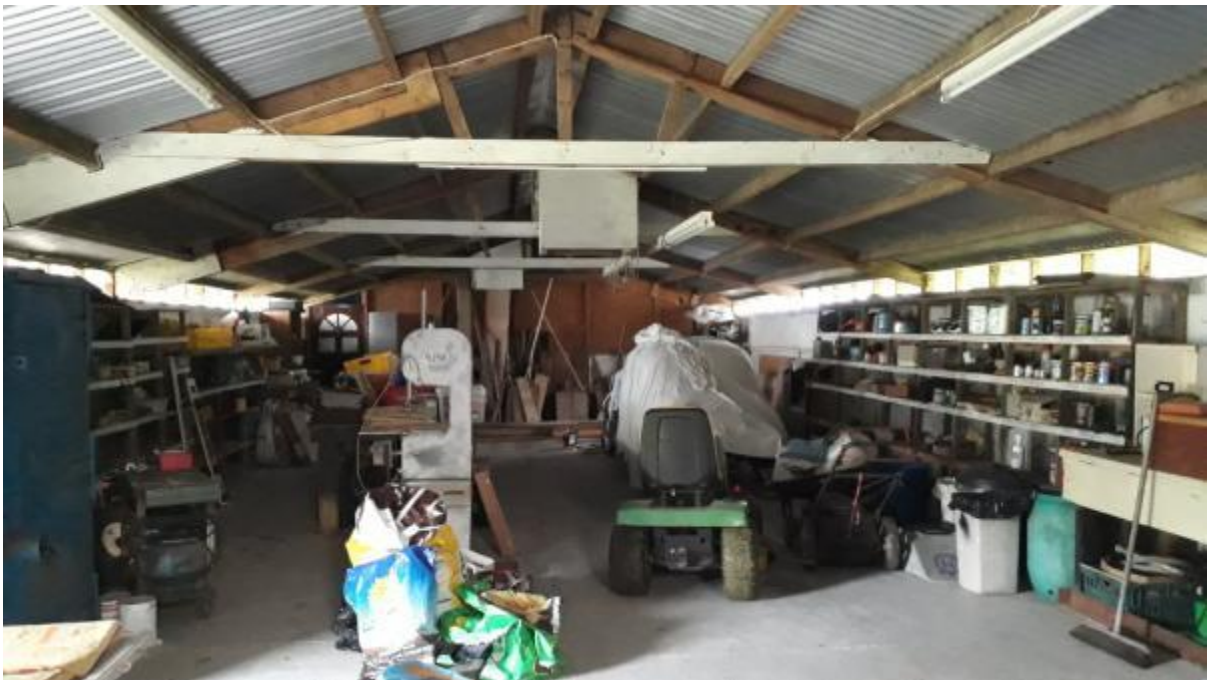
Fig. 16 'Barn 3'

'Barn 3' – The internal space is single skin corrugated iron with no boarding or insulation. ~2 droppings of a small bat, most likely pipistrelle sp., were observed. No evidence of use by birds was observed.

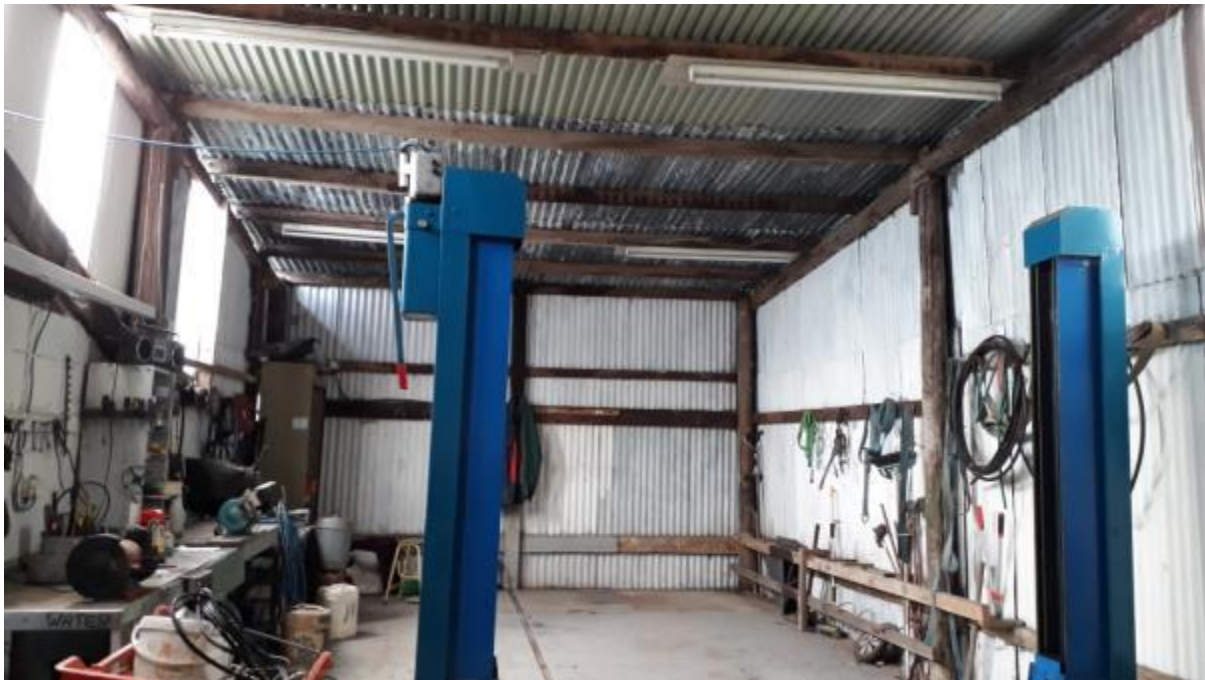
Fig. 17 'Barn 3' double height section
