Preliminary Bat Roost Assessment

at 34 High Street, Aylburton, GL15 6DE

12th August 2023 (REV 1)

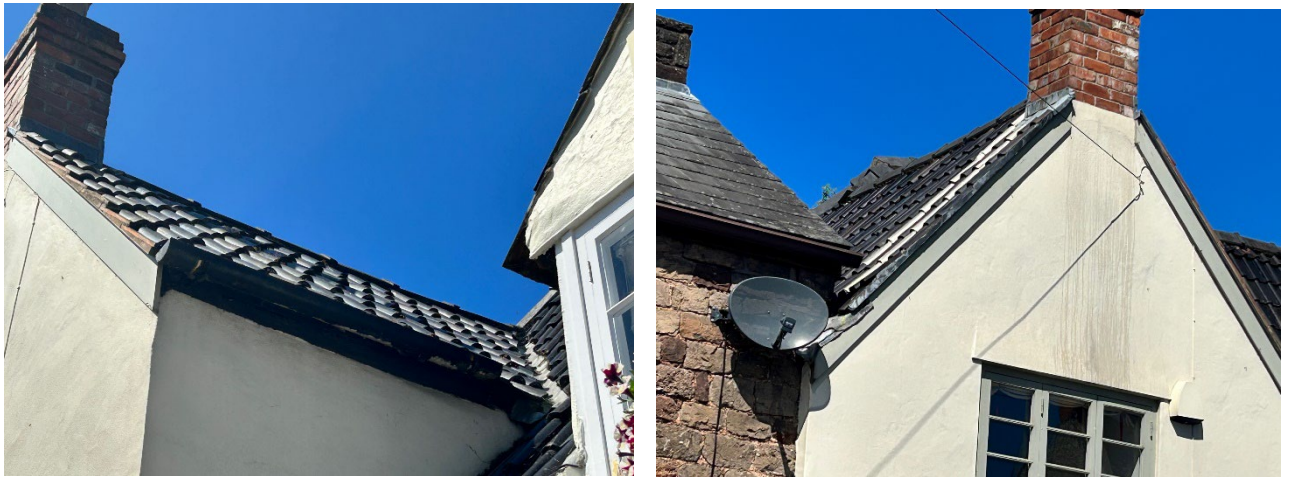
The external ground-level preliminary roost assessment showed there to be bat roost potential with PRFs located under loose tiles on the roof to be replaced (see Photo 1, 2, 3 & 4), and potentially under the weathered wooden fascia board located at the front of the property (see Photo 1). Although these PRFs are considered to be of **low suitability**, as they only offer potential roost sites that could be used by individual bats opportunistically. However, these potential roost sites do not provide enough space, shelter, protection, appropriate conditions and /or suitable surrounding habitat to be used on a regular basis or by larger numbers of bats (i.e. unlikely to be suitable for maternity or hibernation).

No signs of bats using the roof or wooden fascia boards were found during the ground-based assessment. As such, the property of 34 High Street was assess as having **low bat potential**.

Photo 1 & 2: View of the front of the house (location of the proposed tile replacement) from the street.

However, it is suggested that the removal of the tiles is conducted under a Precautionary Method Working, which should detail the slow and ecologically sensitive removal of the tiles, preferably by hand, as far as reasonably possible in light that the tiles are sealed together by the spray foam underneath. If a bat is found during the works, all works should cease immediately until a licenced bat worker is contacted for further advice.

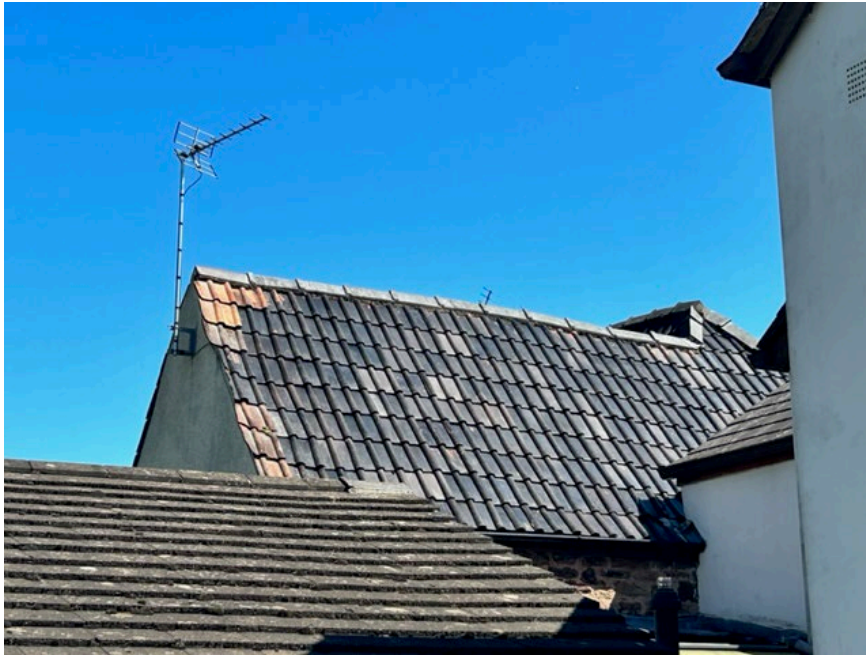
Photo 3: View of the side of the house / roof from the unnamed lane.

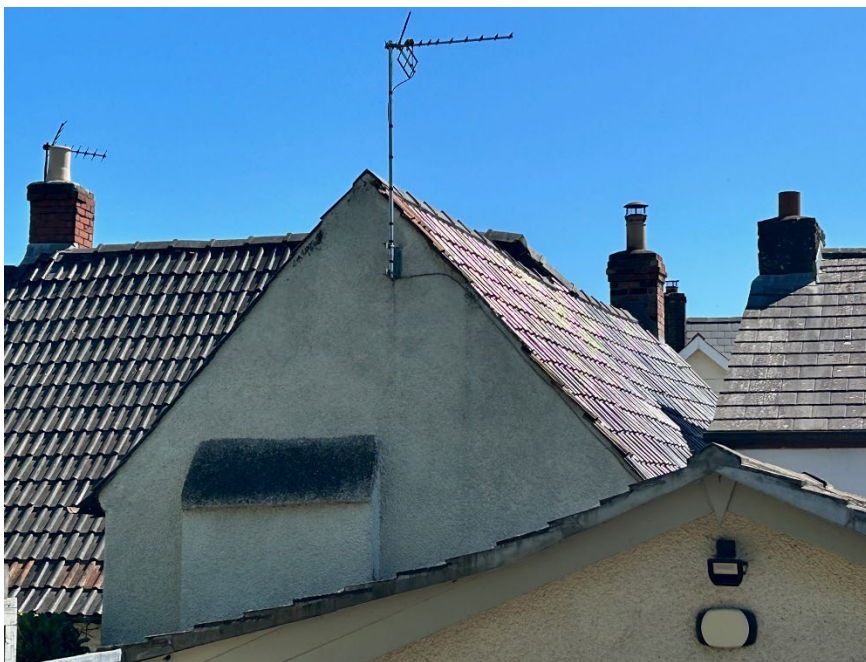
Photo 4: View of the back of the house / roof from the garden.

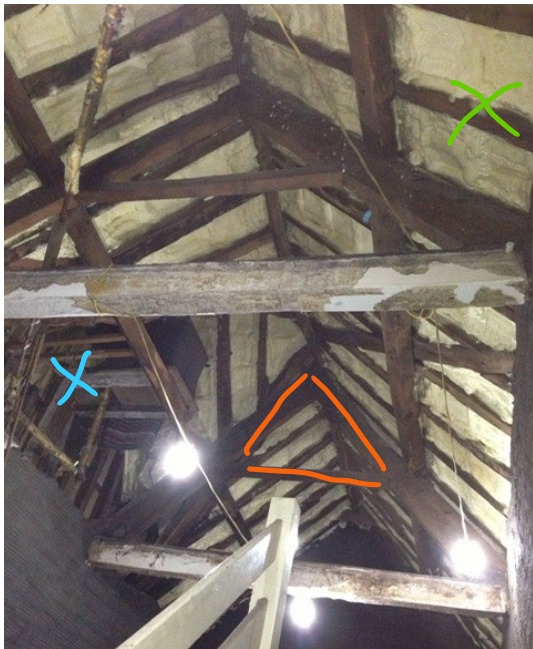
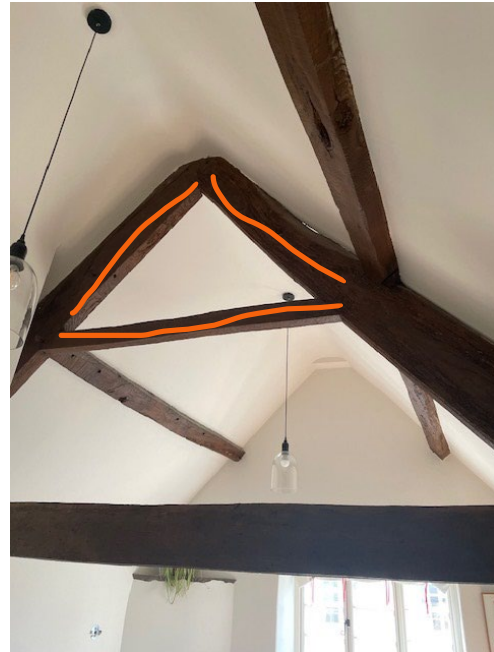
The majority of the roof has no cavity space and the tiles are completely sealed on the underside, as the previous owners of the property had spray foamed the underside of the tiles (see Photo 5 below, photo provided by the owner), and the current owner has plastered up to this to increase the area within the loft bedrooms of the cottage (see Photo 6 below for comparison see location of beams identified in red).

Photo 5 & 6: Evidence of spray foam sealing the underside of the tiles before renovation and plastering up to tiles within current room. The red triangles locate the beams for reference, the blue cross locates the larger of the remain roof cavity spaces (Photos 7 – 9 below), and the green cross locates the smaller space used for storage (Photo 10 below).

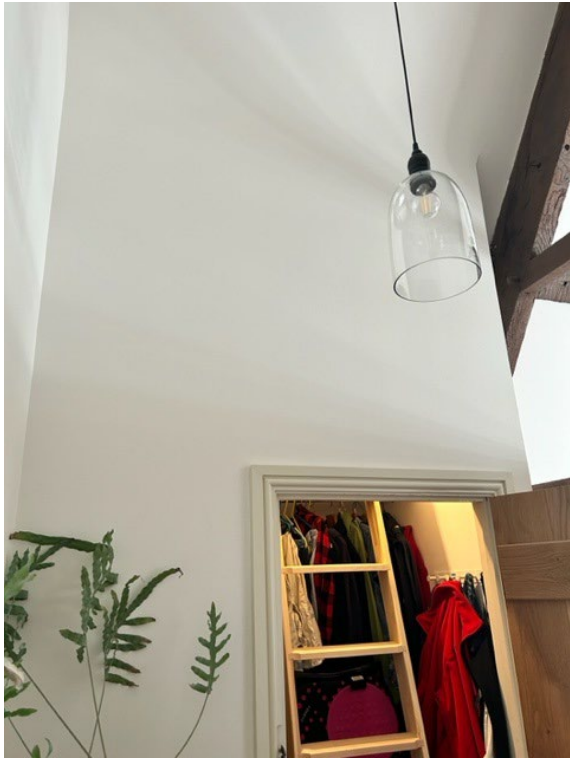
There are two small roof cavity spaces remaining, the largest of which is evident in Photo 5 above, mark with blue cross. The entrance and shape of this space is also shown in Photo 7 below, with Photo 8 & 9 showing the internal space above the cupboard which is lined with various types of insulation. Although this is the larger of the spaces this is approximately 2m in length, and no more than 1m wide and 1m in height. No evidence of bats was recorded within this space and due to the spray foam insulation sealing the tiles from underneath, this part of the roof is considered to have **negligible suitability** for roosting bats.

Photo 7: Entrance the larger roof cavity space above cupboard.

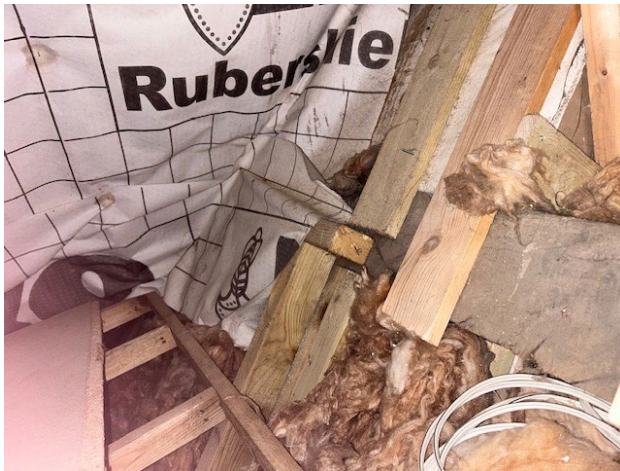
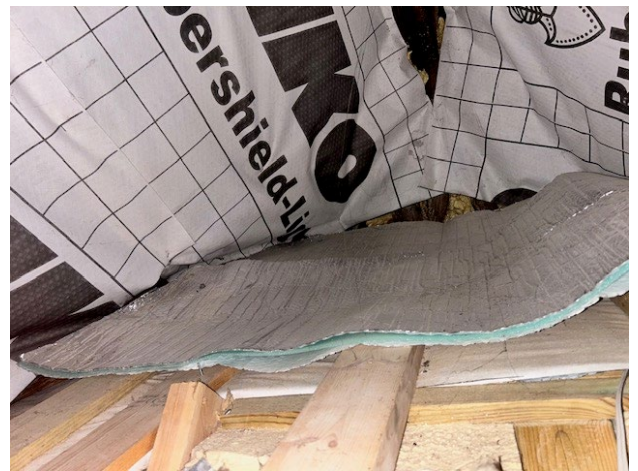
Photo 8 & 9: Internal space above cupboard.

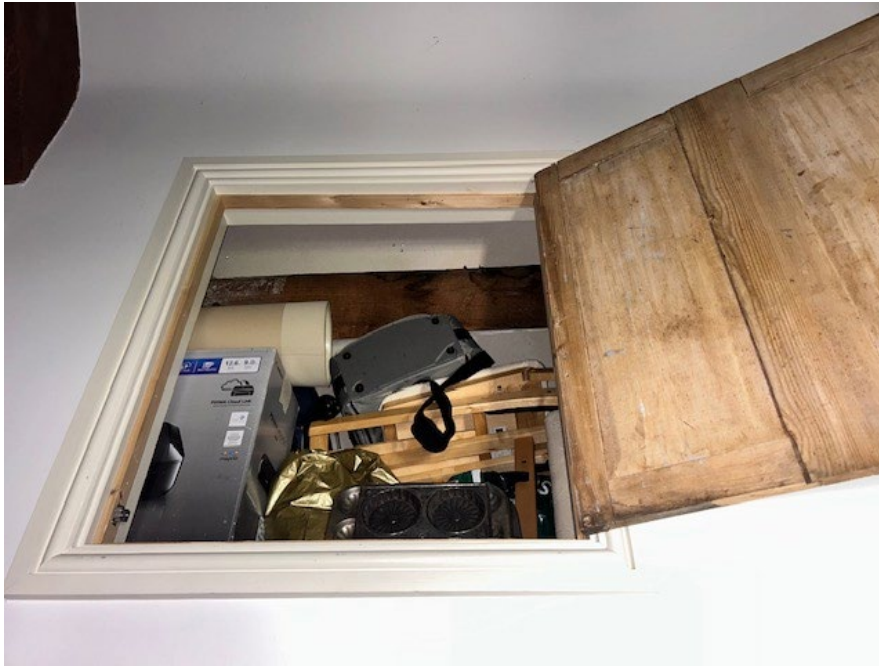
The second cavity space remaining in the roof, is a well-used storage cupboard. As shown in Photo 10 below this is a cupboard rather than a roof space and you can see the plastering up to the spray foam covered tiles within the cupboard. The approximate location of this cupboard is shown as a green cross in Photo 5 above. No evidence of bats was recorded within this space and due to the spray foam insulation sealing the tiles from underneath, this part of the roof is considered to have **negligible suitability** for roosting bats.

Photo 10: Second smaller cavity space being a well-used storage cupboard.
