THE NATIONAL TRUST
 SOUTH WEST REGION
 Bristol Hub Office
 Unit 3 Hubbard Wing
 Leigh Court Business Centre
 Pill Road, Abbots Leigh
 Bristol BS8 3RJ
 Telephone (01275) 378444

ESTATE/PROPERTY	
Horton Court	
DRAWING TITLE	
Implement Shed Before and After	
DRAWN BY	DATE
KCH	AUG 2023
SCALE @ A3	PROPERTY REFERENCE
1:50	HORT
DRAWING No	REVISION
HORT-IC-01	0

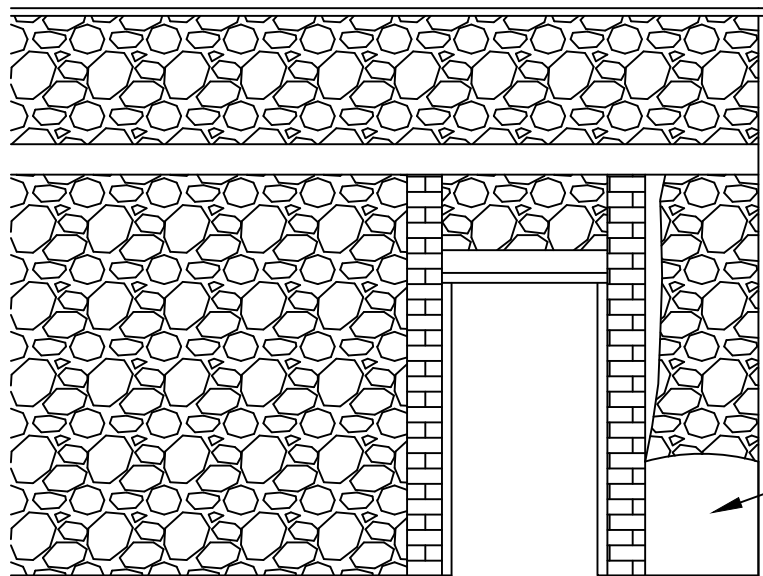
EAST ELEVATION BEFORE

Significant crack in wall and loose high level masonry

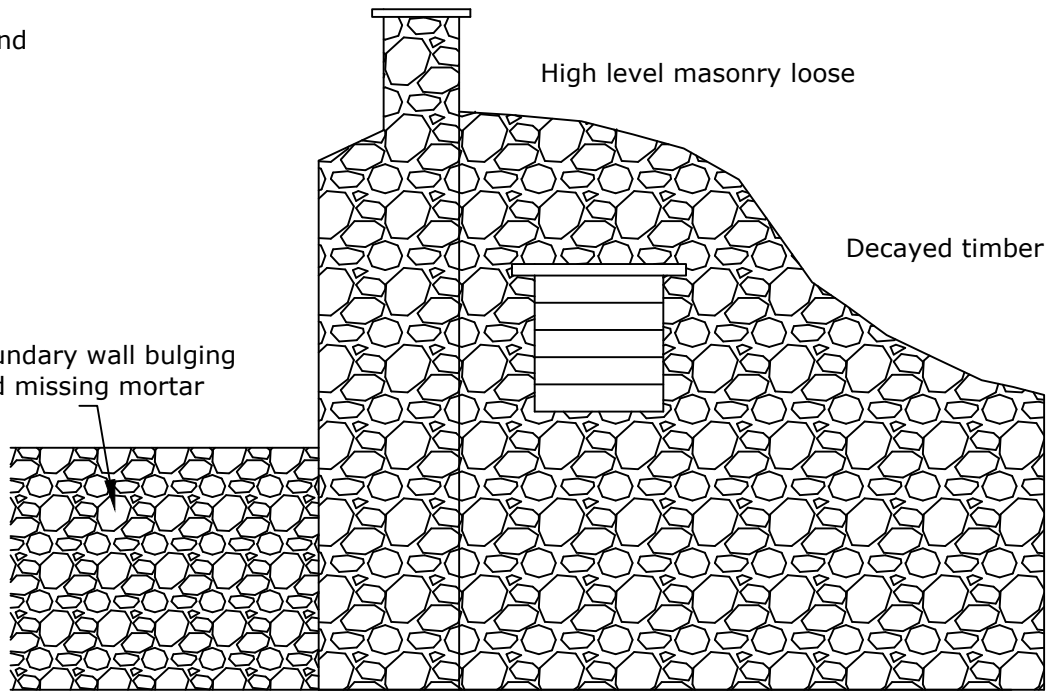
NORTH ELEVATION BEFORE

High level masonry loose

Decayed timber lintels to window

Boundary wall bulging and missing mortar
