**GWARACKENBYGHAN, BOSKENNAL
ST BURYAN
PENZANCE
CORNWALL**

Heritage Assessment

South West Archaeology Ltd. report no. 220707

By A. Allen ACIfA
Report Version: Final
Draft Issued: 17th August 2022
Amended: 17th April 2023, 10th May 2023
Finalised: 26th May 2023

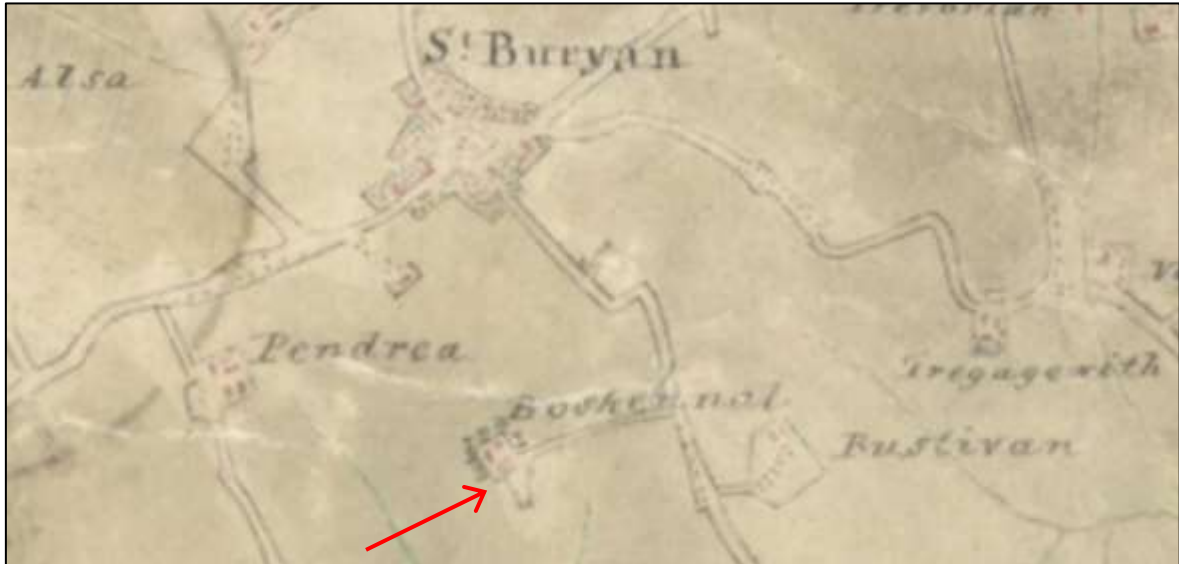
FIGURE 2: EXTRACT FROM THE 1809 ORDNANCE SURVEY (OS) SURVEYOR'S DRAFT MAP; THE SITE IS INDICATED (BL).

The earliest map showing Boskennal is the 1809 Ordnance Survey (OS) surveyor's draft map (Figure 2). There is little clear detail, though it shows a group of three buildings within an enclosure accessed by a track from the east. The enclosure appears to be surrounded by trees.

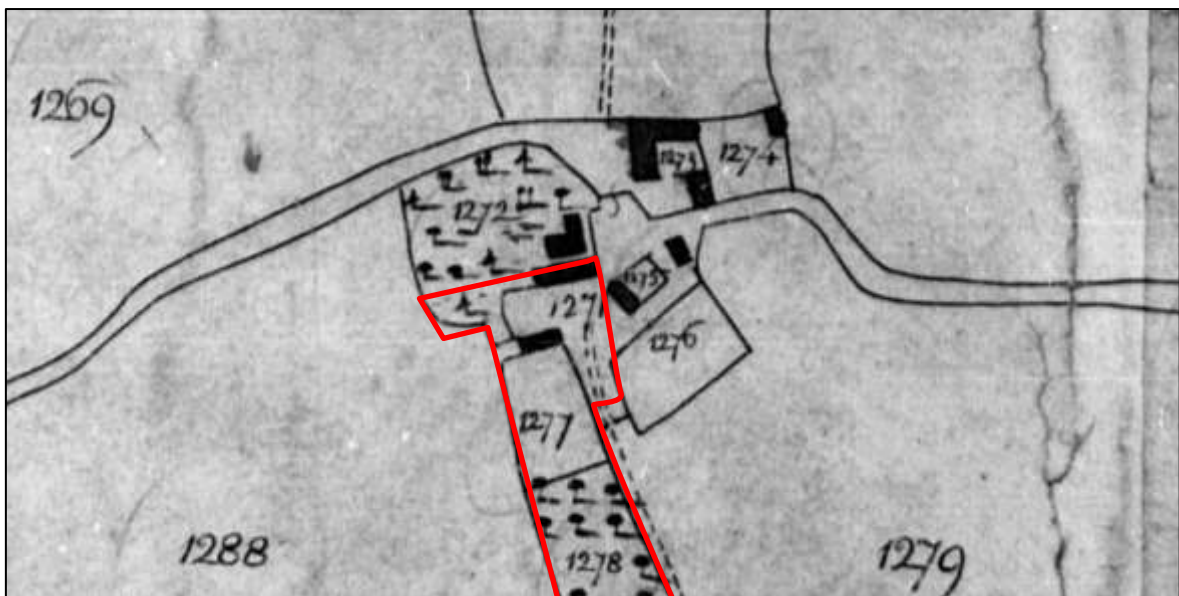
FIGURE 3: EXTRACT FROM THE 1840 ST. BURYAN TITHE MAP. THE APPROXIMATE SITE IS INDICATED (TNA).

The 1840 tithe map is the first to show the site in detail (Figure 3). The farmstead is shown as an irregular group of structures: the L-shaped farmhouse with outbuilding behind, an L-shaped farm building to the north-east, and five other smaller buildings (including the ruined barn in question). Of these latter five, while these could all be farm buildings one (plot no.1275) is listed in the apportionment as *House and Fold*. The 1841 Census listed two other houses at Boskennal: one occupied by John Hollow (agricultural labourer), the other unoccupied. This could mean the farmhouse was divided into two or three dwellings, rather than there being three separate houses, but the mapping evidence does suggest that there were at least two separate residences extant in 1841.

Plot no.1271 is described as *townplace*, and this along with the existence of a farmhouse and two other dwellings would suggest Boskennal had been a hamlet of smaller tenements which, by 1840, had been reduced to a single farm with cottages for agricultural labourers. By 1851, the cottages had gone. A certain level of status is implied by the tithe data, more than for most farms in the district, with the description of plot no.1272 as a dwelling house *and shrubbery* unusual, as is the presence of a *kitchen garden*. The only other use of the term shrubbery or kitchen garden in the apportionment for St Buryan being at Boskenna Manor.

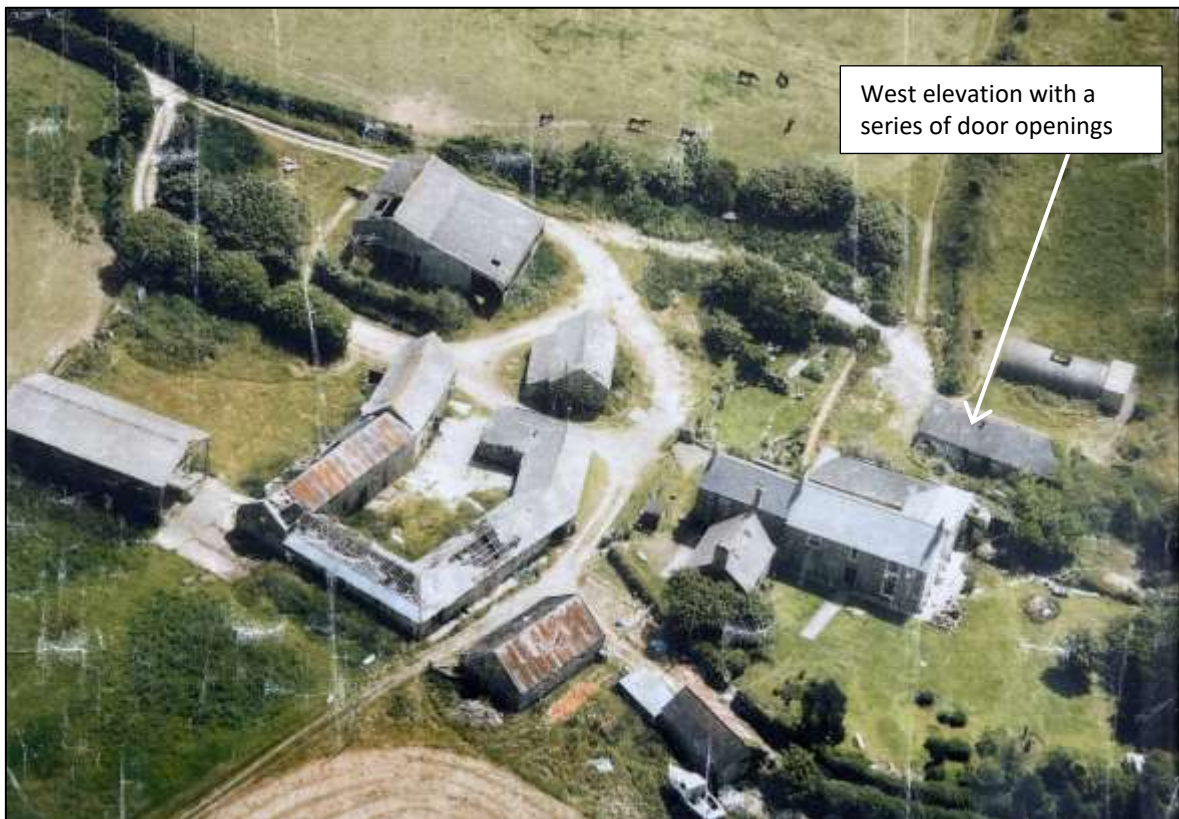
FIGURE 7: AN AERIAL PHOTOGRAPH OF BOSKENNAL C.1990S (SUPPLIED BY AGENT).

Several late 20th century photographs depict the complex before the conversion of the Granary and other farm buildings on the wider site and these show the ruined barn at this time has a pitched roof of rusty corrugated metal sheeting and gabled ends. Earlier architect drawings of the ruined building (Figure 10) show four narrow doorways in the north-west elevation facing the granary (also visible on Figure 7), although their width and placement would suggest some had been forced into this elevation. Four windows are shown in the south-east elevation; three are rather high, the northernmost one looks larger and it appears likely that this could have been a partially-blocked doorway. The north and south elevations show a possible roof raise, and potential loading doors – although this is unclear. A sliced internal elevation also shows the possibility of a loft space, however no evidence of this is visible currently.

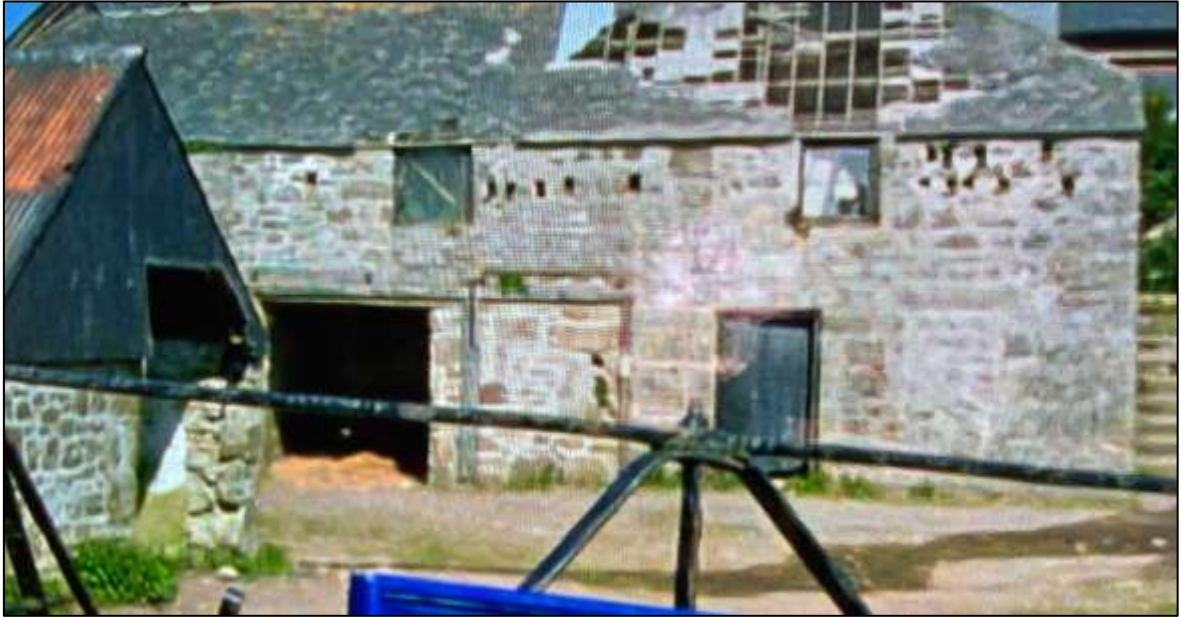
FIGURE 8: A STILL FROM THE PILOT EPISODE OF THE ITV DETECTIVE SERIES *WYCLIFFE* C.1993 WHICH SHOWS BOTH BUILDINGS BEFORE THE GRANARY WAS CONVERTED TO RESIDENTIAL USE (SUPPLIED BY THE CLIENT).

The Granary building becomes converted between these two historic photos (i.e. between 1993 and 2005), and it is clear that the conversion has largely respected the historic appearance, although some of the openings and blocked openings have clearly been modified. The granary appears to have been in a fairly perilous condition in 1993 (see Figure 8) and its conversion no doubt saved it from a similar or worse fate than the ruined building.

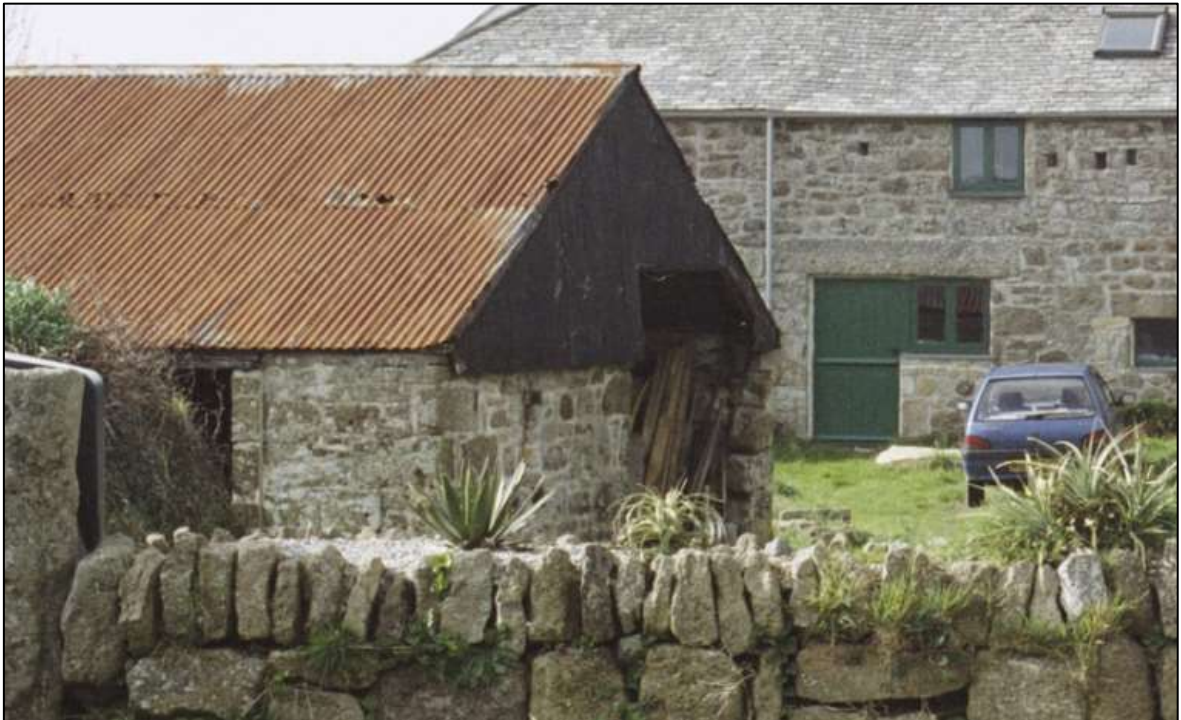
FIGURE 9: EXTRACT FROM A 2005 IMAGE OF THE BUILDINGS (© HISTORIC ENGLAND).

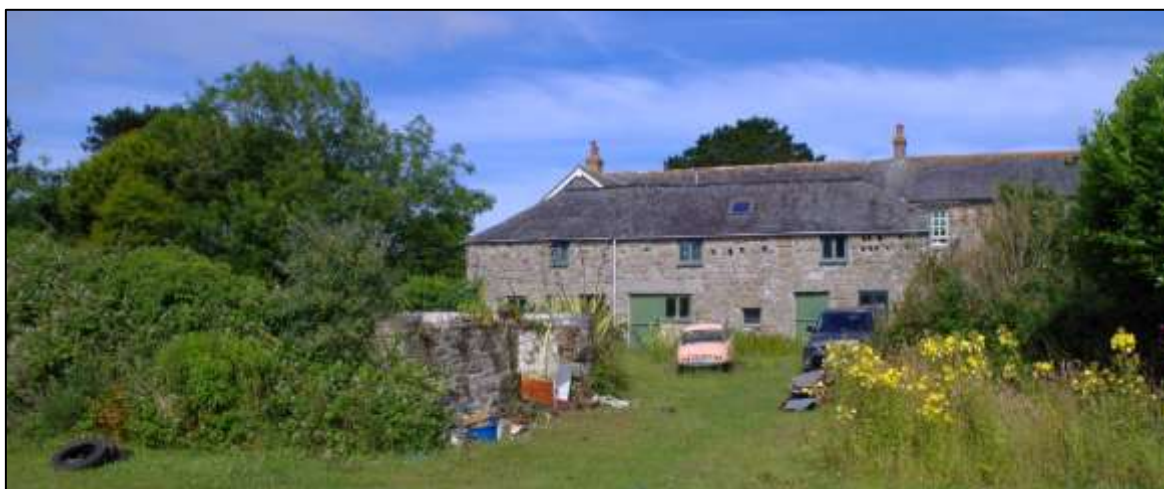
FIGURE 11: GWARACKEWENBYGHAN, WITH THE RUINED BARN IN THE FOREGROUND, AND GRANARY, WITH FARMHOUSE LARGELY HIDDEN BEHIND; VIEWED FROM THE ESE.

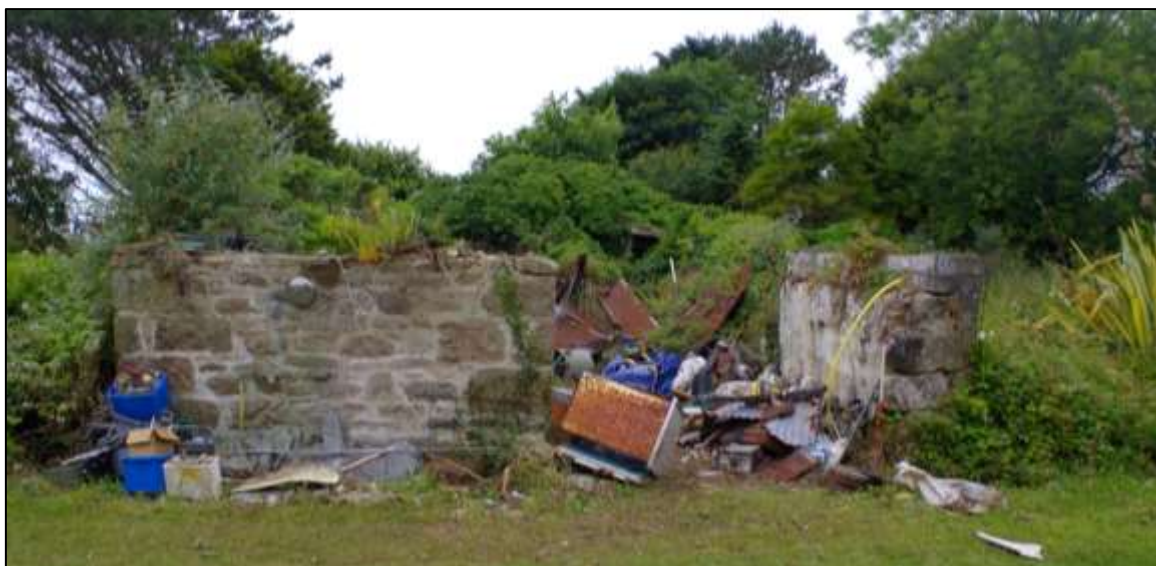
FIGURE 12: THE NORTH-EAST ELEVATION OF THE BARN; VIEWED FROM THE NORTH-EAST (1M SCALE).

The north elevation provided the main access into the barn, although the opening has been altered/ widened – this looks clear from the earlier photographs, the return wall to the west side has been cut creating a ragged reveal. The wide opening sits to the west side of the elevation and includes large, faced and dressed granite quoins to either side of the opening, although the west side has begun deteriorating, with mortar falling out, leaving a ragged edge. The section of wall to the east

end looks like it may have been rebuilt in areas, heavily repointed with a cement mortar. The top wall plate is rough, with areas of stonework and mortar that has fallen away, it is unclear if it was ever formerly a taller building or constructed as only one-storey high.

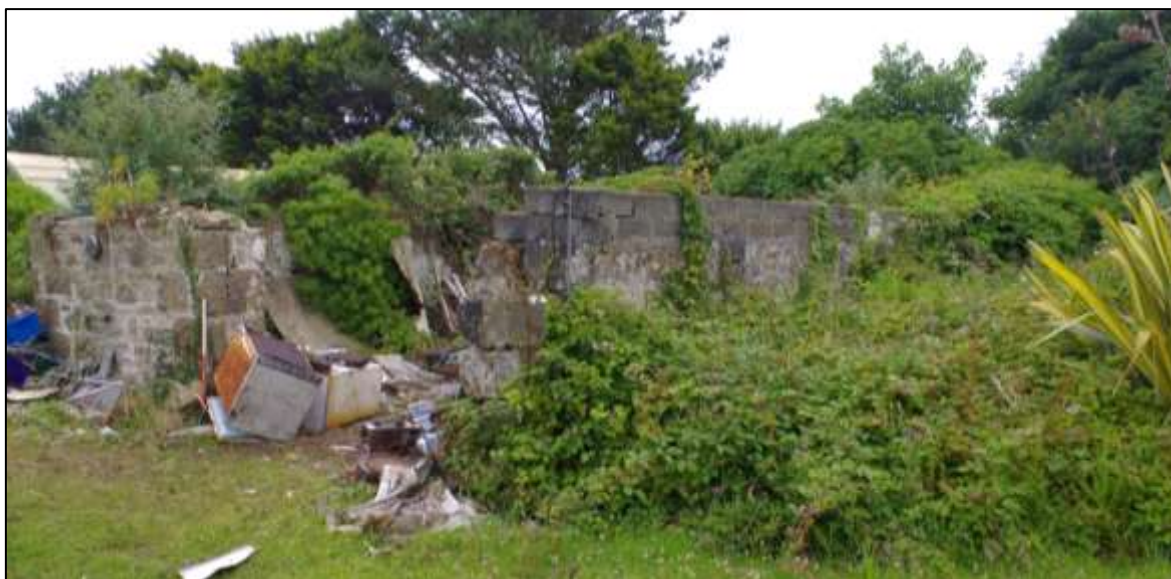
Sat in front of this elevation is an overgrown raised garden bed, lined with granite rubble, the shrubbery made it difficult to see towards the southern end of this exterior face. This elevation is built using rough courses of small granite-rubble, with a crudely and thickly applied lime mortar that has almost become render and the build here is similar to the upper raise on the granary building. It has been raised in two courses of chunky dark-grey concrete blocks above the former wall plate and suggests an earlier-mid 20th century phase of neglect/rebuild to this side, again it isn't clear if this building was ever more than one storey.

FIGURE 13: THE NORTH-EAST AND NORTH-WEST FACING ELEVATIONS (THE ONLY VISIBLE ELEVATIONS); VIEWED FROM THE NORTH-WEST (1M SCALE).

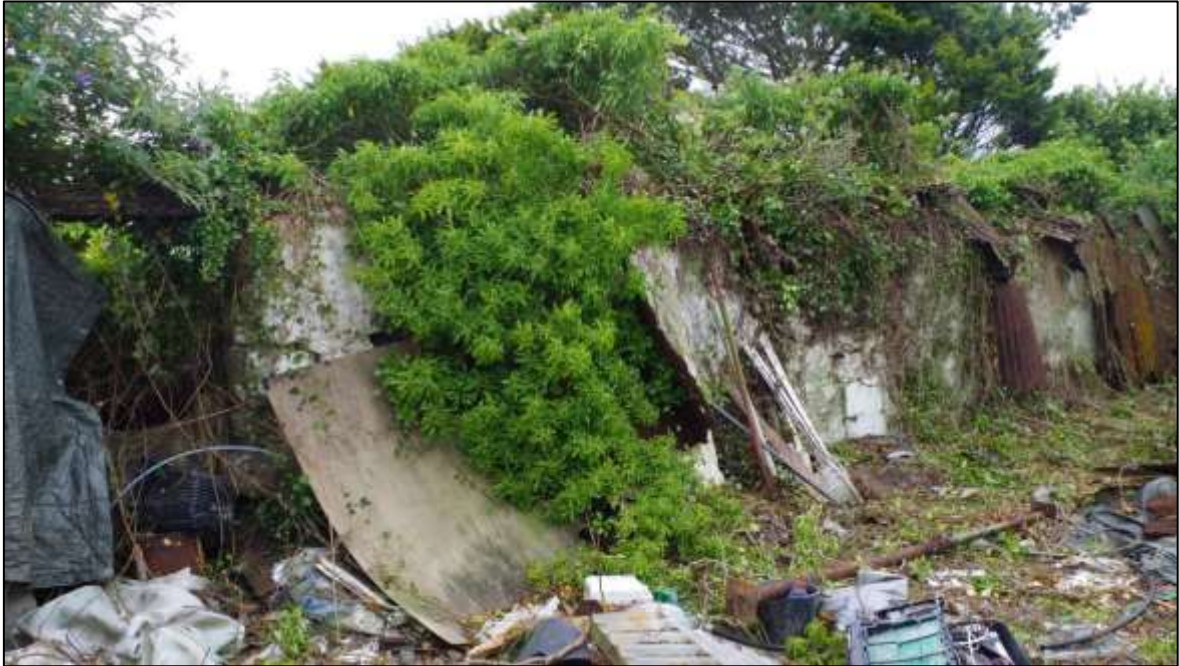
The east elevation looked to use a different, neater granite coursing (as noted from the southern doorway reveal), with larger shaped stones; it was also slightly thicker in depth and battered towards the base whereas the other walls had a straight profile. This could imply earlier building fabric could be present and the building has been rebuilt on the same footprint. Two high-set small square windows and a doorway to the north end suggest the building may have once fronted onto or been directly associated with the adjacent former kitchen garden. The presence of windows appears to confirm this is far from a generic agricultural barn with several entrances, exits and obviously windows for light, suggesting processing could be occurring in the interior, or it is occupied in some capacity.

FIGURE 14: A DOOR AND TWO WINDOWS WERE IDENTIFIED IN THE SOUTH-EAST ELEVATION; VIEWED FROM THE NORTH.

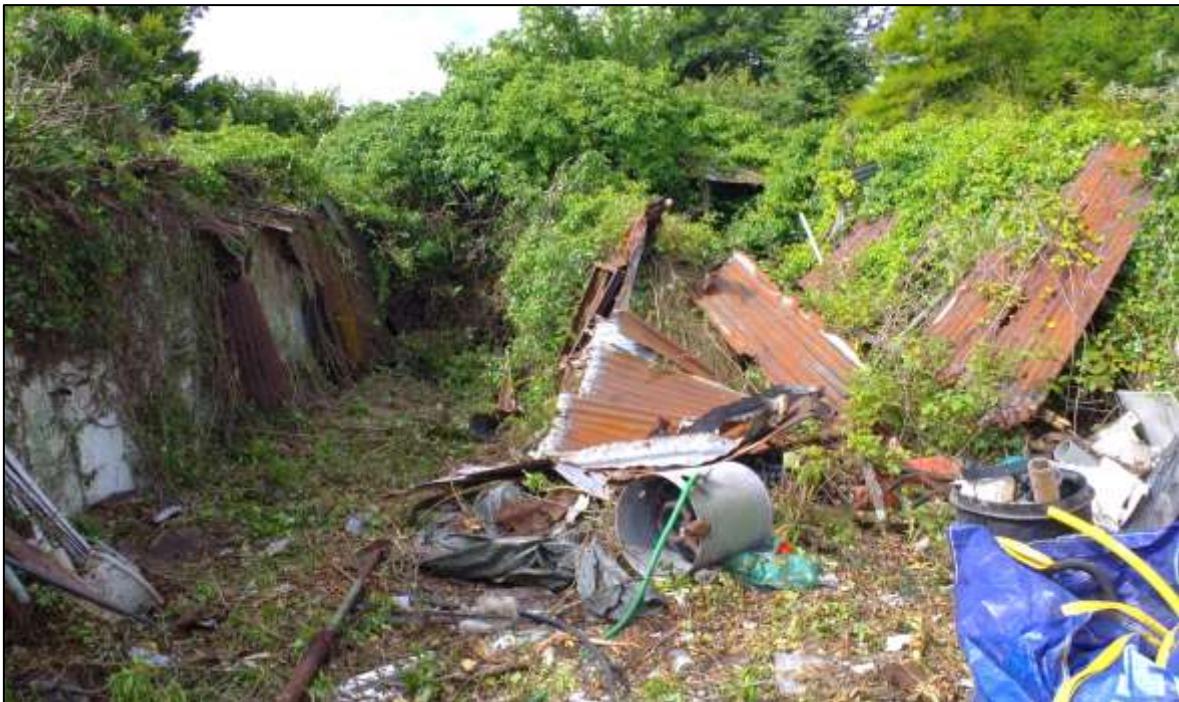
FIGURE 15: THE INTERIOR; VIEWED FROM THE NORTH-EAST.

Internally the barn was still in the process of being cleared, so areas were difficult to access, particularly to the south, and other parts of the structure were largely concealed. The building was accessed from the large opening to the north-west corner. On the northern internal elevation, a modern boiler unit sits in the east corner, and elevation has been thickly rendered in a blue/ grey, modern cement. The east elevation provides a bit more context, with a blocked, single doorway with a timber lintel and large granite quoins to the opening. The wall here was notably thick, over 0.6m thick, slightly thicker than the stonework of the northern elevation. Further south along the elevation two high, small windows could be identified, with shallow splayed sides to one side, and elements of timber lintel barely surviving above. The south end was covered with tall vegetation, mimicking a gable end, which has been confirmed by historic photographs (see Figure 7-9).

The remains of the 20th century corrugated sheet metal roof and part remnants of 20th century timber trusses were noted amongst the vegetation and rubble. The west elevation included a timber door towards the north end, possibly a later forced addition. The concrete block work raised the wall plate to this side by three courses of smaller blocks, to match that of the east elevation. Both west and east elevation had been painted in a thick white paint, making the coursing difficult to identify internally. The floor was uneven, and a single granite slab was identified, although this looked to be out of place and not determinate of a full slabbed floor surviving.

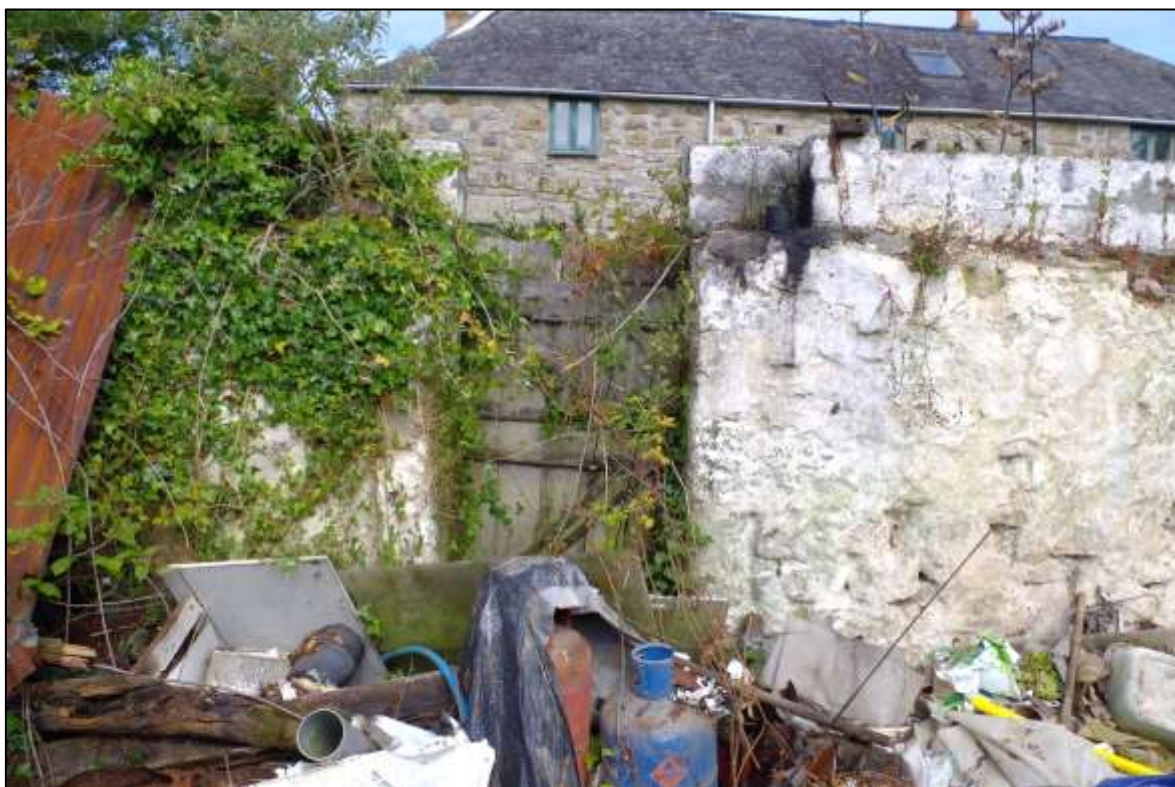
- Two windows, potentially a third to the southern end. Both look to have shallow splayed sides, northern one looks splayed only to one reveal, and elements of their timber lintel survive (although the timbers look to be a modern replacements)
- Large iron pintle in east elevation possibly associated with a former function, internal partitions and doorways?
- Doorway to north corner of east elevation exposes thick battered walls (more than 0.6m thick) of much heavier build than the other walls, suggesting the possible survival of an earlier build fabric in this elevation.
- Door to the west elevation, possibly an opening forced at a later date, includes even-width planks with plain ledging bars internally and large nails for possible large iron straps.
- Granite slab to floor, although does look to be out of place or reset.

FIGURE 16: A DOOR OPENING IN THE NORTH-WEST ELEVATION; VIEWED FROM THE SOUTH-EAST.

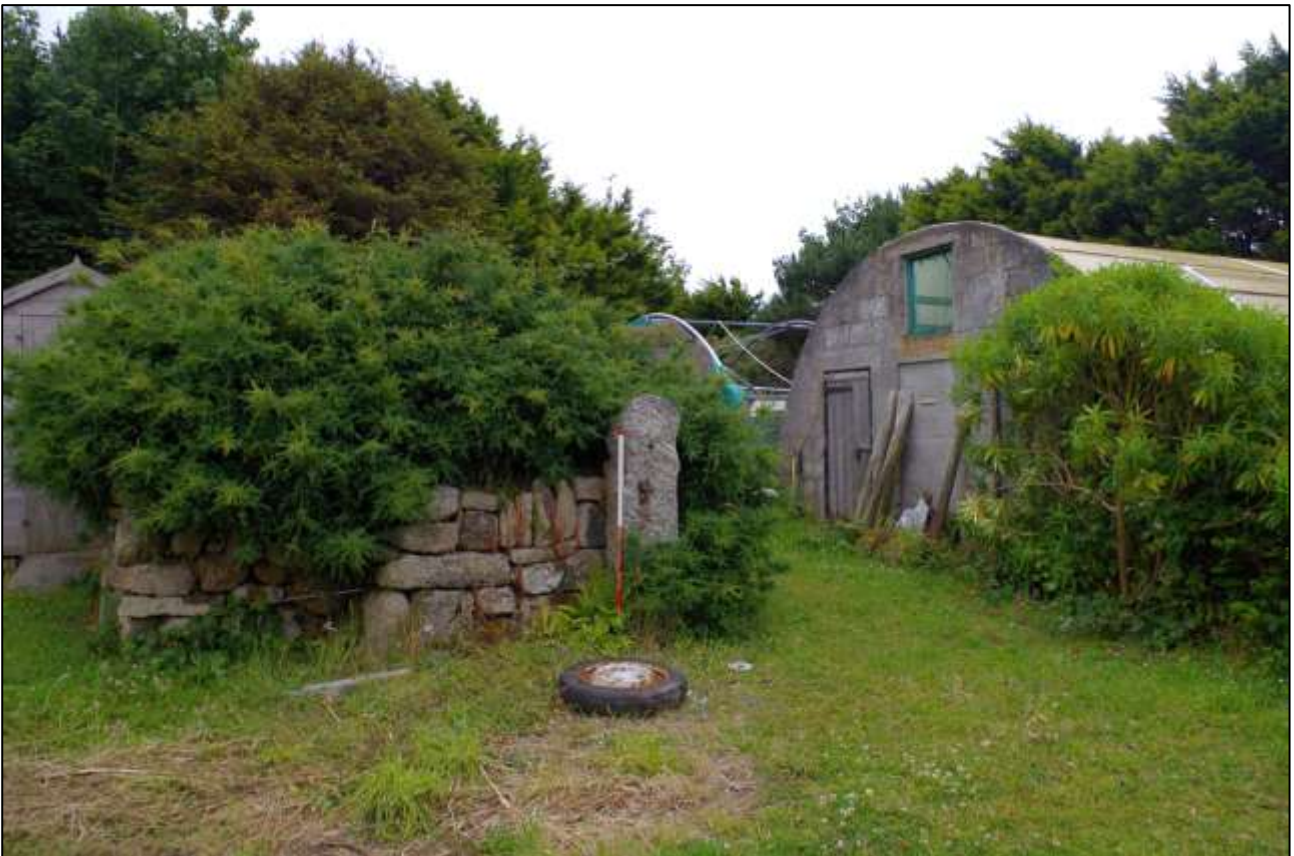
2. THE MODERN GARDEN BUILDINGS TO THE SOUTH-EAST, WITH (REUSED) GRANITE GATEPOST AND LATER GARDEN WALLS; VIEWED FROM THE NORTH-WEST (1M SCALE).

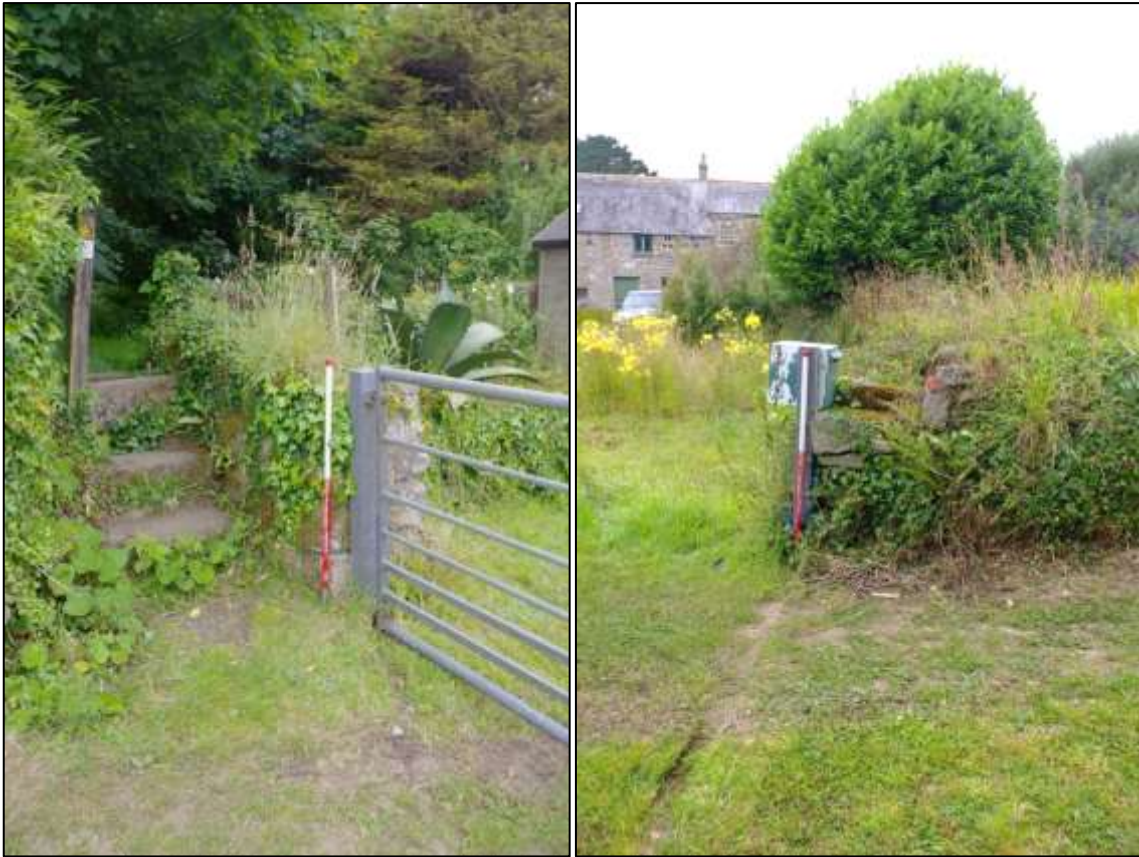
3. LEFT: FOOTPATH ACCESS TO THE NORTH OF THE GATE; VIEWED FROM THE NORTH-WEST (1M SCALE).

4. RIGHT: ELEMENTS OF THE LATER GARDEN/BOUNDARY WALL; VIEWED FROM THE SOUTH-EAST (1M SCALE).

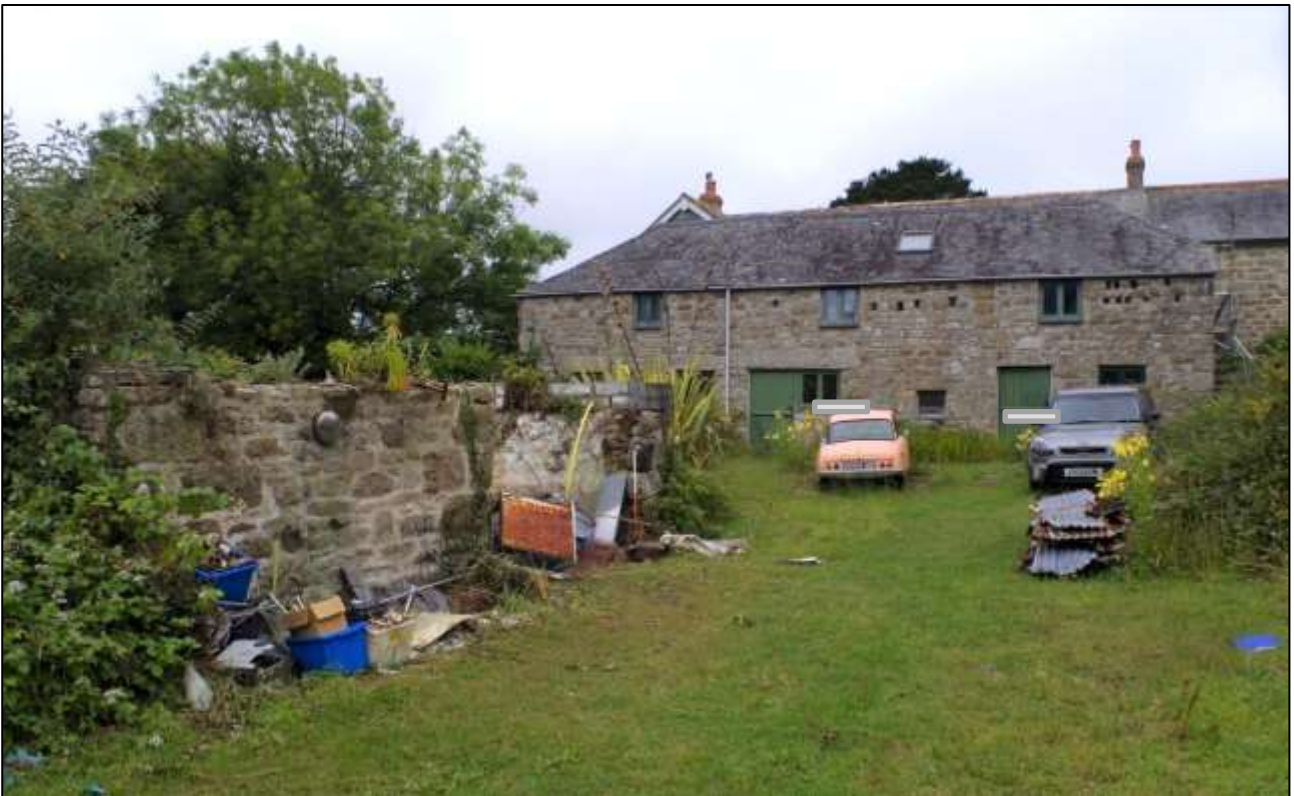
5. GWARACKEWENBYGHAN WITH THE RUINED BARN IN THE FOREGROUND, THE FORMER GRANARY AND POLITE 18TH/19TH CENTURY RESIDENCE BEHIND; VIEWED FROM THE ESE (1M SCALE).

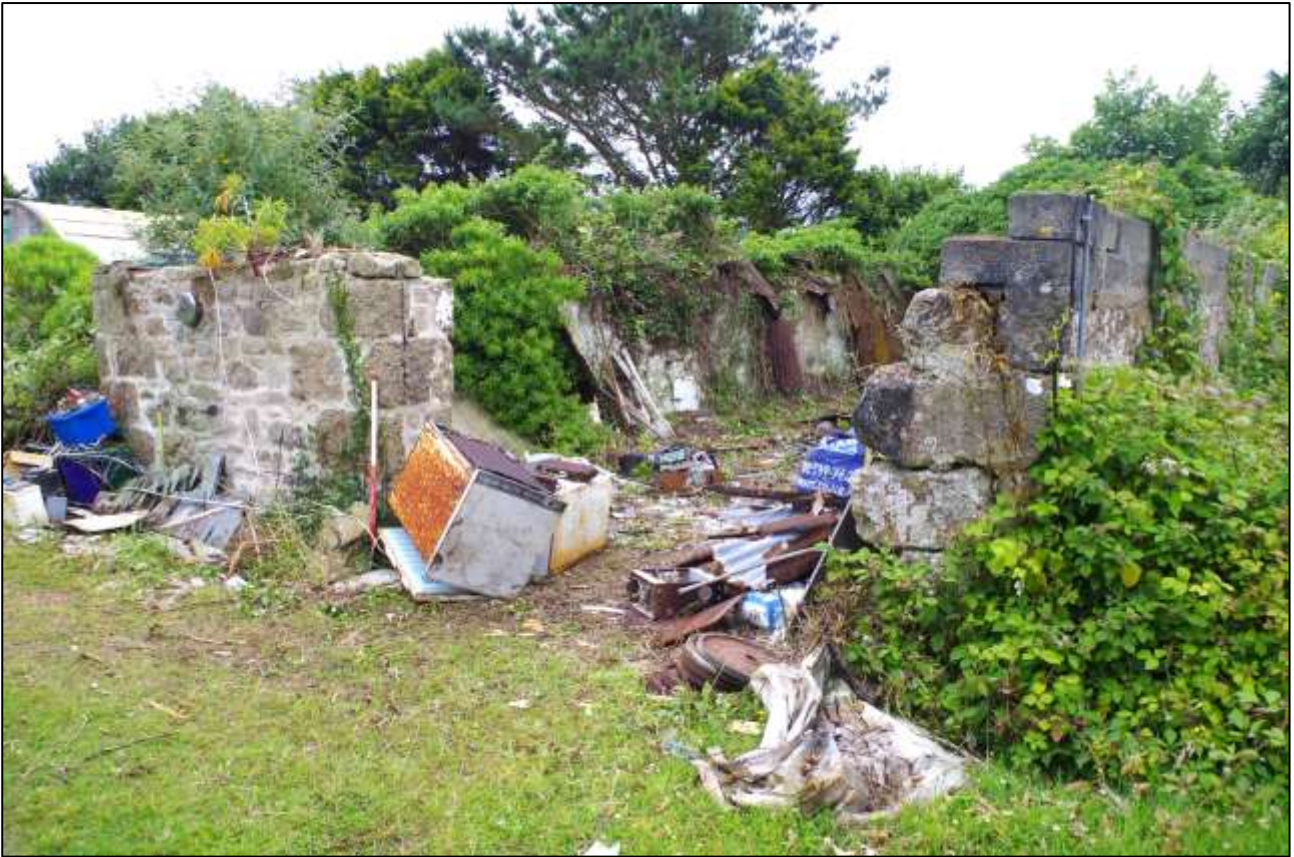
6. THE NORTH-EAST GABLE ELEVATION OF THE RUINED BARN; VIEWED FROM THE NORTH (1M SCALE).

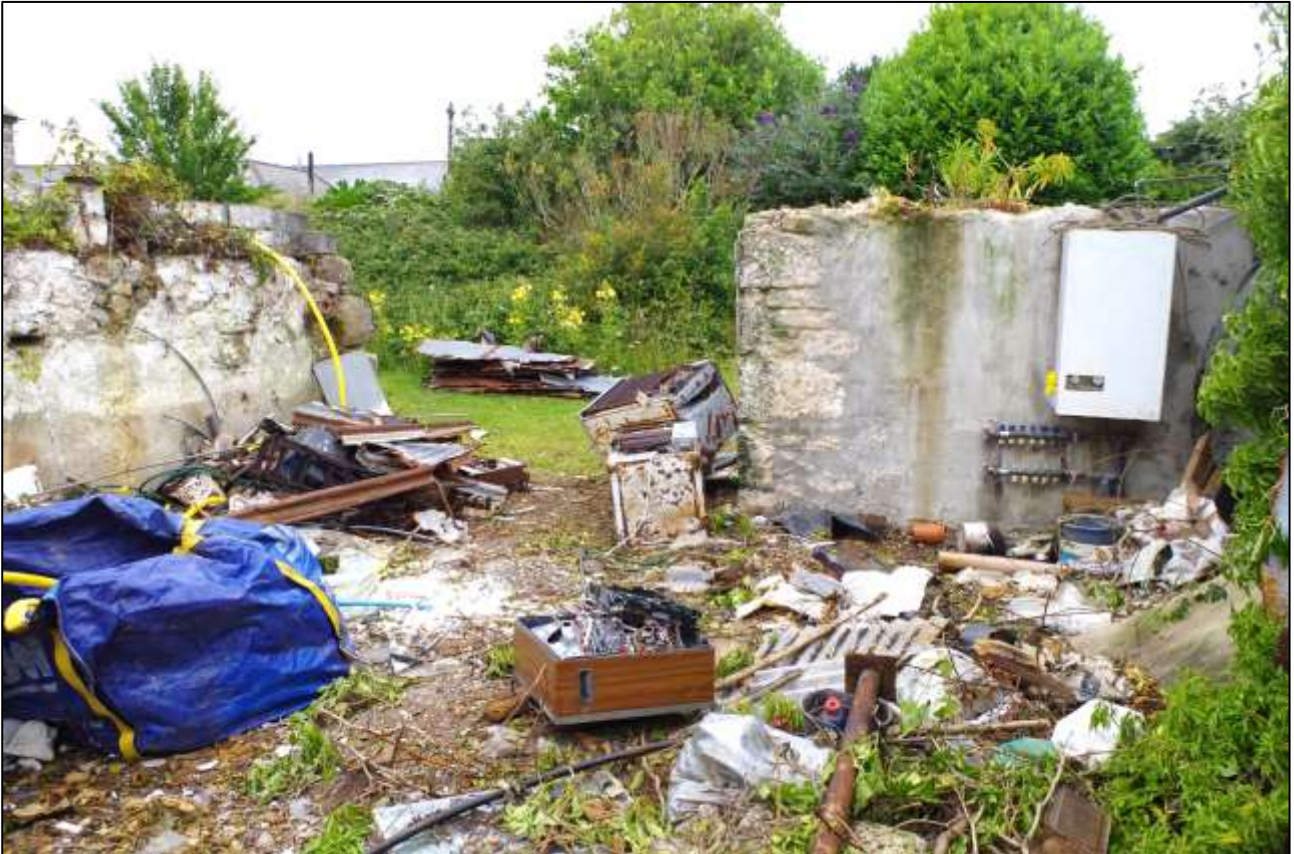
7. THE INTERNAL NORTH-EASTERN ELEVATION; VIEWED FROM THE SOUTH.

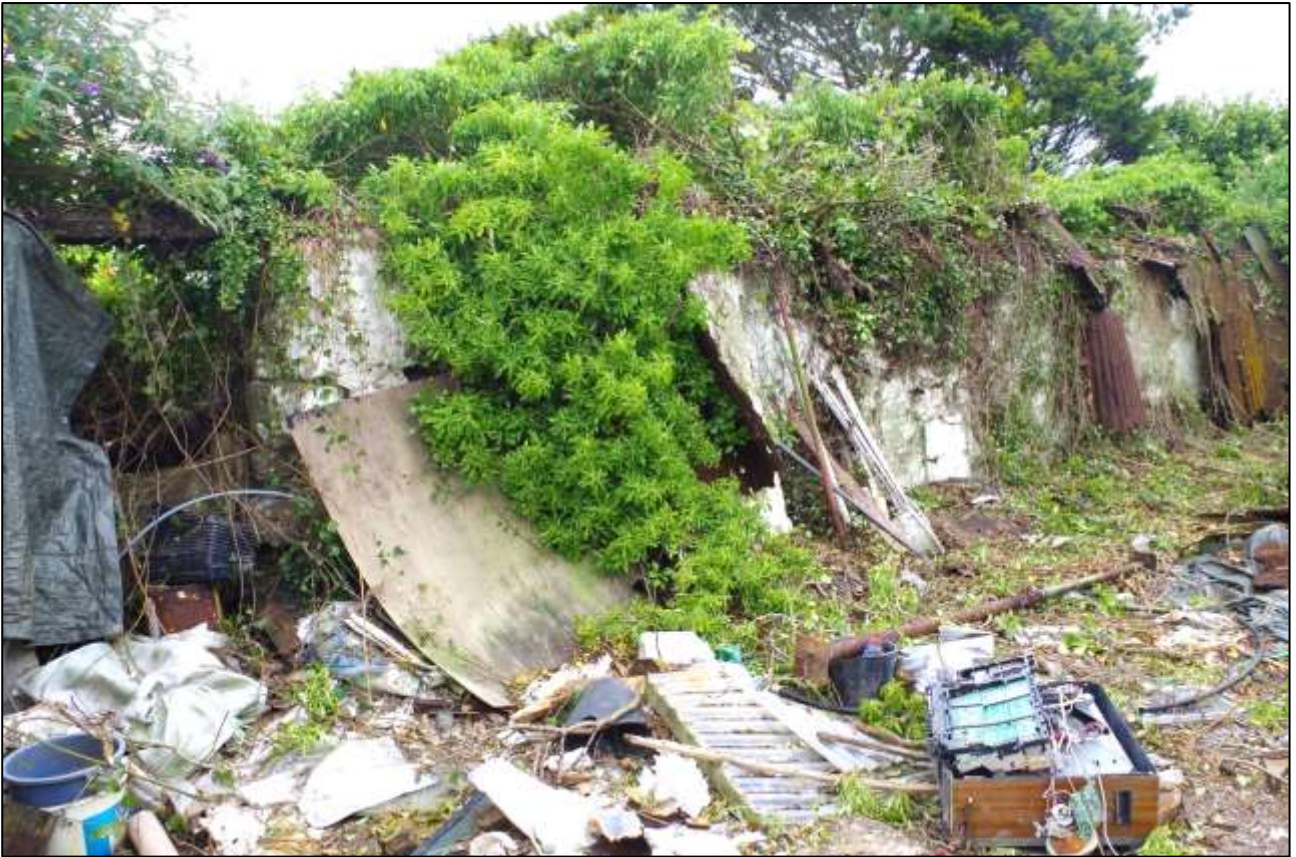
8. THE INTERNAL SOUTH-EAST ELEVATION, THE PARTIALLY-BLOCKED DOORWAY TO LEFT; VIEWED FROM THE NORTH-WEST.

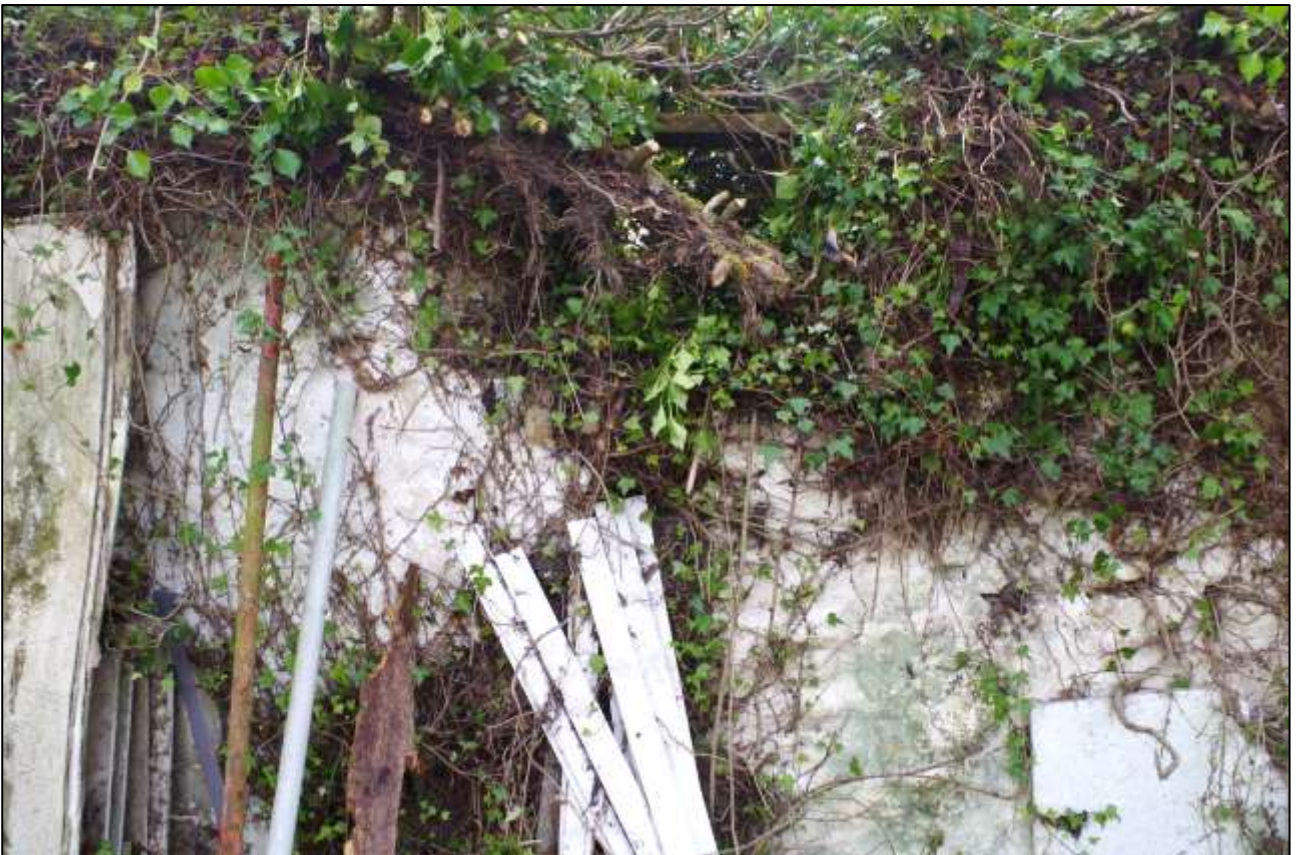
9. ONE OF THE WINDOW OPENINGS IN THE SOUTH-EAST ELEVATION; VIEWED FROM THE NORTH-WEST.

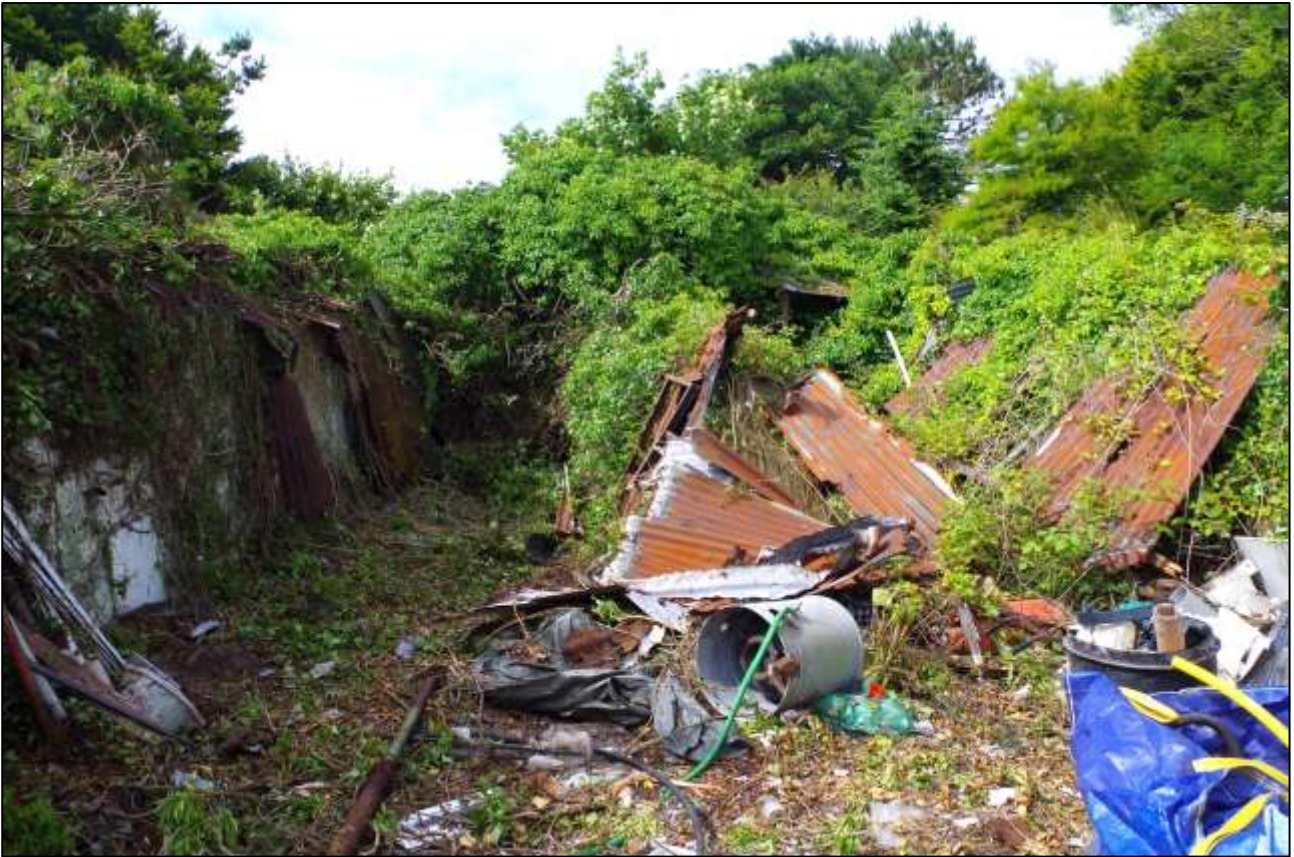
10. THE INTERIOR OF THE RUINED STRUCTURE; VIEWED FROM THE NORTH-EAST.

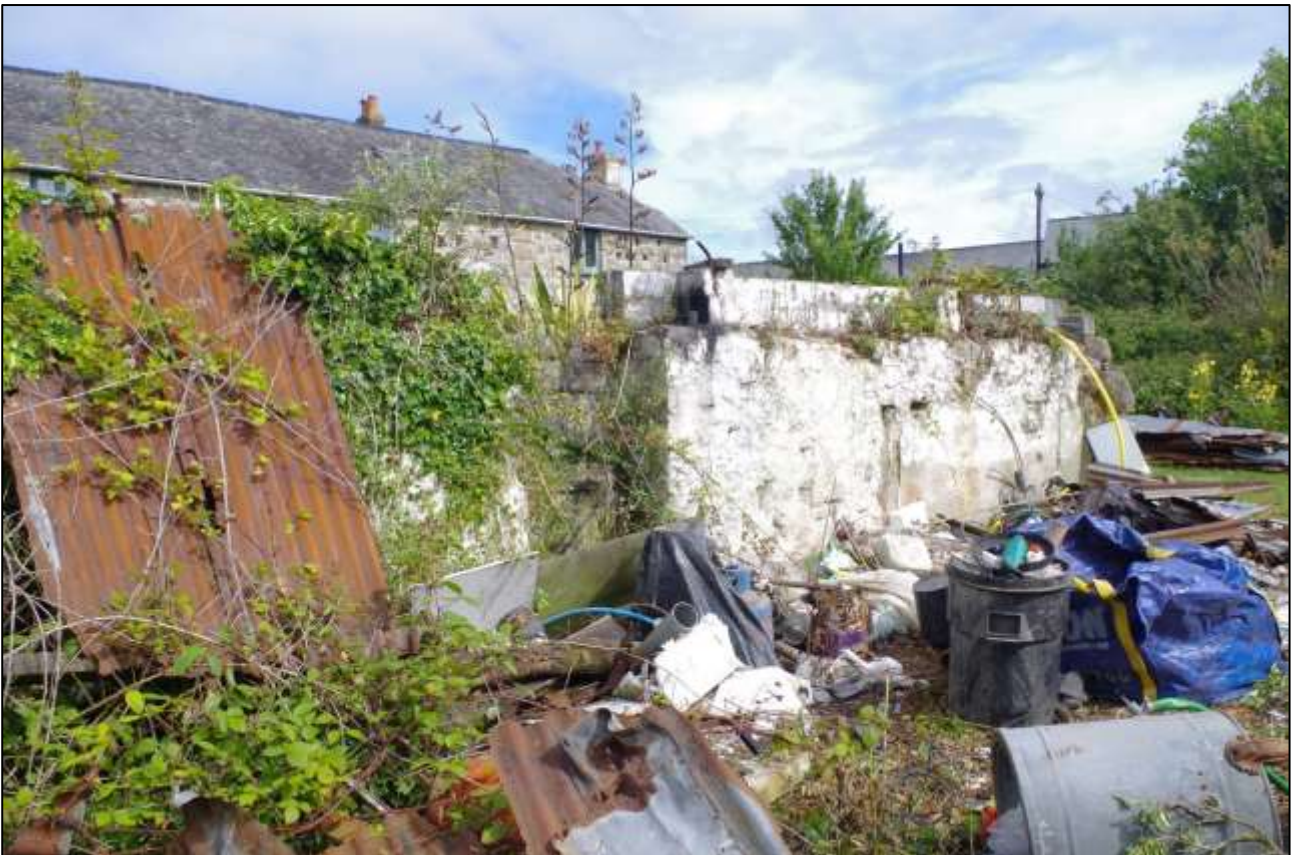
11. THE NORTH END OF THE NORTH-WESTERN INTERNAL ELEVATION; VIEWED FROM THE SOUTH-EAST.

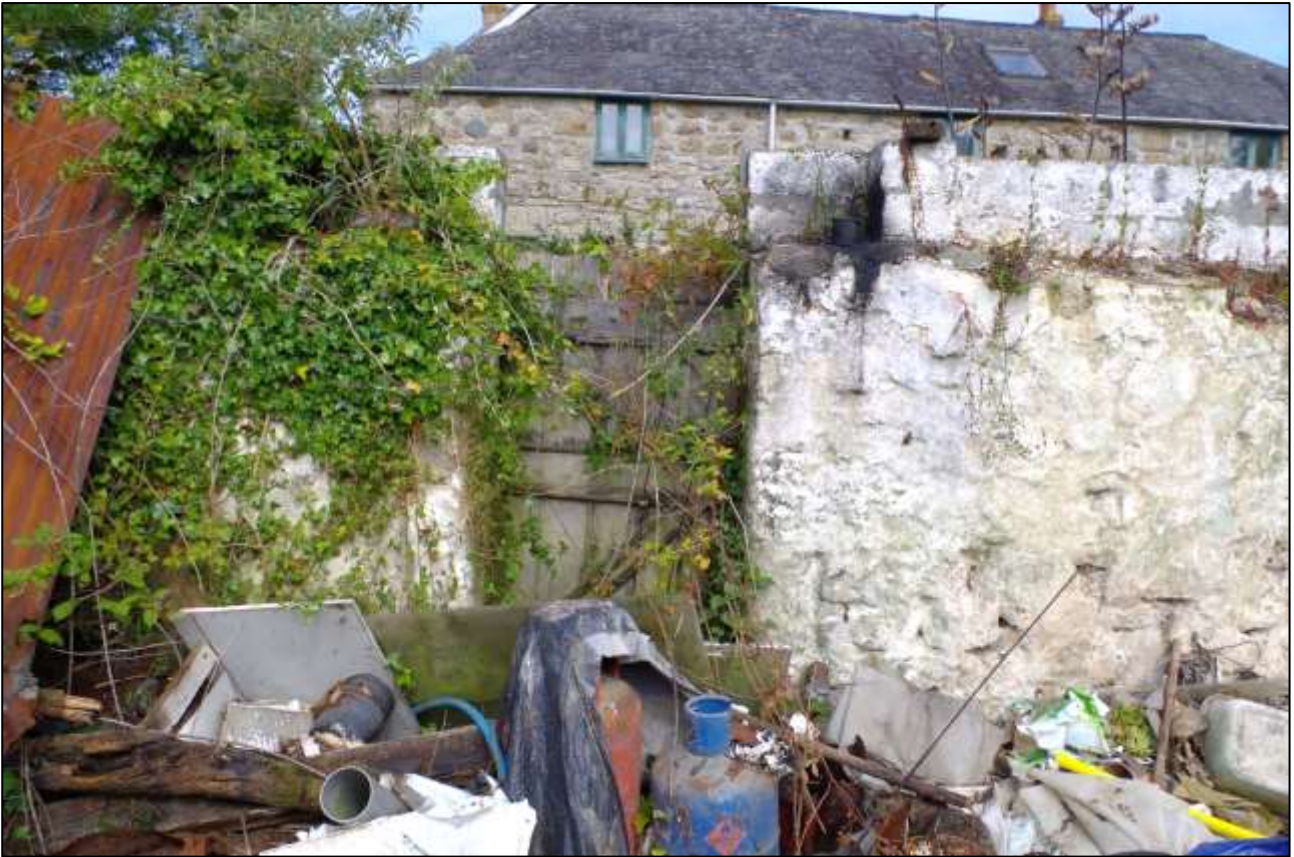
12. POSSIBLE LATER FORCED DOORWAY TO THE NORTH-WEST ELEVATION; VIEWED FROM THE SOUTH-EAST.
