**GWARACKENBYGHAN, BOSKENNAL
ST BURYAN
PENZANCE
CORNWALL**

Heritage Assessment

South West Archaeology Ltd. report no. 220707

By A. Allen ACIfA
Report Version: Final
Draft Issued: 17th August 2022
Amended: 17th April 2023, 10th May 2023
Finalised: 26th May 2023

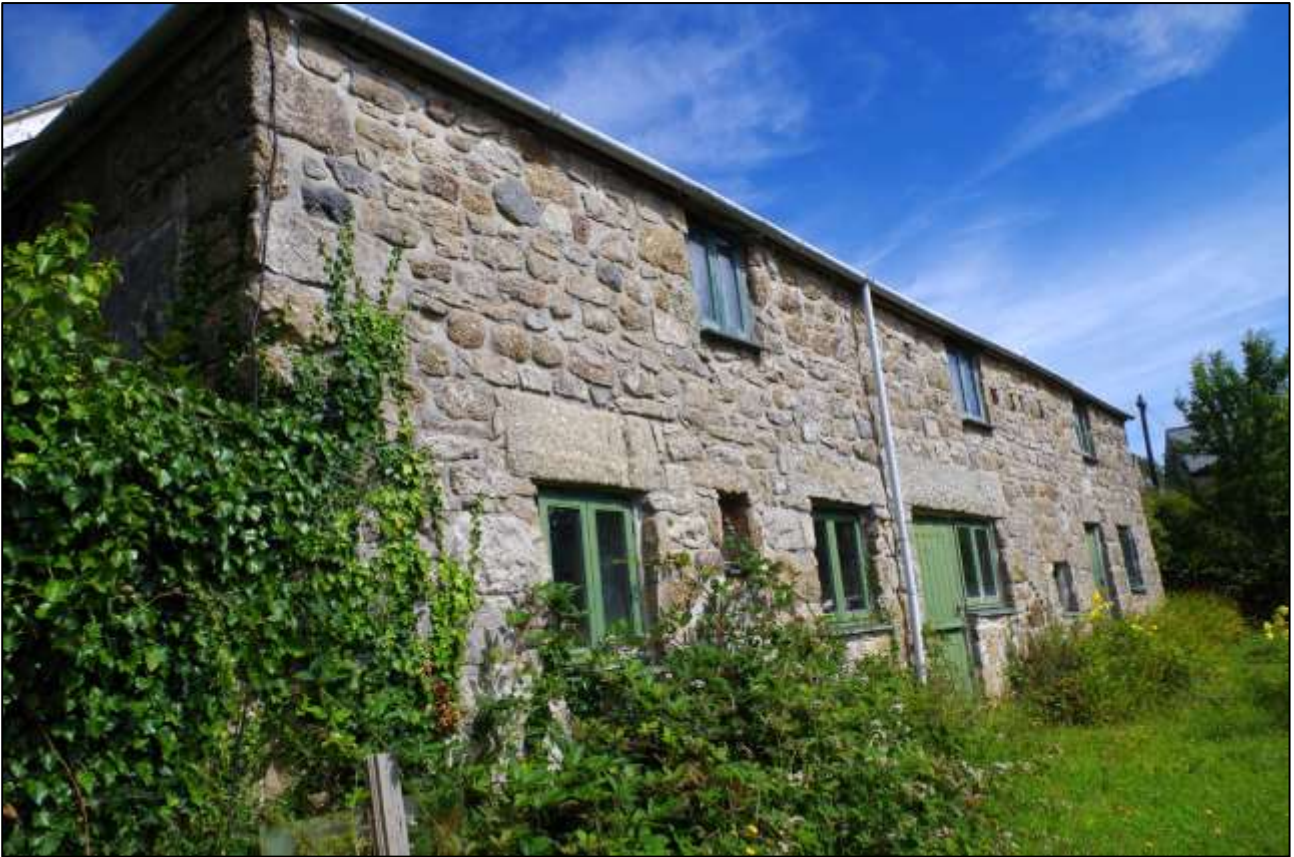
Build lines visible to this long east elevation would suggest it has developed into a longer linear range over time. An earlier build fabric appears to survive to the south end and suggests the building developed northwards. The south elevation has undergone heavy alteration and was noted as significantly complex in its presentation, including heavy cement repointing, and blocked/ altered former openings with reused granite dressings. Despite this the building has retained some earlier

The south-east and north-east corners are very battered with large, dressed granite quoins to the edges that suggests earlier build material survives in part to the elevation. There is a build line, with quoins in the third bay, suggesting the end (north) bay of the four is an extension and the smaller looser stonework at the eaves could suggest the roof to the building has also been raised above the earlier three bays.

14. THE EAST ELEVATION OF THE LISTED GRANARY; VIEWED FROM THE SOUTH.

It is recommended further building recording is conducted as part of any planning conditions before any alteration works commence.

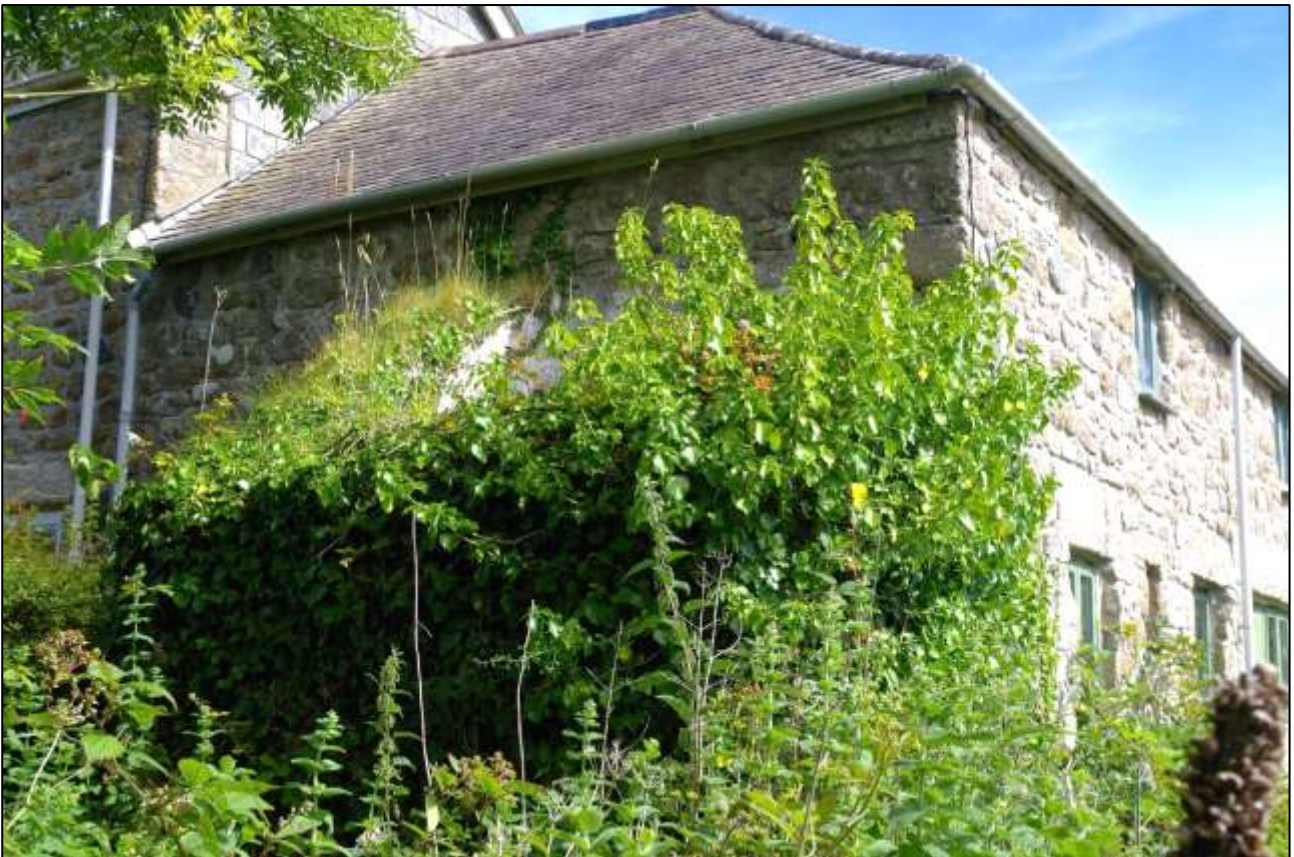
15. THE SMALL DERELICT LEAN-TO AT THE SOUTH END OF THE FORMER GRANARY; VIEWED FROM THE SOUTH.

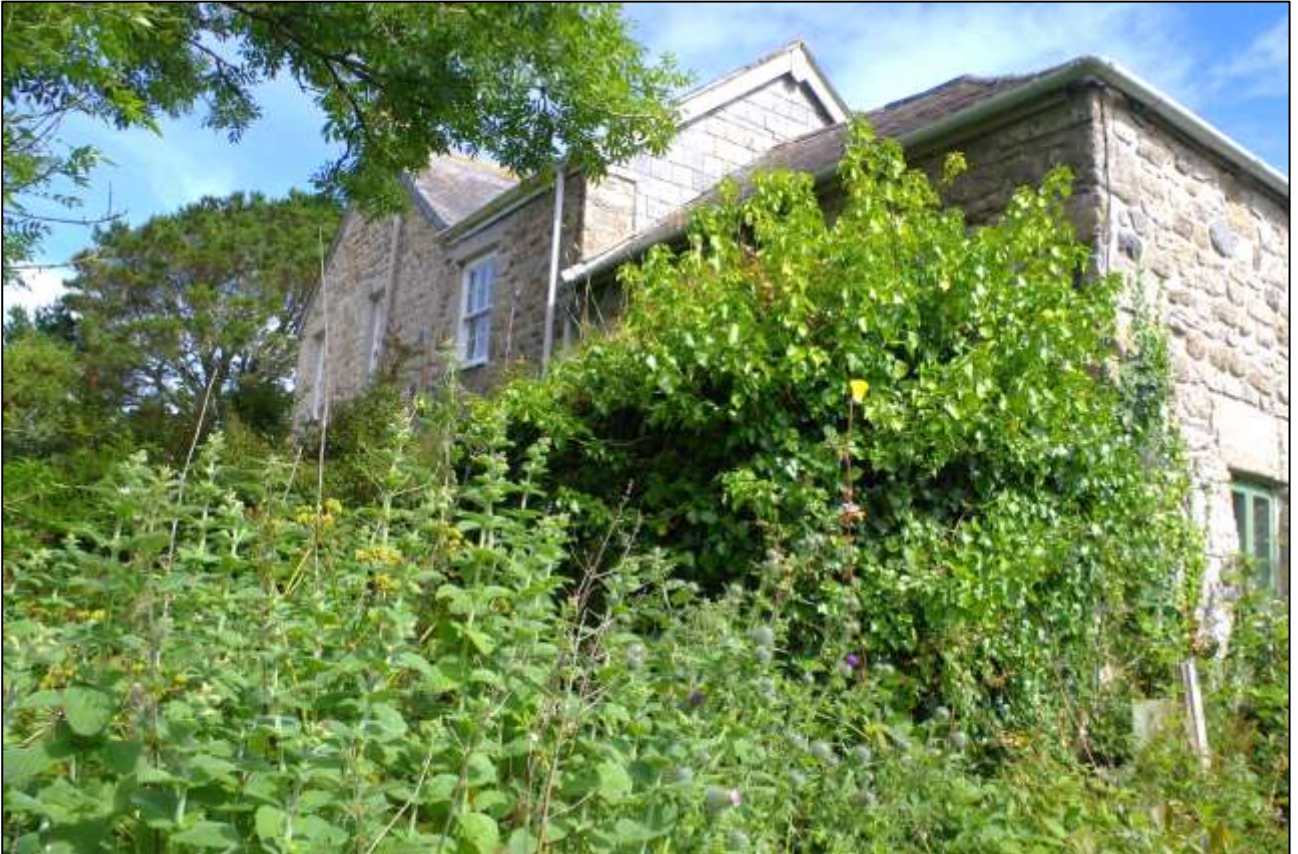
16. THE SOUTH-WEST ELEVATION OF THE GRANARY AND THE FORMER FARMHOUSE BEYOND; VIEWED FROM THE SOUTH.
