Mark Tunmore BSc, MCIEEM
The Boat House, Church Cove, Lizard,
Helston, Cornwall, TR12 7PH
T: 01326 290287
M: 0797 9013257
21 February 2023

1. INTRODUCTION

Mark Tunmore was instructed by Christopher Morris on 23 January 2023 to carry out a bat and nesting bird survey at a property known as Gwarackewenbyghan, located at Boskennal, St Buryan, Cornwall, TR19 6DF. The survey was requested in preparation for a planning application to carry out internal and external improvements on the granary building, to demolish the polytunnel and piggery and to construct living accommodation within the current footprint of a collapsed barn. The survey was carried out on 1 February 2023; the weather at the time was dry with 8/8 cloud cover, light winds and mild temperatures, thus providing optimal survey conditions.

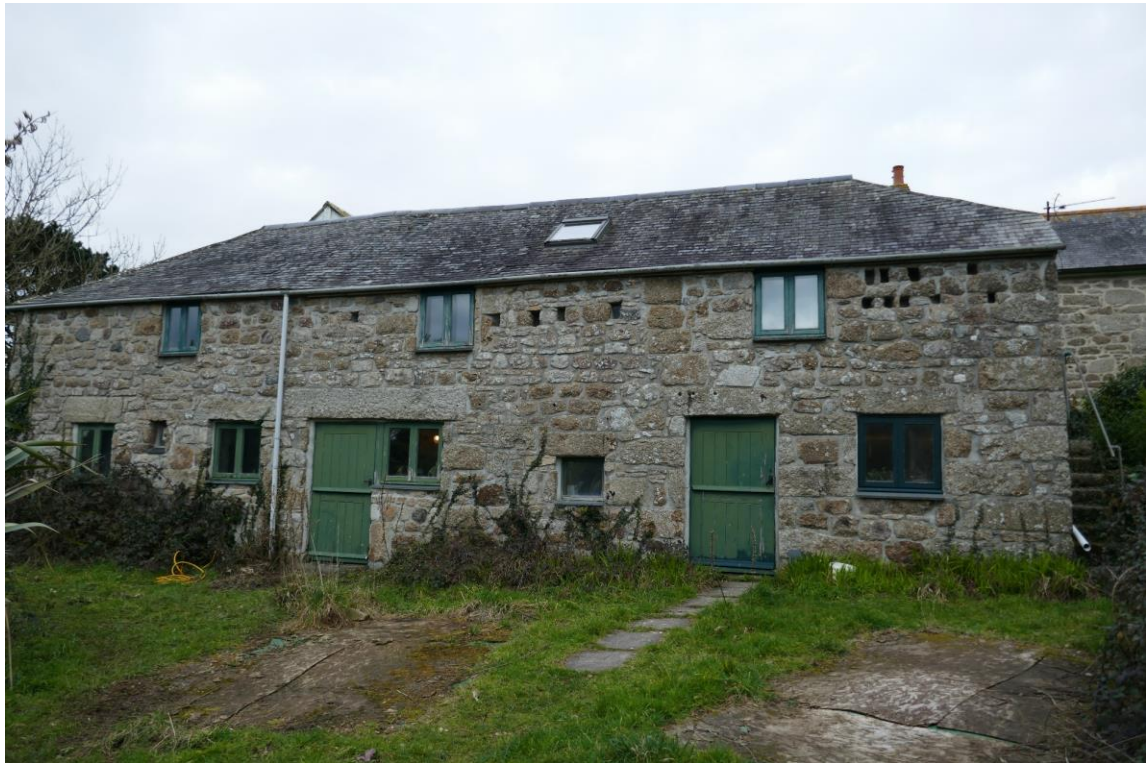
Figure 1. Eastern aspect of the granary.

This two-storey stone-built structure (Figure 1) was joined on to a dwelling on the west side of the building, which was not part of the landholding. The building is a Grade II listed building. The walls were tightly pointed and on the east side of the building two rows of square holes were present in two rows (Figure 2), totalling 14 in number. These were examined from a ladder and did not extend far enough down to support roosting bats due to sealing with cement (Figure 2); they did, however, have potential for nesting birds and the remains of a nest was found in one of them.

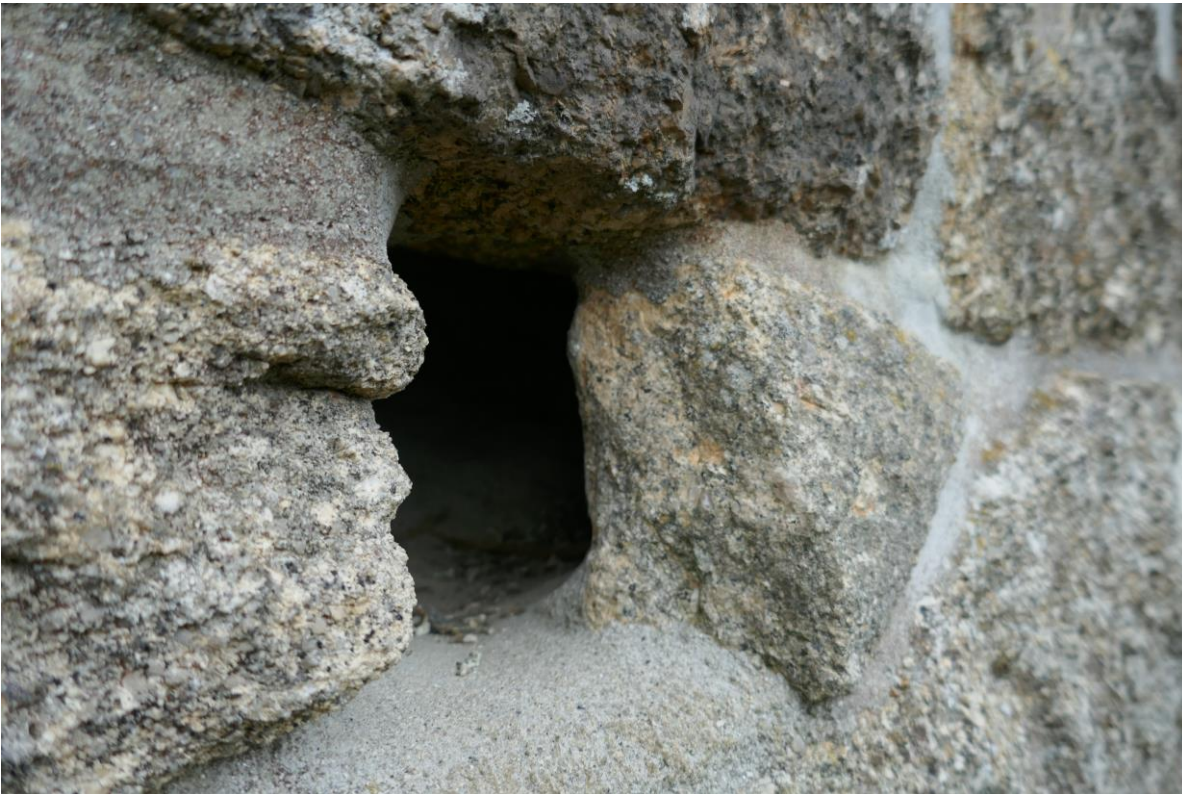
Figure 2. Close-up of one of the square holes in the eastern aspect of the building.

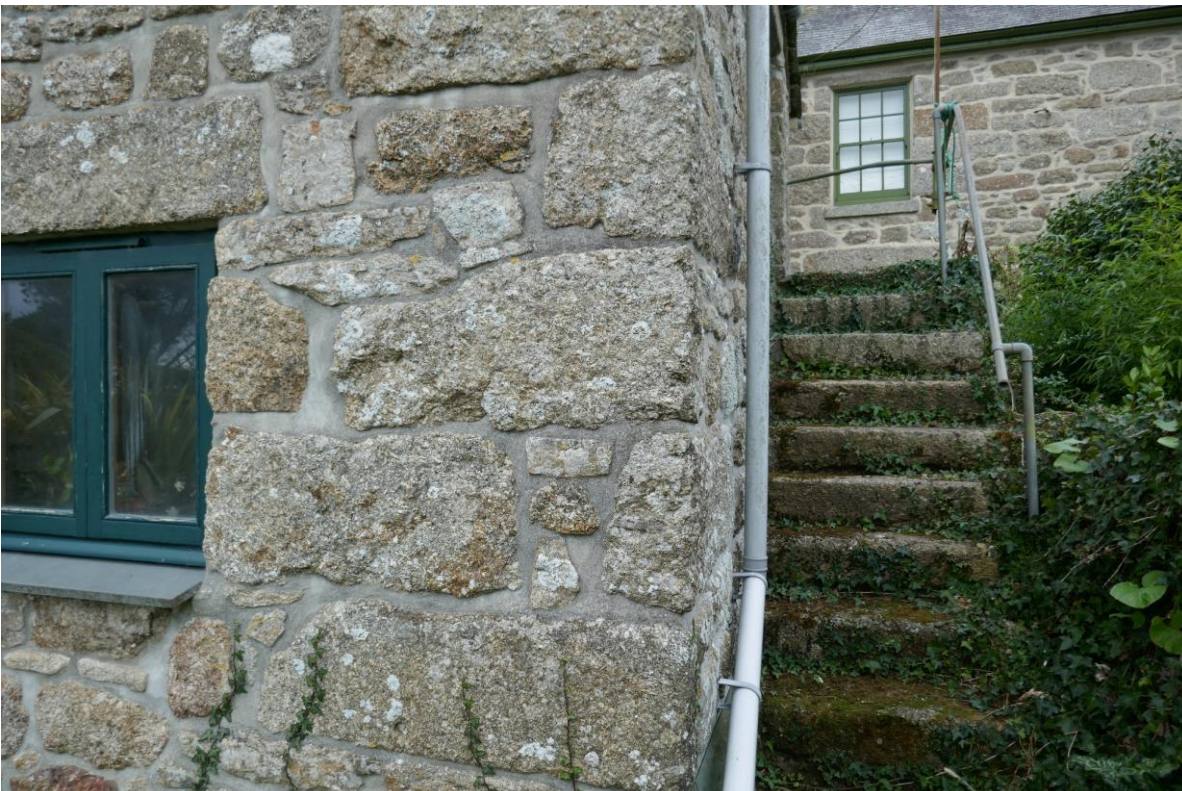
A flight of stone steps led up to the upper level on the north end of the building (Figure 3), which allowed close inspection of the wooden fascia there. Suitable gaps for roosting bats were present in places (Figure 4). At the front of the building the fascia was capped at the top and the gap was too large to allow use by bats; on the

Figure 3. Flight of stone steps on the north side of the granary.

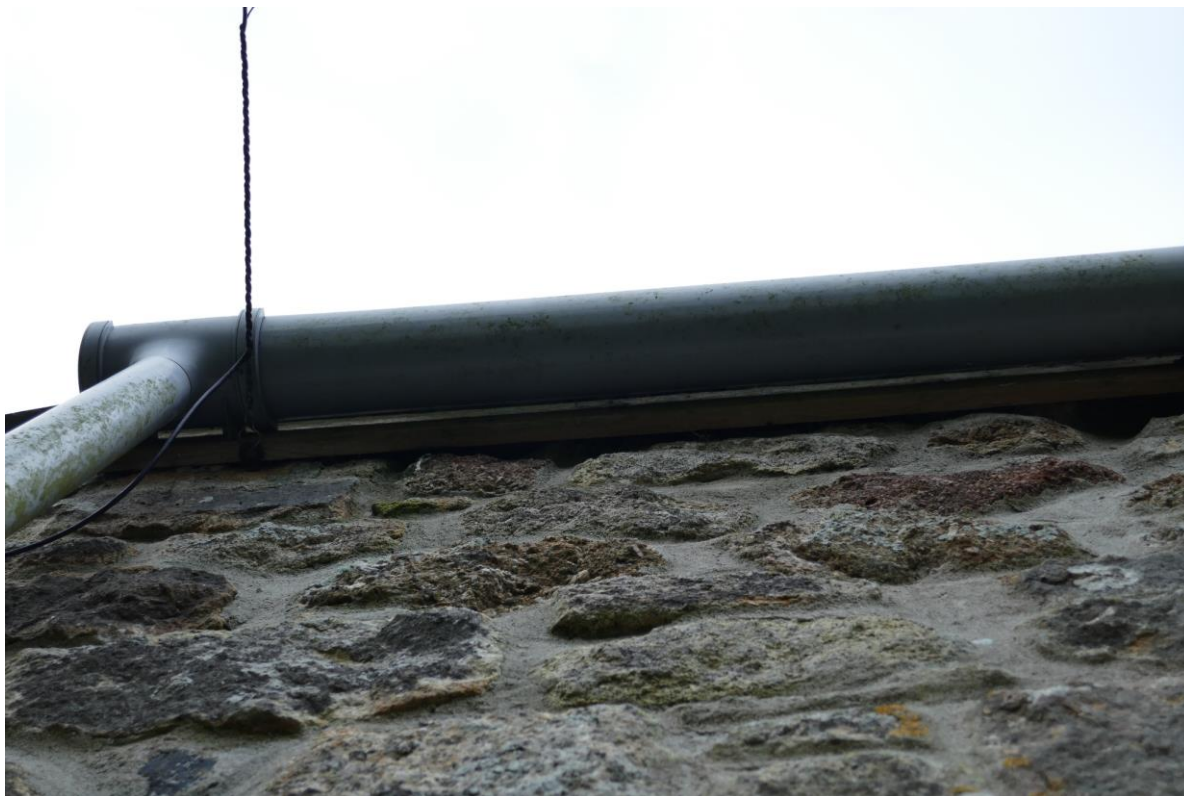
Figure 4. Gap behind fascia on north side of the granary, suitable for roosting bats.

The proposed plans have potential to impact upon features that may hold roosting bats. In keeping with the national bat survey guidelines (Collins, 2016) befitting a moderate potential roost site, two emergence surveys are recommended at the granary and the collapsed barn between May and September, at least one of which must be between May and August.

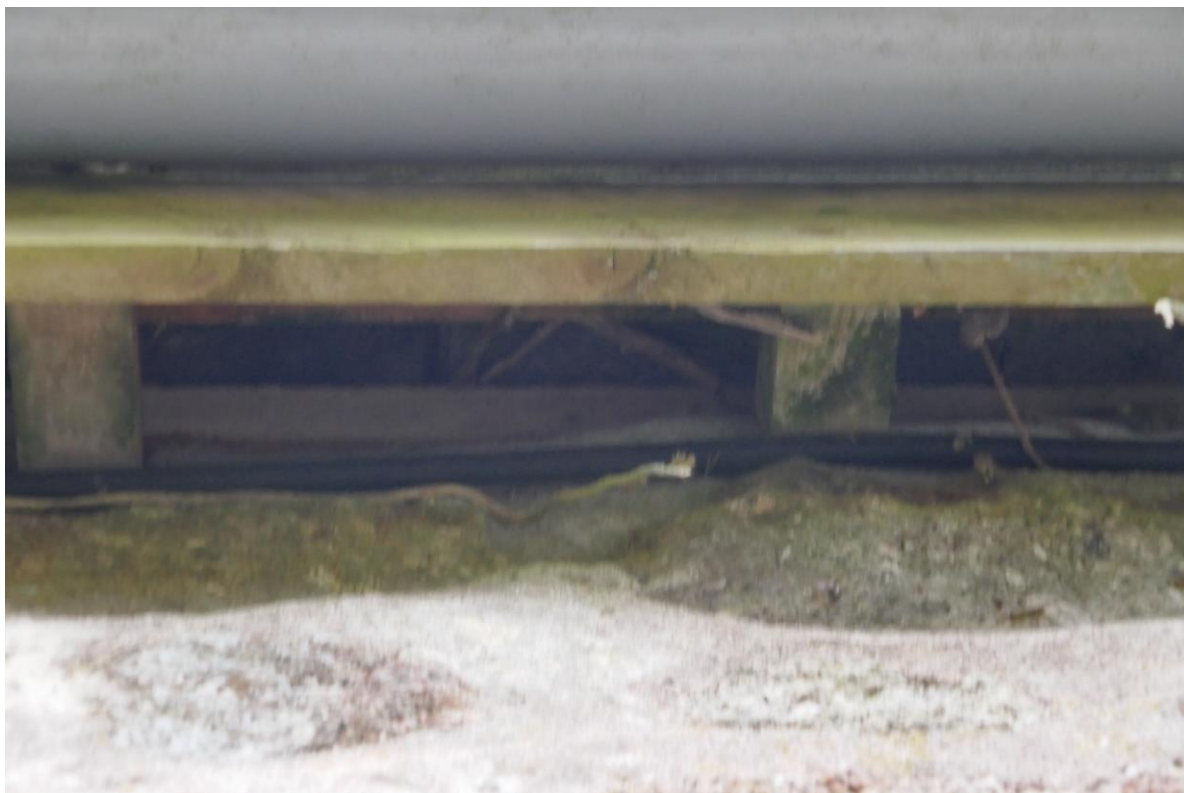
southern gable a large gap at the eaves led into the roof void of the building, offering potential for bats (Figure 5).

Figure 5. Open gap on the southern gable, leading into the roof void.

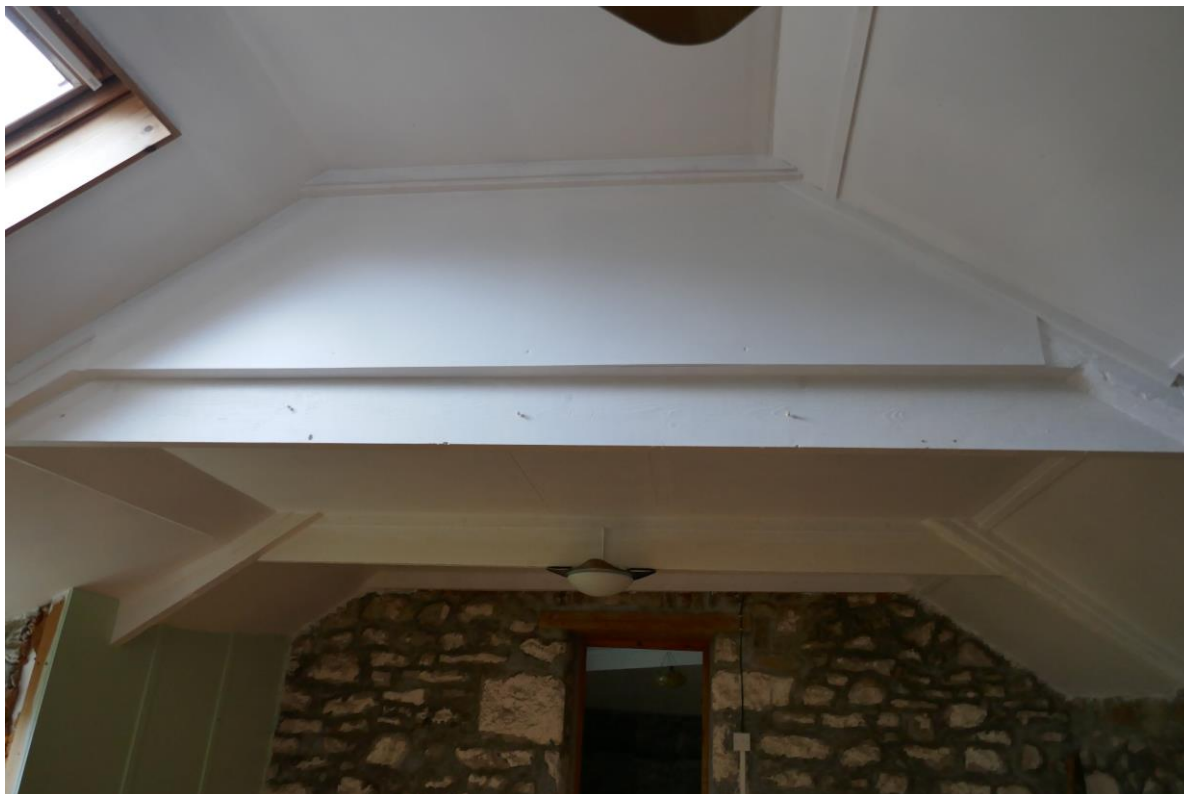
The hipped roof of the building was constructed of slate; occasional slates were missing, leaving suitable gaps; gaps were also present beneath ridge tiles in places. A single velux windows was present on the east side. Inside the building a boxed void was present on the upper floor but there was no access to this (Figure 6). On the ground floor a blocked fireplace was present.

Figure 6. Boxed void on the upper floor of the granary.

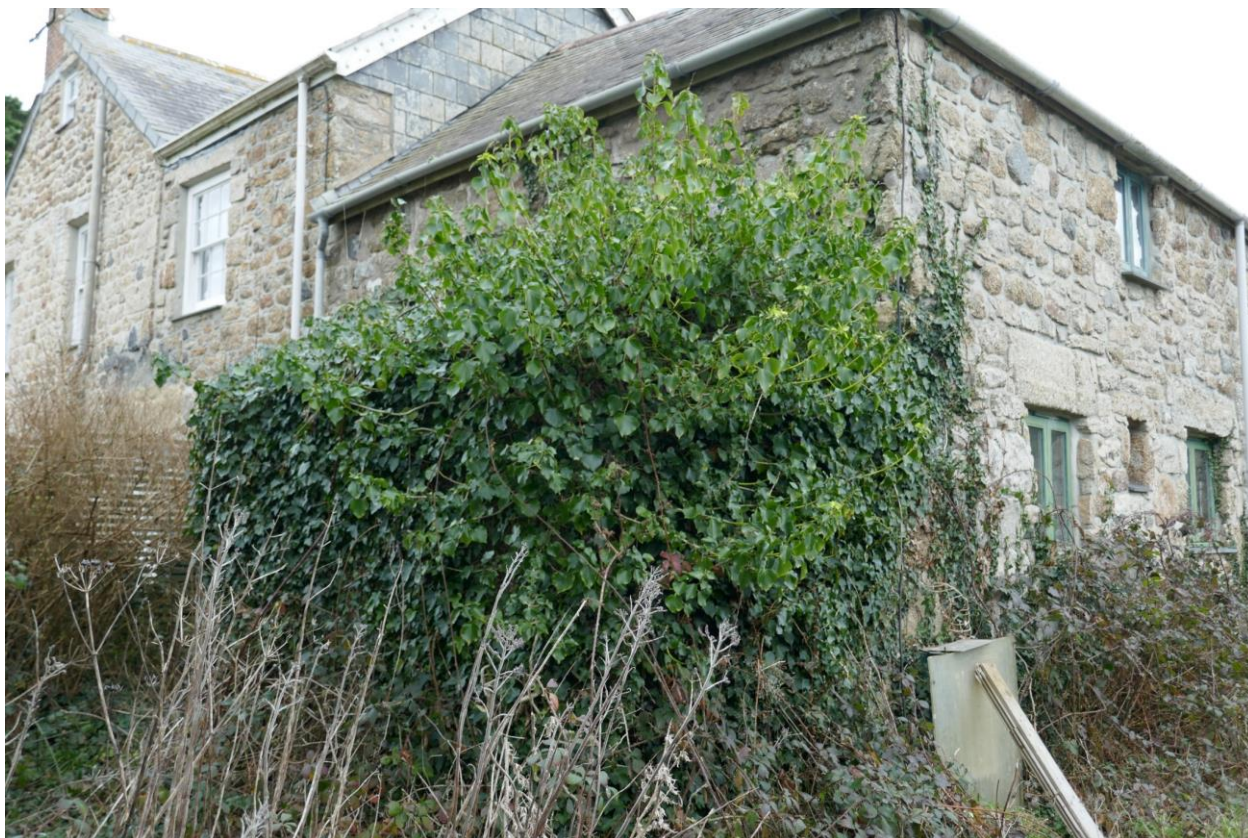
Figure 7. Ivy-covered lean-to on the south side of the granary.

Built on to the south side of the building there was a small lean-to, which was covered with a dense growth of ivy (Figure 7). The building was stone-built and cement rendered inside and out. No roof was present and the room was accessed from the west side via an open entrance (Figure 8); a recess was present above the entrance, on each side, which led to spaces within the wall (Figure 9).

A precautionary approach to nesting birds must be adopted during building works. Birds may nest between March and September inclusive and if any nests are found within 5m of the works then work in that area must cease until nesting has finished. It is very likely that birds will nest in the granary lean-to, the eaves of the granary and the holes present in the walls of this building, as well as in parts of the collapsed barn; the piggery also offers potential for nesting birds. The safest way to avoid risk is for work to be scheduled to take place outside the nesting season; if work needs to take place during the nesting season then it must be done with full confidence that no nesting birds are present, in consultation with the ecologist.

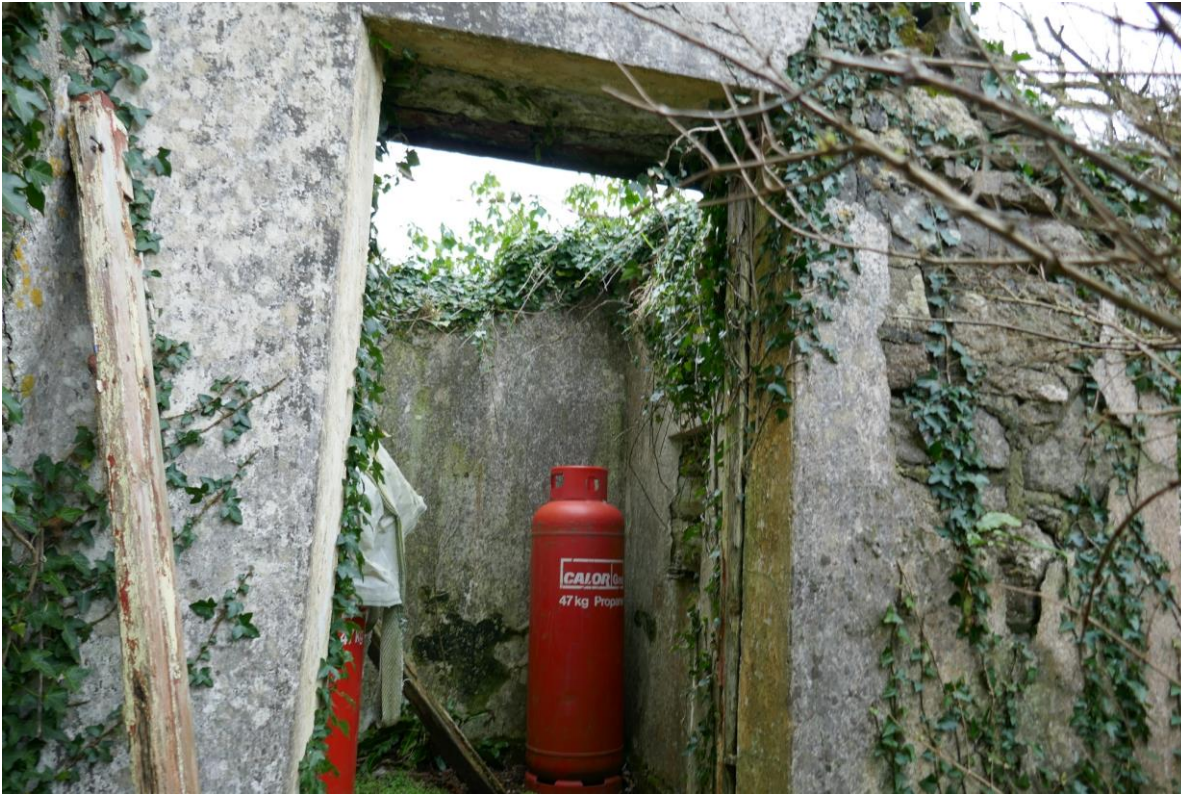
Figure 8. Entrance to the lean-to on the west side.

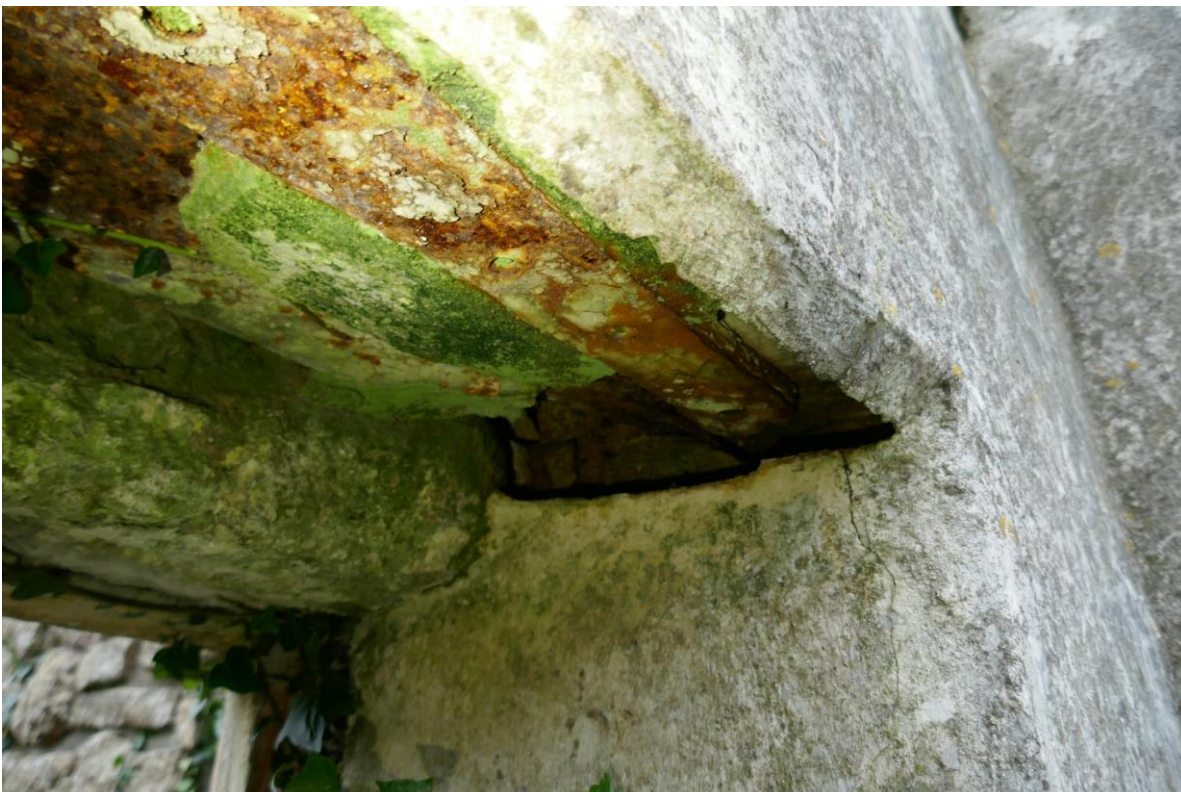
Figure 9. Recess leading into the stonework at the edge of the lean-to entrance.

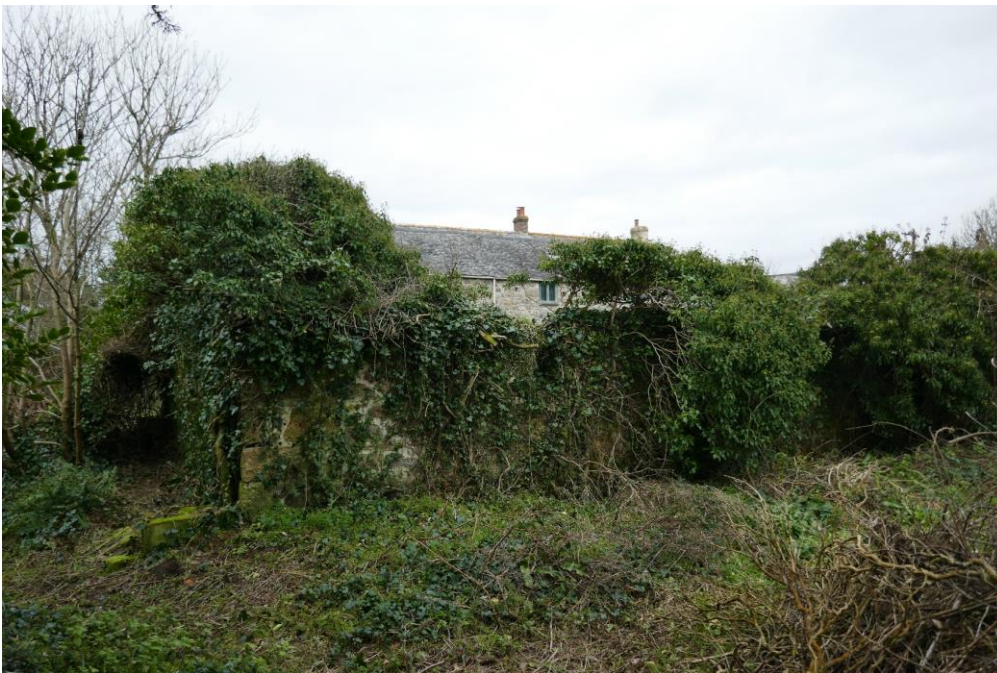
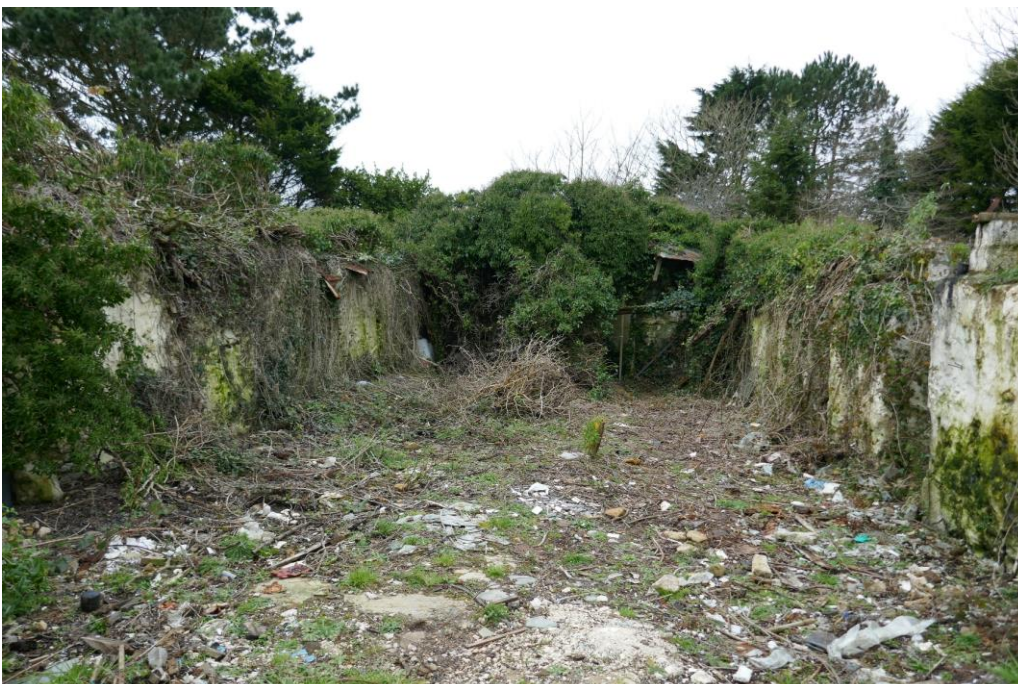
The remains of this single storey structure were located immediately to the east of the granary (Figures 10 & 11). It was stone built and the roof was missing with some stacked slates being the only evidence of this. The walls were largely intact but heavily covered with a growth of dense ivy, as well as some bramble and Buddleia; some gaps in the masonry were present in places, which held potential for roosting bats. The interior walls were covered with a lime render, which was in a poor state of repair. The remains of a tin roof were present at the back of the building, which provided a sheltered recess potentially attractive to nesting birds.

Figure 10. Eastern aspect of the collapsed barn, looking towards the granary.

Figure 11. Interior of collapsed barn.

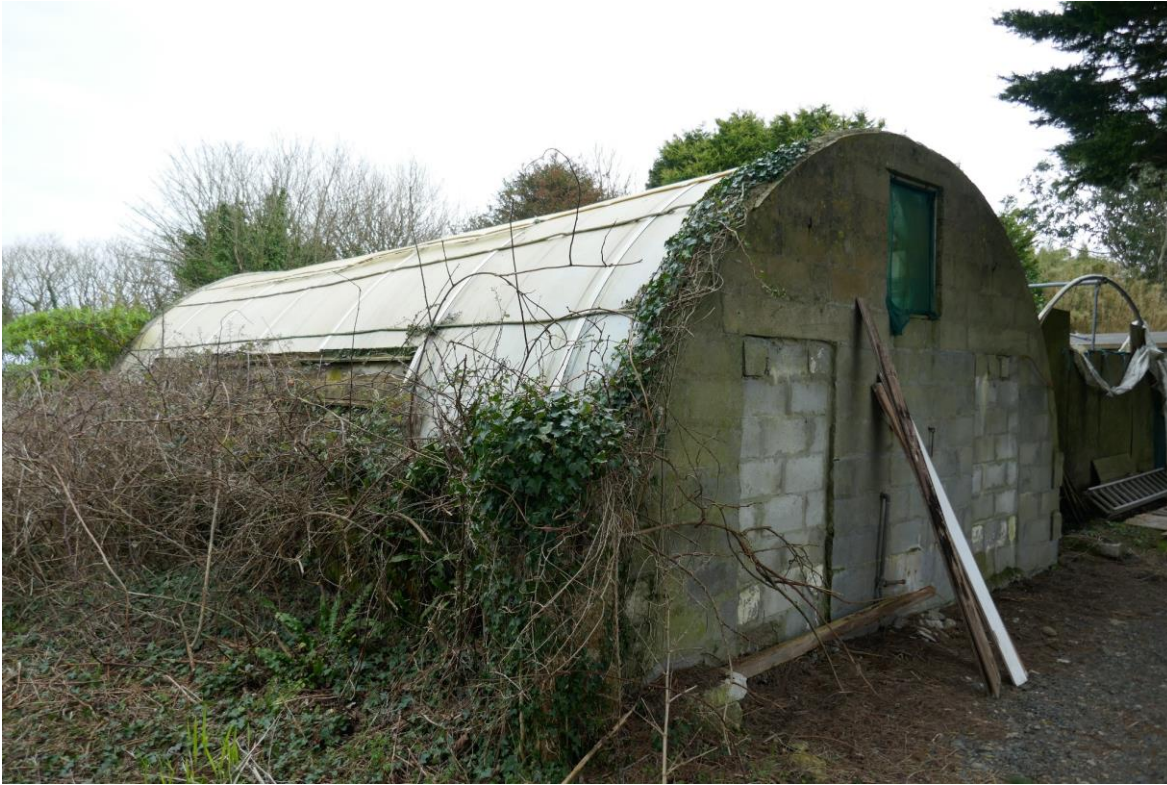
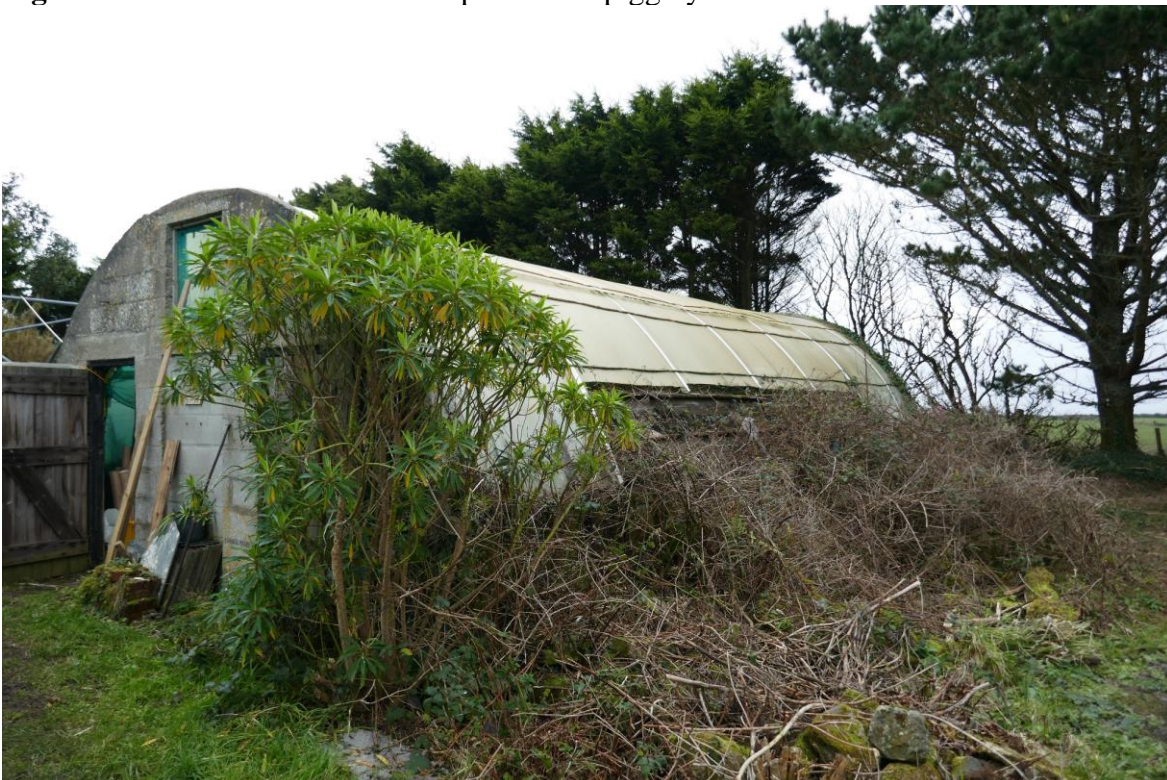
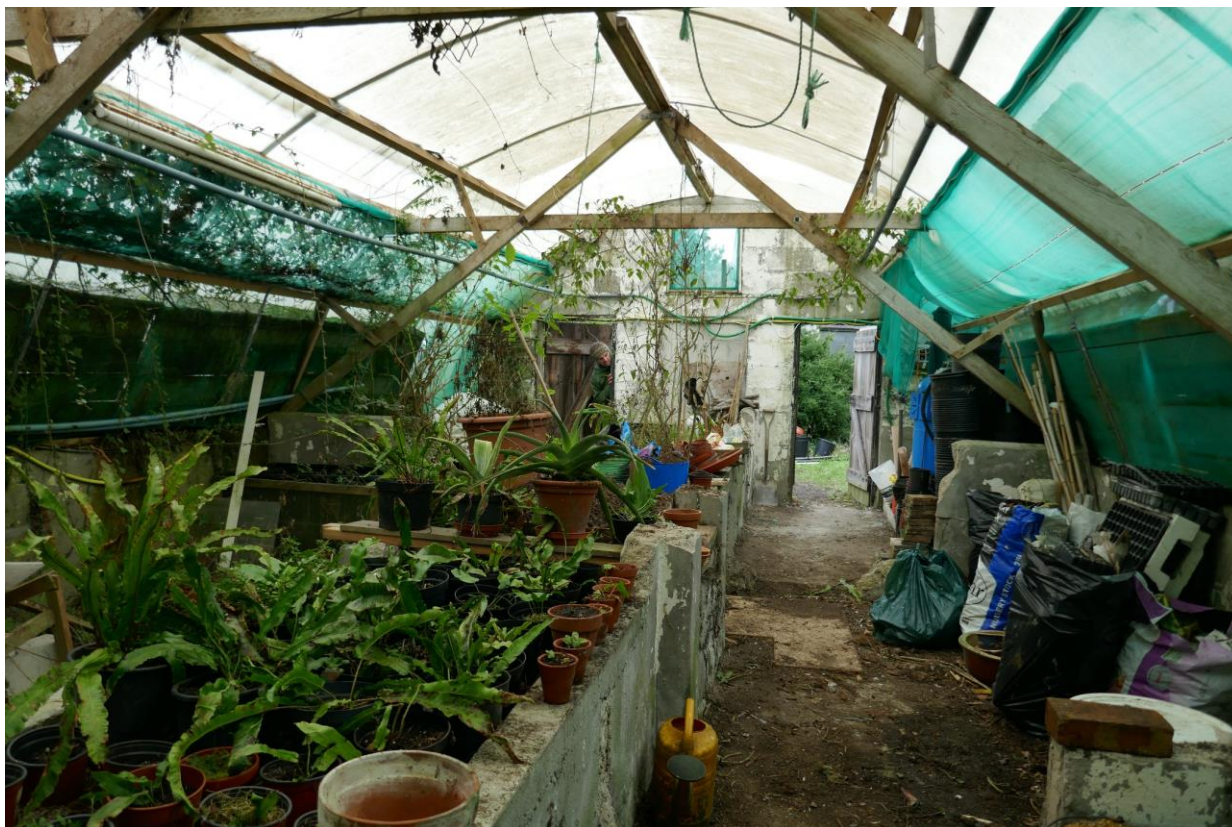
To the south of the collapsed barn was a domed structure known as the piggery, which was being used as a plant propagation area (Figures 12–14). The end walls and the lower part of the long sides were constructed of concrete block with the domed roof and some of the sides made of plastic sheeting (corex). It was accessed by two wooden doors at the northern end, which are kept closed. Soil and debris was present on the floor which may have made evidence of bats more difficult to see. Some gaps were present between the plastic sheets which made access by bats possible.

Figure 12. Southern and western aspect of the piggery.

Figure 13. Northern and eastern aspect of the piggery.

Figure 14. Interior of the piggery.

Although the piggery is of low potential for bats and would normally require a single emergence survey, there are no suitable features for day roosting bats and an emergence survey would be pointless. The building does offer potential for night roosting bats, however, and a period of remote monitoring of seven nights is recommended between May and August. No surveys of the polytunnel are necessary.

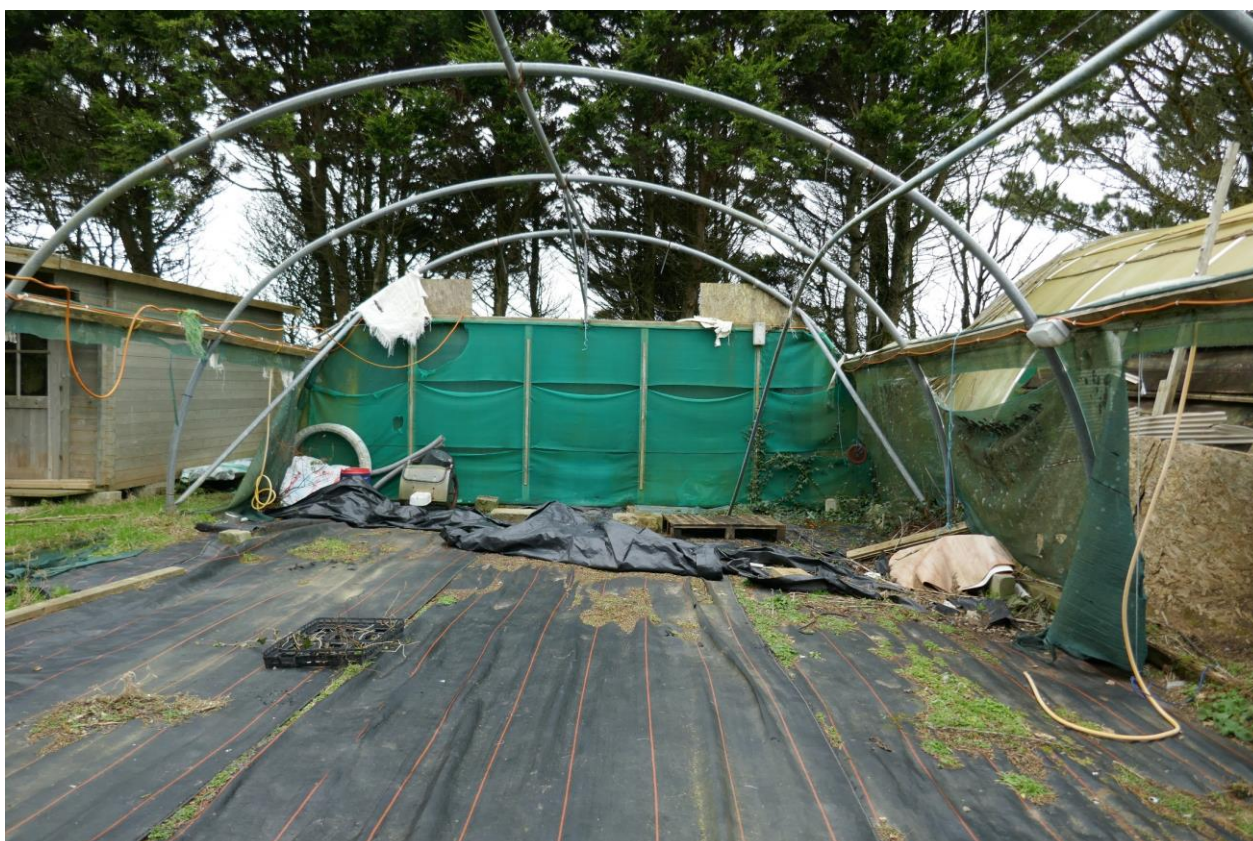
Adjacent to the piggery were the remains of a collapsed polytunnel, which consisted of the steel framework and a few hanging fragments of the netting that formed the original structure (Figure 15).

Figure 15. Remains of the polytunnel.

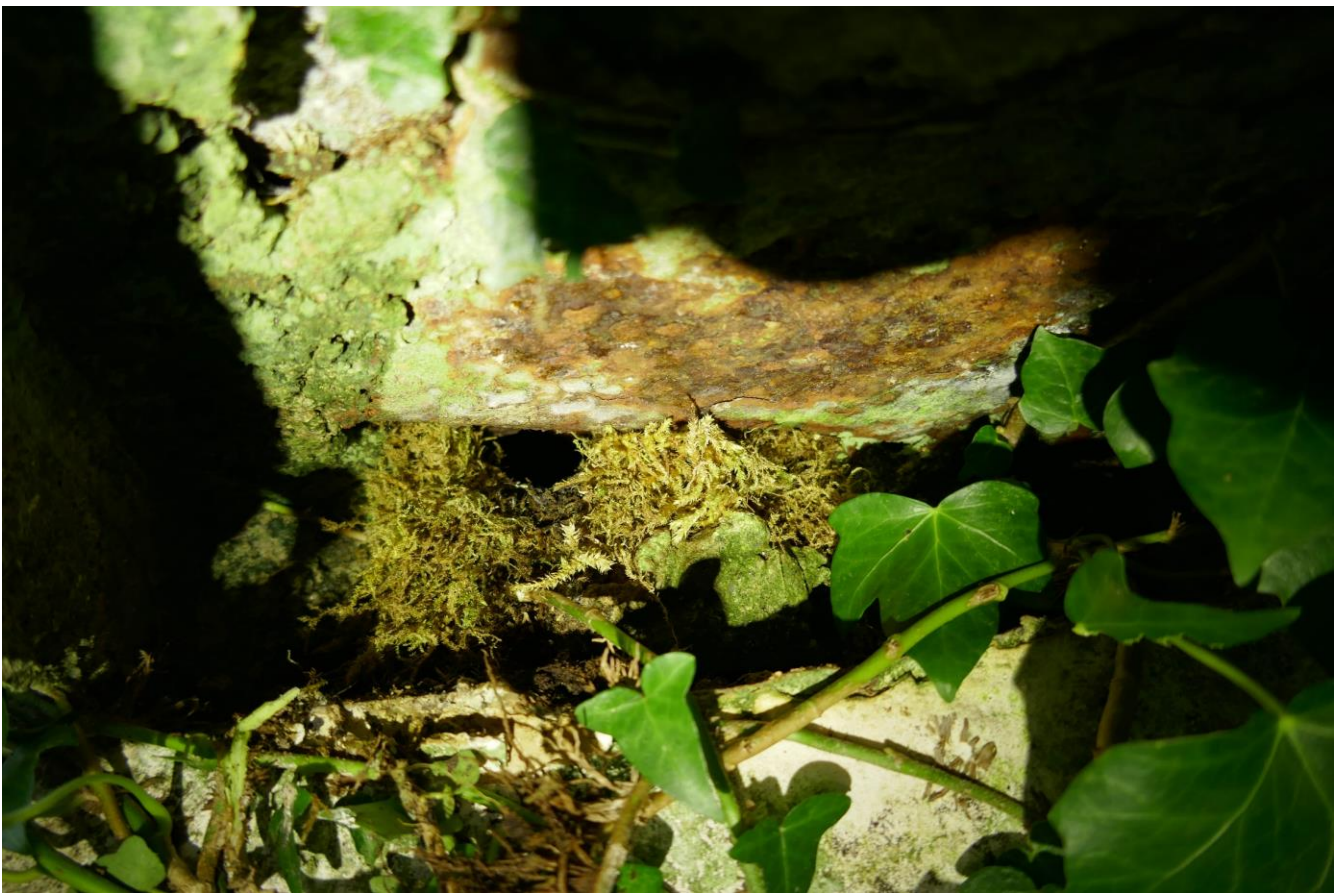
An old nest of a Wren *Troglodytes troglodytes* was present in one of the recesses above the door frame in the granary lean-to (see Figure 16).

Figure 16. Disused nest of Wren *Troglodytes troglodytes* in the door frame of the granary lean-to.
