Mark Tunmore was instructed by Christopher Morris in April 2023 to carry out a bat and nesting bird survey at a property known as Gwarackewenbyghan, located at Boskennal, St Buryan, Cornwall, TR19 6DF. The survey was requested in preparation for a planning application to carry out internal and external improvements on the granary building, to demolish the polytunnel and piggery and to construct living accommodation within the current footprint of a collapsed barn. This followed a visual assessment carried out on 11 February 2023, which identified the granary and collapsed barn as holding moderate potential for roosting bats and the piggery as holding low potential using the national survey guidelines (Collins, 2016). Under this guidance two emergence surveys of the granary and collapsed barn were recommended and a period of remote monitoring in the piggery. As no external features were present that could host roosting bats it was not necessary to carry out an emergence survey at the piggery. No further surveys were carried out on the polytunnel as it held negligible potential for roosting bats and is excluded from this report. This report summarises the results of the surveys and p

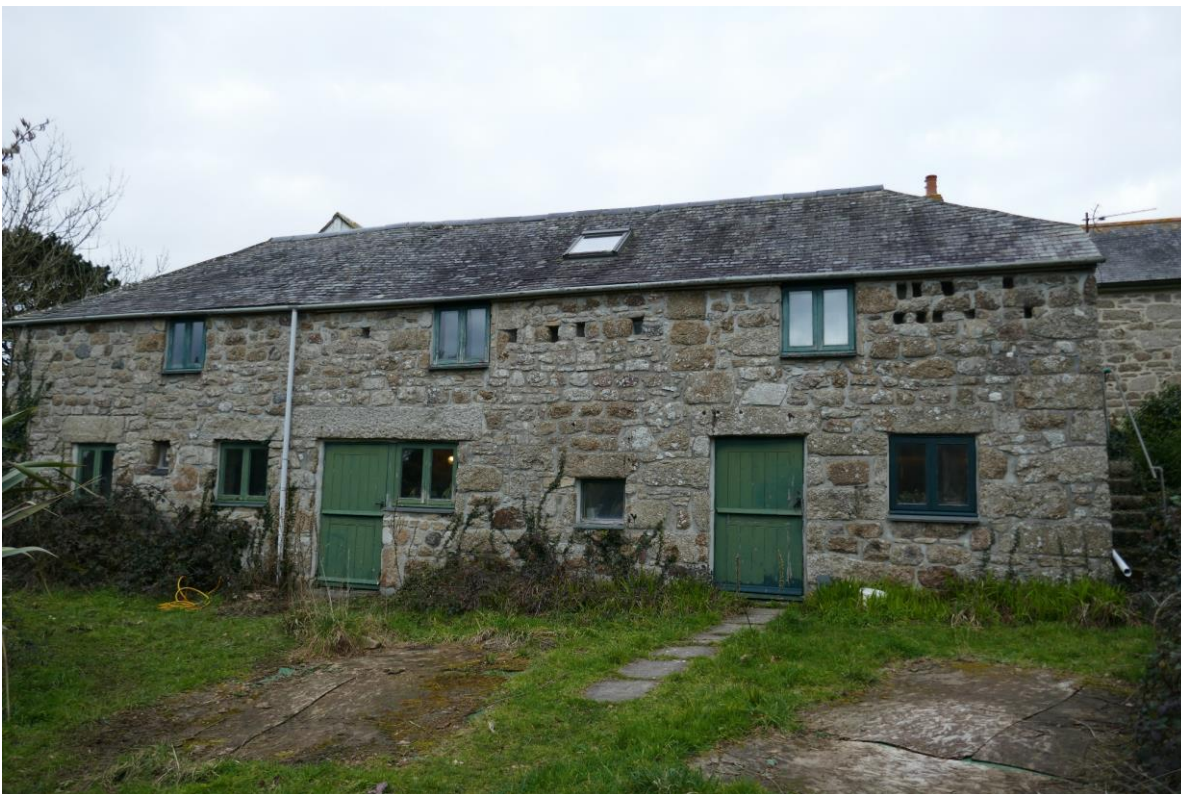
Figure 1. Eastern aspect of the granary.

This two-storey stone-built structure (Figure 1) was joined on to a dwelling on the west side of the building, which was not part of the landholding. The building is a Grade II listed building. The walls were tightly pointed and on the east side of the building two rows of square holes were present in two rows (Figure 2), totalling 14 in number. These were examined from a ladder and did not extend far enough down to support roosting bats due to sealing with cement (Figure 2); they did, however, have potential for nesting birds and the remains of a nest was found in one of them.

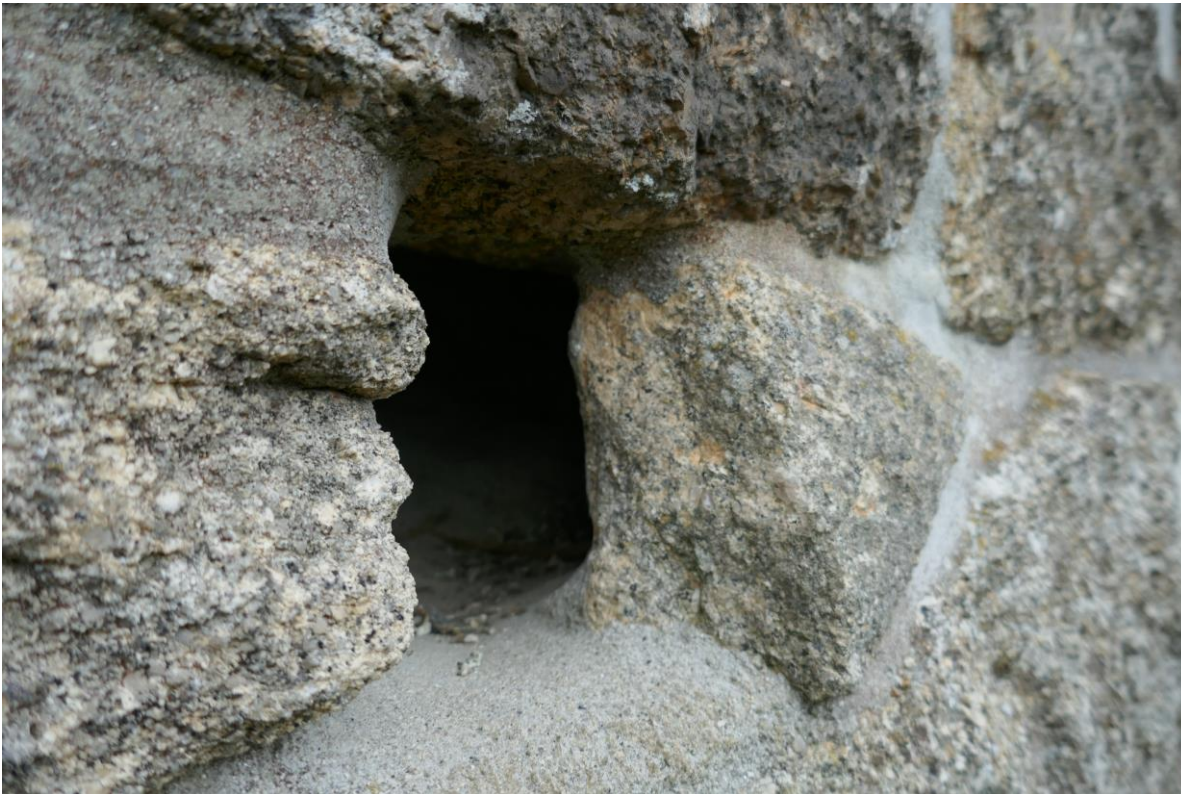
Figure 2. Close-up of one of the square holes in the eastern aspect of the building.

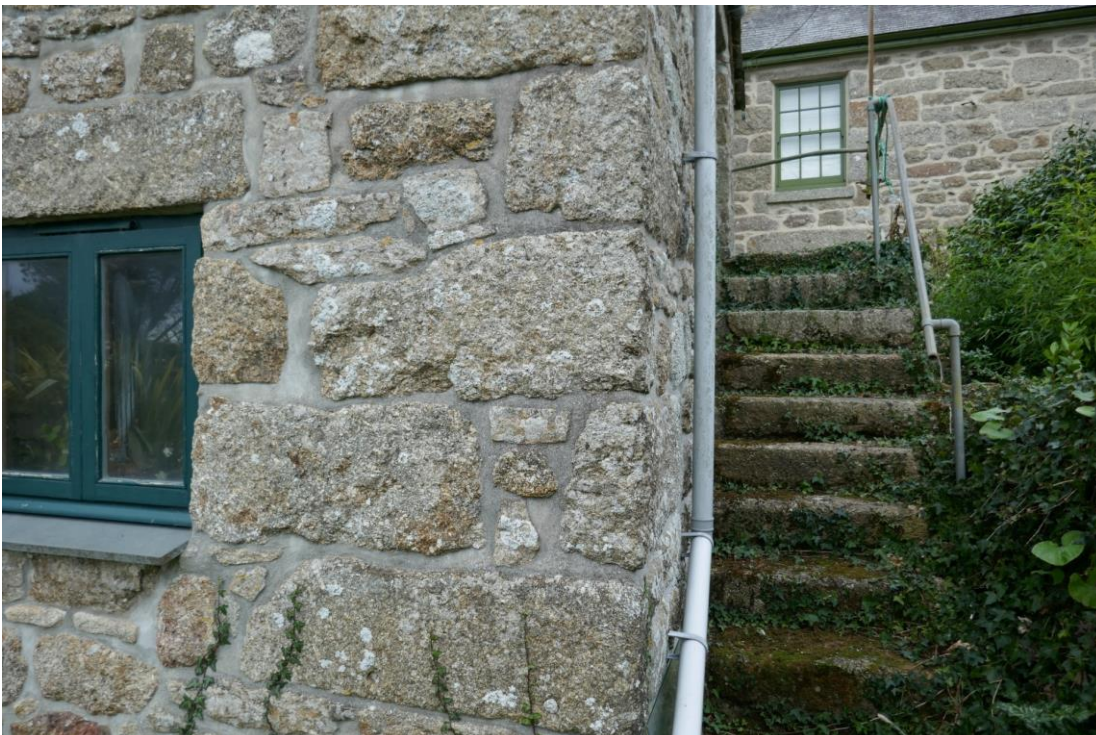
A flight of stone steps led up to the upper level on the north end of the building (Figure 3), which allowed close inspection of the wooden fascia there. Suitable gaps for roosting bats were present in places (Figure 4). At the front of the building the fascia was capped at the top and the gap was too large to allow use by bats; on the southern gable a large gap at the eaves led into the roof void of the building, offering potential for bats (Figure 5).

Figure 3. Flight of stone steps on the north side of the granary.

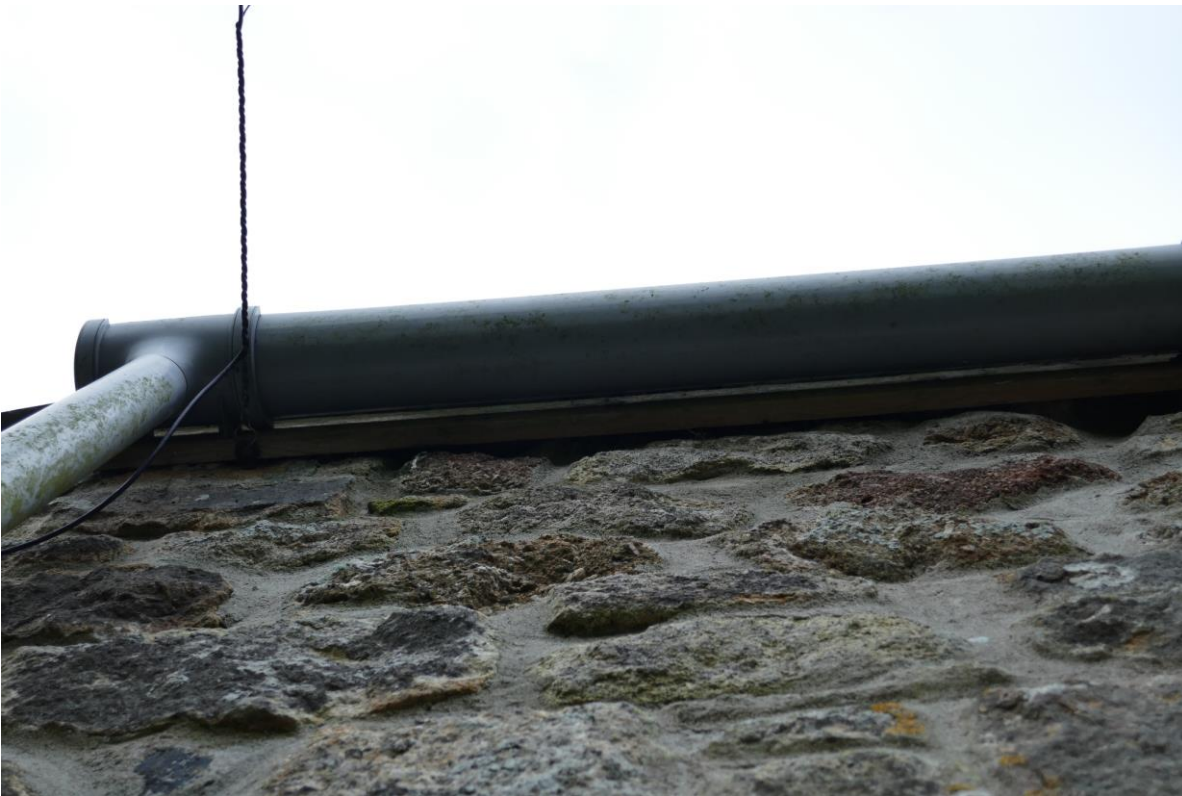
Figure 4. Gap behind fascia on north side of the granary, suitable for roosting bats.

- The granary roof will be soft stripped by hand in the presence of a licensed bat ecologist with roof tiles and fascias removed with care and checked for bats underneath. Any other features identified by the ecologist as holding potential for roosting bats will also be removed under a watching brief. This would include the stud walls and ceiling within the granary as it is possible that the bat roost is located in this area.

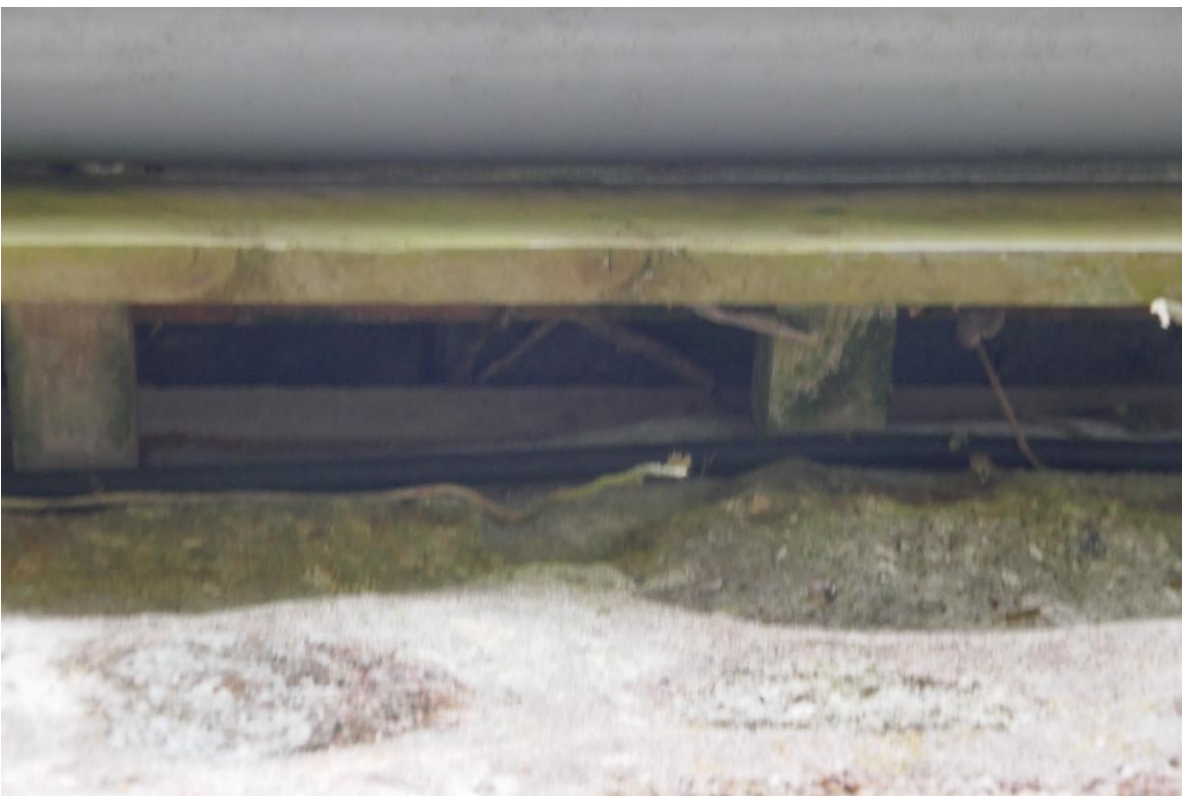
Figure 5. Open gap on the southern gable, leading into the roof void.

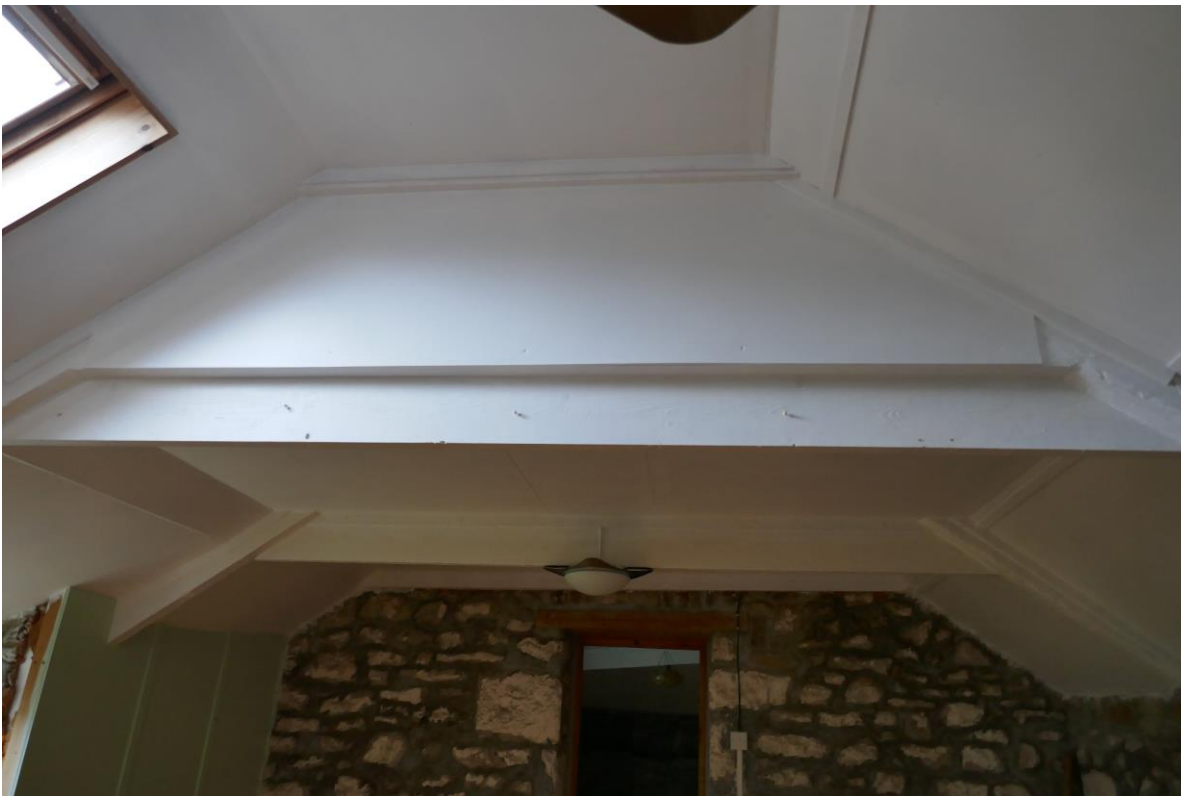
The hipped roof of the building was constructed of slate; occasional slates were missing, leaving suitable gaps; gaps were also present beneath ridge tiles in places. A single Velux window was present on the east side. Inside the building a boxed void was present on the upper floor but there was no access to this (Figure 6). On the ground floor a blocked fireplace was present.

Figure 6. Boxed void on the upper floor of the granary.

Due to the structure of the ceiling in the granary there was no access to the enclosed roof void and it is not known if evidence of bats was present there. In the piggery, presence of soil and debris on the ground made searching for bat evidence difficult and the presence of just a few droppings could have been overlooked.

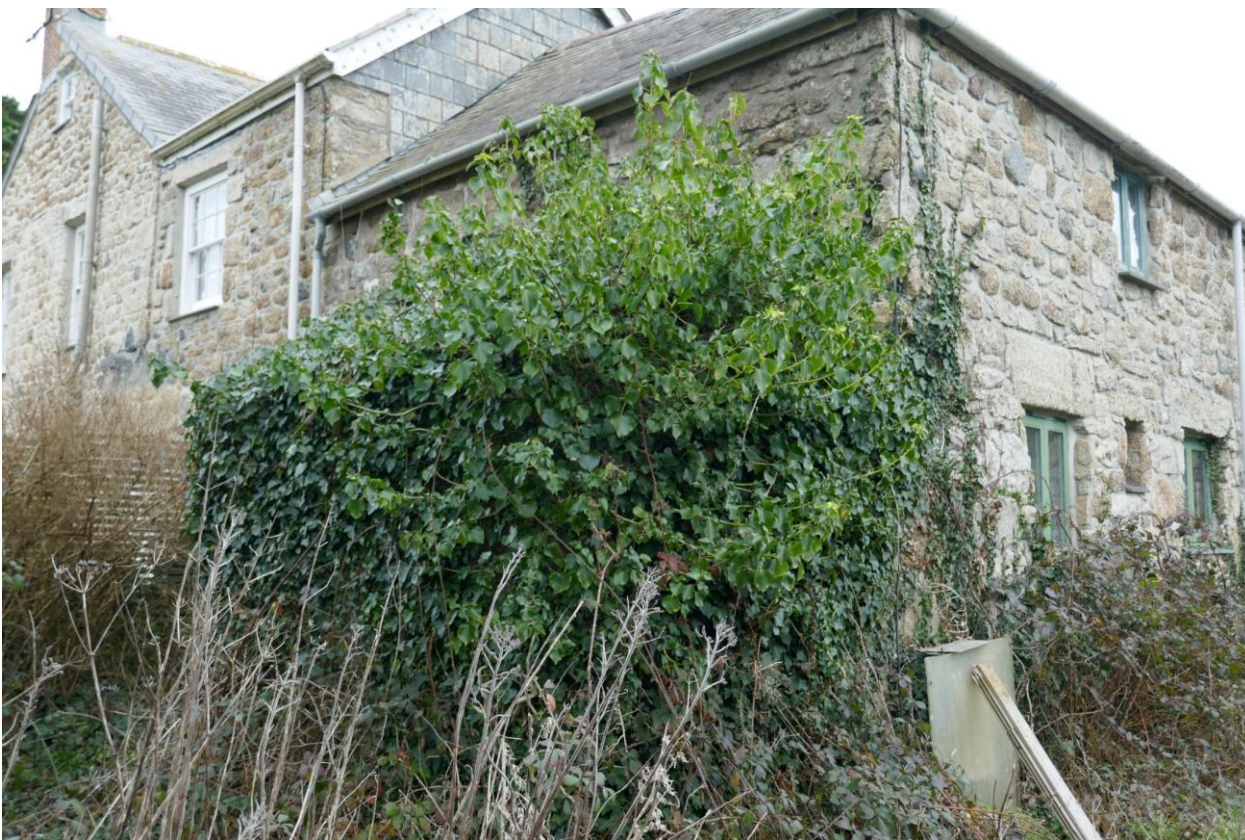
Figure 7. Ivy-covered lean-to on the south side of the granary.

Built on to the south side of the building there was a small lean-to, which was covered with a dense growth of ivy (Figure 7). The building was stone-built and cement rendered inside and out. No roof was present and the room was accessed from the west side via an open entrance (Figure 8); a recess was present above the entrance, on each side, which led to spaces within the wall (Figure 9).

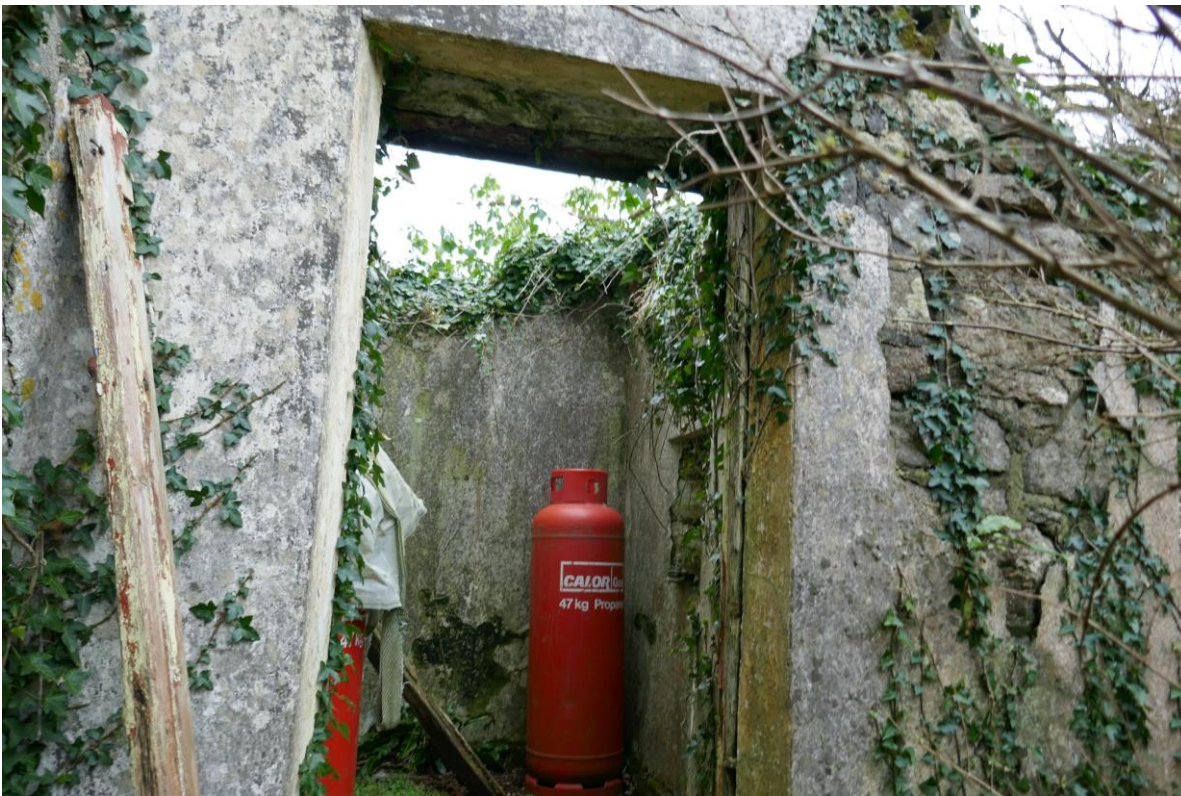
Figure 8. Entrance to the lean-to on the west side.

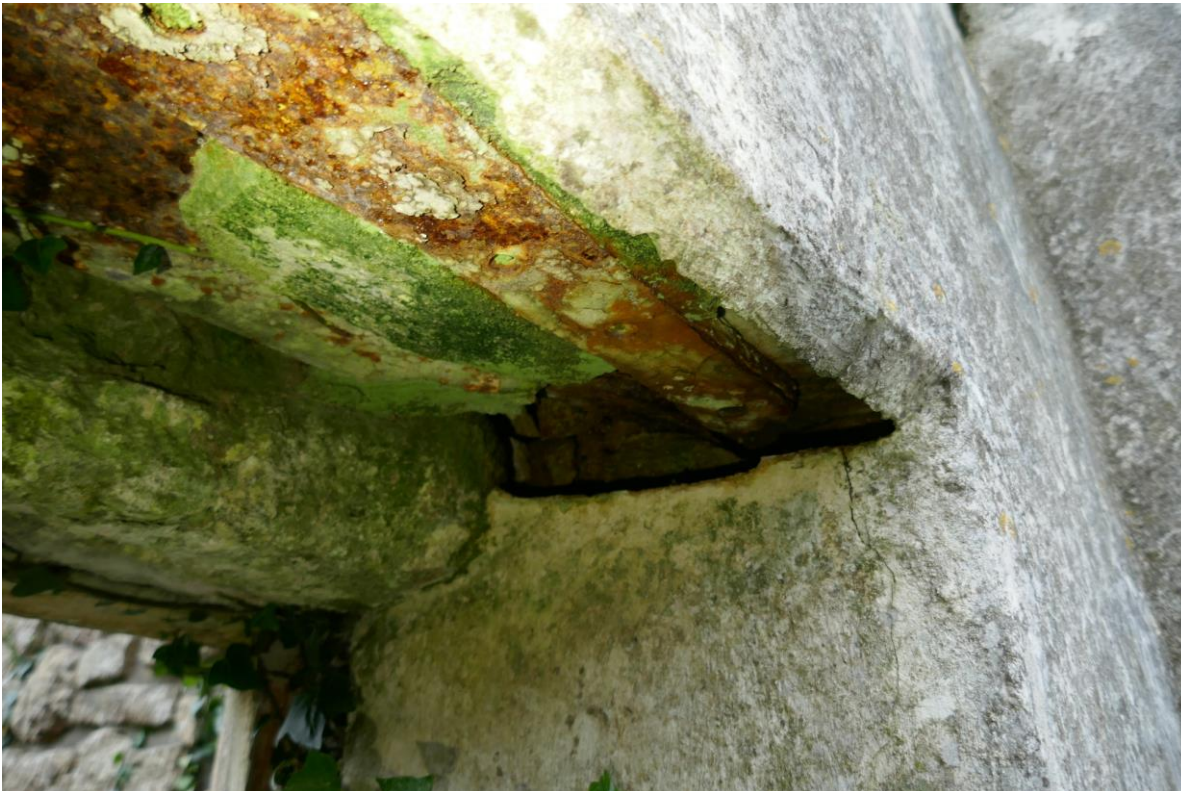
Figure 9. Recess leading into the stonework at the edge of the lean-to entrance.

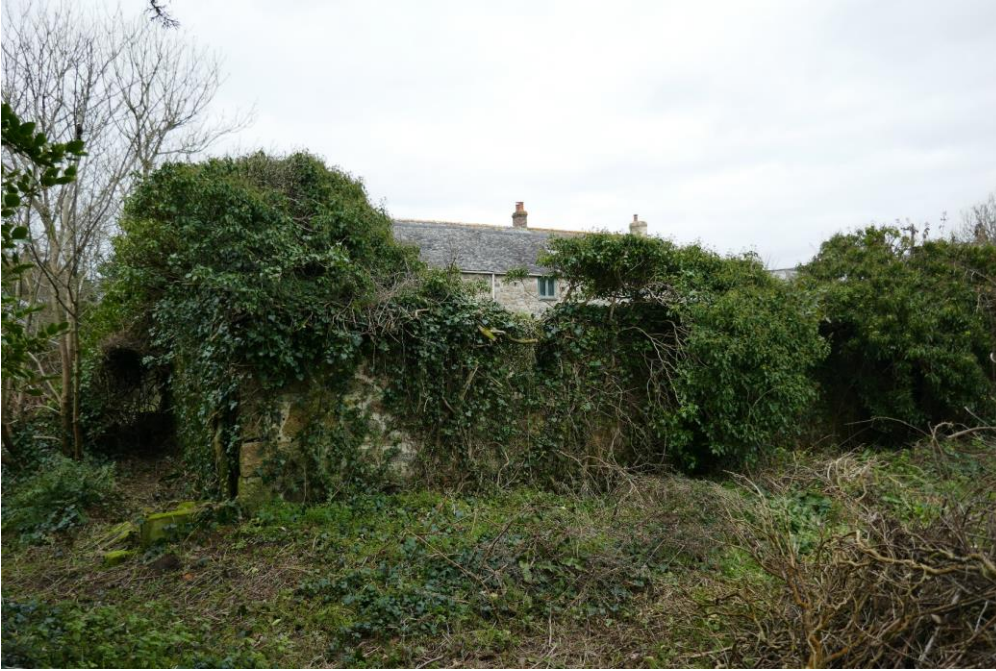
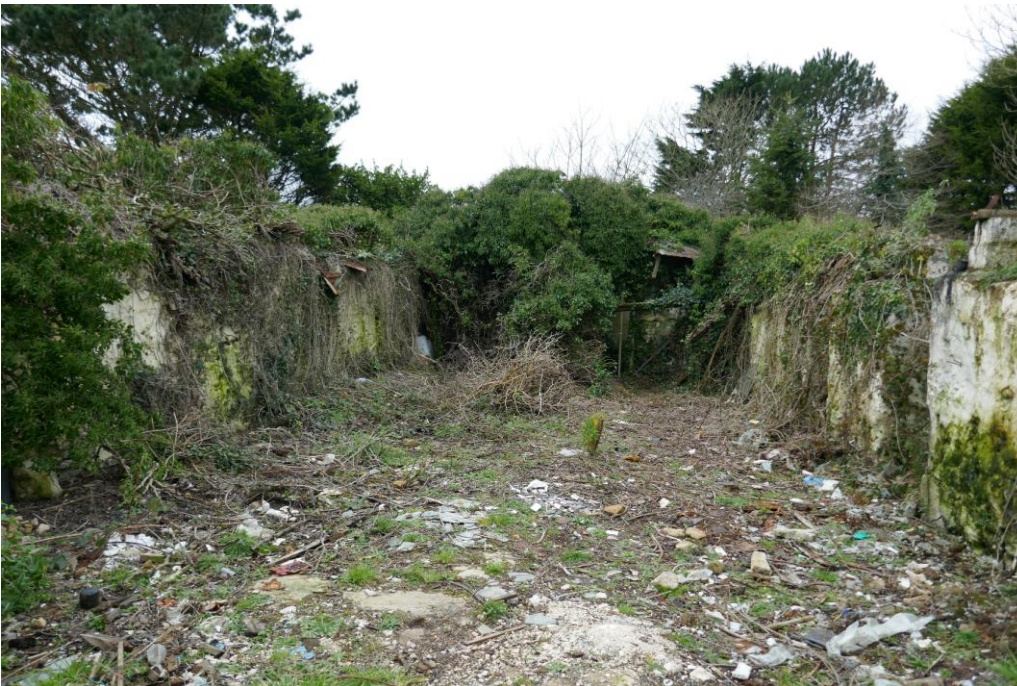
The remains of this single storey structure were located immediately to the east of the granary (Figures 10 & 11). It was stone built and the roof was missing with some stacked slates being the only evidence of this. The walls were largely intact but heavily covered with a growth of dense ivy, as well as some bramble and Buddleia; some gaps in the masonry were present in places, which held potential for roosting bats. The interior walls were covered with a lime render, which was in a poor state of repair. The remains of a tin roof were present at the back of the building, which provided a sheltered recess potentially attractive to nesting birds.

Figure 10. Eastern aspect of the collapsed barn, looking towards the granary.

Figure 11. Interior of collapsed barn.

- The collapsed barn and the piggery were not shown to be used by roosting bats so would not form part of the licence application and it is possible to work on these structures at other times of the year. Both buildings, and especially the collapsed barn, have high potential for nesting birds, however, and the dense ivy must be removed from the collapsed barn in October to February to reduce the risk of nesting birds being present when work begins. The piggery should also be demolished within that period.

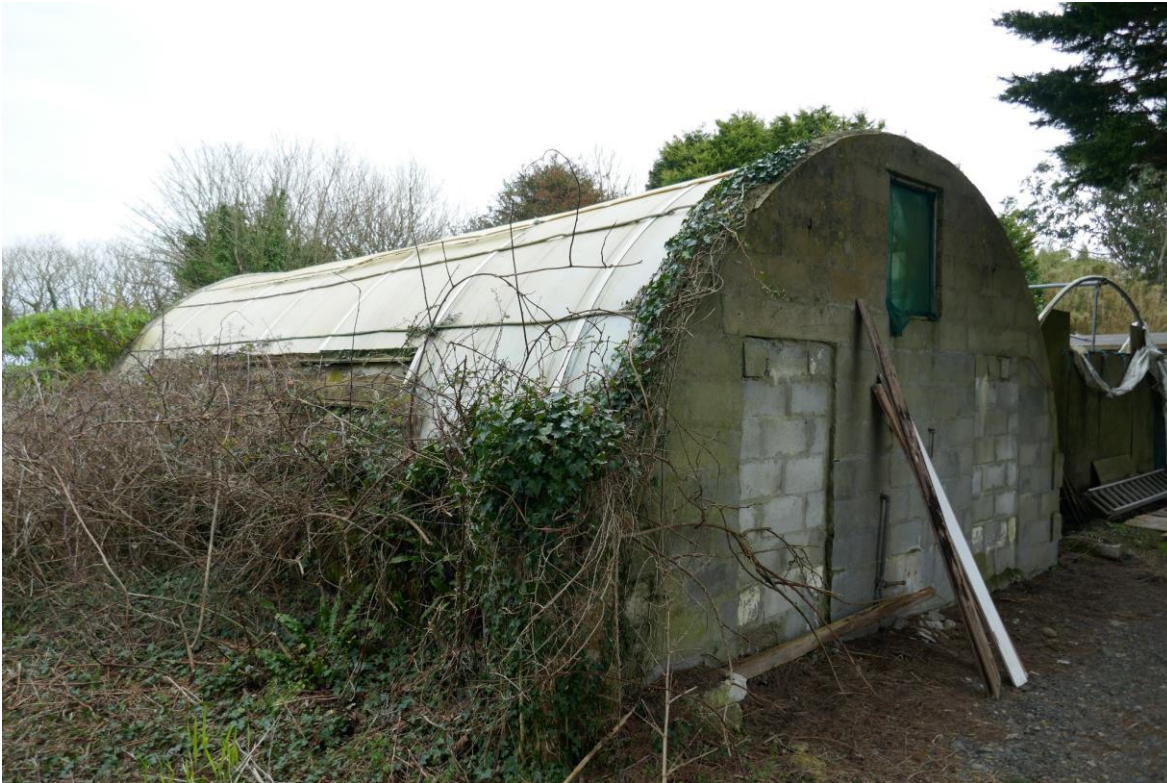
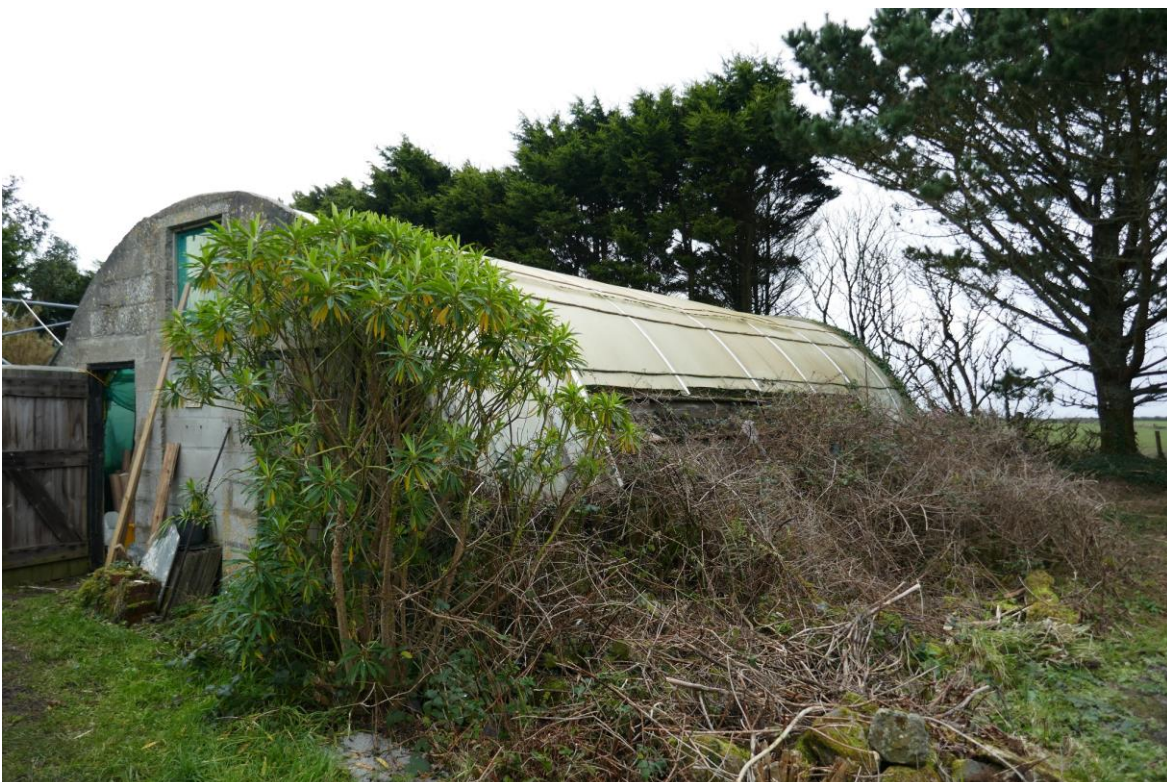
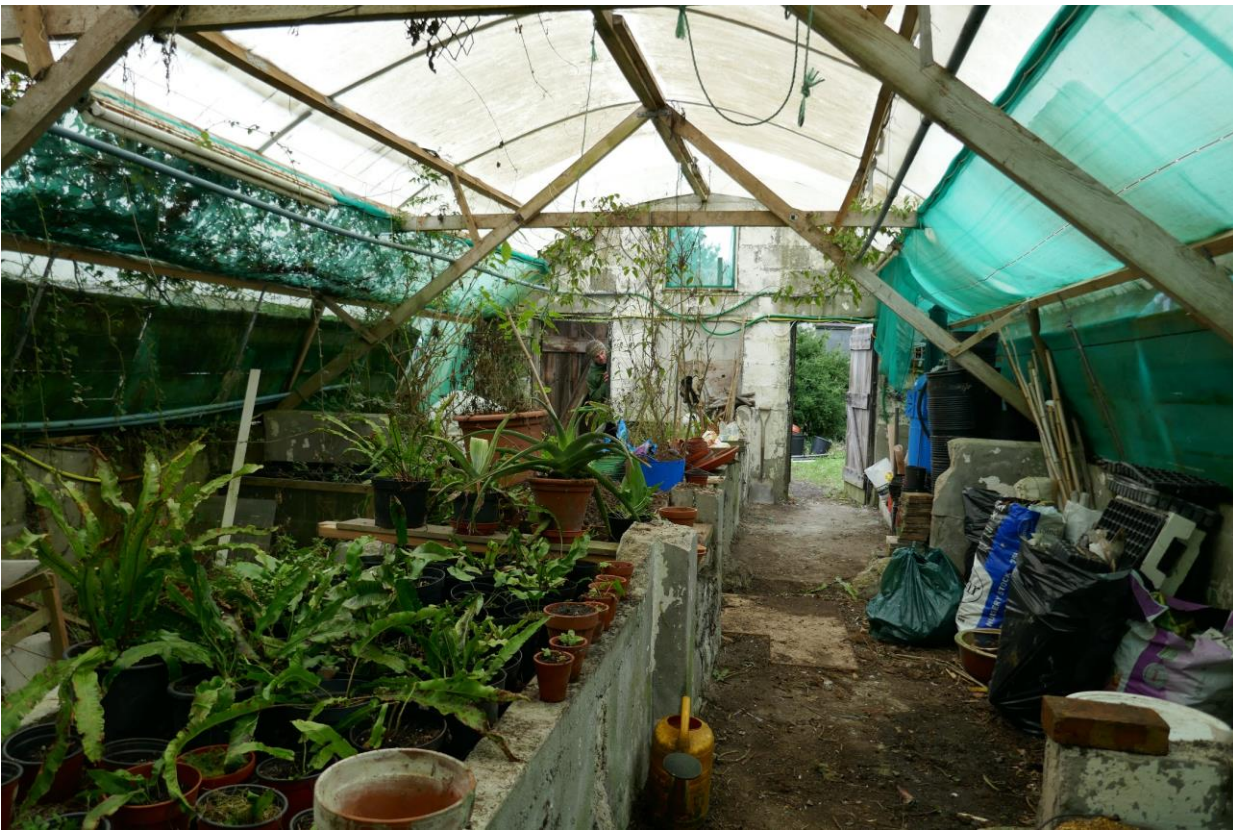
To the south of the collapsed barn was a domed structure known as the piggery, which was being used as a plant propagation area (Figures 12–14). The end walls and the lower part of the long sides were constructed

of concrete block with the domed roof and some of the sides made of plastic sheeting (Corex). It was accessed by two wooden doors at the northern end, which are kept closed. Soil and debris was present on the floor which may have made evidence of bats more difficult to see. Some gaps were present between the plastic sheets which made access by bats possible.

Figure 12. Southern and western aspect of the piggery.

Figure 13. Northern and eastern aspect of the piggery.

Figure 14. Interior of the piggery.

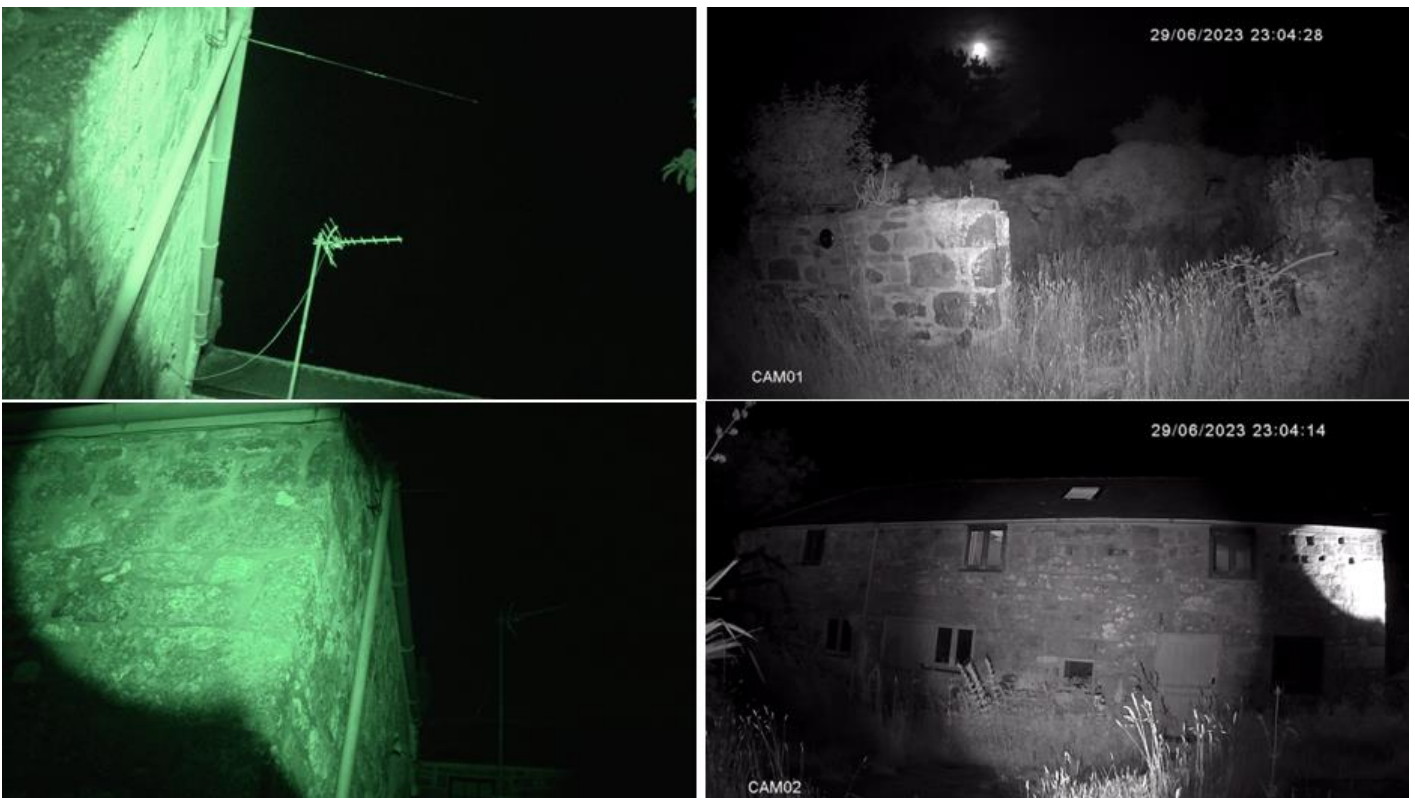
Figure 3. Infrared illumination. **Top left:** IR Surveyor, Granary northern aspect, 11 May 2023. **Top right:** Surveyor 2, Collapsed barn, 29 June 2023. **Bottom left:** IR Surveyor, Granary northern aspect, 29 June 2023. **Bottom right:** Surveyor 2, Granary eastern aspect, 29 June 2023.

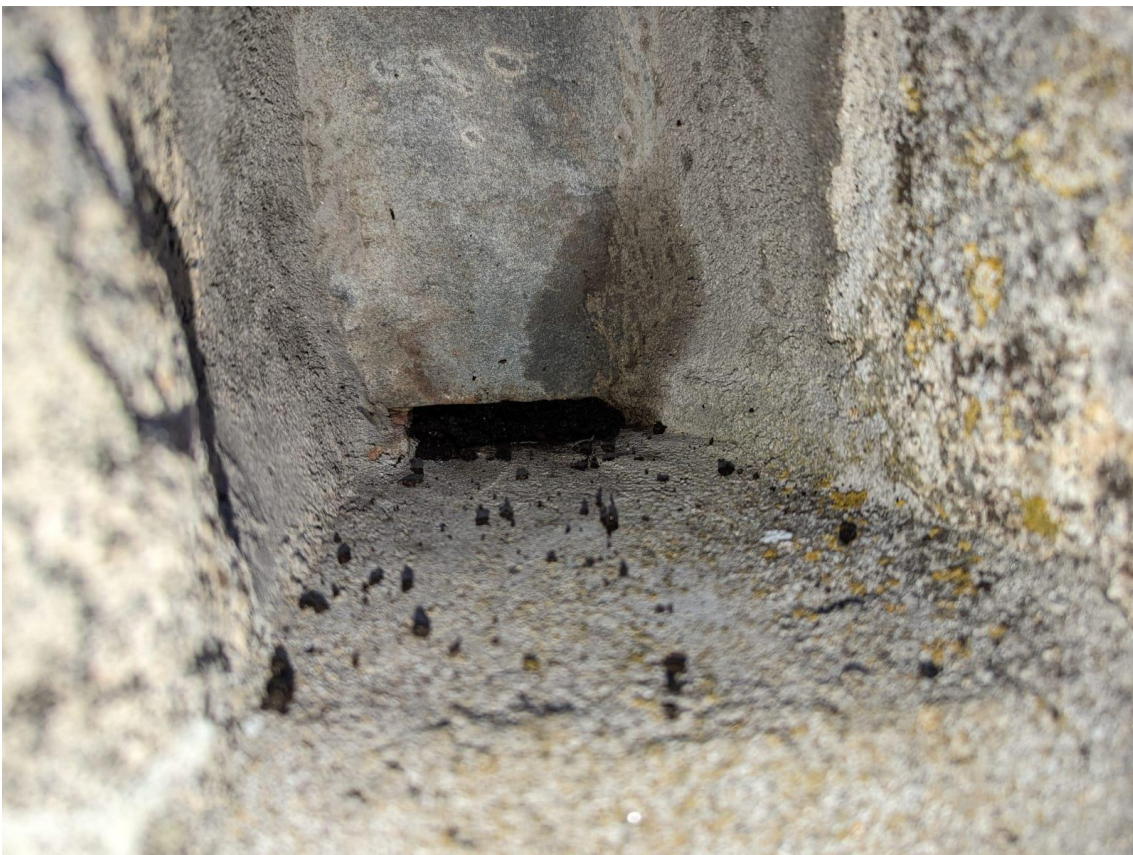
No evidence of bats was found but it was not possible to access the roof void of the granary to check there. On the second emergence survey on 29 June bats were seen to emerge from one of the square alcoves in the wall on the eastern aspect of the granary. This was examined from a ladder the next day and a large quantity of bat droppings were evident at the back of the alcove, where a slit approximately 2cm high led into a space behind it (Figure 17). A sample of droppings was taken for DNA analysis.

Figure 17. Bat droppings at the back of the alcove.

- Before a licence application can take place a further emergence survey will take place before the end of September. It will also be necessary to confirm the identity of the bat species by DNA analysis of the droppings as *Myotis* bats are notoriously difficult to identify from call parameters. However, Natterer's Bat is one of the more distinctive species and the call parameters are a close match for the species so there is reasonable confidence in the identification.

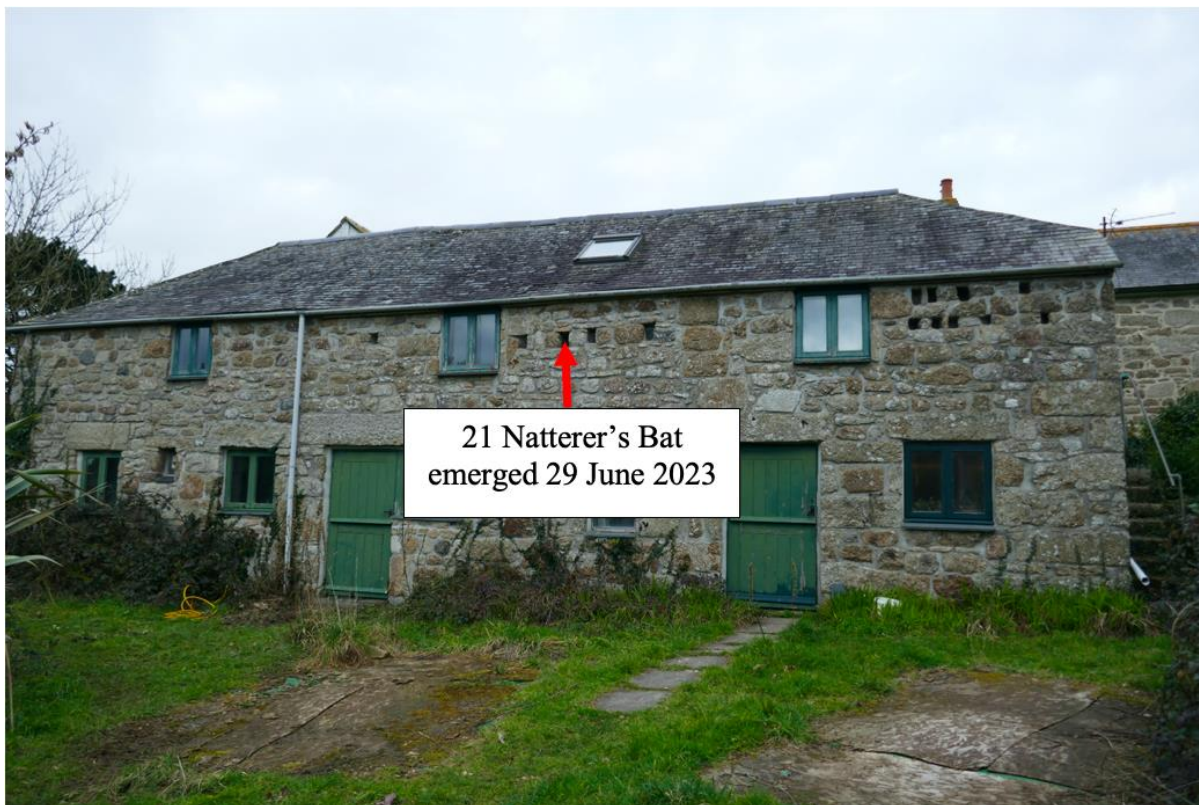
During the second emergence survey on 29 June, 21 **Natterer's Bat** *Myotis nattereri* emerged from one of the square alcoves in the wall on the eastern aspect of the granary between 22.10 and 22.50 B.S.T. (see Figure 18). The Natterer's bats were seen to be using a flight route that took them south along the front of the granary to a darkened corner of the garden; several individuals were also spotted returning to roost during the survey. This behaviour and the apparent absence of bats on the previous survey is indicative of a maternity (breeding) roost being present.

Figure 18. Natterer's Bat emergence location at the granary.

The surveys have demonstrated the presence of a maternity roost of Natterer's Bat within a space behind the southern wall of the granary, which is being accessed by a narrow slit at the back of a square alcove.

- **The exact location of the current roost will be further investigated and it will be retained in situ with the final architectural plans to include retention of the roost area and access point.** No artificial lighting will be included in the plans which will impact upon the roost area or the bats' flight line to the access point.
