**REMEDICATION AND ENABLING WORKS
VALIDATION REPORT**

**Land to the rear of Suncroft,
Warkworth,
Northumberland,
NE65 0PX**

**Report Ref: 22-1214-VAL
Date Issued: July 2023**

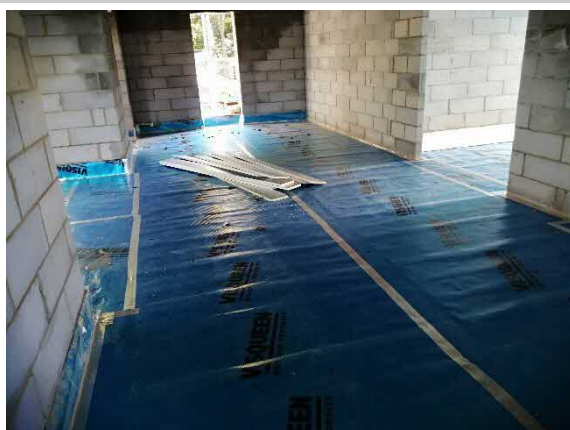
General overviews of membrane at Plot 2 following internal placement. No materials were stored on the membrane which had the potential to cause damage.
