GROUND GAS PROTECTION MEASURES VALIDATION REPORT

**Land to the rear of Suncroft,
Warkworth,
Northumberland**

**Report Ref: 22-1214-GVAL1
Date Issued: February 2023**

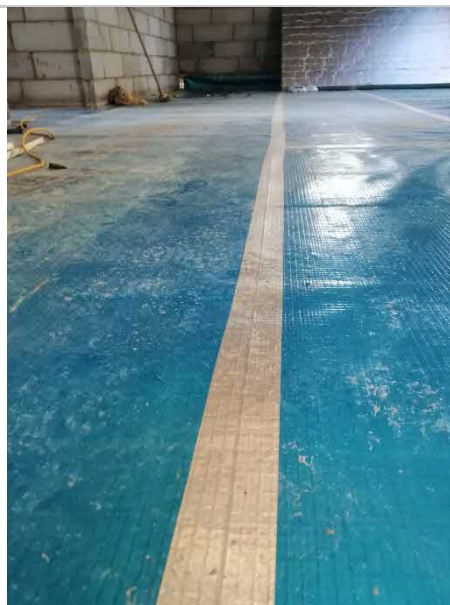
General overviews of membrane at Plot 1 following internal placement. No materials were stored on the membrane which had the potential to cause damage.

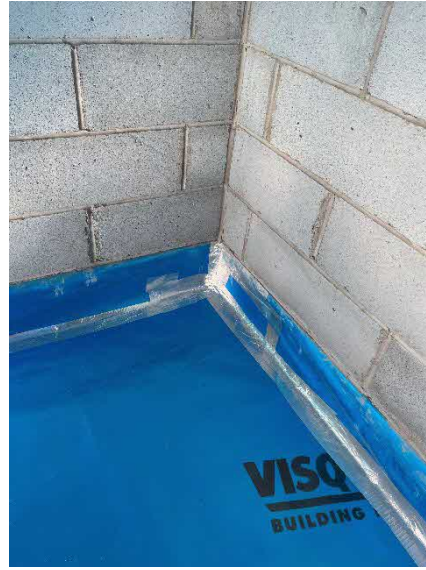
General condition of membrane of corner units and joints within the garage plot.

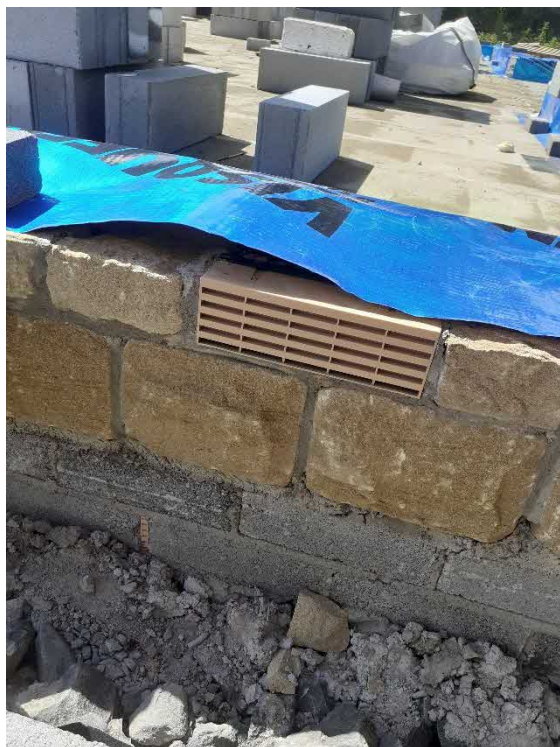
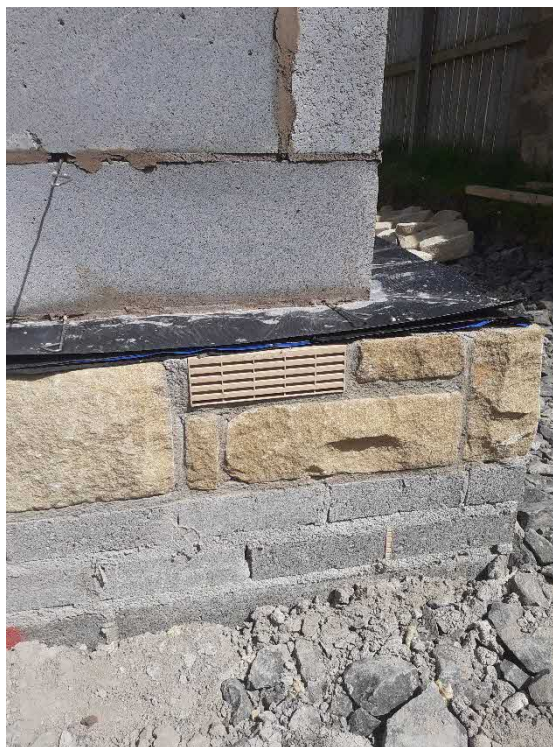
Periscopic ventilation bricks shown to be free of obstructions in Plots 1-2.

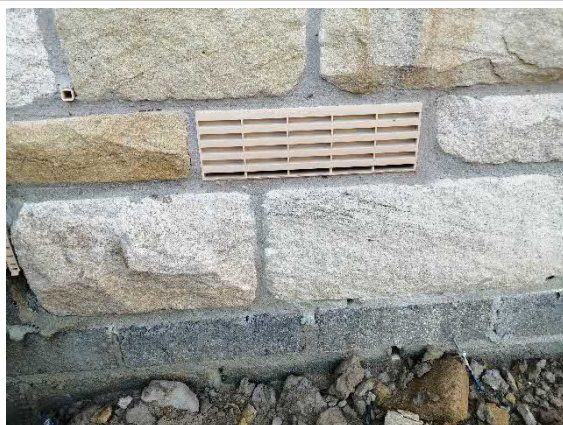
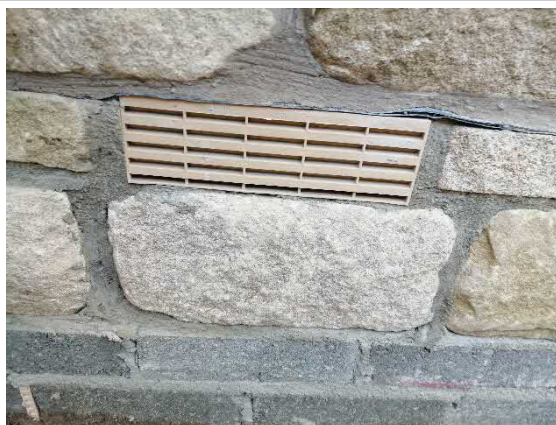
Periscopic ventilation bricks shown to be free of obstructions in Plot 1.

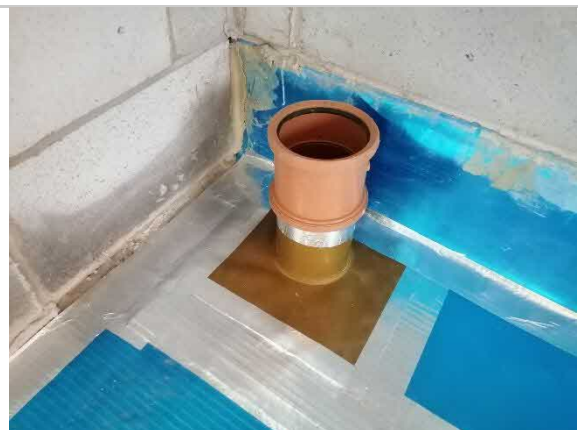
Membrane sealed around service entries within Plot 2. ERGO can confirm these service entries were adequately sealed.
