Suncroft House & Garden Station Road, Warkworth Environmental Study

Draft 13 June 2013

Date: 13 June 2013
Ref: Issue 12023/amd2

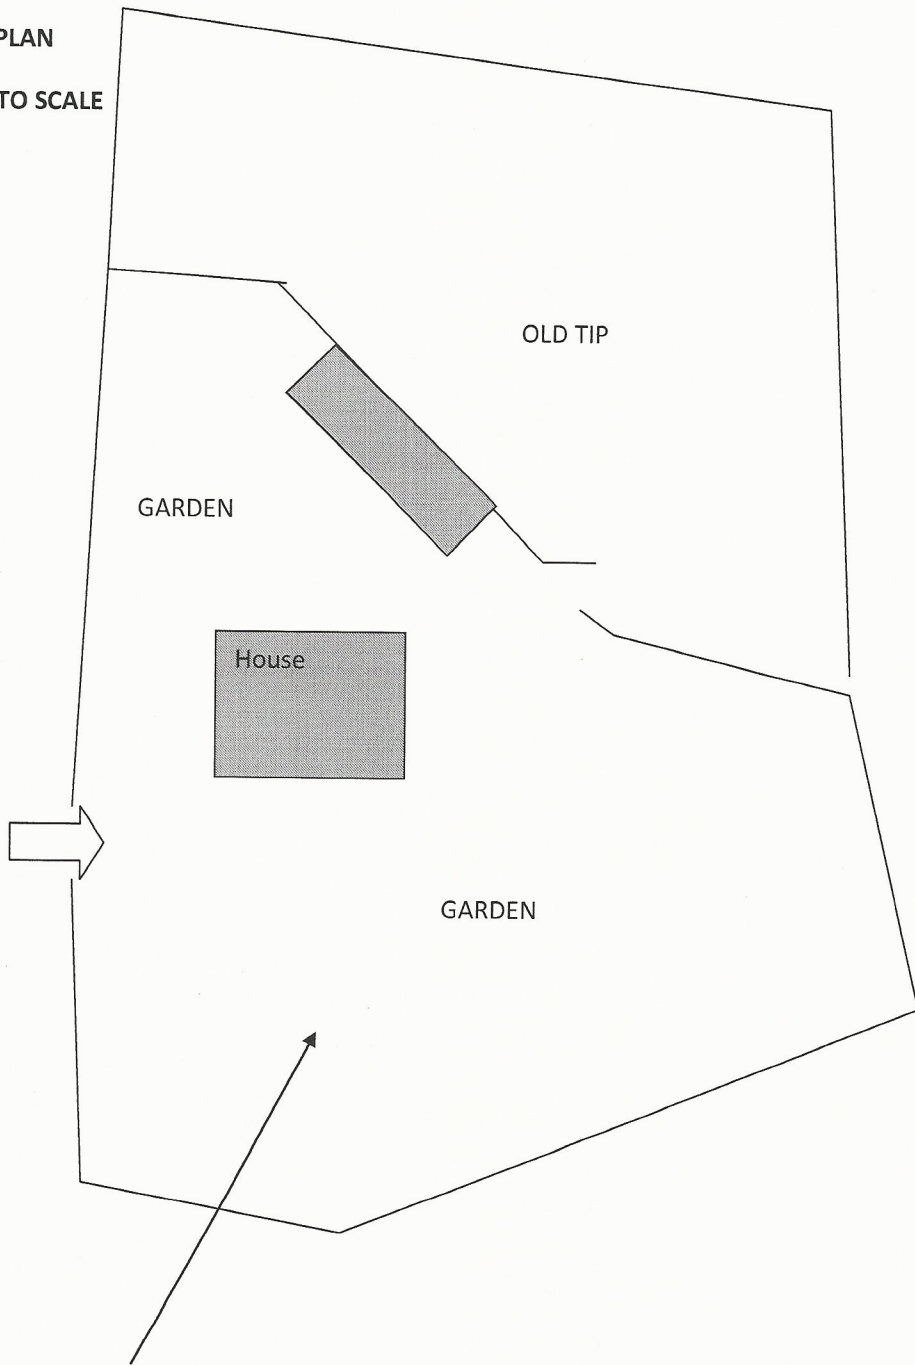
SITE PLAN

The study area and location are presented in the Appendix. The site is centred on O.S. Grid Reference 424780E, 606370N and has an approximate area of 1800m². Access is off Station Road. The site rises from Station Road along the southern boundary. It is occupied by a private house and garden with hedge and associated outbuildings. There was no visual evidence of land contamination, poor house-keeping, distressed vegetation or significant ground irregularity (depressions or mounds) on Site at the time of the site visit. A tank thought to contain heating oil was noted.

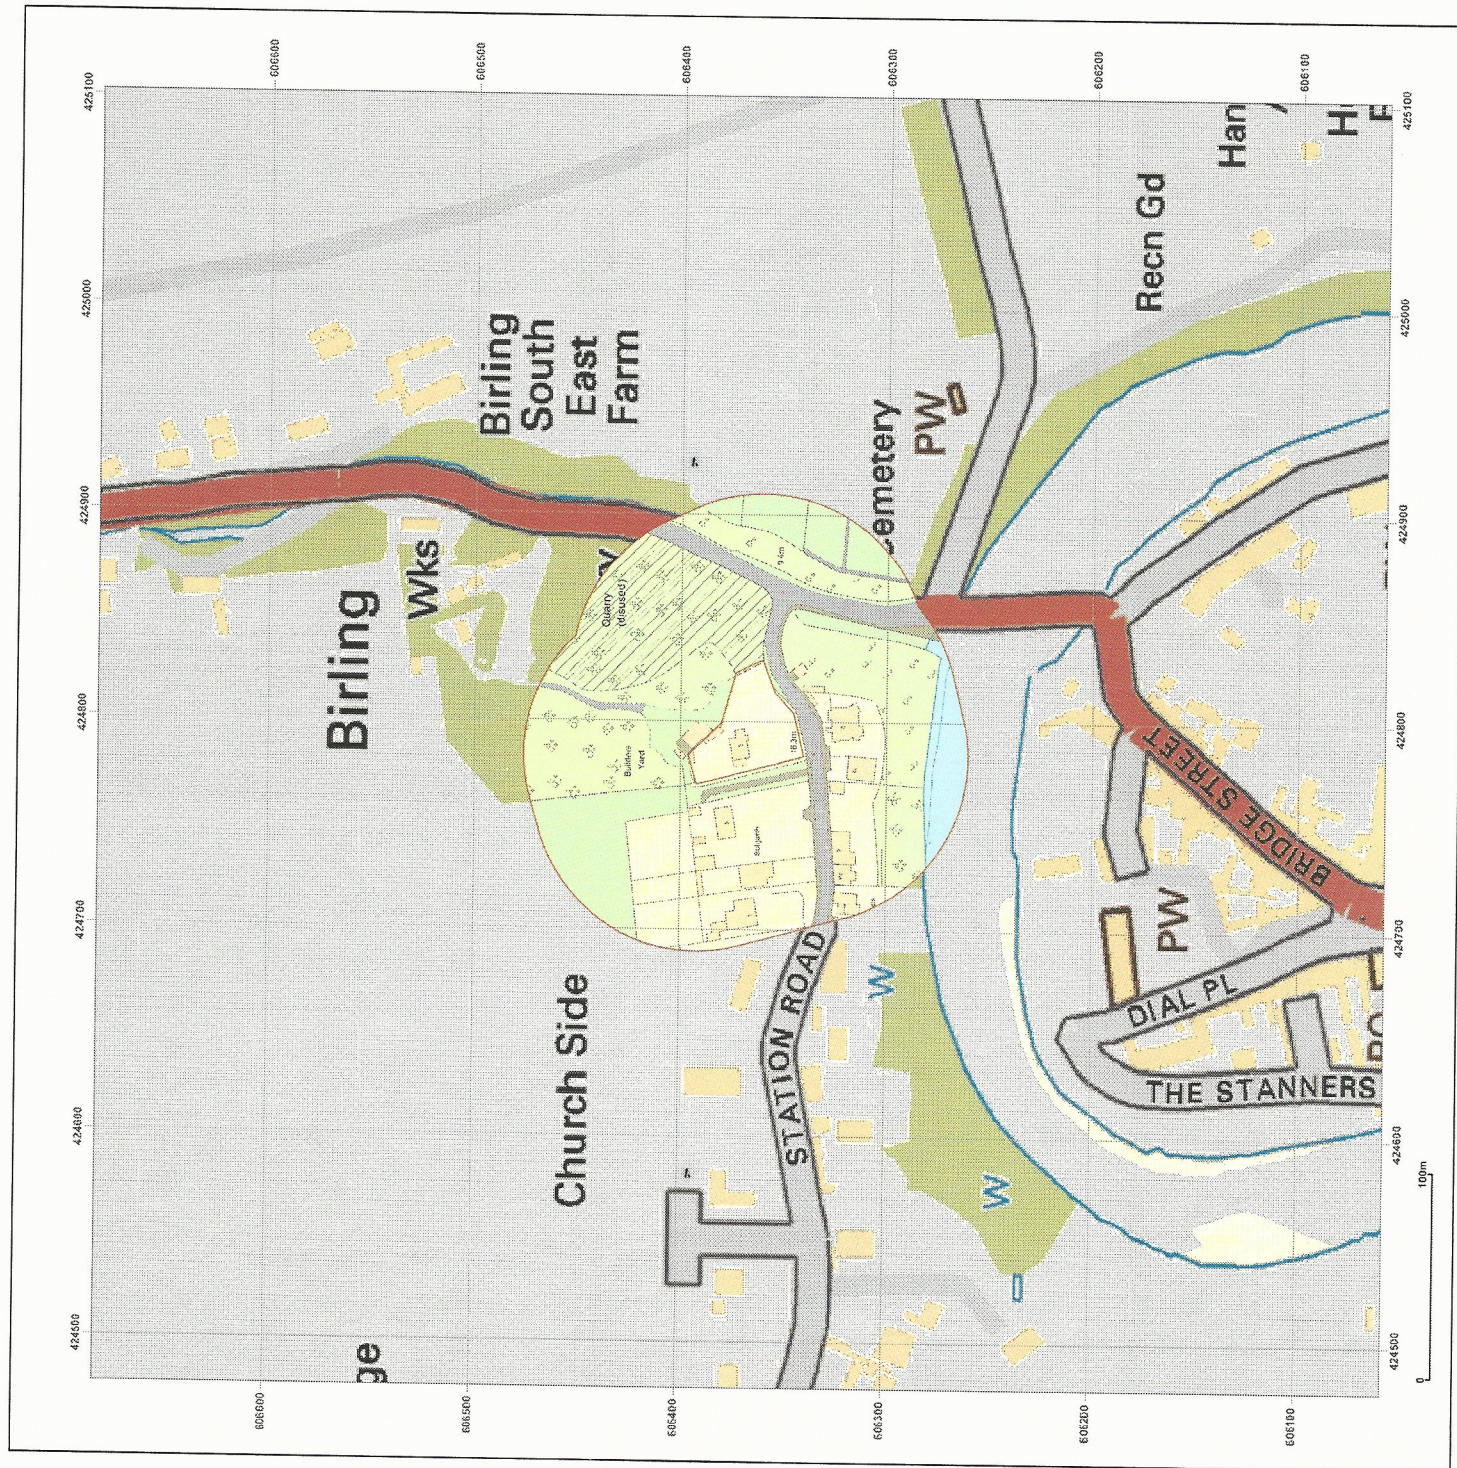
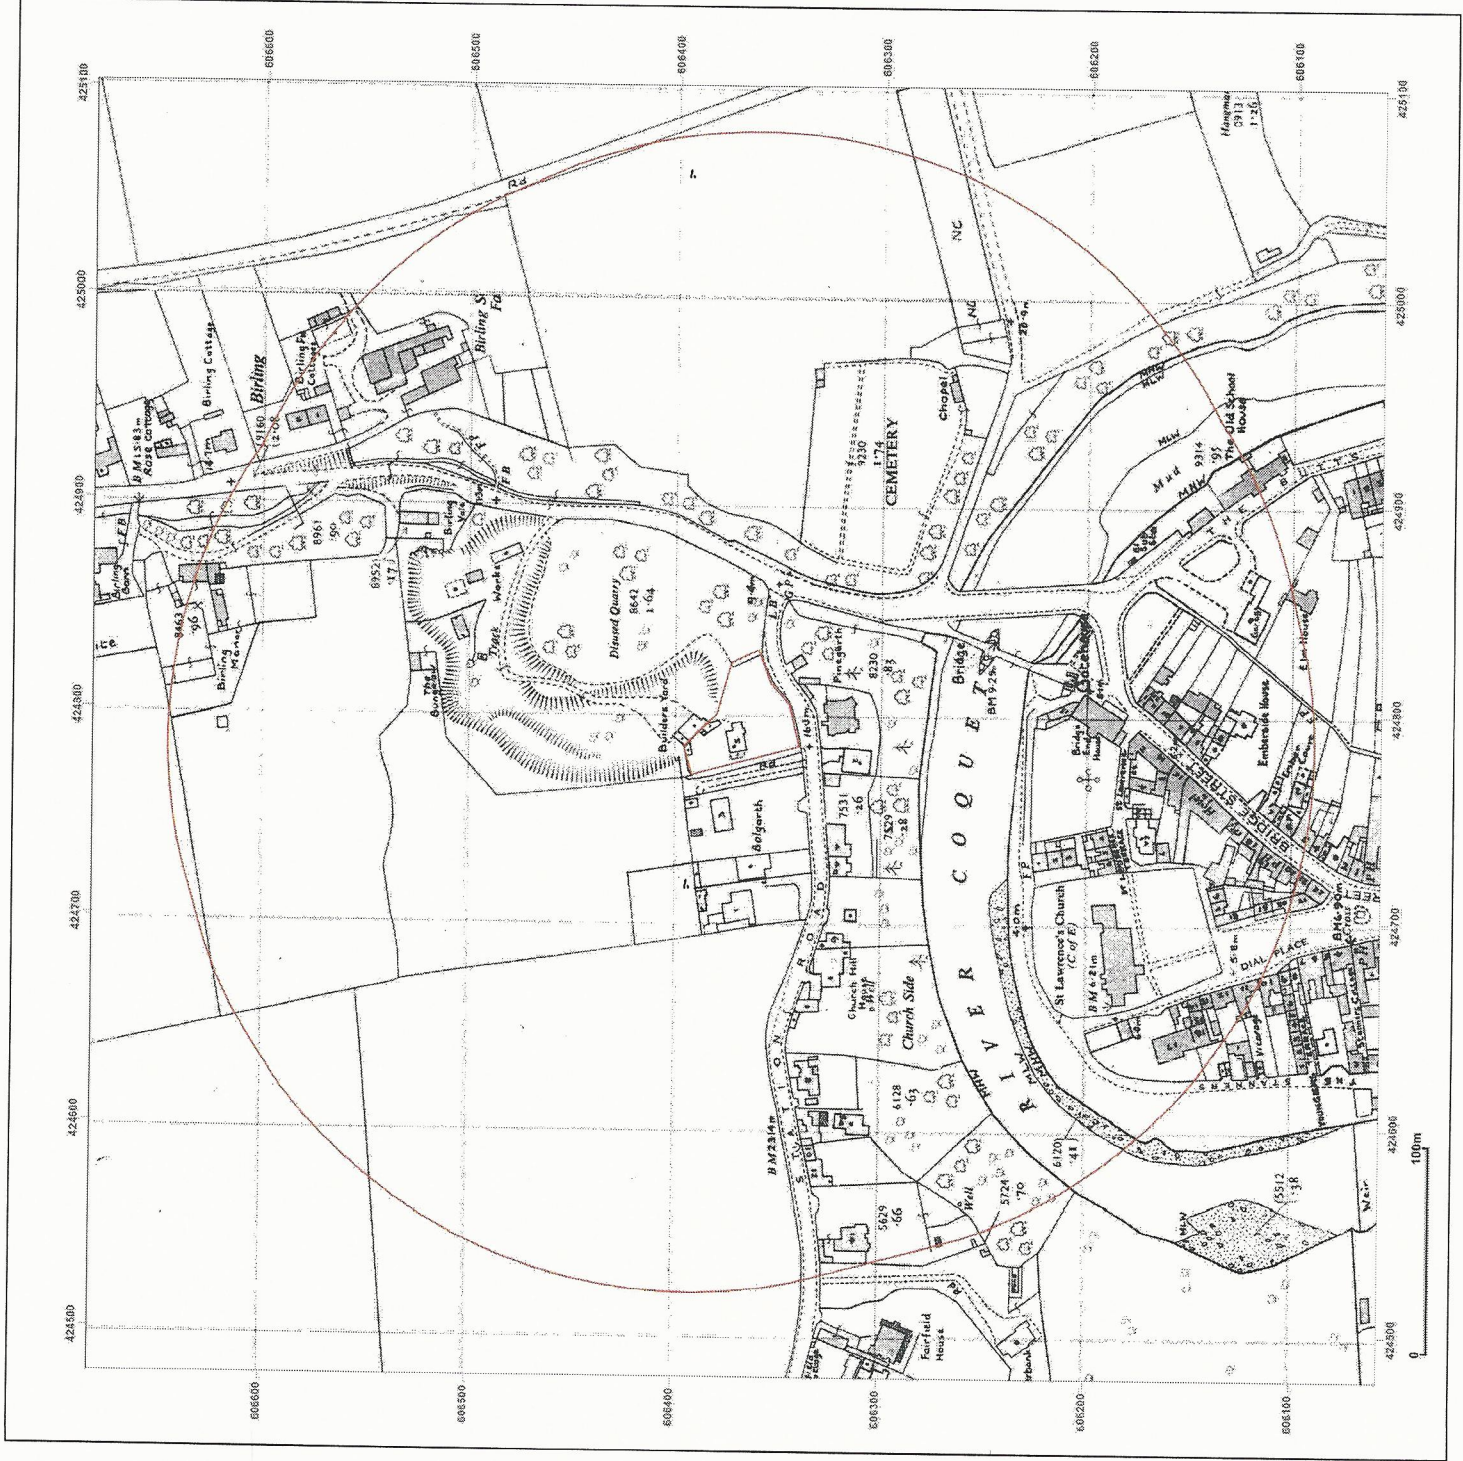
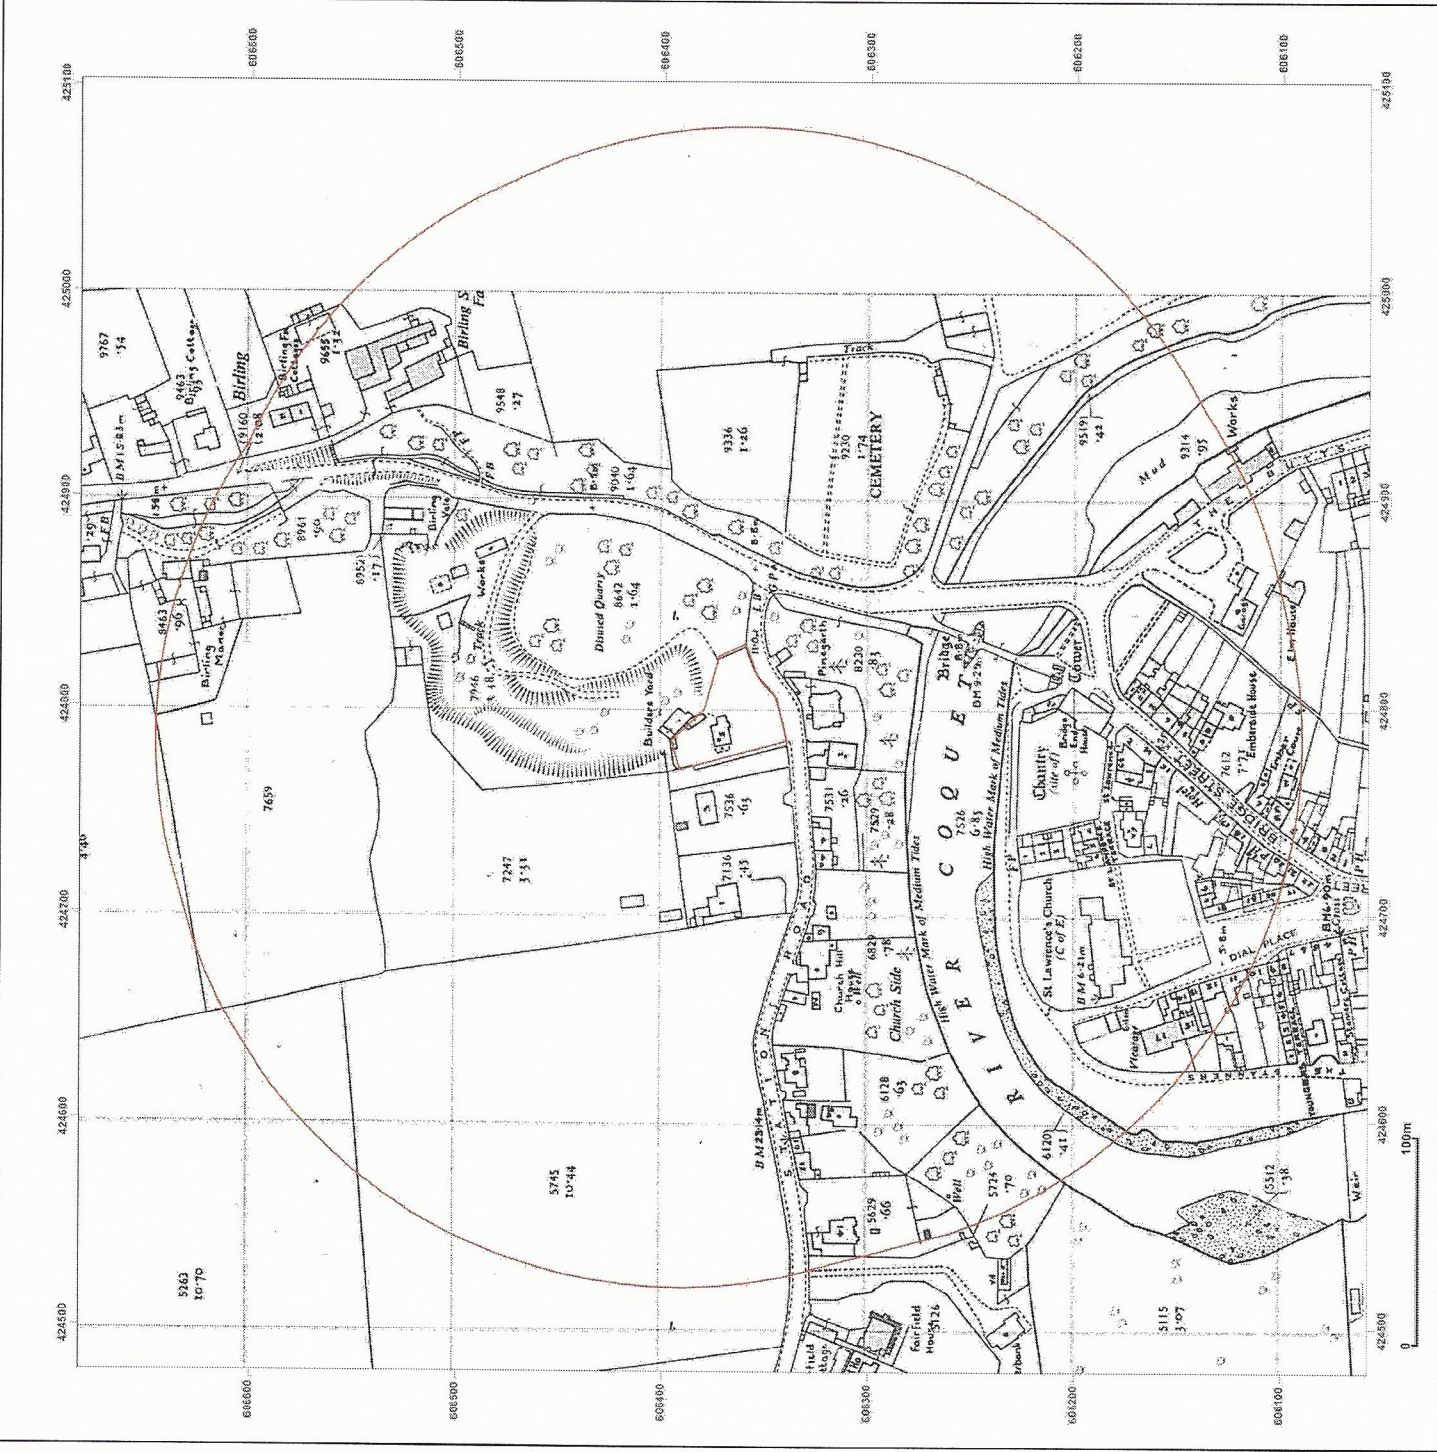
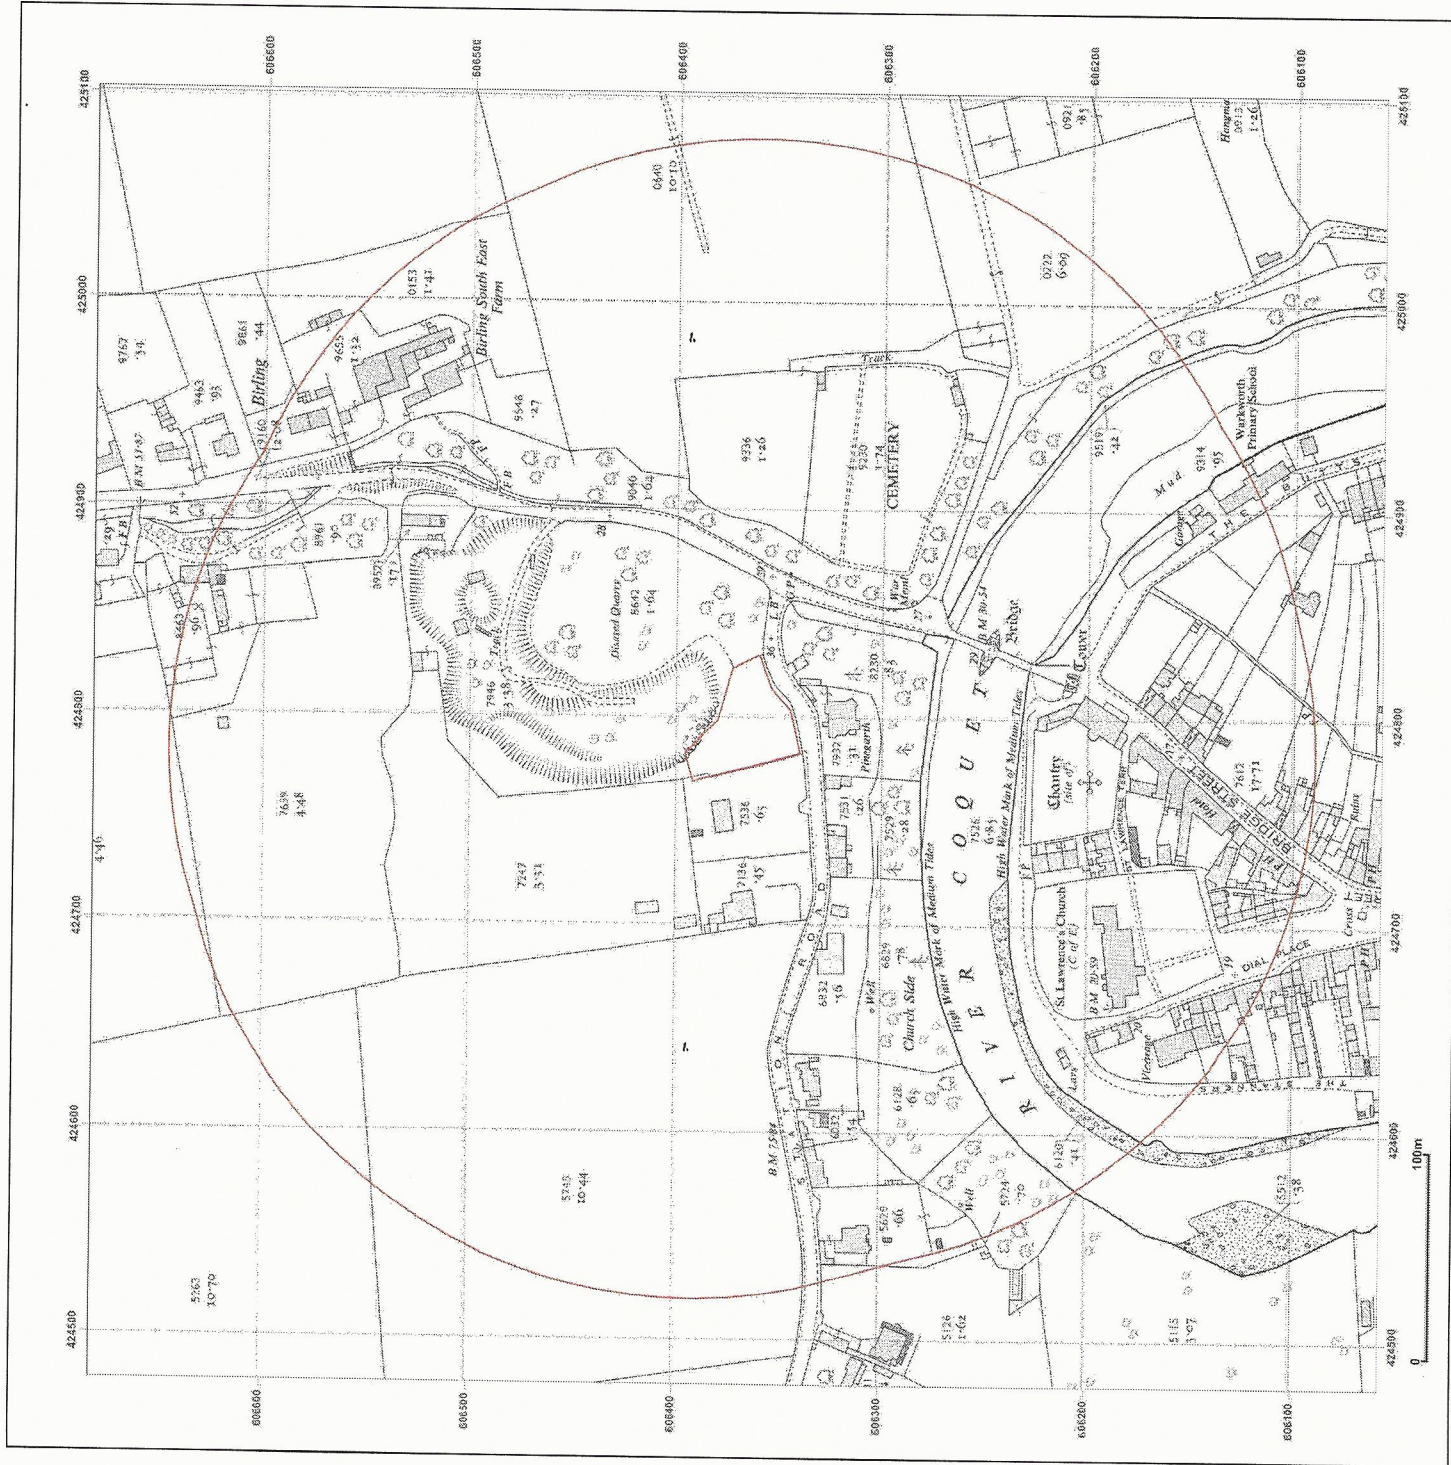
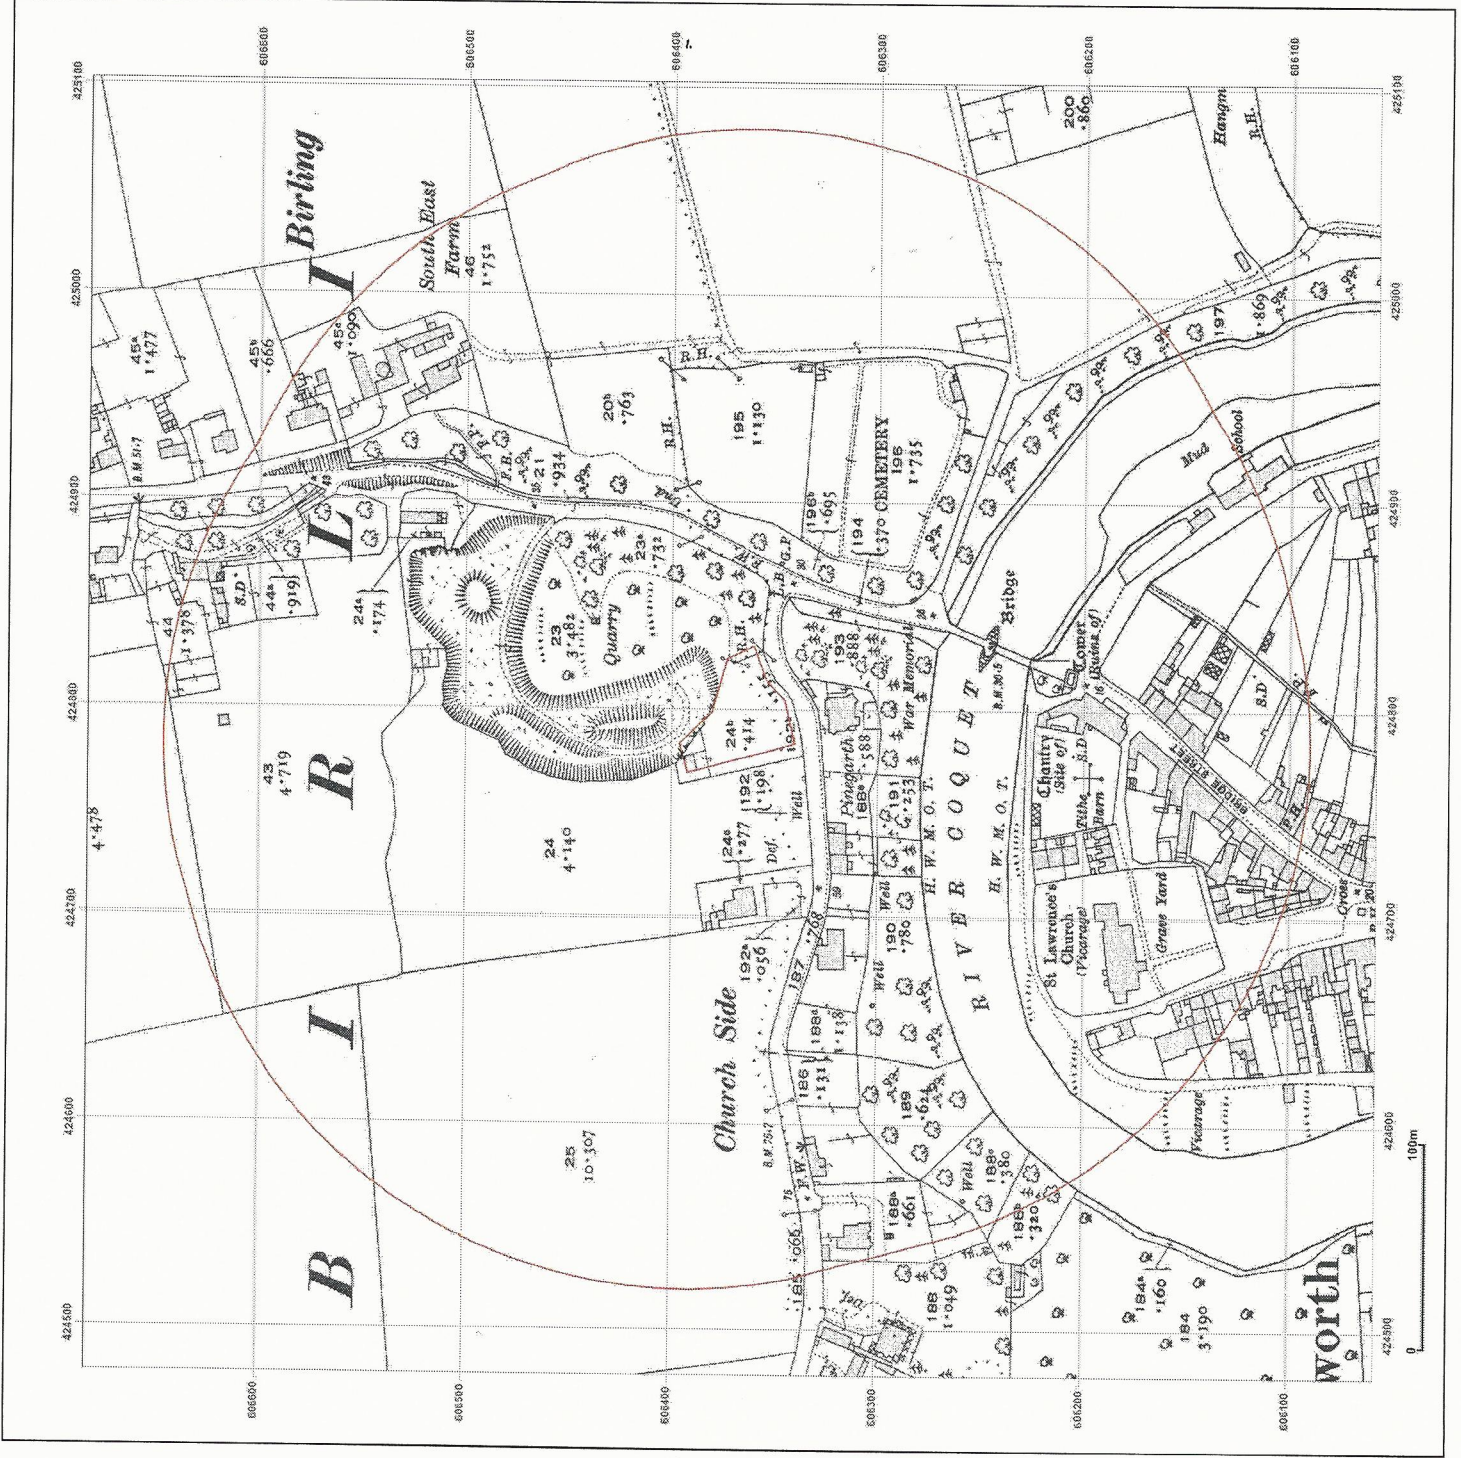
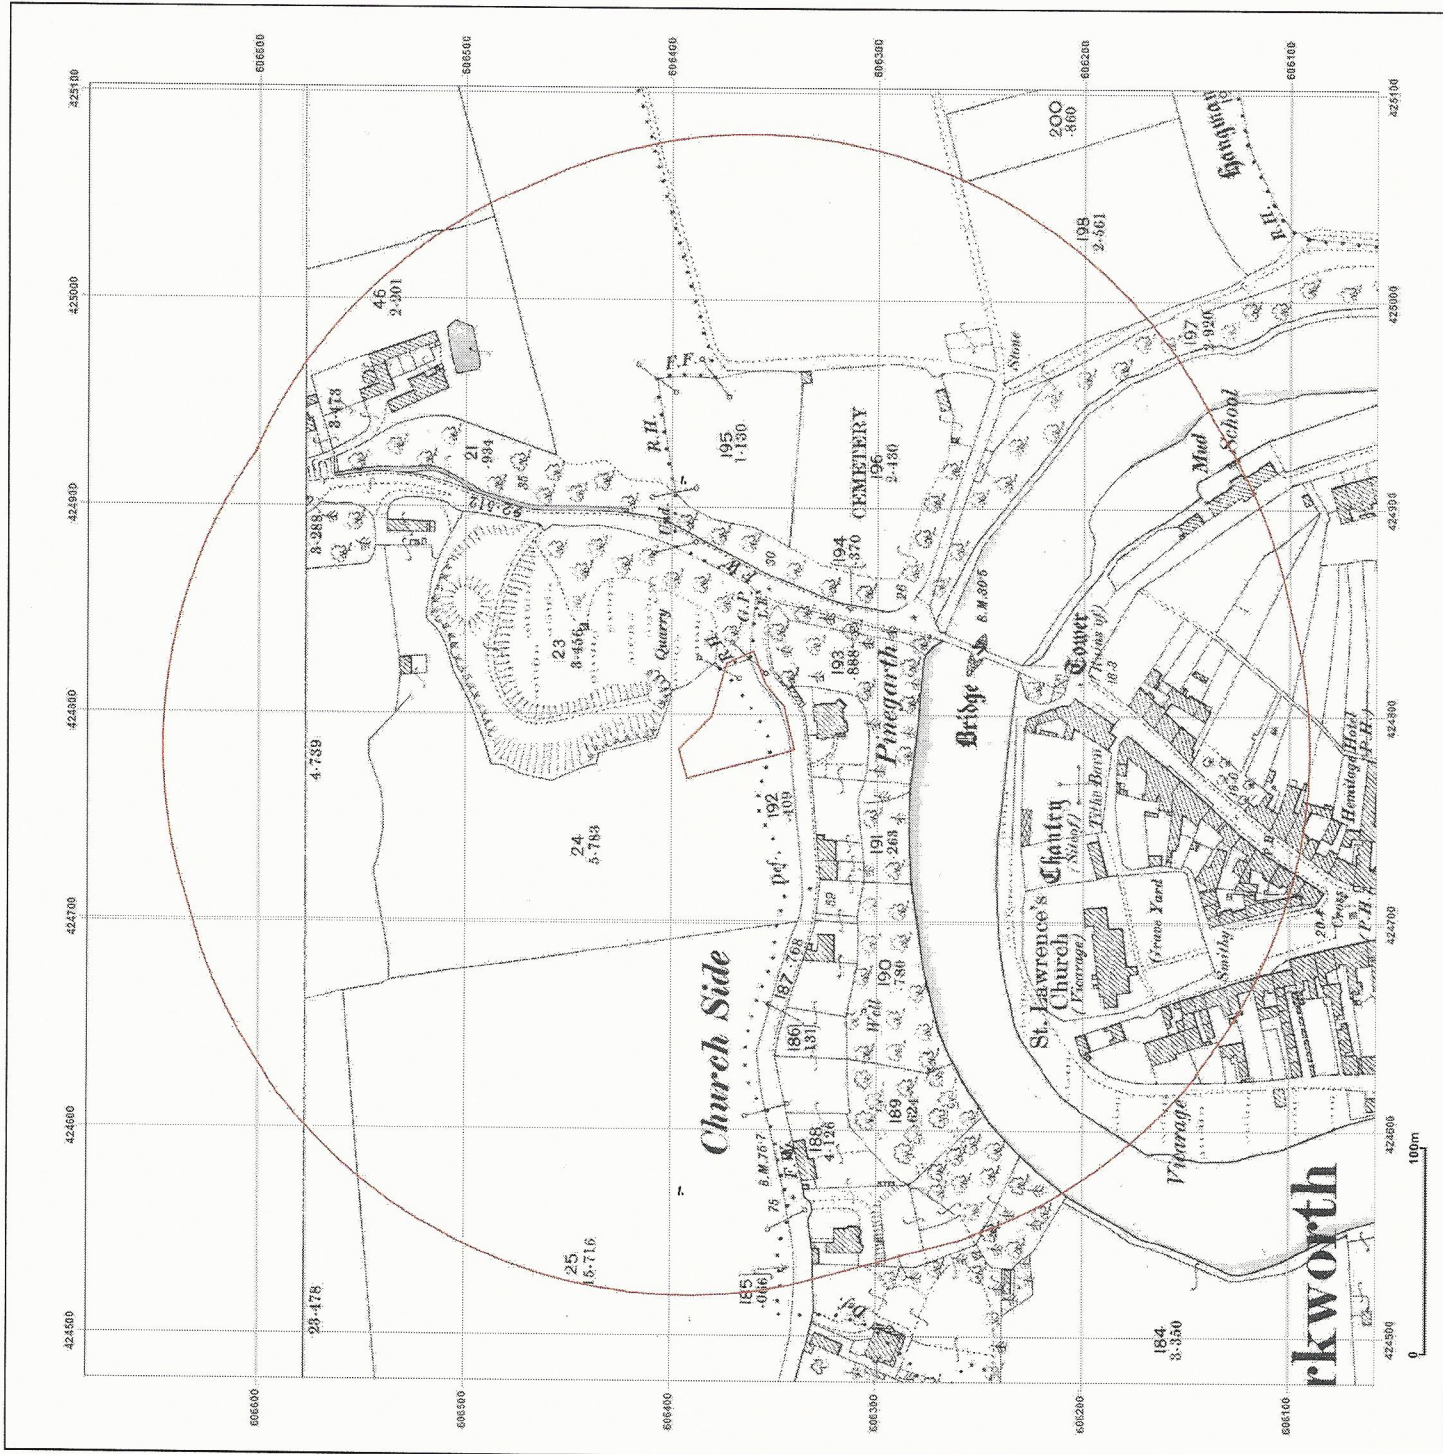
Date	Onsite	Offsite	Comments
1855	Open ground	Quarry and woodland immediately north east Well 100m south west Cemetery 50m south east	Open ground
1897	No change	Quarry boundary retracted 20m north Housing south of site	
1923	Small outbuilding in north of plot	Quarry shown occupying its original boundary	Small outbuilding in north of site
1959	No change	Housing extending to west	
1981	House and outbuildings on site	Housing extending west, next door.	House and outbuildings on site
1989	Little change	Little change	
2012	Little change	Little change

Information provided by the Client indicates that the property was acquired in the late 1950's. Correspondence suggests that the quarry immediately north of the Site was, around that time, operated as a tip by the Council.
