**REMEDICATION AND ENABLING WORKS
VALIDATION REPORT**

**Land to the rear of Suncroft,
Warkworth,
Northumberland,
NE65 0PX**

**Report Ref: 22-1214-VAL
Date Issued: July 2023**

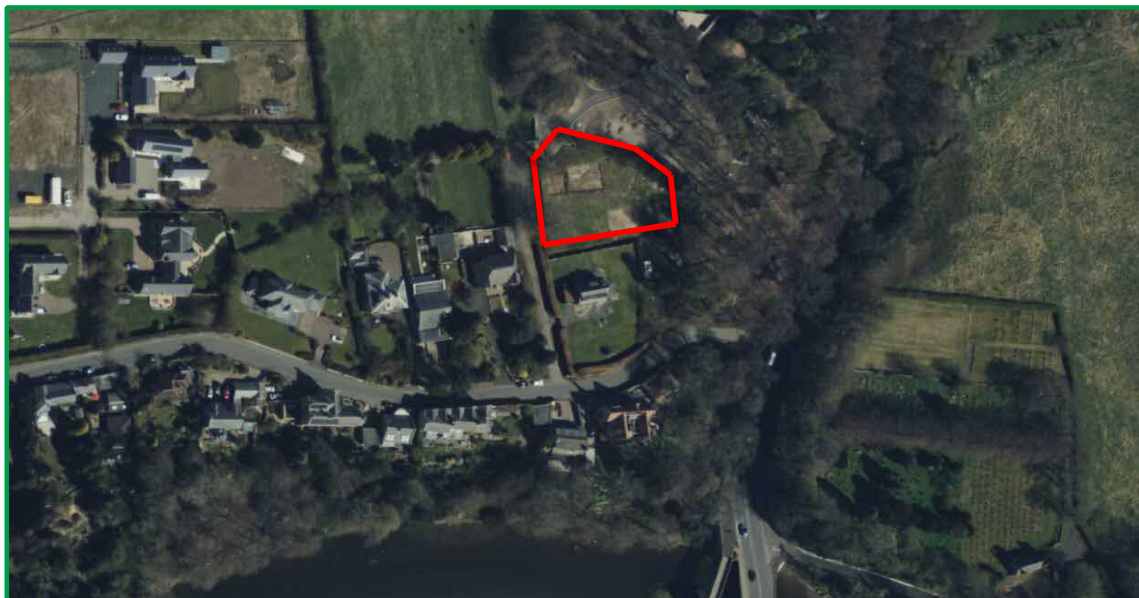
Figure 1.1 Site Location Plan – Land to the rear of Suncroft, Warkworth

The development area is c.0.18ha in size and is situated to the rear of Suncroft, located off Station Road in the north of Warkworth (see ERGO drawing ref: 22-1214-001 within Appendix III). For the avoidance of doubt, ERGO can confirm that the parcel of land refers to the red-line boundary as indicated in Figure 1.1 below.

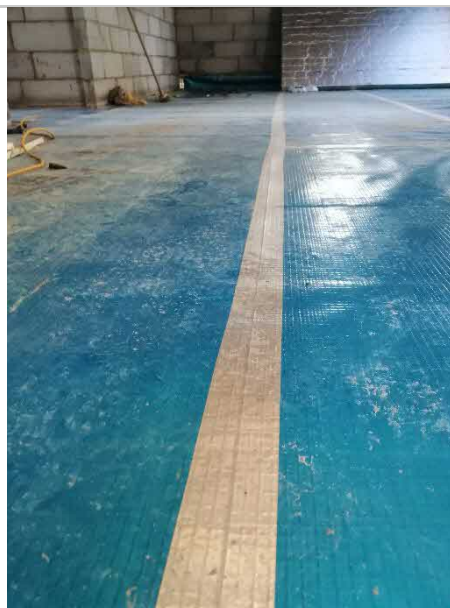
The membrane comprised a Visqueen Gas Barrier gas membrane resistant to carbon dioxide and low levels of methane. The photographs show the general condition of the plot membranes prior to the laying insulation and pouring the concrete screed. Plot were swept prior to the laying of the gas membrane. Installation was completed by means of perimeter and infill.

General overviews of membrane at Plot 1 following internal placement. No materials were stored on the membrane which had the potential to cause damage.

Where damage was observed during the inspection, suitable repair was undertaken as necessary under supervision by ERGO to ensure the membrane was installed appropriately. ERGO can confirm there were no holes or rips in the membrane prior to the laying of insulation and pouring of the concrete.

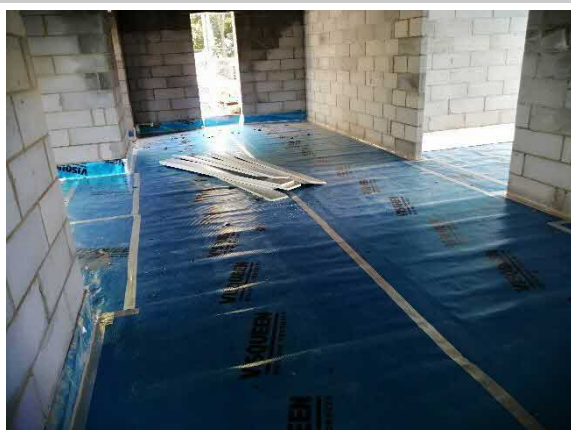
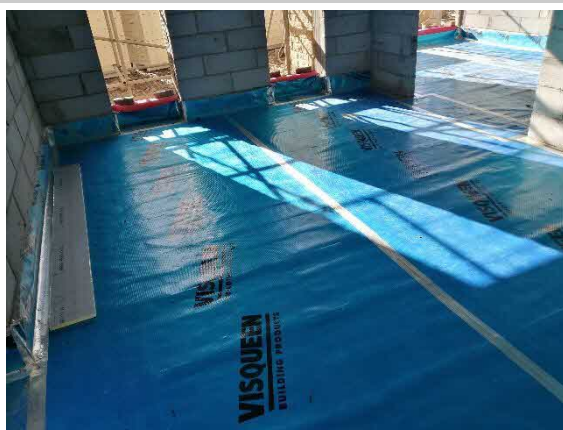
General overviews of membrane at Plot 2 following internal placement. No materials were stored on the membrane which had the potential to cause damage.

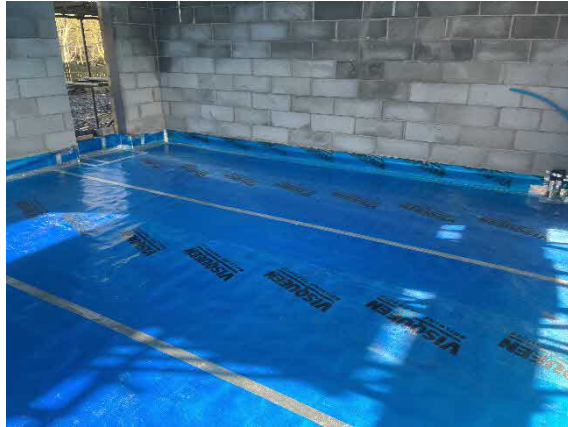
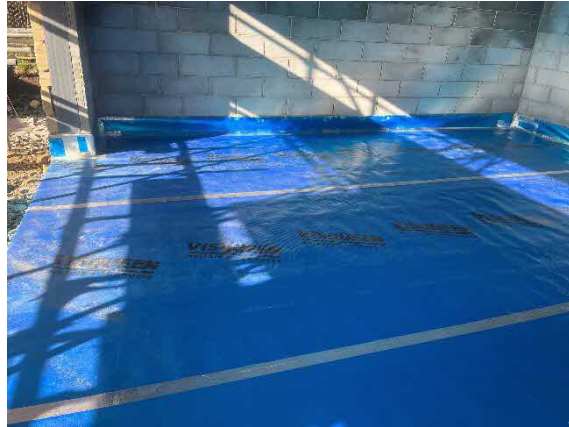
General overviews of membrane within the garden following internal placement. No materials were stored on the membrane which had the potential to cause damage.

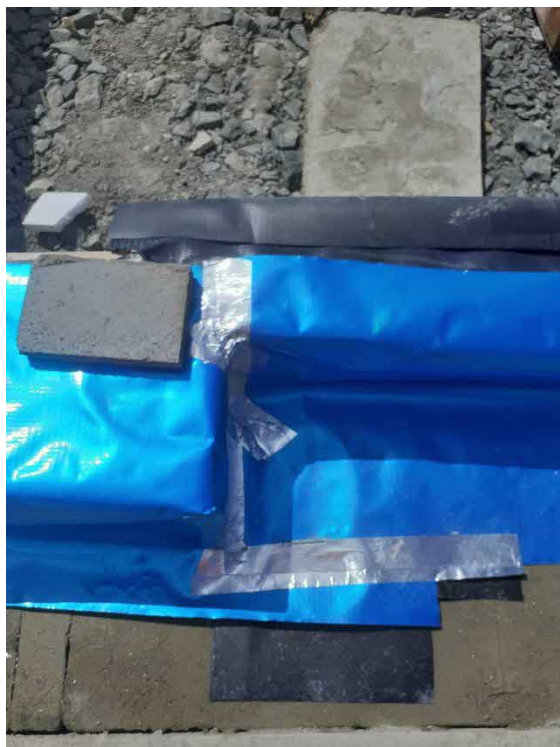
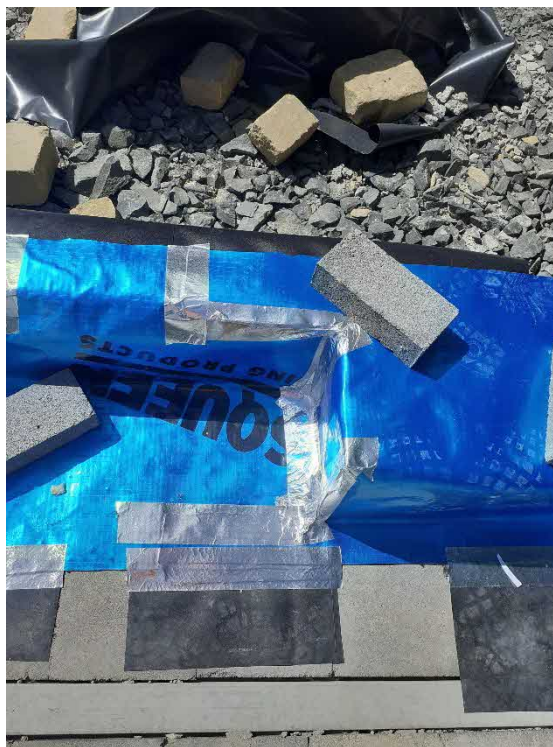
All external joints were inspected and ERGO can confirm that the membrane was overlapped and taped appropriately. Where evidence of incorrectly sealed gas membrane joints was encountered, contractors were supervised whilst adequate repairs were undertaken. Photos detailing examples of the quality of works under are displayed below.

General condition of membrane of corner units and joints within Plots 1-2.

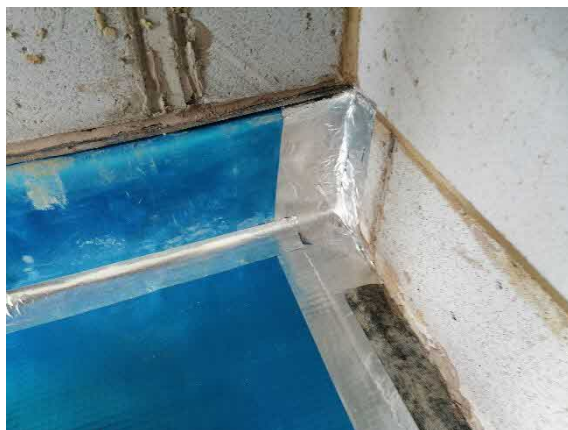
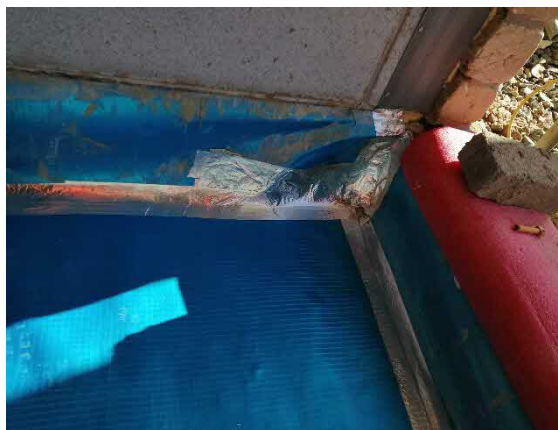
General condition of membrane of corner units and joints within Plots 1-2. Note protection placed during works within Plate 9.

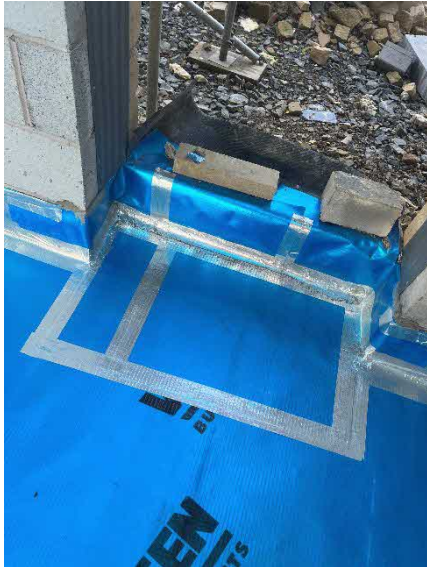
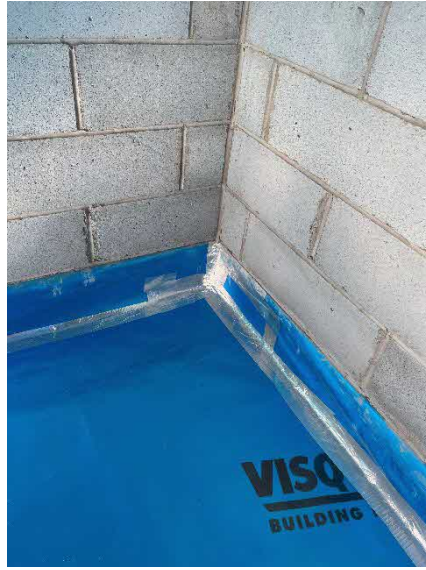
General condition of membrane of corner units and joints within the garage plot.

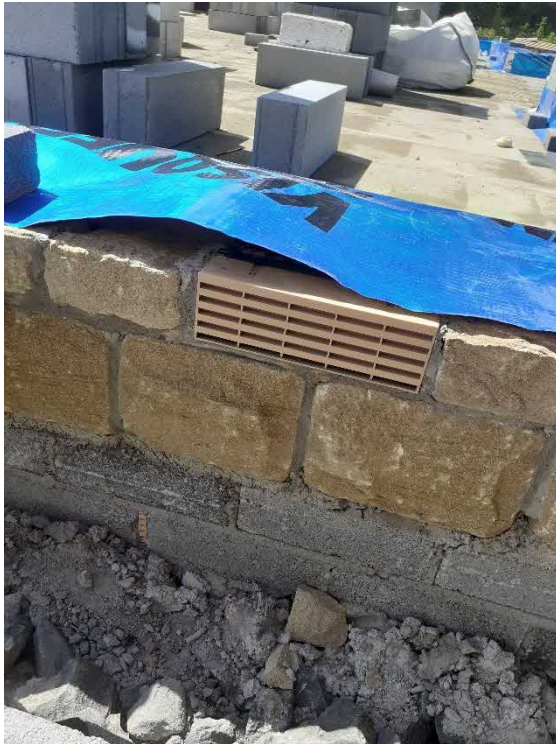
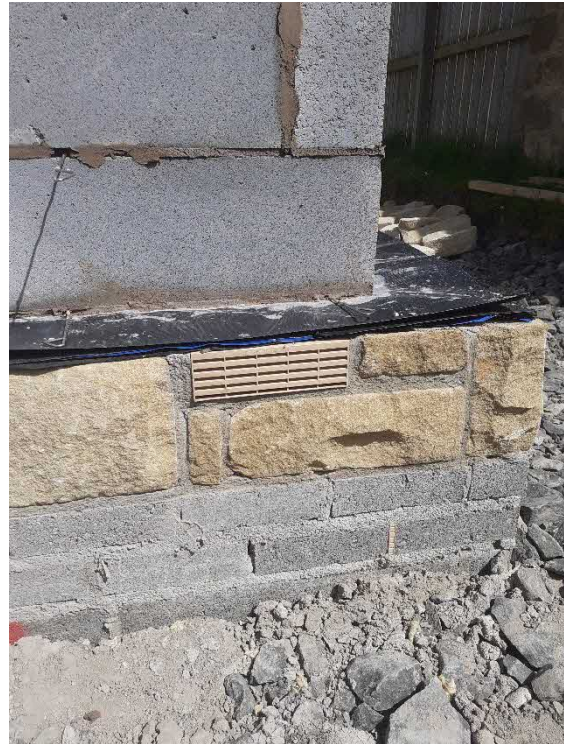
Plots were installed with an adequate number of ventilation blocks and can confirm that they appear to be clear of debris and unimpeded. Photos detailing examples of the quality of works are displayed below.

Periscopic ventilation bricks shown to be free of obstructions in Plots 1-2.

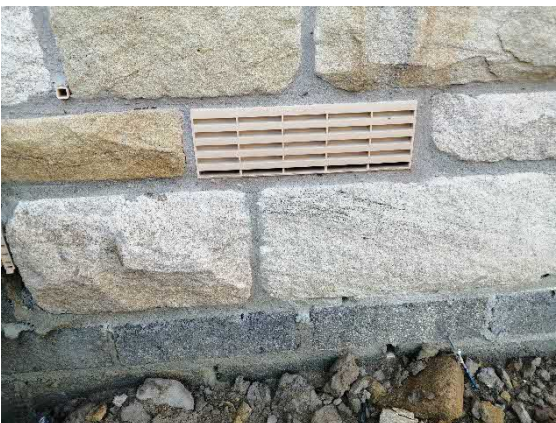
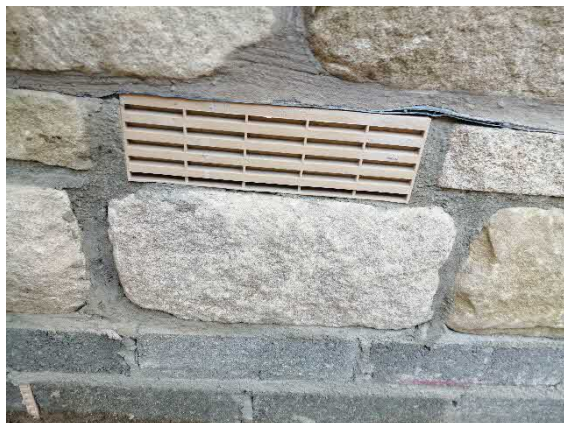
Periscopic ventilation bricks shown to be free of obstructions in Plot 1.

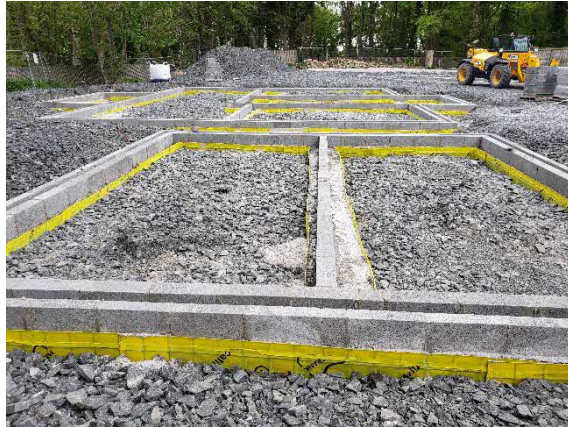
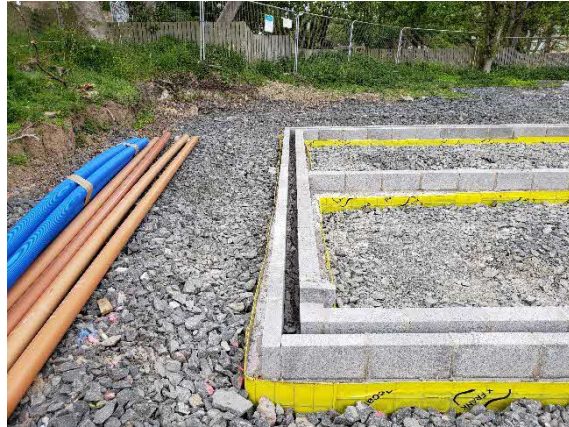
Showing the sub-floor areas to be clear of waste and/or obstruction. ERGO can confirm a 225mm void was apparent within each substructure.

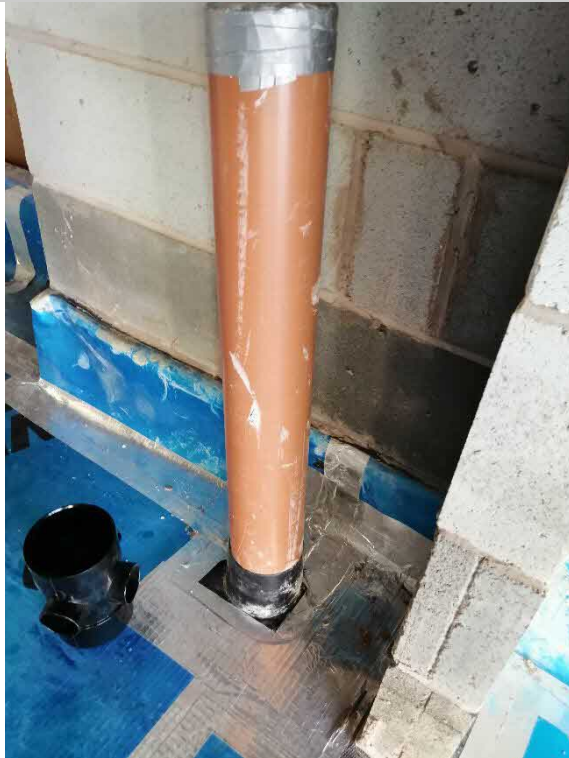
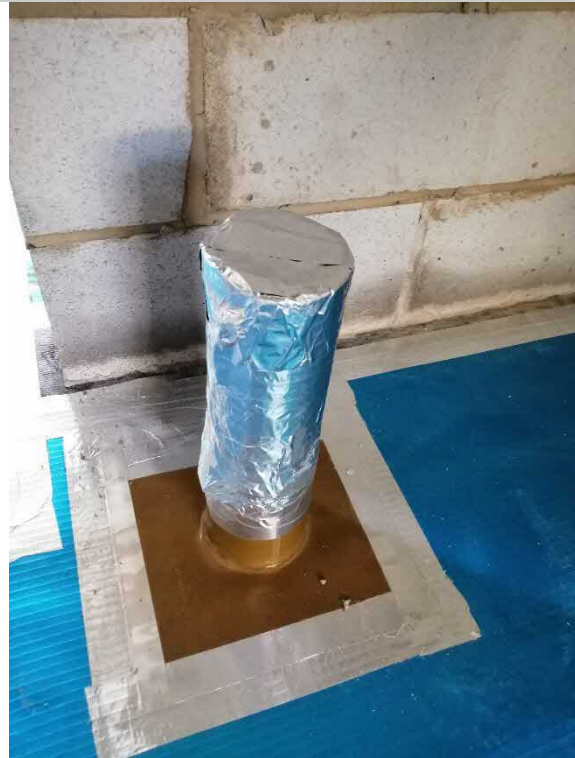
Service entries were present within the footprint of all plots, adjacent to periphery walls. ERGO inspected each one and can confirm that the service entries have been adequately sealed against the membrane.

Membrane sealed around service entries within Plot 1. ERGO can confirm these service entries were adequately sealed.

Following conversation with the Developer, ERGO understand the service penetrations to have been adequately installed with Filoseal products. Details of the installation are available from the developer.

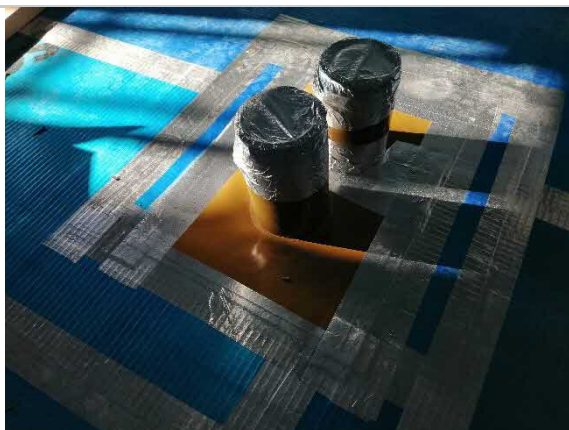
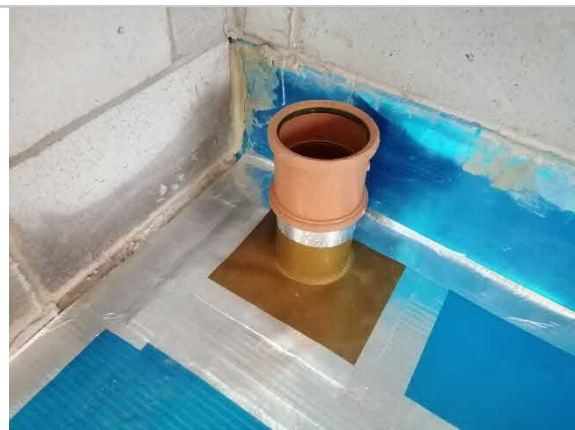
Membrane sealed around service entries within Plot 2. ERGO can confirm these service entries were adequately sealed.

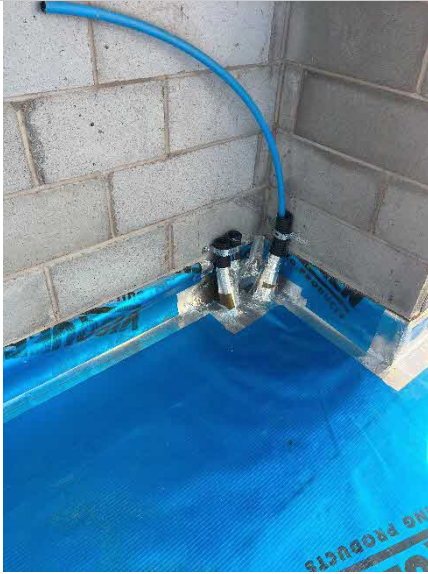
PLATE 23

Membrane sealed around service entries within the garage plot. ERGO can confirm these service entries were adequately sealed.

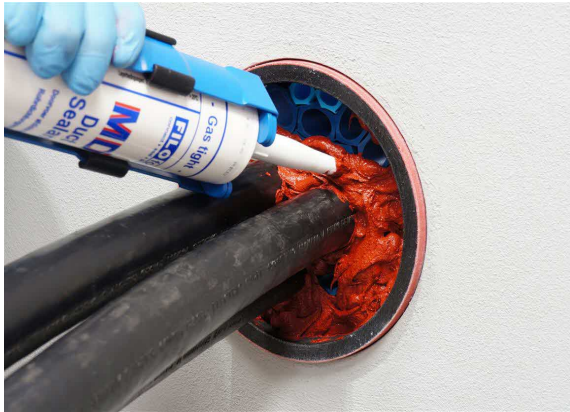
FiloSeal+HD Duct Seal

Duct sealing system FiloSeal+HD is an engineered universal solution for sealing larger heavy cables and pipes in ducts, boreholes or transit frames.

Up to 2 bar Pressure Resistance
100Kg pulling Force on the cables when sealed
10xd at 45°, with 1 bar pressure bending test
