GROUND GAS PROTECTION MEASURES VALIDATION REPORT

**Land to the rear of Suncroft,
Warkworth,
Northumberland**

**Report Ref: 22-1214-GVAL1
Date Issued: February 2023**

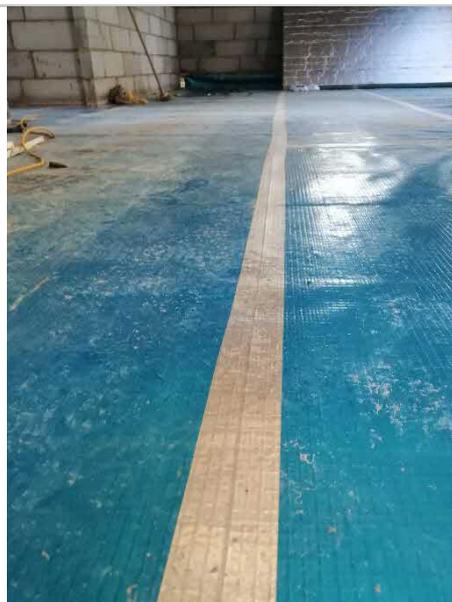
PLATE 1

General overviews of membrane at Plot 1 following internal placement. No materials were stored on the membrane which had the potential to cause damage.

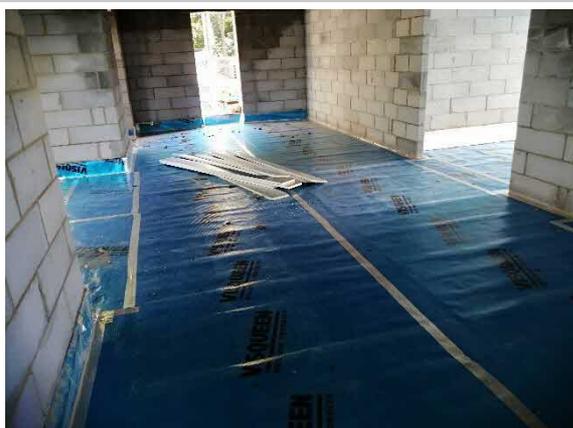
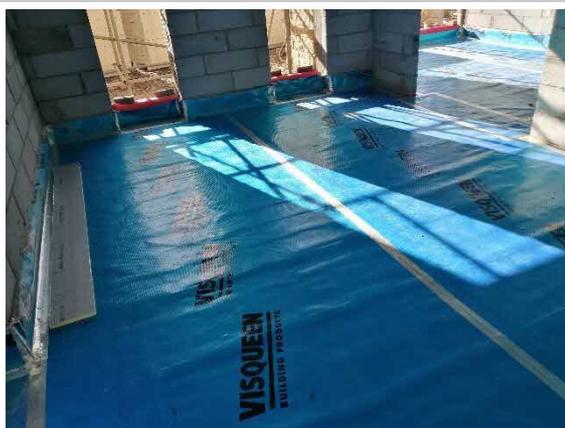
PLATE 3

General overviews of membrane at Plot 2 following internal placement. No materials were stored on the membrane which had the potential to cause damage.

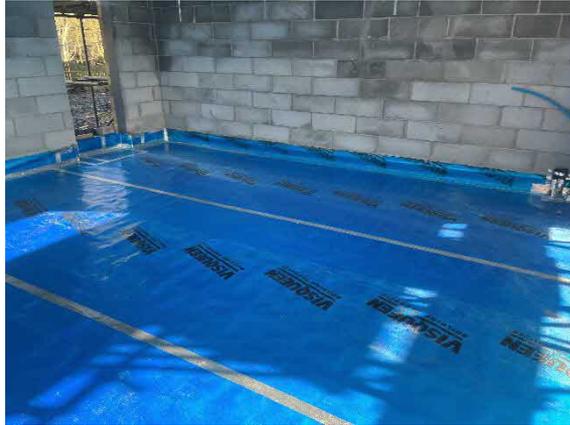
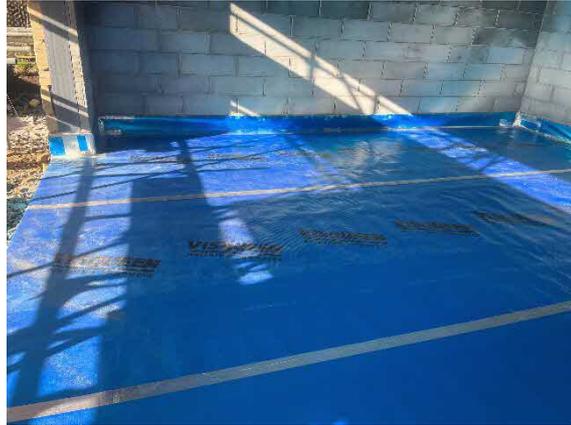
PLATE 5

General overviews of membrane within the garden following internal placement. No materials were stored on the membrane which had the potential to cause damage.

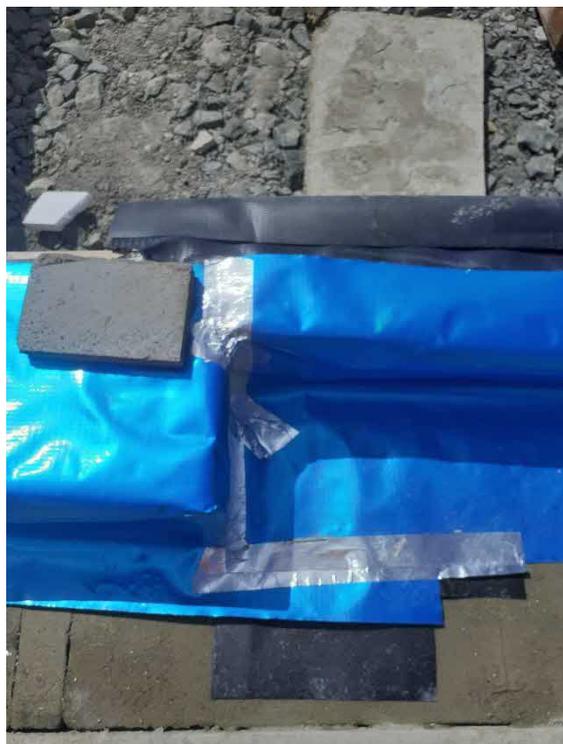
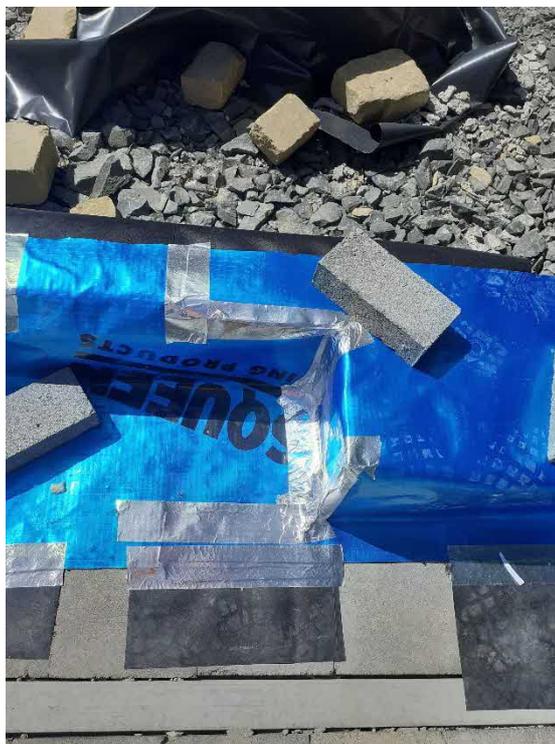
PLATE 7

All external joints were inspected and ERGO can confirm that the membrane was overlapped and taped appropriately. Where evidence of incorrectly sealed gas membrane joints was encountered, contractors were supervised whilst adequate repairs were undertaken. Photos detailing examples of the quality of works under are displayed below.

General condition of membrane of corner units and joints within Plots 1-2.

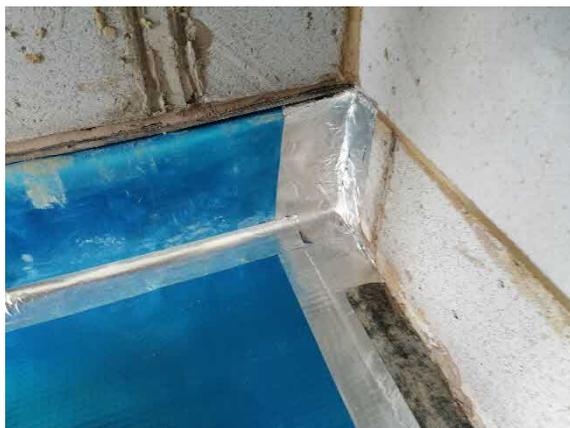
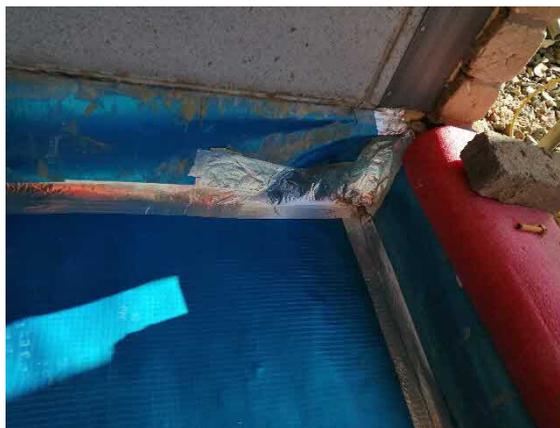
PLATE 9

General condition of membrane of corner units and joints within Plots 1-2. Note protection placed during works within Plate 9.

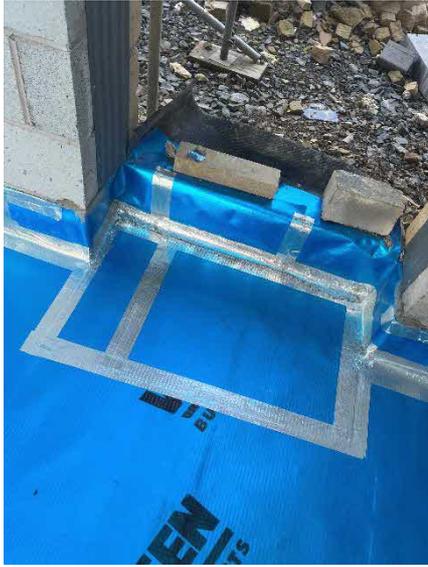
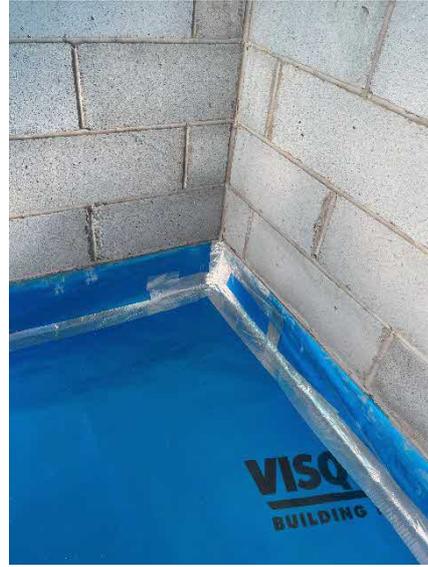
PLATE 11

General condition of membrane of corner units and joints within the garage plot.

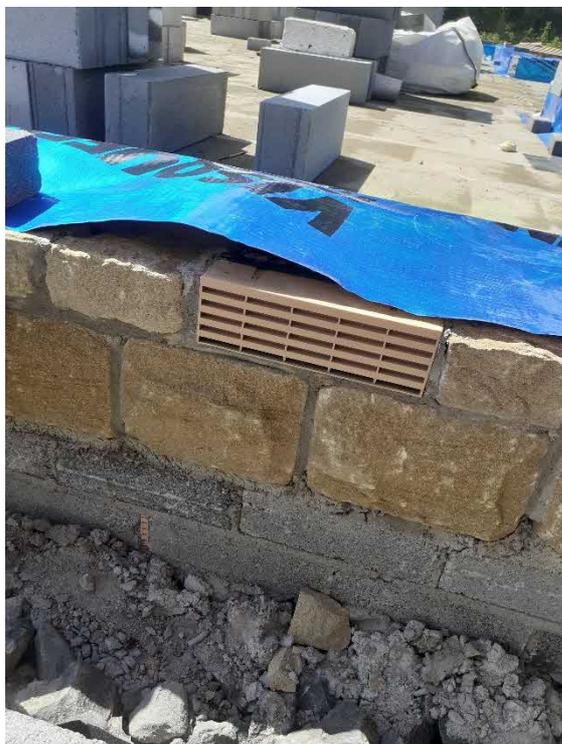
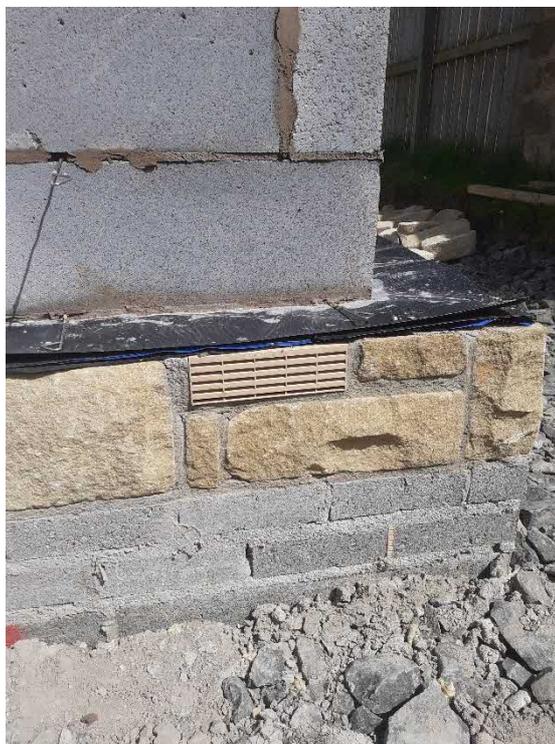
PLATE 13

Periscopic ventilation bricks shown to be free of obstructions in Plots 1-2.

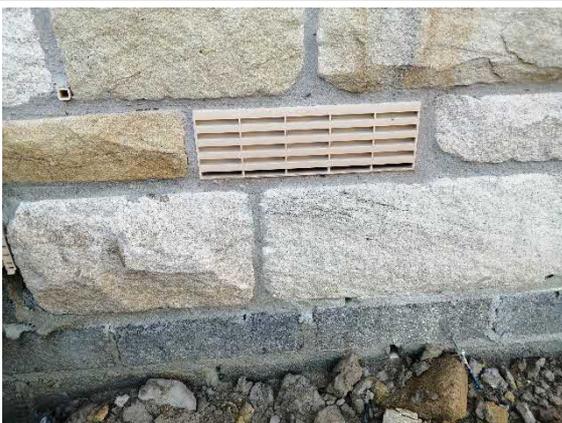
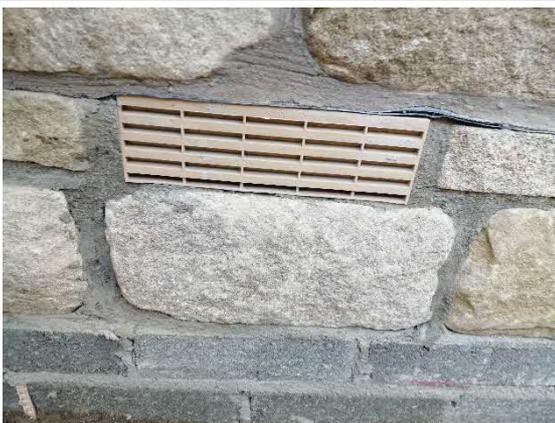
PLATE 15

Periscopic ventilation bricks shown to be free of obstructions in Plot 1.

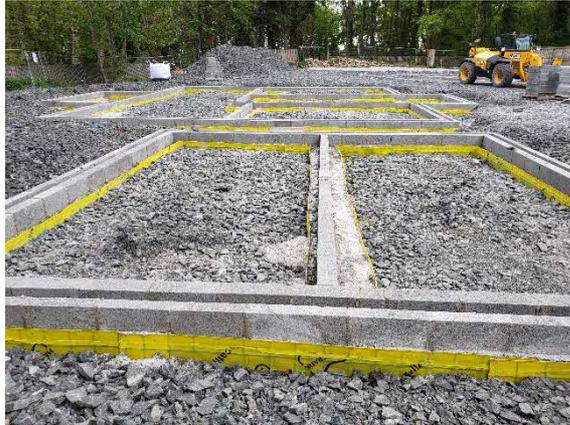
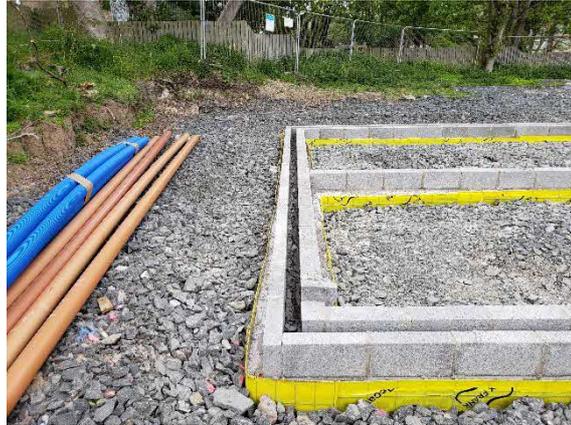
PLATE 17

Showing the sub-floor areas to be clear of waste and/or obstruction. ERGO can confirm a 225mm void was apparent within each substructure.

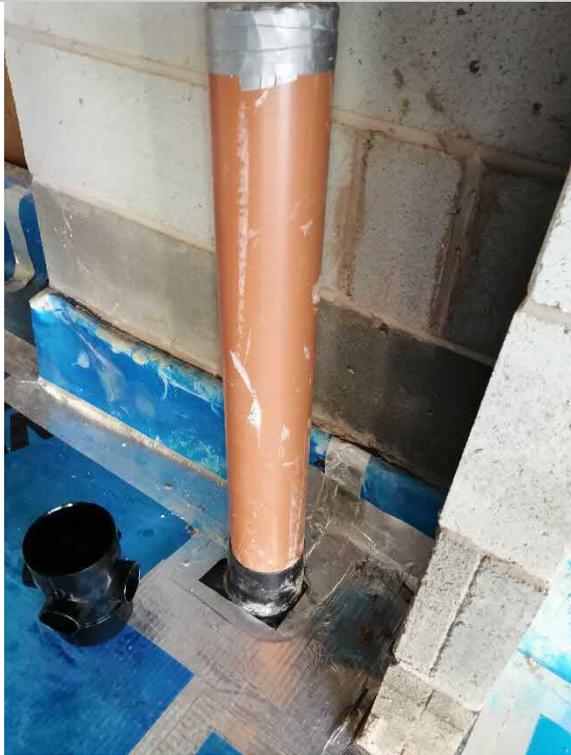
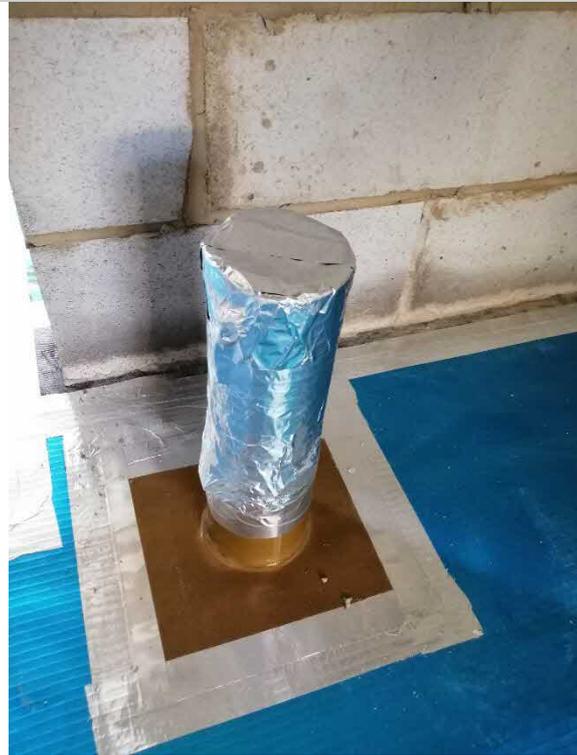
PLATE 19

Membrane sealed around service entries within Plot 1. ERGO can confirm these service entries were adequately sealed.

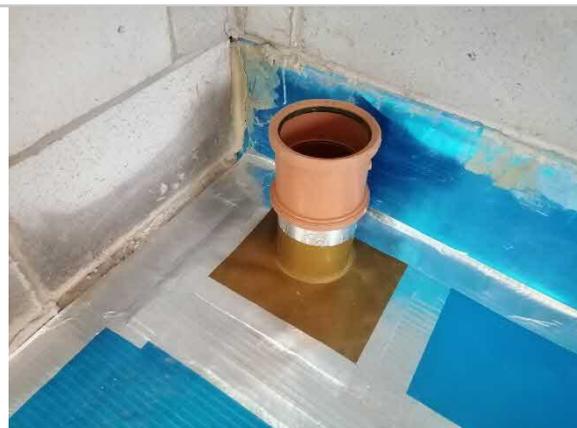
PLATE 21

Membrane sealed around service entries within Plot 2. ERGO can confirm these service entries were adequately sealed.

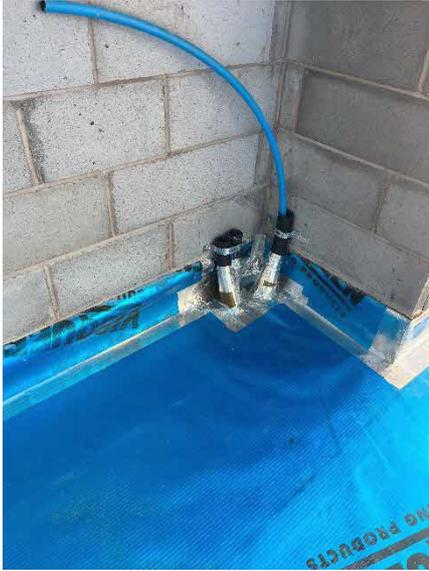
PLATE 23

Membrane sealed around service entries within the garage plot. ERGO can confirm these service entries were adequately sealed.
