Barns J and K, Hixham Hall Barns, Furneux Pelham

Great crested newt and
bat survey and
assessment

Report ref.:
WRL101/R002V2

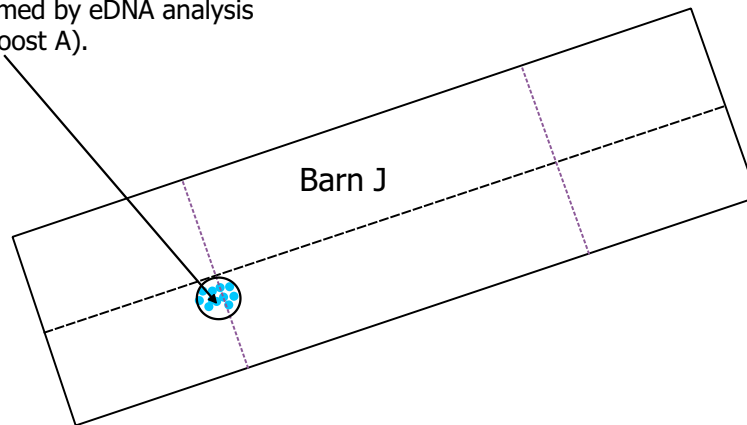
Barn J Sample 1: approximately 15 mixed-age droppings concentrated directly below an area of loose roofing felt were confirmed by eDNA analysis to be from barbastelle bat (Roost A).

- 4.2.1** No bats were recorded during the roost check. However, approximately 15 mixed-age droppings were identified directly below an area of loose roofing felt. A sample of these droppings (sample 1) was subject to multi-species DNA analysis which confirmed the droppings belong to barbastelle bat¹⁵. The number and location of droppings indicates the presence of a barbastelle day roost (Roost A).

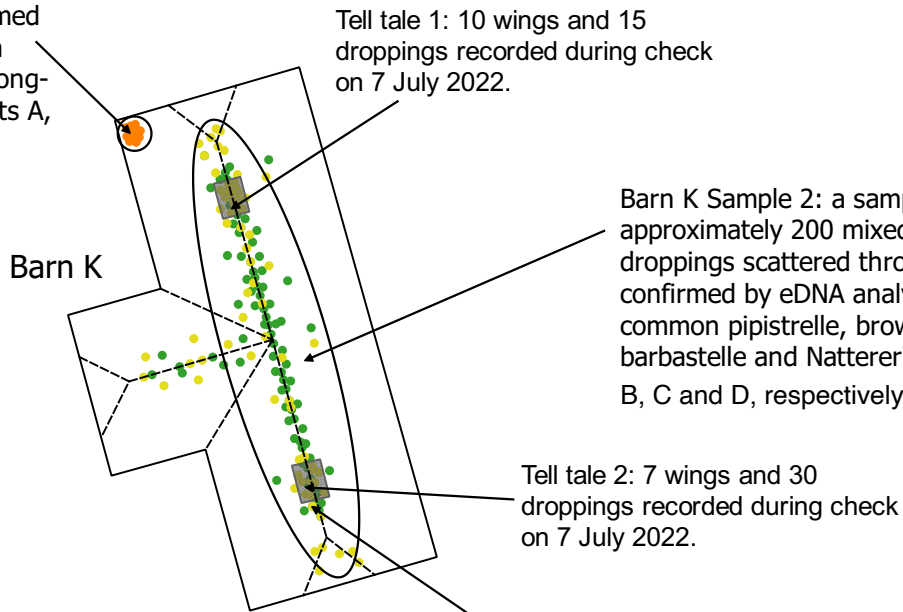
Barn K Sample 1: approximately 20 mixed-age droppings concentrated below a mortice and tenon joint were confirmed by eDNA analysis to be from common pipistrelle, brown long-eared and barbastelle (Roosts A, B and C).

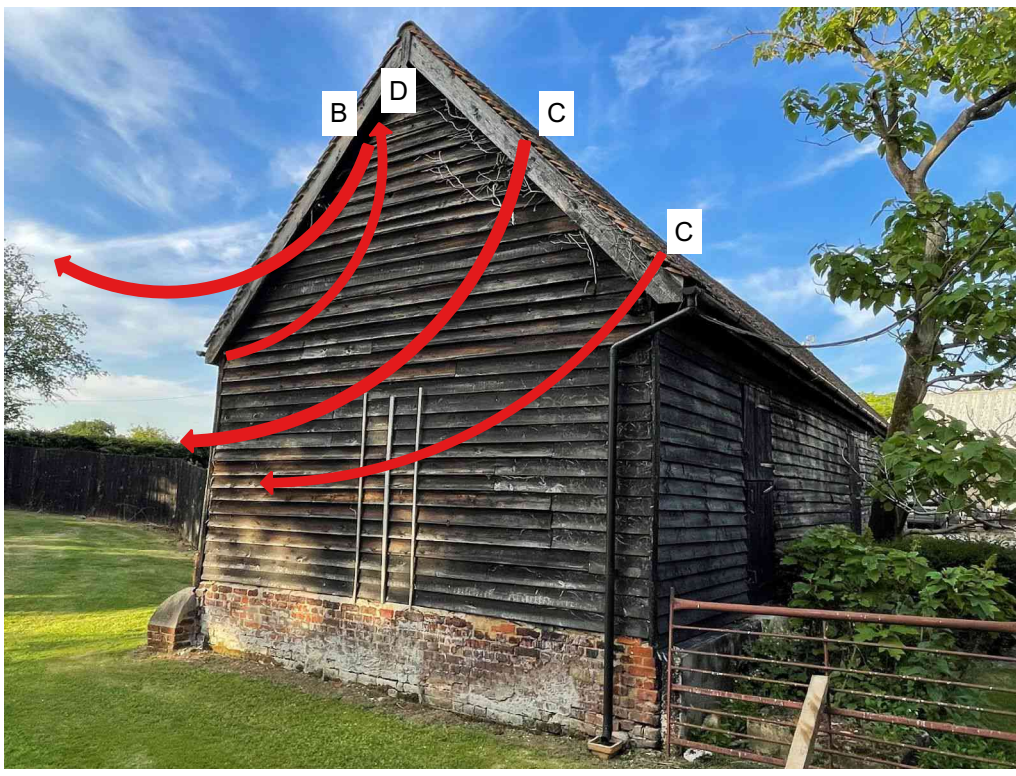
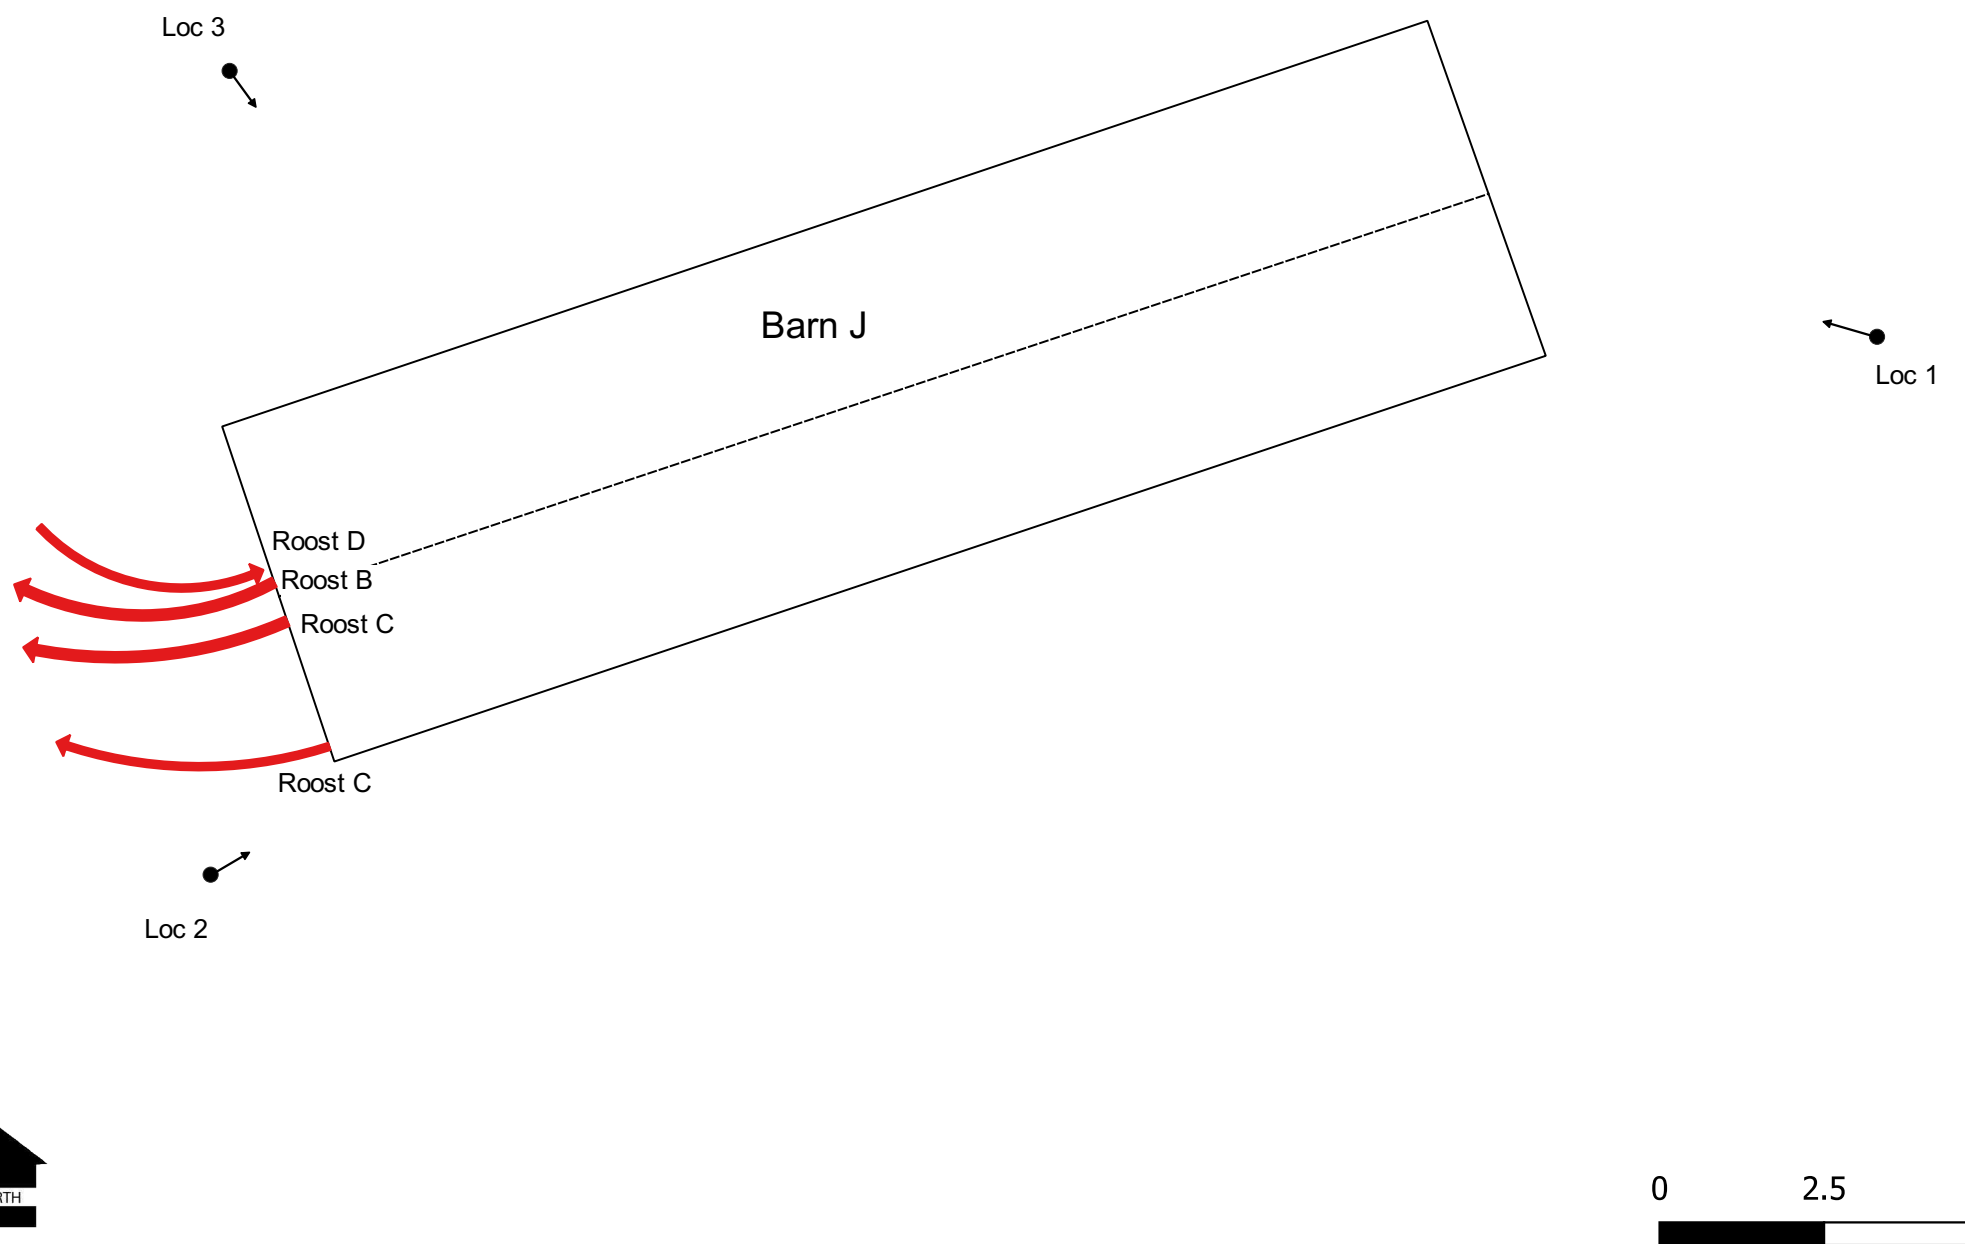
Figure 4.
Results of bat survey
visit 1, Barn J

Two common pipistrelle bats emerged from a gap under the fascia on the western gable end at 14 minutes and 22 minutes after sunset (Roost B)

Three common pipistrelle bats emerged from gaps under roof tiles on the western gable end (on the southern elevation of the pitched roof) at 16, 22 and 27 minutes after sunset (Roost C).

One common pipistrelle returned to roost to a gap under the fascia on the western gable end at 65 minutes after sunset (Roost D).

Visit no	Figure	Date	Survey type (survey locations)	Results of the survey	Incidental records of bat activity
Barn J					
1	4	14/06/22	Emergence (1, 2, 3)	Roost B Two common pipistrelle bats emerged via a gap under the fascia on the western gable end at 14 minutes and 22 minutes after sunset.	High levels of activity from commuting and foraging common pipistrelle. Passes from commuting and foraging soprano pipistrelle were also noted. Other species recorded include long-eared bats, myotis and a noctule, Leisler's or serotine bat. The first bat recorded was a common pipistrelle at 14 minutes after sunset, which emerged from Roost B.
				Roost C Three common pipistrelle bats emerged via gaps under roof tiles on the western gable end (on the southern elevation of the pitched roof) at 16, 22 and 27 minutes after sunset.	
				Roost D One common pipistrelle returned to roost to a gap under the fascia on the western gable end at 65 minutes after sunset.

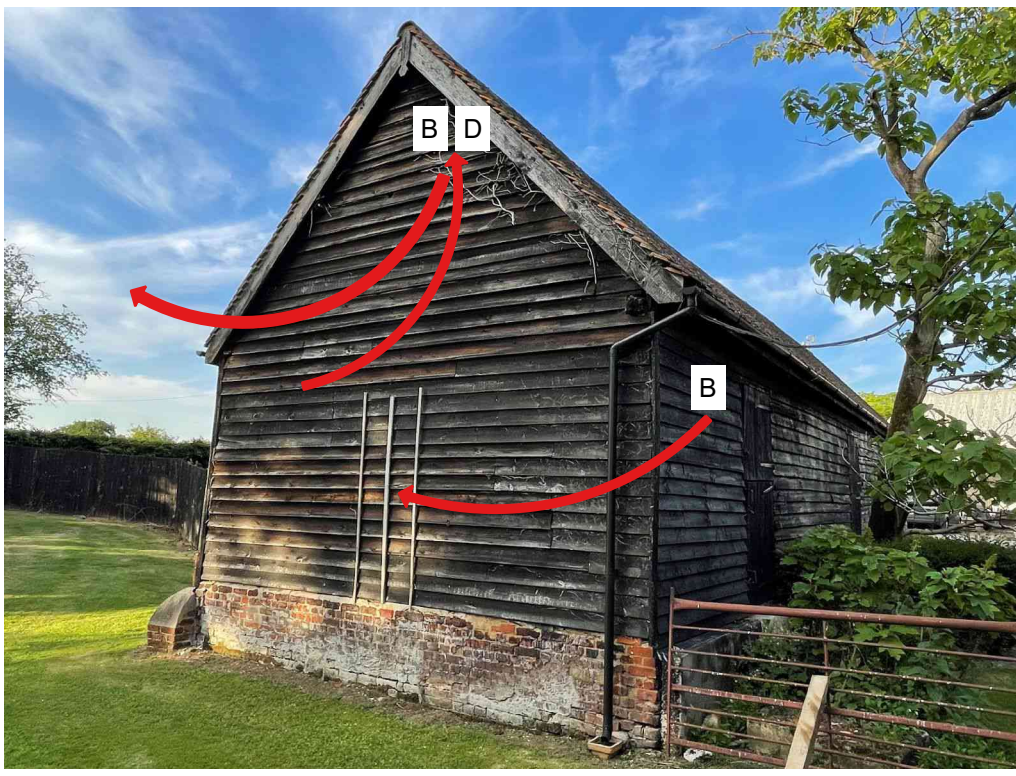
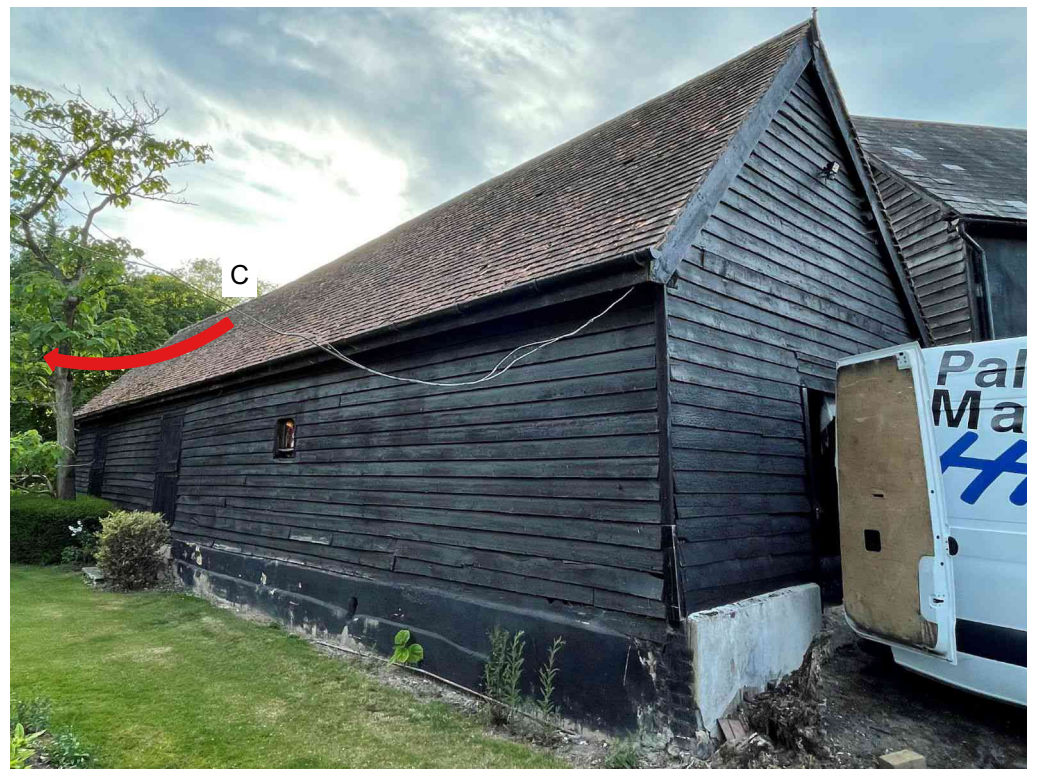
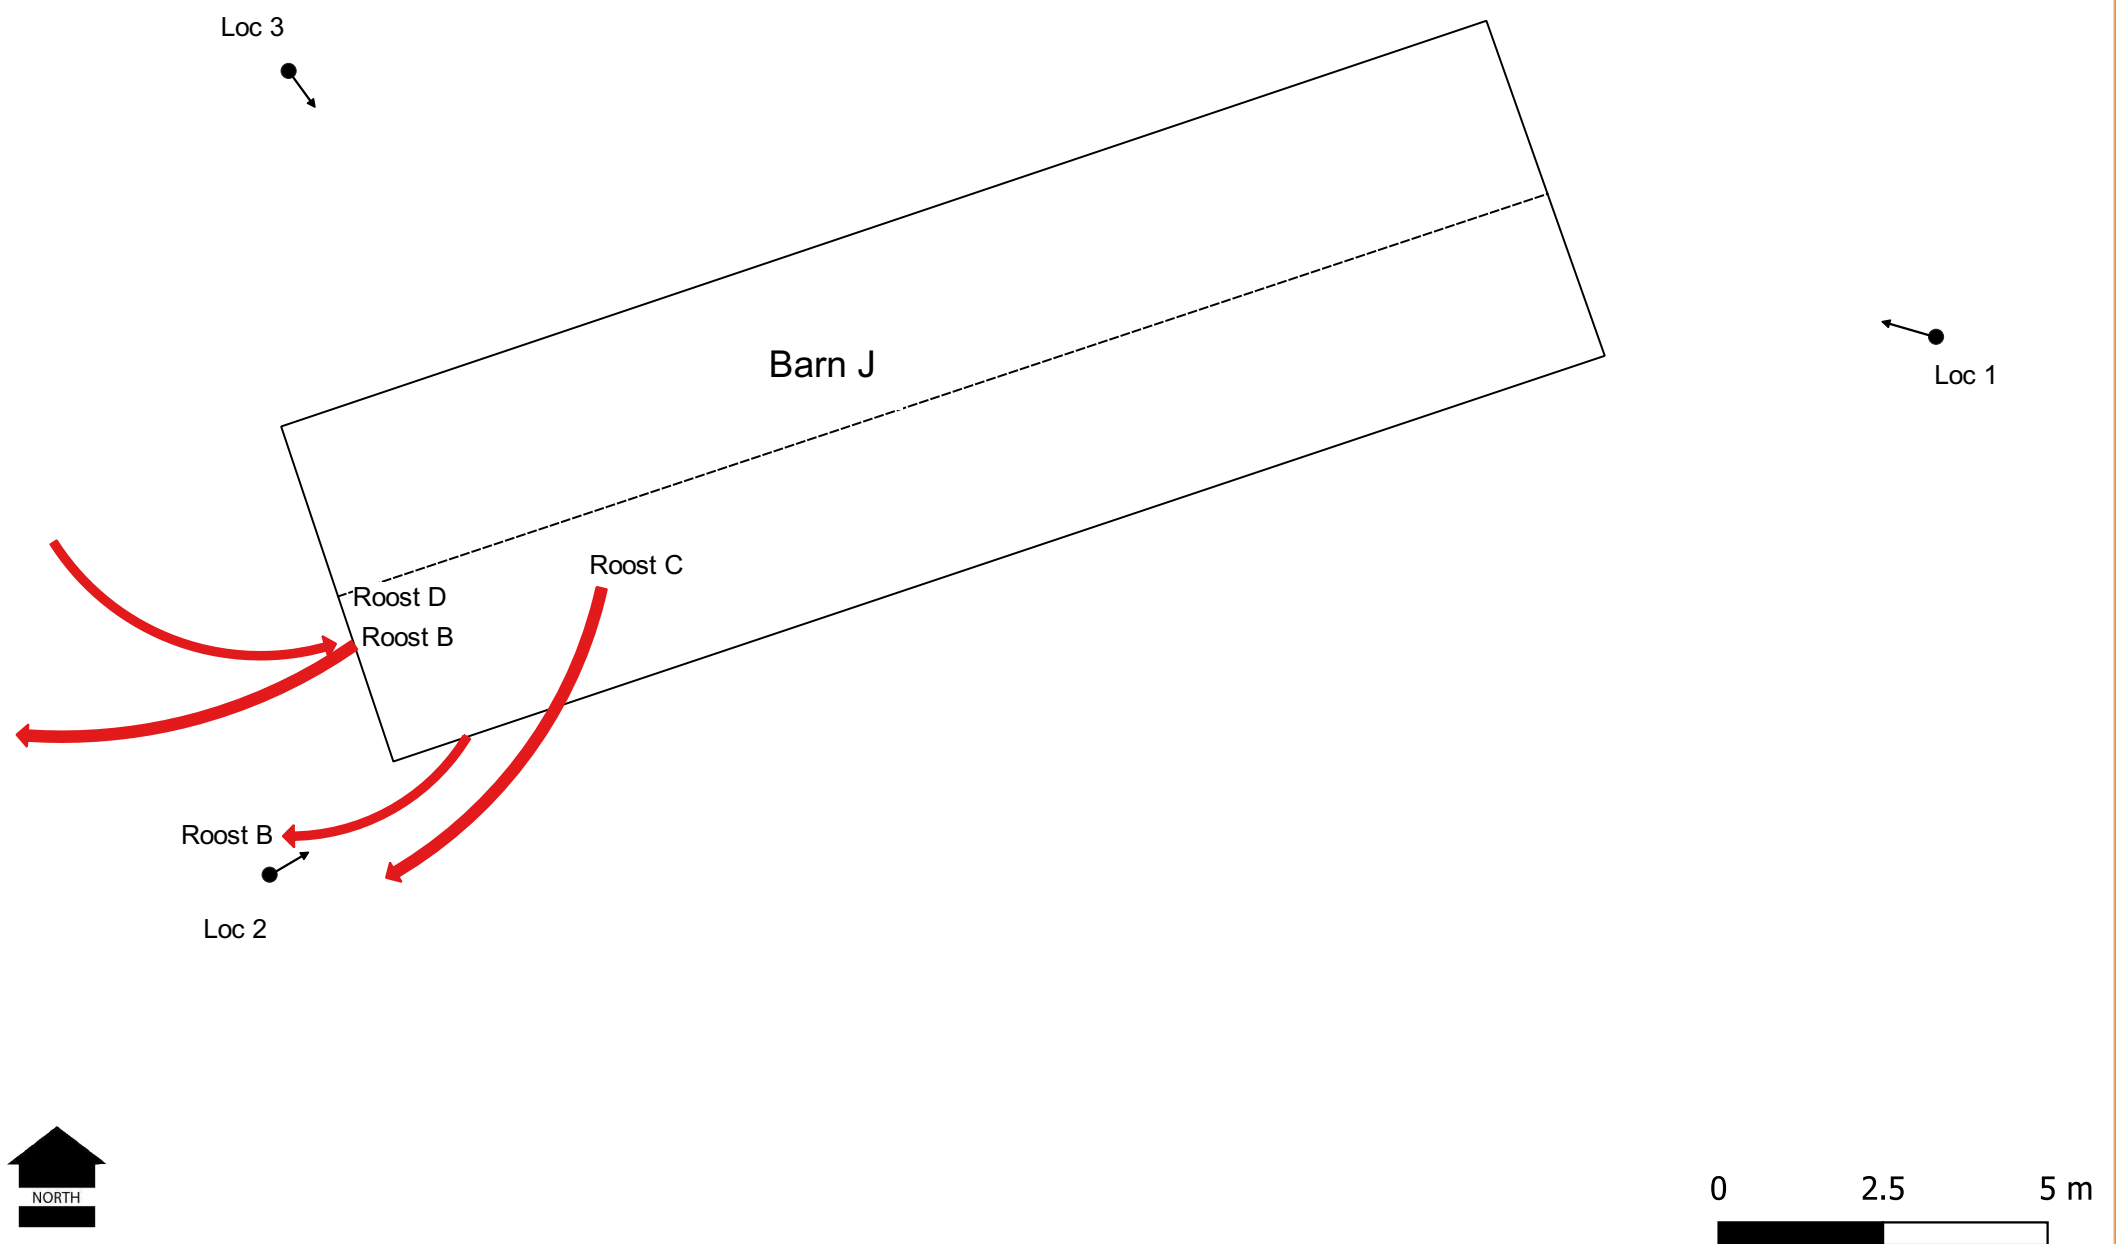
Figure 5.
Results of bat survey
visit 2, Barn J

Two common pipistrelle bats emerged from beneath the weatherboarding on the western gable end at 15 minutes and 22 minutes after sunset (Roost B).

One common pipistrelle emerged from under the weatherboarding on the southern elevation of the barn at 18 minutes after sunset (Roost B).

One common pipistrelle returned to roost at the weatherboarding on the western gable end at 55 minutes after sunset (Roost D).

Two common pipistrelles emerged from gaps under roof tiles on the southern elevation of the pitched roof at 16 and 18 minutes after sunset (Roost C).

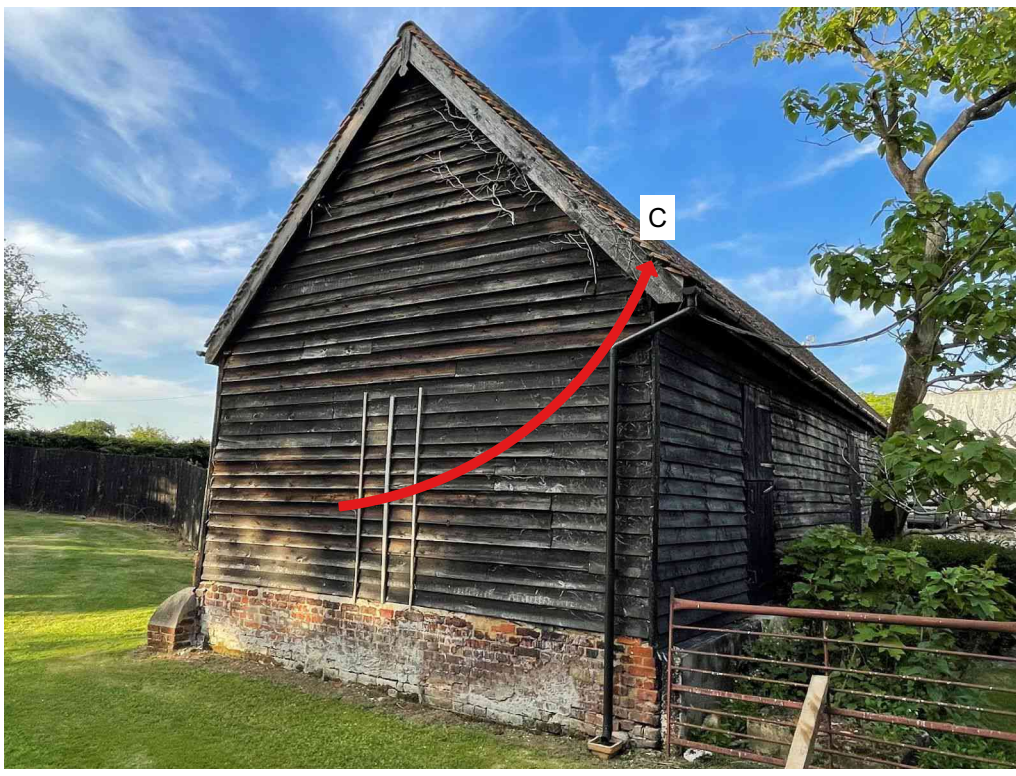
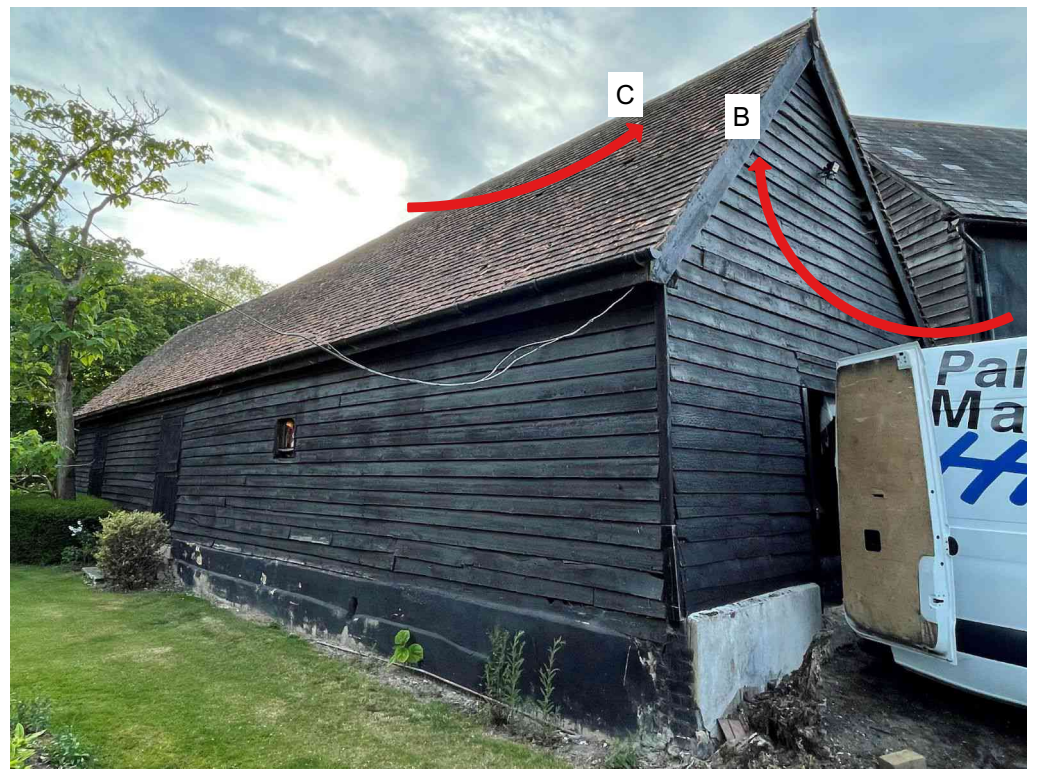
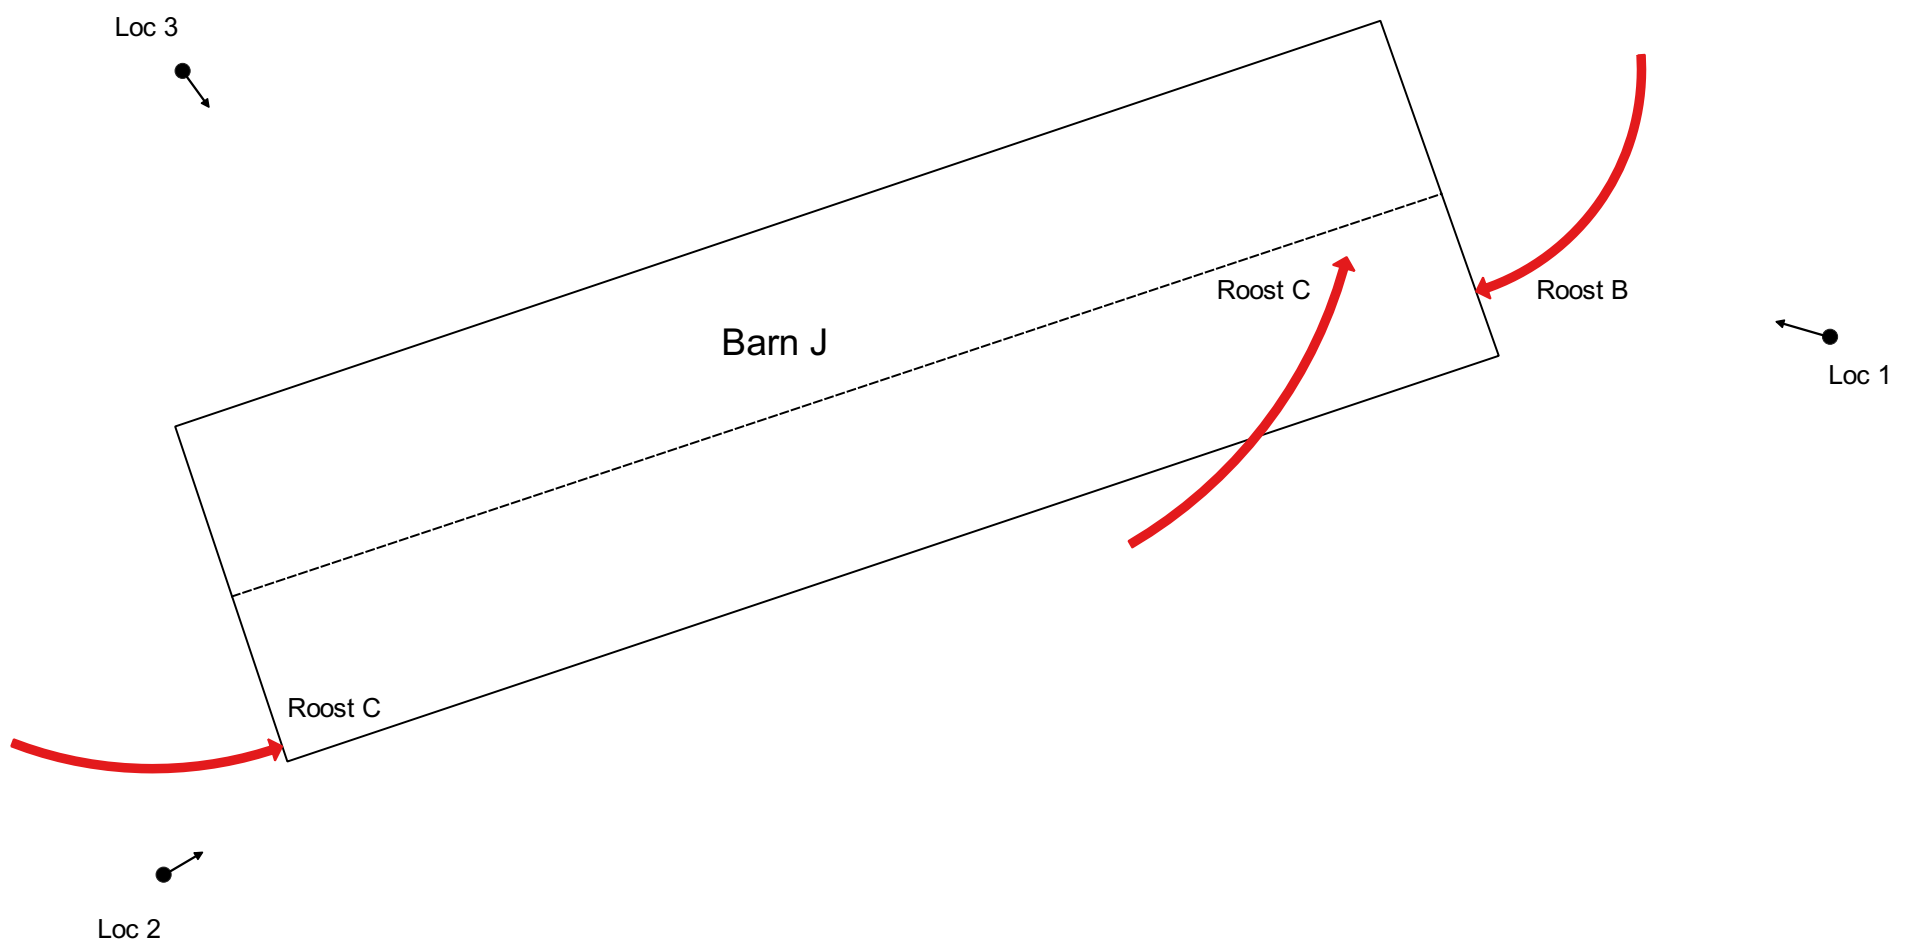
Figure 6.
Results of bat survey
visit 3, Barn J

One common pipistrelle returned to roost under roof tiles at the western gable end at 18 minutes before sunrise (Roost C).

One bat echolocating at around 50 kHz, considered most likely to be a common pipistrelle, returned to roost under a roof tile on the southern elevation of Barn J at 17 minutes before sunrise (Roost C).

One common pipistrelle returned to roost to a gap under the fascia on the eastern gable end at 15 minutes before sunrise (Roost B).

3	6	28/07/22	Return to roost (1, 2, 3)	Roost C One bat echolocating at around 50 kHz, considered most likely to be a common pipistrelle, returned to roost under a roof tile on the southern elevation of Barn J at 17 minutes before sunrise. One common pipistrelle returned to roost under roof tiles at the western gable end at 18 minutes before sunrise.	High levels of activity from commuting and foraging common pipistrelle with social calls also noted. Moderate commuting and foraging activity from soprano pipistrelle. Other bat species recorded included long-eared bats and myotis. The last bat recorded was a common pipistrelle at 12 minutes before sunrise.

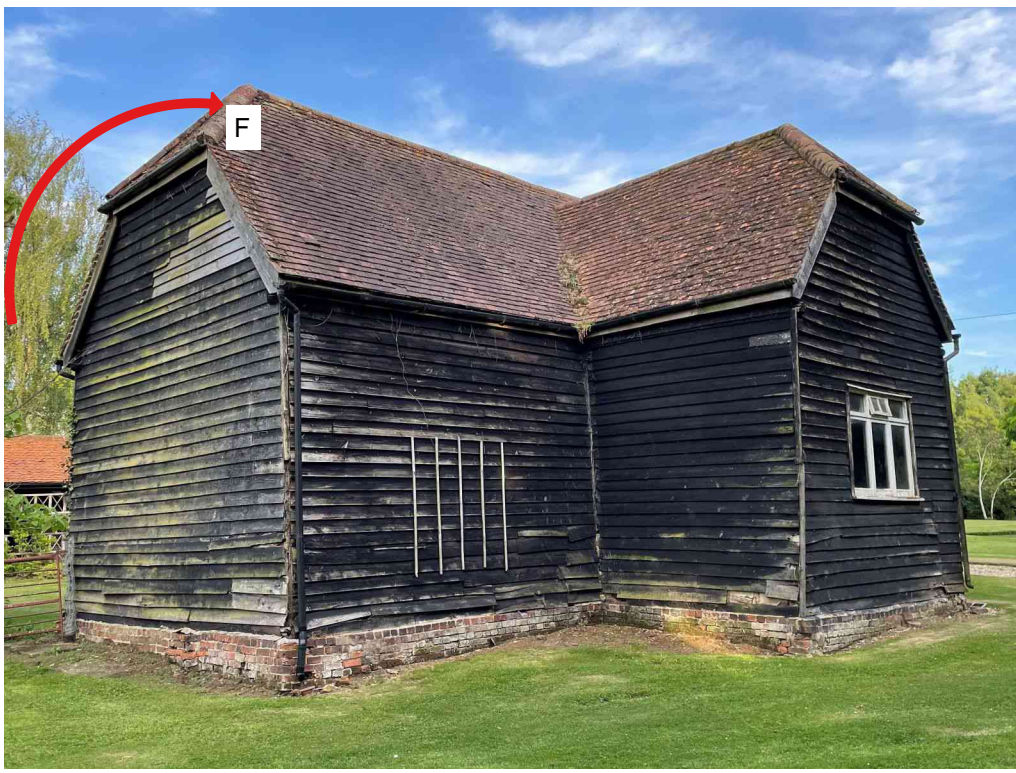
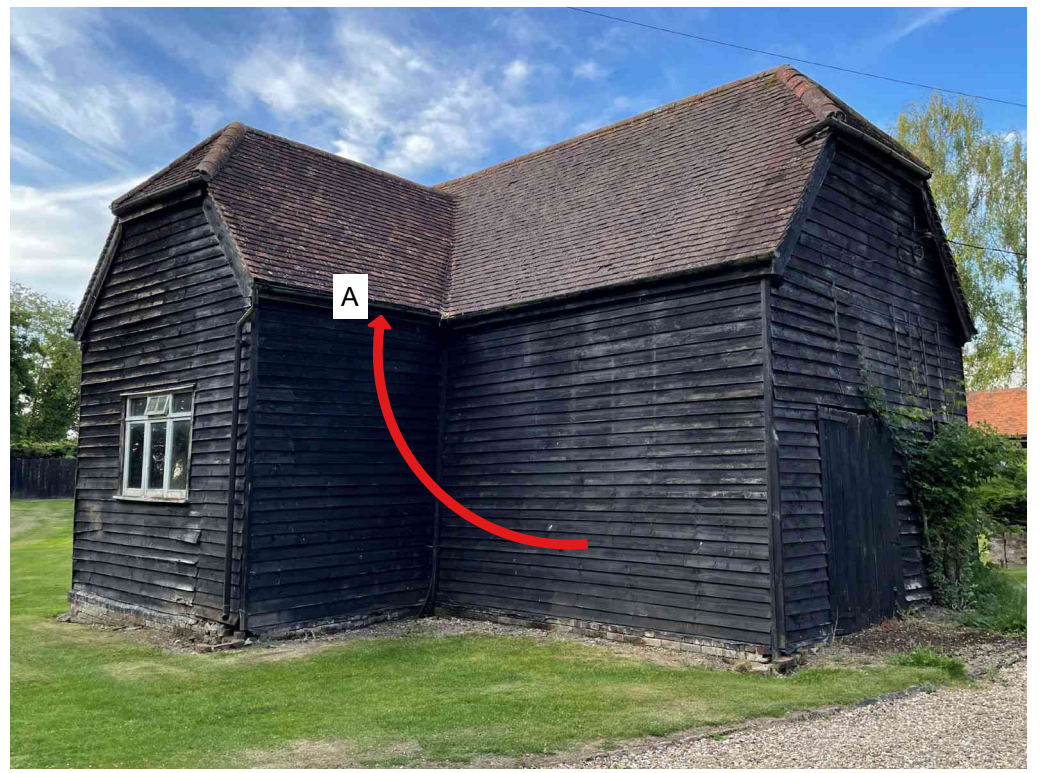
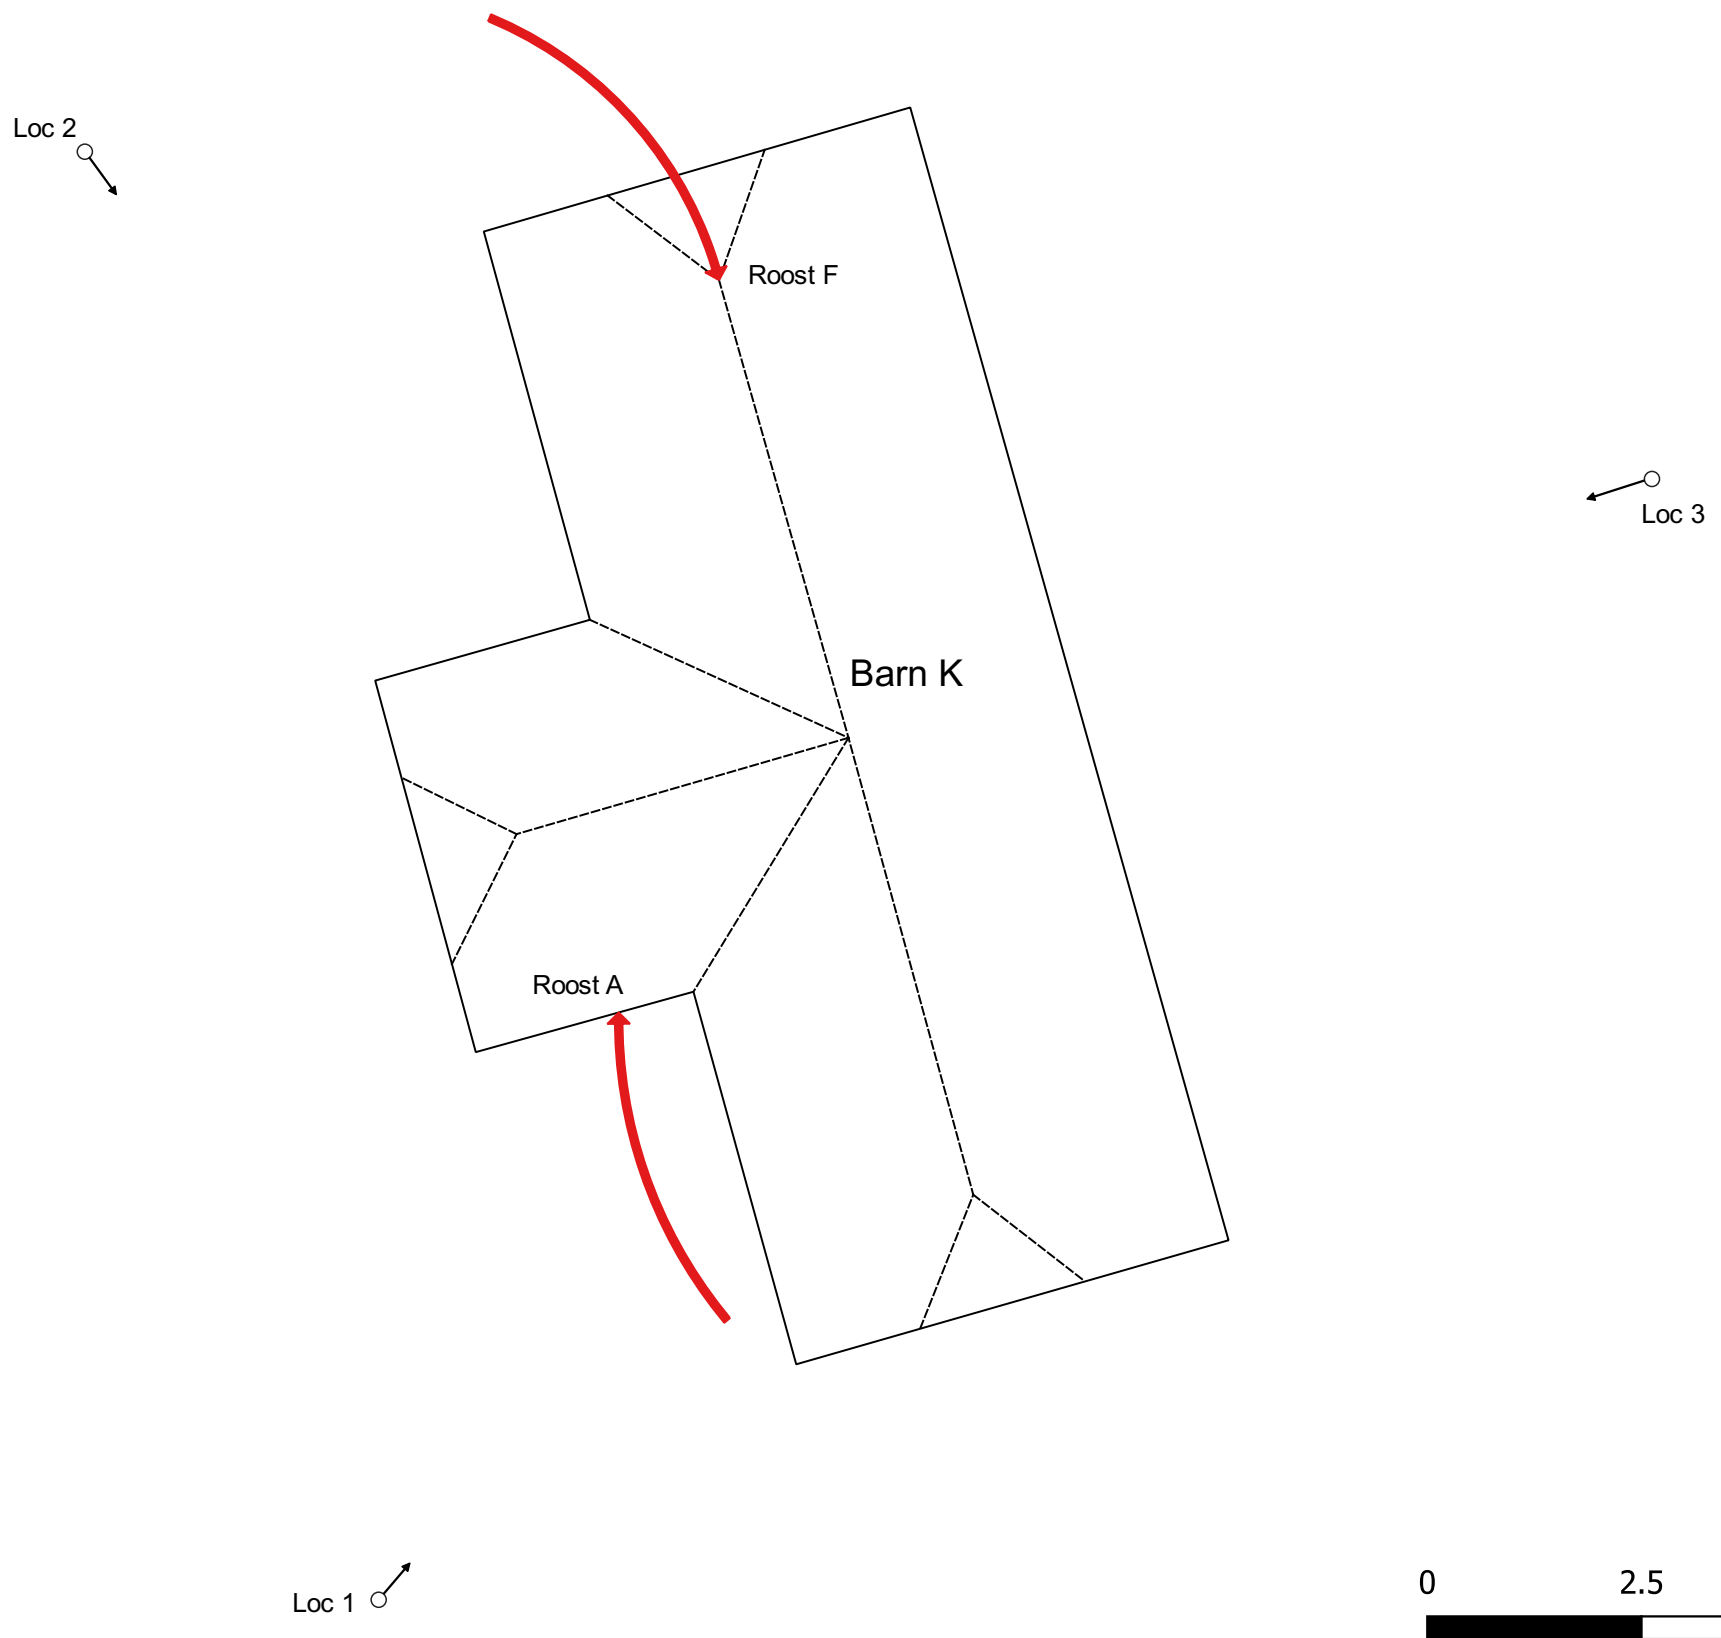
Figure 7.
Results of bat survey
visit 1, Barn K

One common pipistrelle returned to roost to the half hip apex at the northern gable end at 51 minutes before sunrise (Roost F).

One common pipistrelle returned to roost via a gap under the fascia on the side of the western gable end at 48 minutes before sunrise (Roost A).

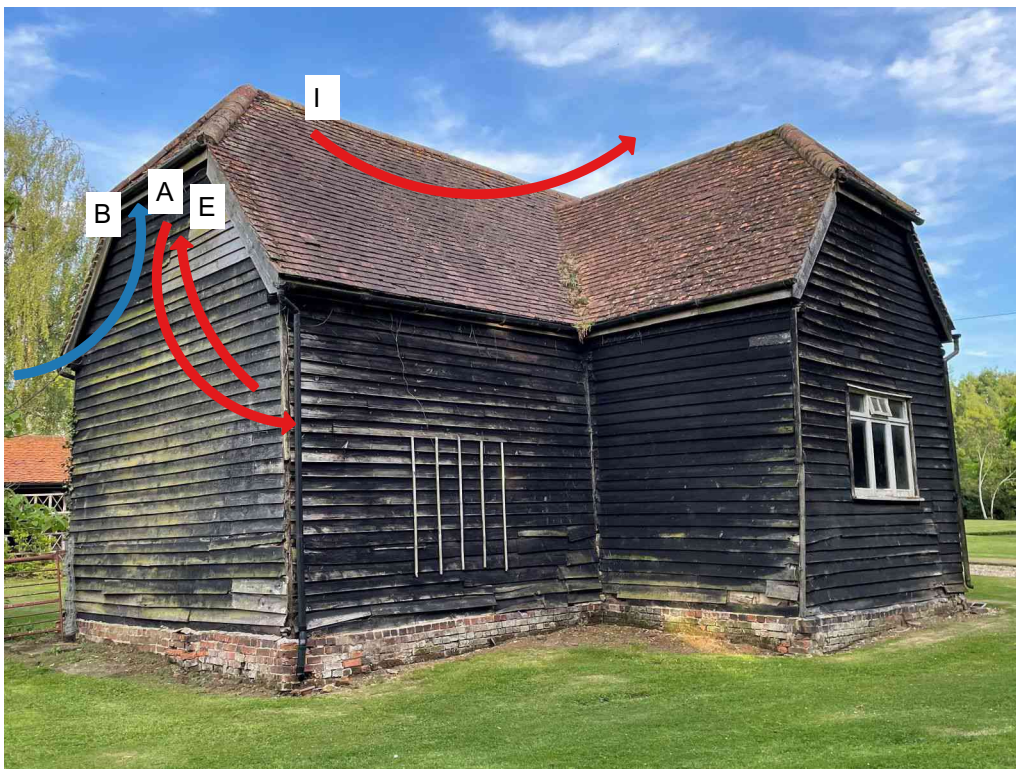
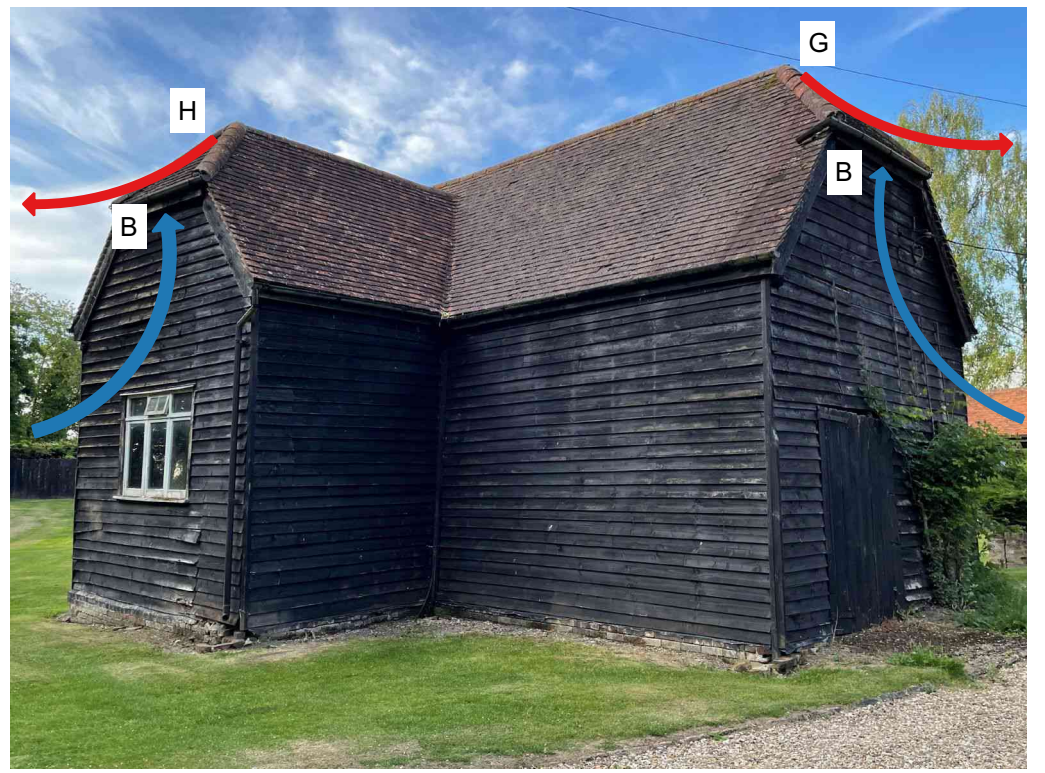
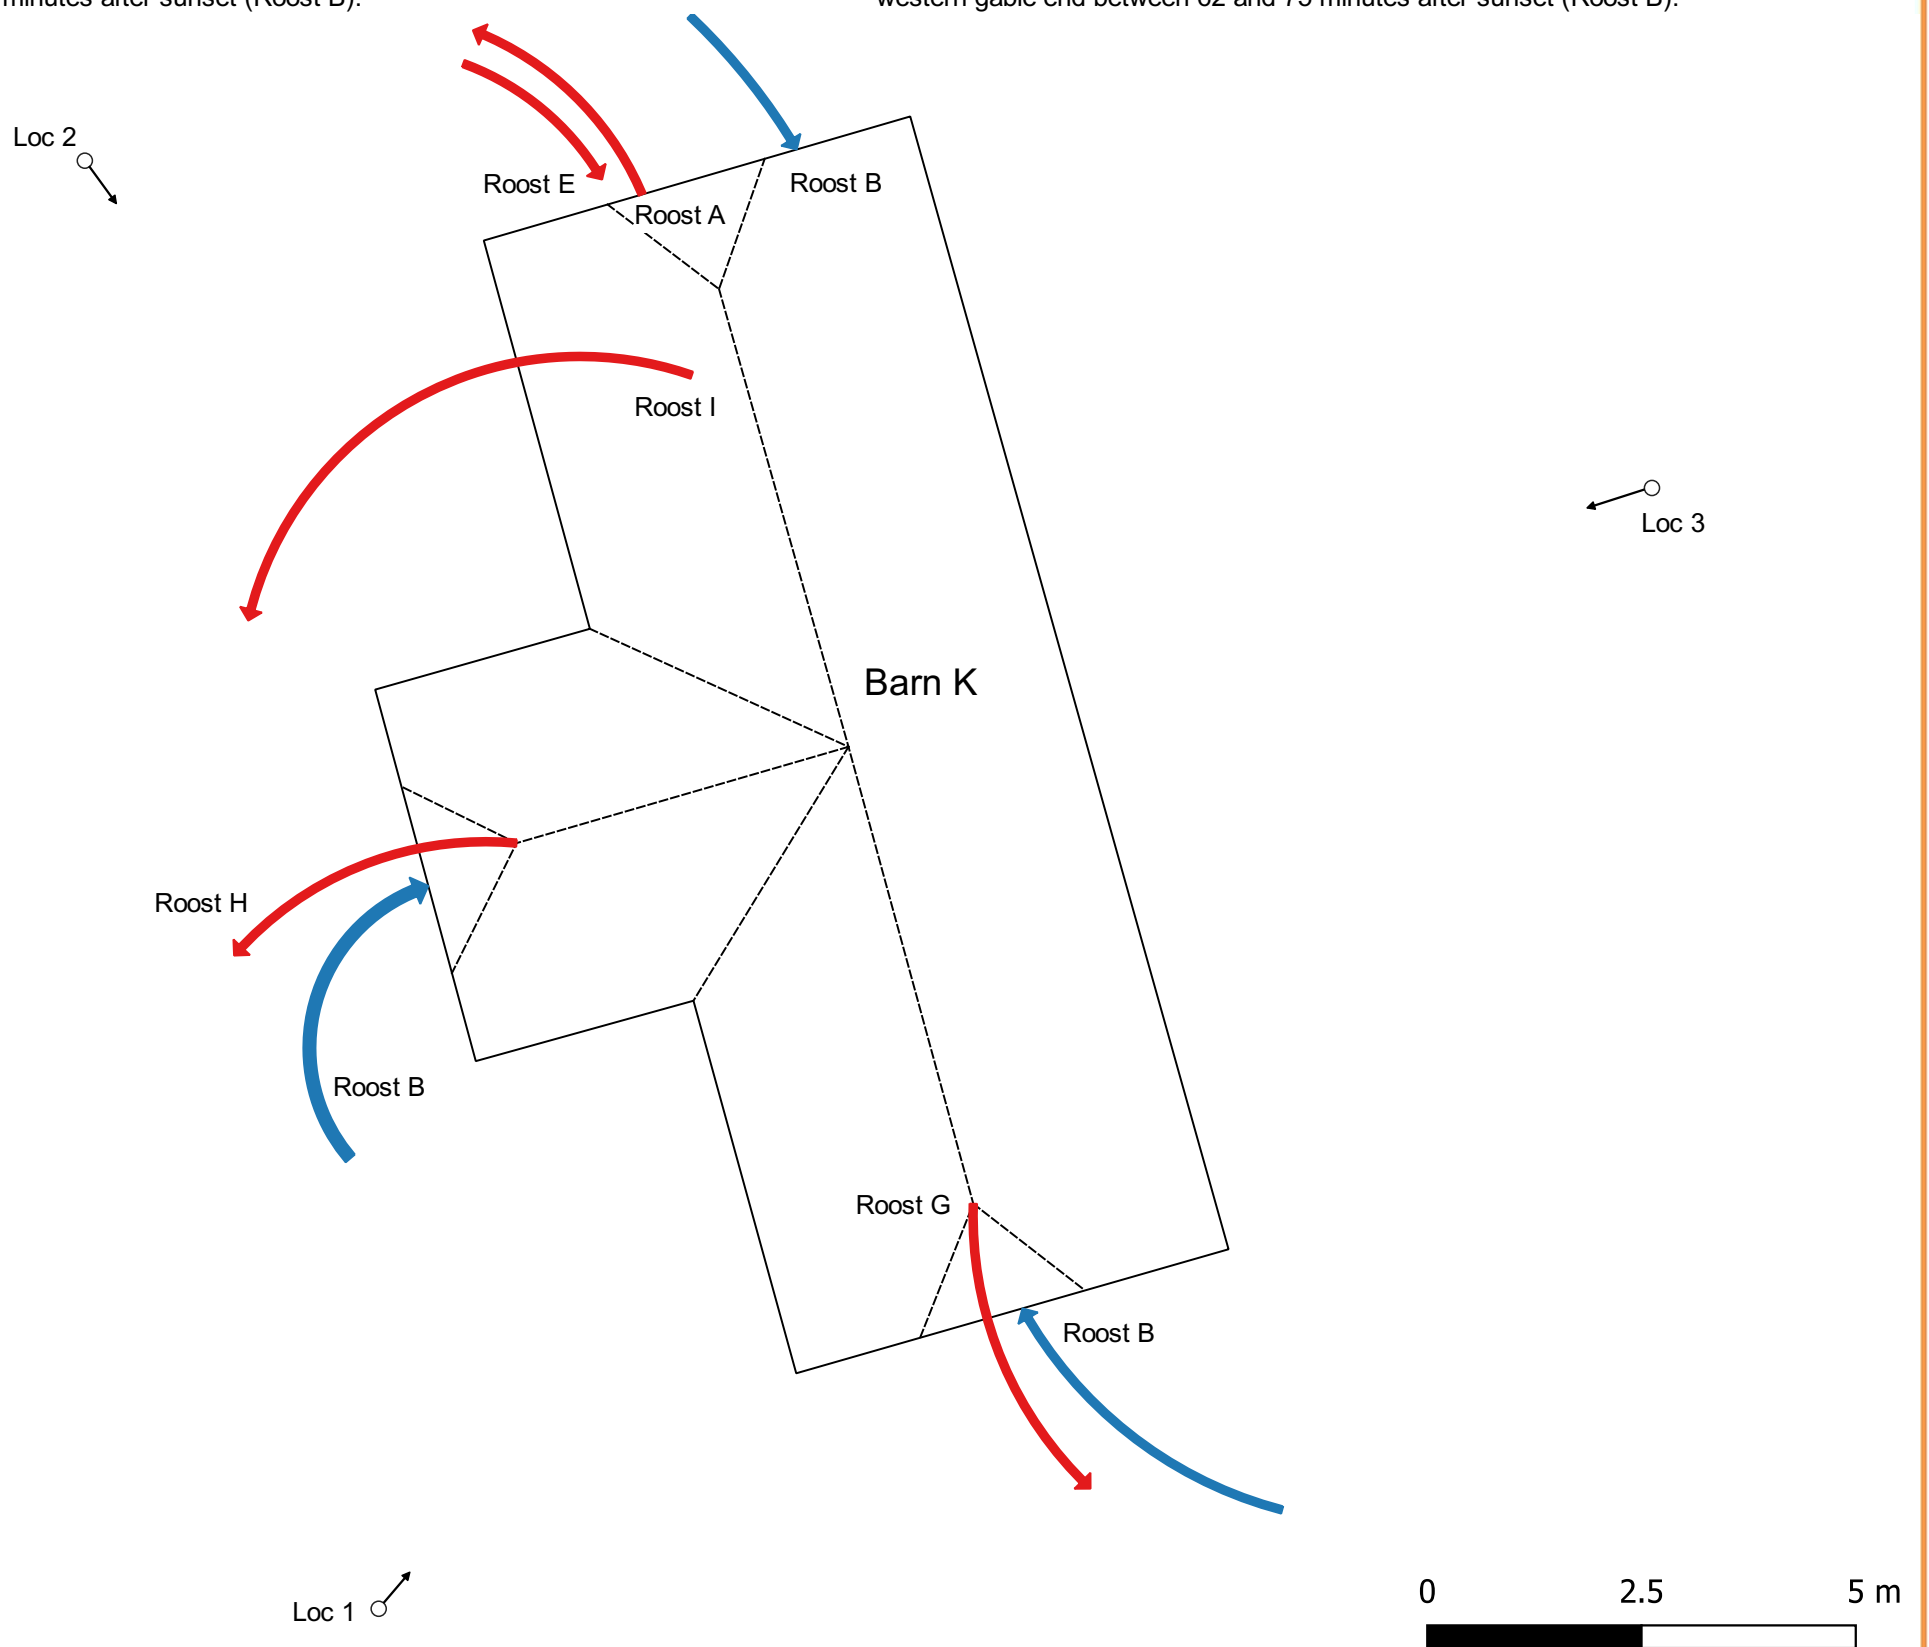
Figure 8.
Results of bat survey visit 2, Barn K

One common pipistrelle emerged from a roof tile on the western elevation at 23 minutes after sunset (Roost I).

One common pipistrelle emerged from the half hip apex at the southern gable end at 10 minutes after sunset (Roost G).

One brown-long eared bat returned to roost via a gap under the fascia on the northern gable end at 57 minutes after sunset (Roost B).

Three brown long-eared bats returned to roost via a gap under the fascia on the western gable end between 62 and 75 minutes after sunset (Roost B).

Roost F One common pipistrelle returned to roost to the half hip apex at the northern gable end at 51 minutes before sunrise.	
2	8	05/07/22	Emergence (1, 2, 3)	Roost G One common pipistrelle emerged from the half hip apex at the southern gable end at 10 minutes after sunset.	High levels of activity from commuting and foraging common pipistrelle with social calls also noted. Other species recorded include soprano pipistrelle, long-eared bats and myotis. The first bat recorded was a common pipistrelle at six minutes after sunset.
				Roost H One common pipistrelle emerged from the half hip apex at the western gable end at 15 minutes after sunset.	
				Roost I One common pipistrelle emerged from a roof tile on the western elevation at 23 minutes after sunset.	
				Roost A One common pipistrelle emerged from the weatherboarding on the northern gable end at 36 minutes after sunset.	
				Roost E One common pipistrelle returned to roost to the weatherboarding on the northern gable end at 49 minutes after sunset.
