Barns J and K, Hixham Hall Barns, Furneux Pelham

Great crested newt and
bat survey and
assessment

Report ref.:
WRL101/R002V2

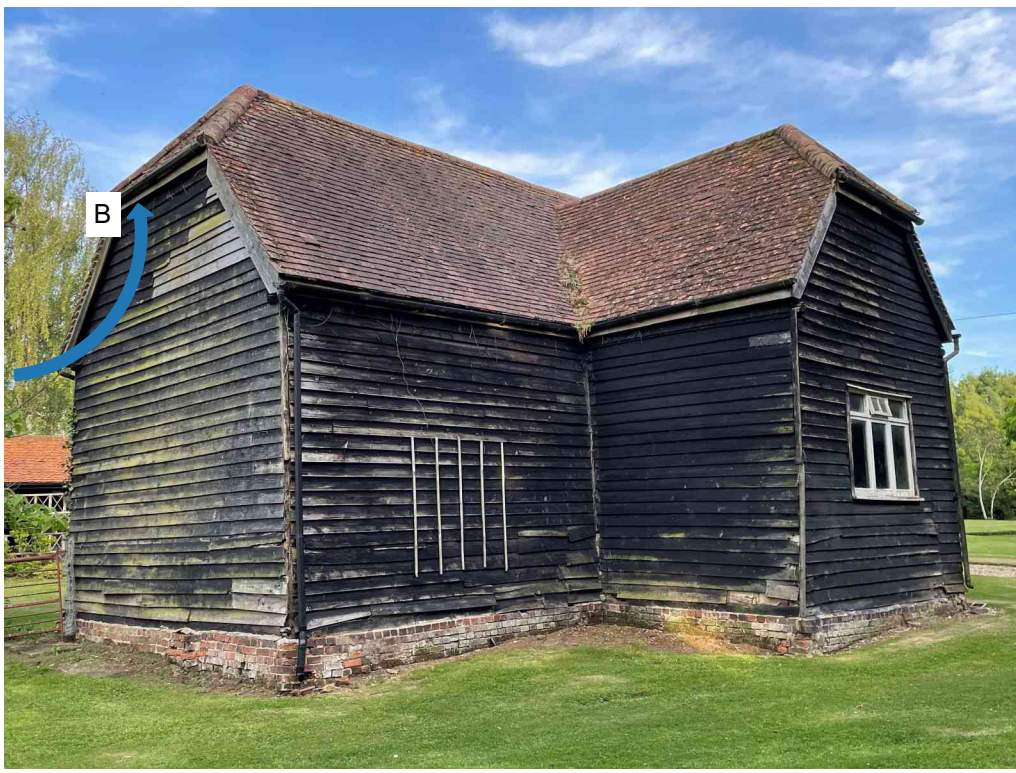
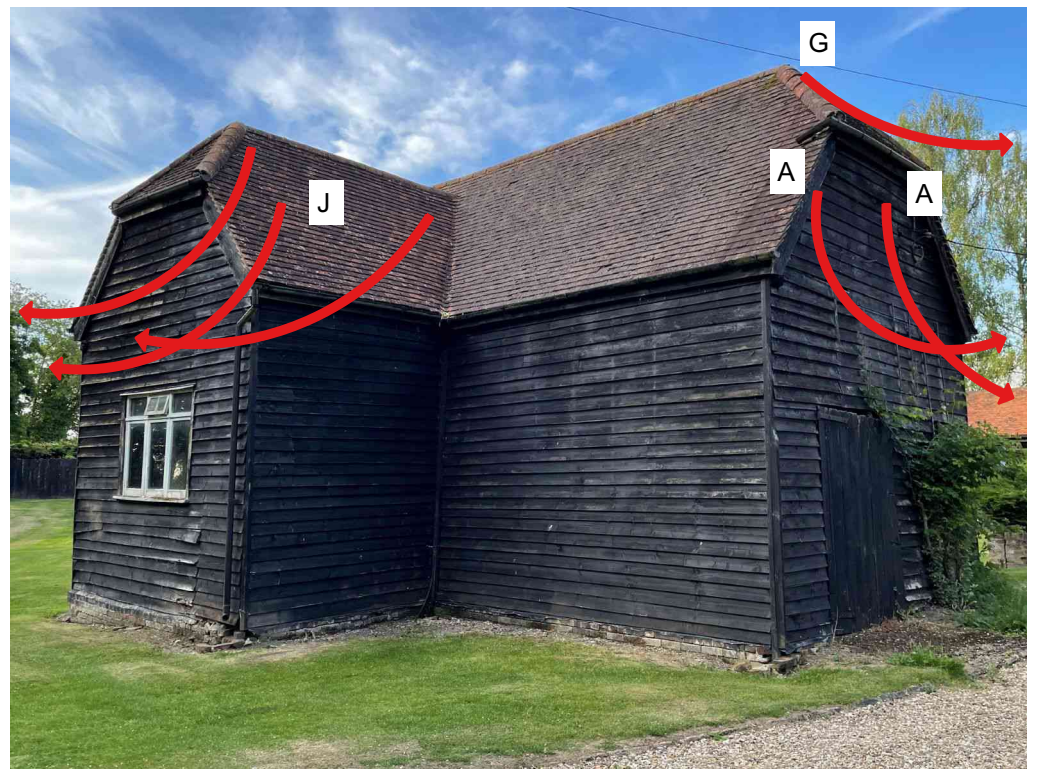
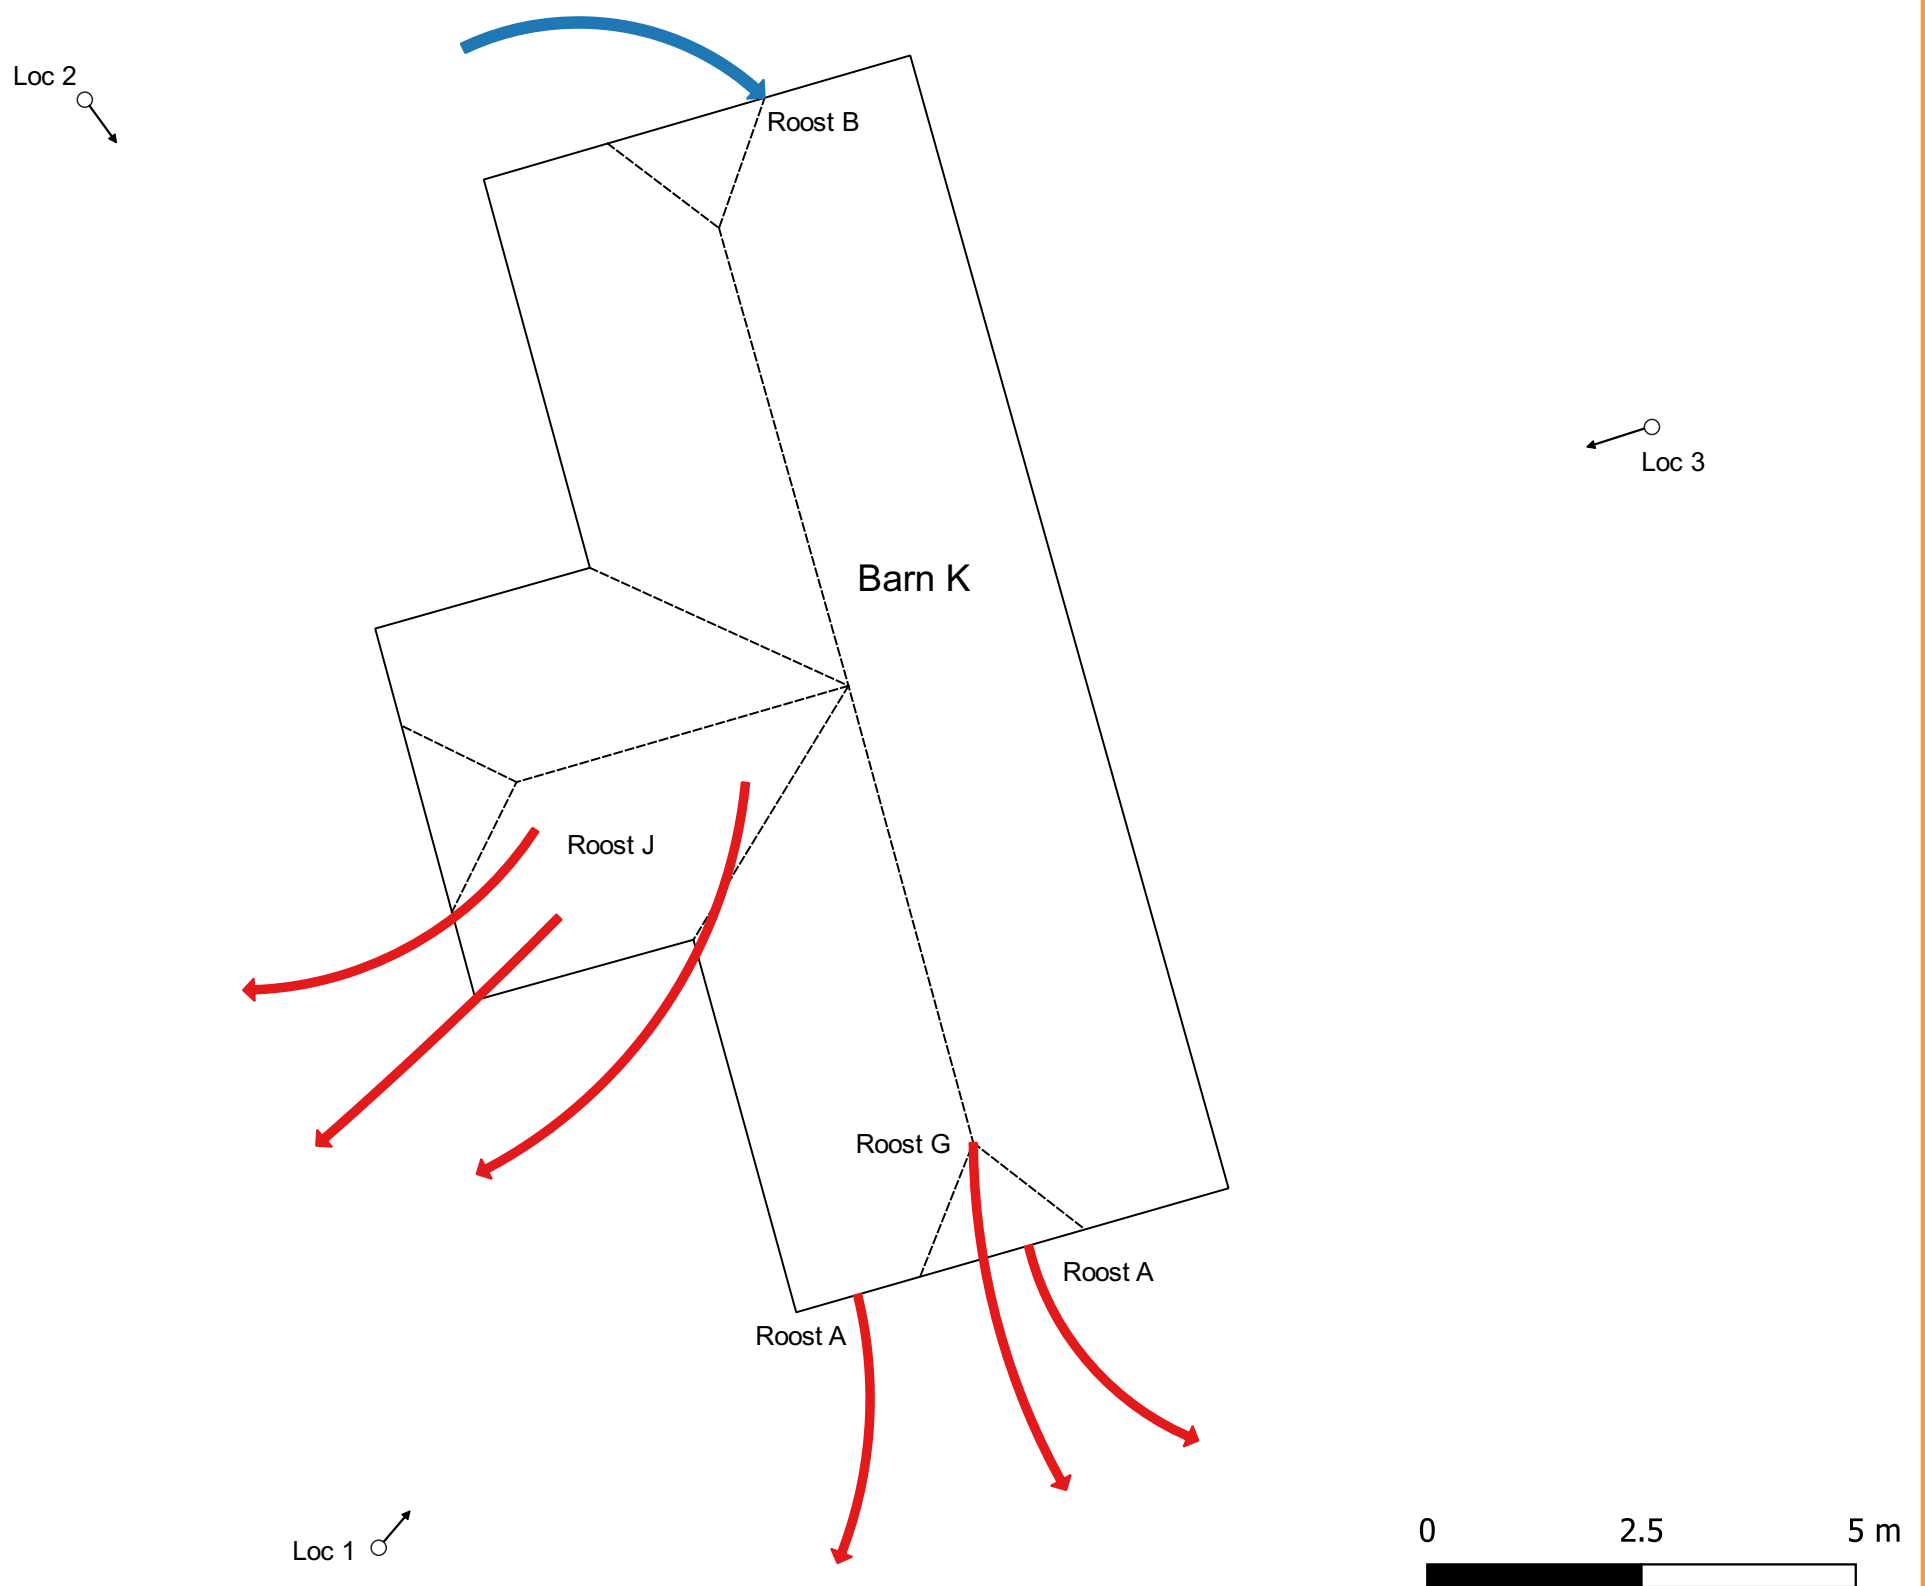
Figure 9.
Results of bat survey
visit 3, Barn K

Two brown-long eared bats returned to roost via a gap under the fascia on the northern gable end at 61 and 78 minutes after sunset (Roost B).

One common pipistrelle emerged from the weatherboarding on the southern gable end at six minutes after sunset (Roost A).

One common pipistrelle emerged from under the fascia on the southern gable end at eight minutes after sunset (Roost A).

One common pipistrelle emerged from the half hip apex at the southern gable end at 10 minutes after sunset (Roost G).

Three common pipistrelle emerged from underneath roof tiles on a south facing roof pitch between 10 and 14 minutes after sunset (Roost J).

Visit no	Figure	Date	Survey type (survey locations)	Results of the survey	Incidental records of bat activity
3	9	28/07/22	Emergence (1, 2, 3)	Roost A One common pipistrelle emerged from the weatherboarding on the southern gable end at six minutes after sunset. One common pipistrelle emerged from under the fascia on the southern gable end at eight minutes after sunset.	High levels of activity from commuting and foraging common pipistrelle with social calls also noted. Other species recorded include soprano pipistrelle, long-eared bats and barbastelle. The first bat recorded was a common or soprano pipistrelle at five minutes after sunset.
				Roost G One common pipistrelle emerged from the half hip apex at the southern gable end at 10 minutes after sunset.	
				Roost J Three common pipistrelle emerged from underneath roof tiles on a south facing roof pitch between 10 and 14 minutes after sunset.

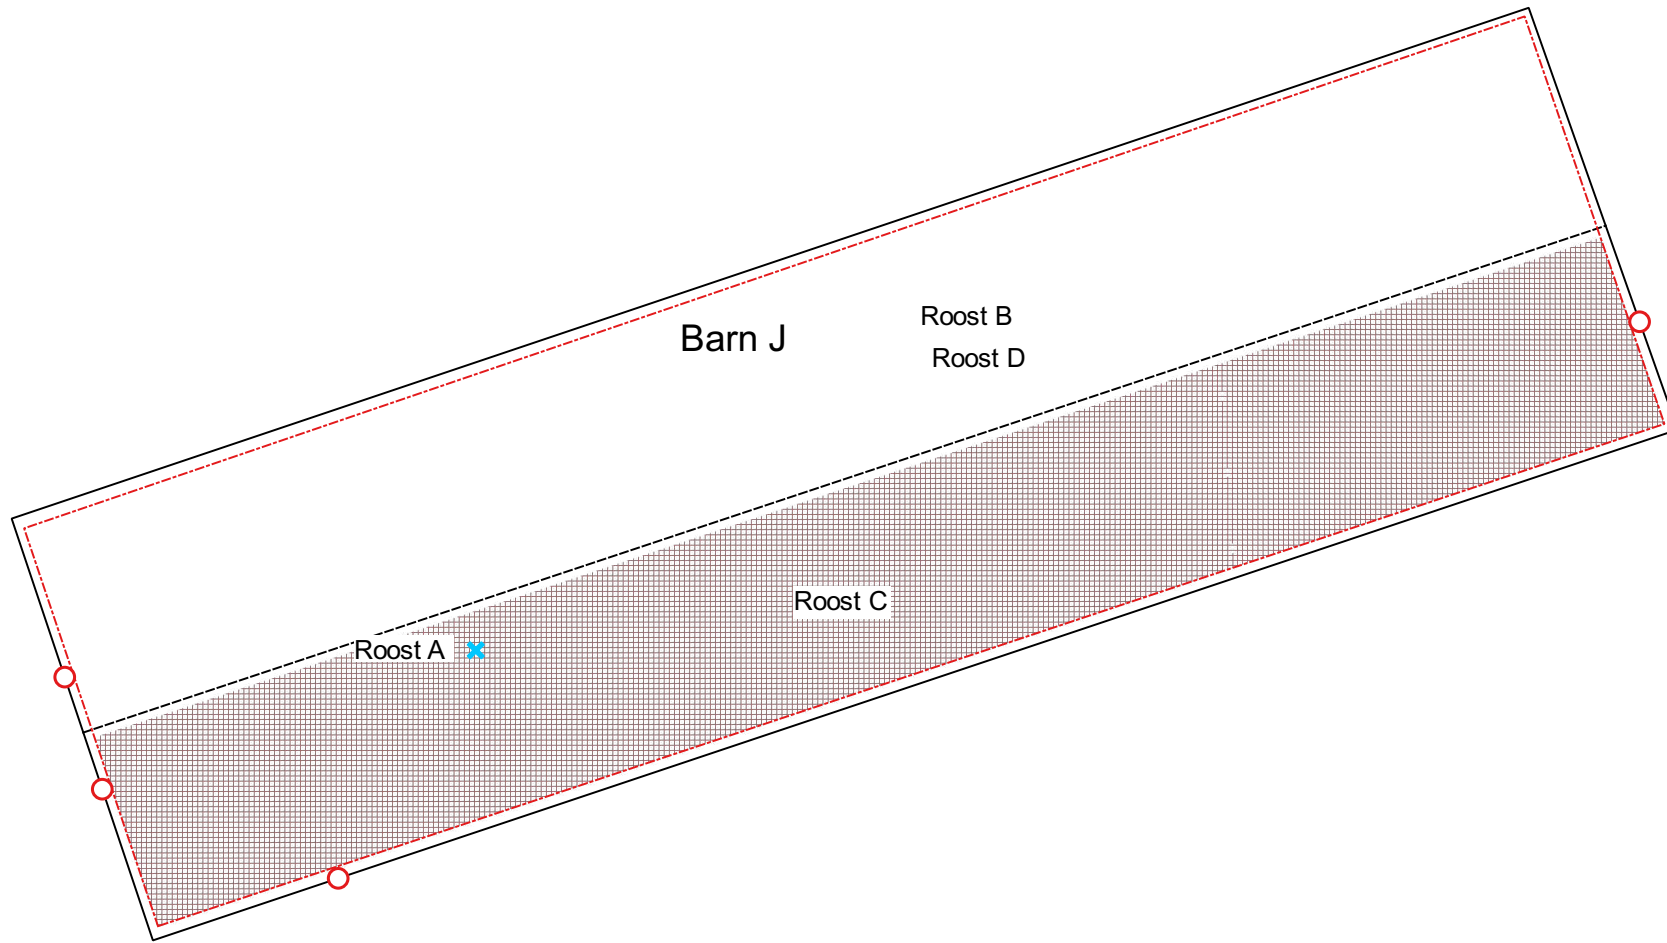
Figure 10.

Bat roost
summary, Barn J

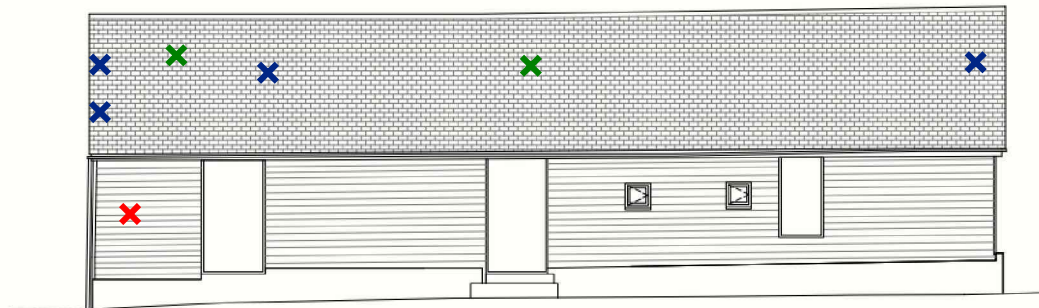
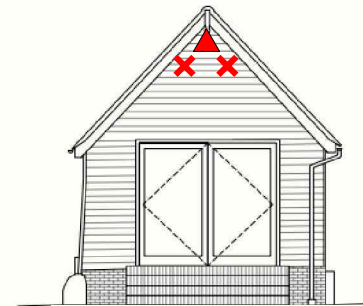
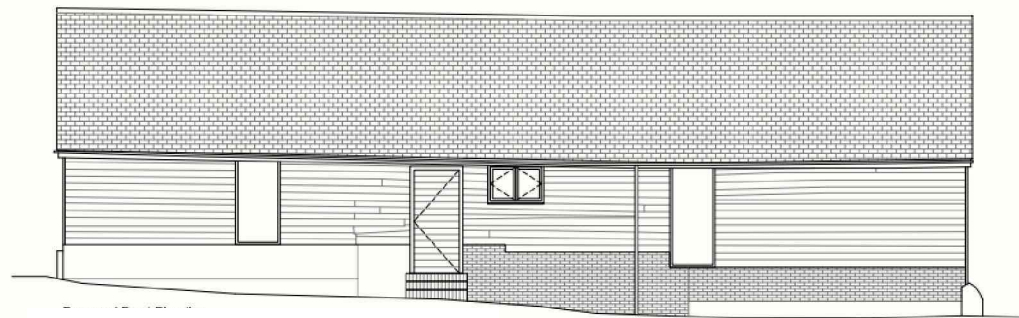
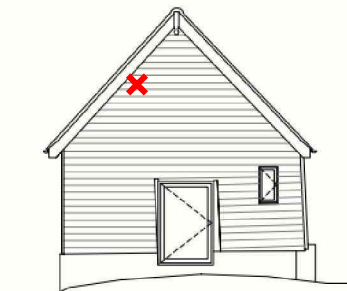
Proposed southern elevation

Proposed western elevation

Proposed northern elevation

Proposed eastern elevation

6.2.3 As shown on Figure 12 in Appendix A, a total of nine permanent replacement roosting opportunities capable of supporting the types of roost currently present within barn J will be incorporated into the fabric of the newly converted barn. These will comprise:

- One gap (approximately 25mm) will be created under the weatherboarding to replace the barbastelle day roost A. The gap will allow barbastelle bats to access a crevice between the weatherboarding and bitumen felt lining.

- Four gaps (approximately 25mm) will be created under the weatherboarding to replace the common pipistrelle day roost B. The gaps will be located at the same locations that common pipistrelles currently use to access the barn and will allow common pipistrelle bats to access crevices between the weatherboarding and bitumen felt lining.

- Four gaps (approximately 60-80mm x 15-25mm) will be created under roof tiles to replace common pipistrelle day roost C. The gaps will be located at the same location that common pipistrelles currently use and will allow common pipistrelle bats to access crevices between the roof tiles and bitumen felt lining.

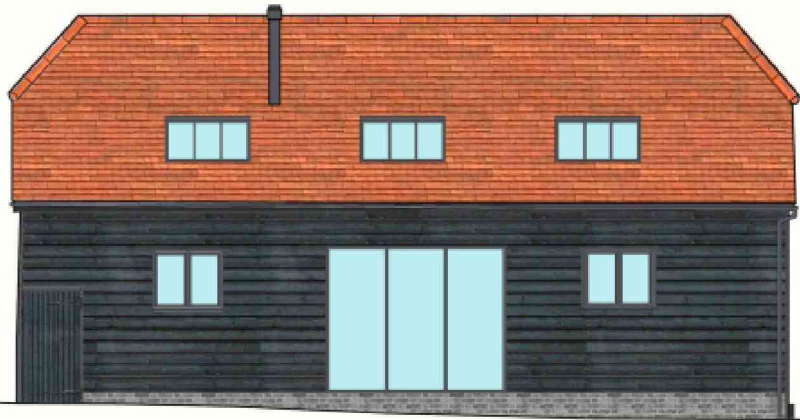
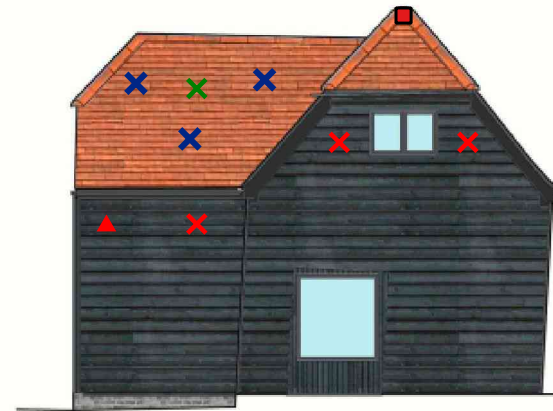
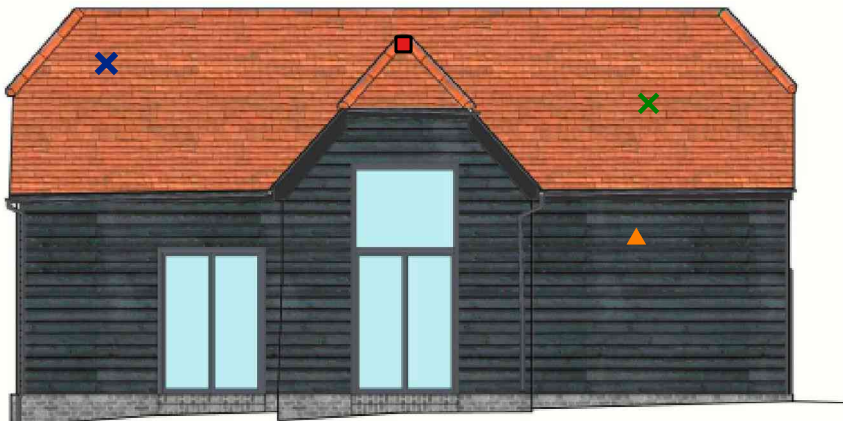
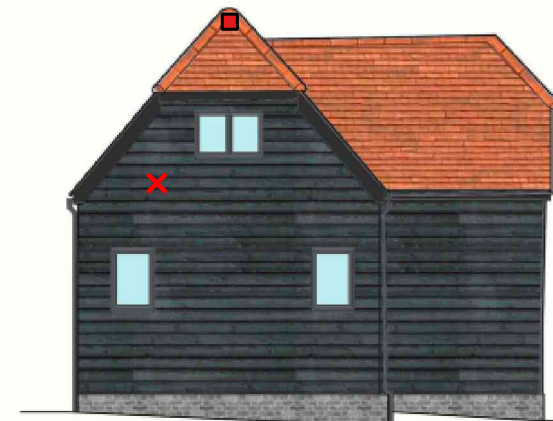
Figure 13.

Replacement bat roosts and enhancements for Barn K

6.2.6 As shown on Figure 13 in Appendix A, a total of 13 permanent replacement roosting opportunities capable of supporting the types of roost currently present within barn K will be incorporated into the fabric of the newly converted barn. These will comprise:

- Four gaps (approximately 15-25mm) will be retained or created under the weatherboarding to replace common pipistrelle day roost A. The gaps will be located at the same locations that common pipistrelles currently use to access the barn and will allow common pipistrelles to access crevices between the weatherboarding and bitumen felt lining.

- Three gaps will be created under hip tiles to replace common pipistrelle day roosts F, G and H. These will be installed at the half-hip apex of the northern, southern and western gable ends to replicate the current roost locations and will allow common pipistrelles to access gaps beneath the hip tiles.

- Four gaps (approximately 60-80mm x 15-25mm) will be created under roof tiles to replace common pipistrelle day roosts I and J. The gaps will be located at the same locations that common pipistrelles currently use, and will allow bats to access crevices between the roof tiles and bitumen felt lining.

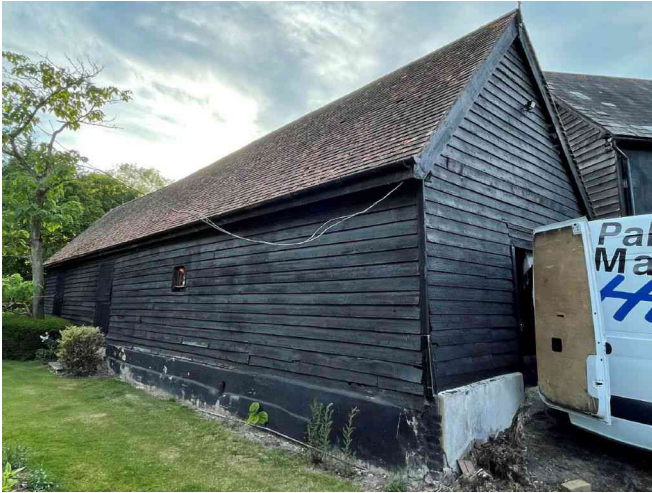
Photograph 1: South and east elevations of Barn J.

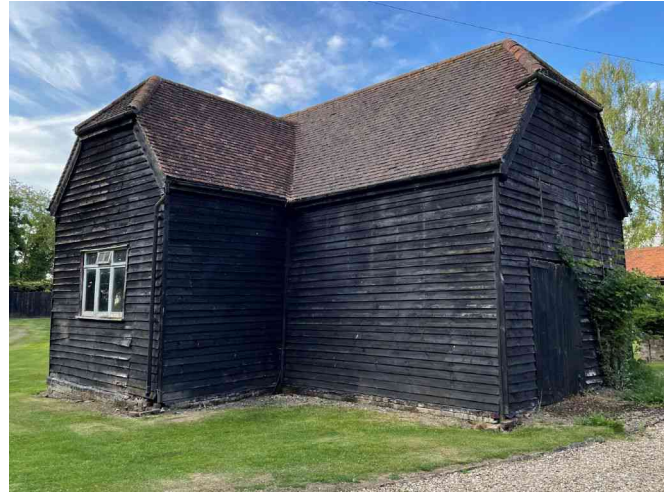
Photograph 2: West and south gable ends of Barn K.

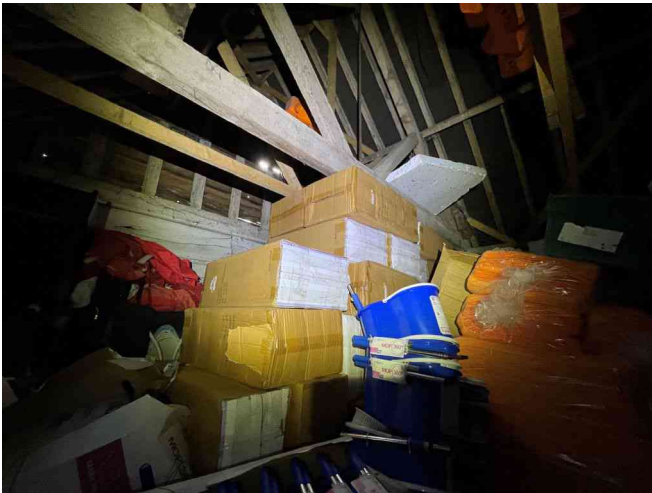
Photograph 3: Internal view of the western gable end of Barn J with gaps visible in weatherboarding.

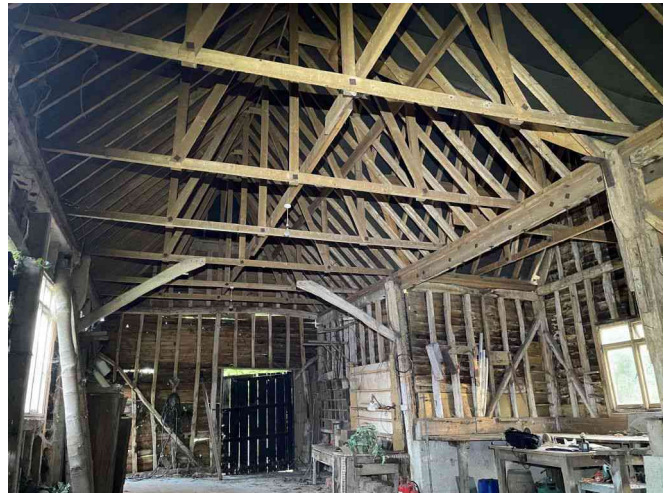
Photograph 4: Internal view of Barn K.

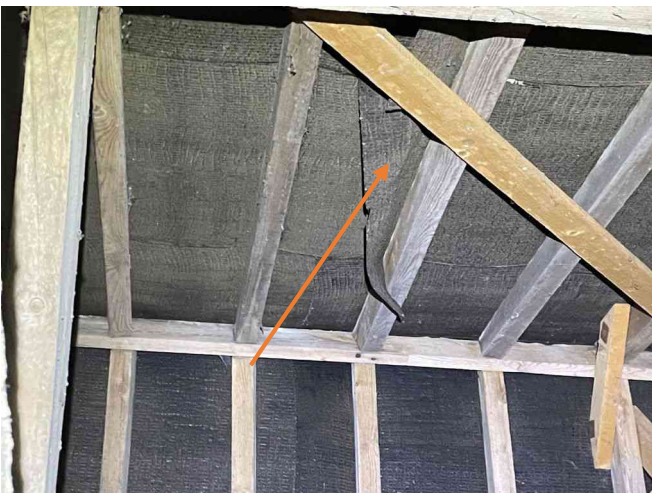
Photograph 5: Barn J Roost A.

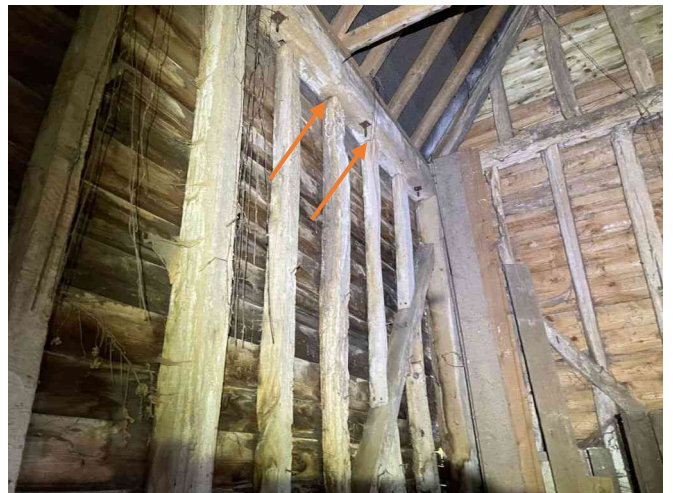
Photograph 6: Internal view of mortice and tenon joints in Barn K.

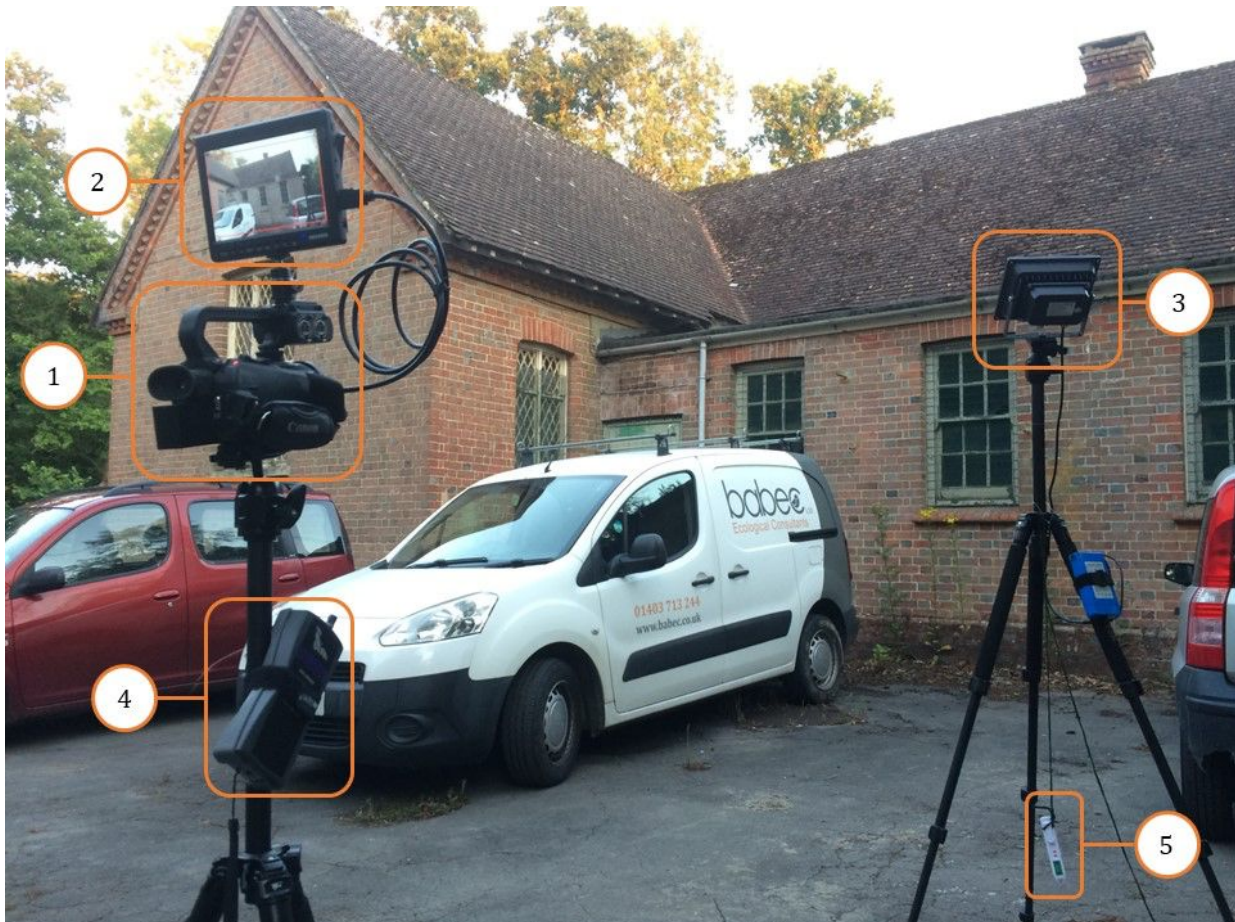
1. Canon XA series camcorder 2. Screen 3. Infrared floodlamp 4. Batlogger-M 5. Thermometer

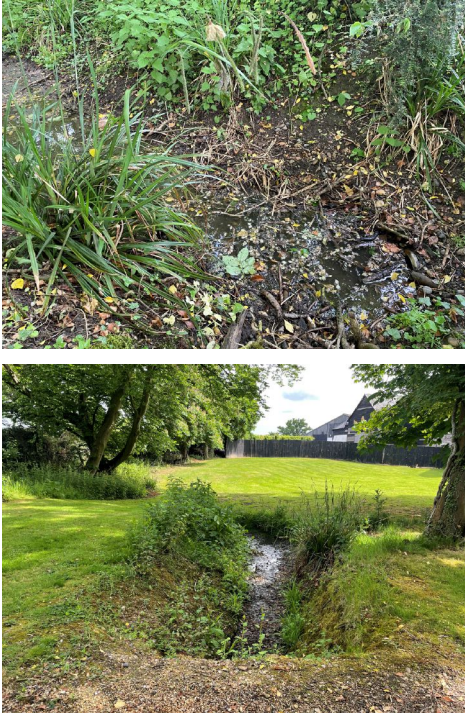
<i>Location</i>	Hertfordshire = Zone A	1
		<i>Pond area</i>	50m ²	0.05
		<i>Pond drying</i>	Dries annually	0.1
		<i>Water quality</i>	Poor	0.33
		<i>Shade</i>	90%	0.40
		<i>Waterfowl</i>	Absent	1
		<i>Fish</i>	Absent	1
		<i>Ponds within 1km</i>	19	1
		<i>Terrestrial habitat</i>	Moderate	0.67
		<i>Macrophytes</i>	5%	0.35
		HSI score	Poor	0.45
P2

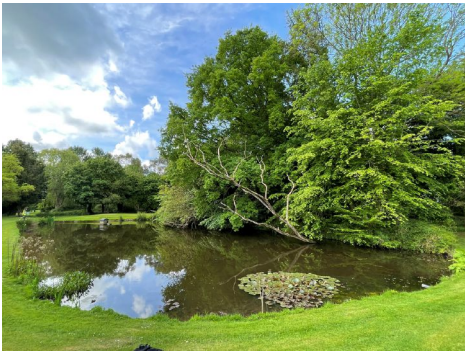
<i>Location</i>	Hertfordshire = Zone A	1
		<i>Pond area</i>	500m ²	1
		<i>Pond drying</i>	Never dries	0.9
		<i>Water quality</i>	Moderate	0.67
		<i>Shade</i>	40%	1
		<i>Waterfowl</i>	Minor	0.67
		<i>Fish</i>	Major	0.01
		<i>Ponds within 1km</i>	19	1
		<i>Terrestrial habitat</i>	Moderate	0.67
		<i>Macrophytes</i>	5%	0.35
		HSI score	Poor	<0.5

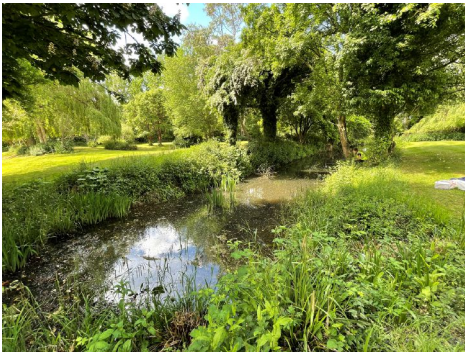
<i>Location</i>	Hertfordshire = Zone A	1
		<i>Pond area</i>	200m ²	0.4
		<i>Pond drying</i>	Never	0.9
		<i>Water quality</i>	Moderate	0.67
		<i>Shade</i>	80%	0.6
		<i>Waterfowl</i>	Minor	0.67
		<i>Fish</i>	Possible	0.67
		<i>Ponds within 1km</i>	19	1
		<i>Terrestrial habitat</i>	Moderate	0.67
		<i>Macrophytes</i>	10%	0.4
		<i>HSI score</i>	Average	0.67
