**ROECROFT FARM, ULNES WALTON  
LANE, ULNES WALTON, LEYLAND  
PR26 8LT**

**Archaeological Building Recording**

**North Star Archaeology**

**June 2022**

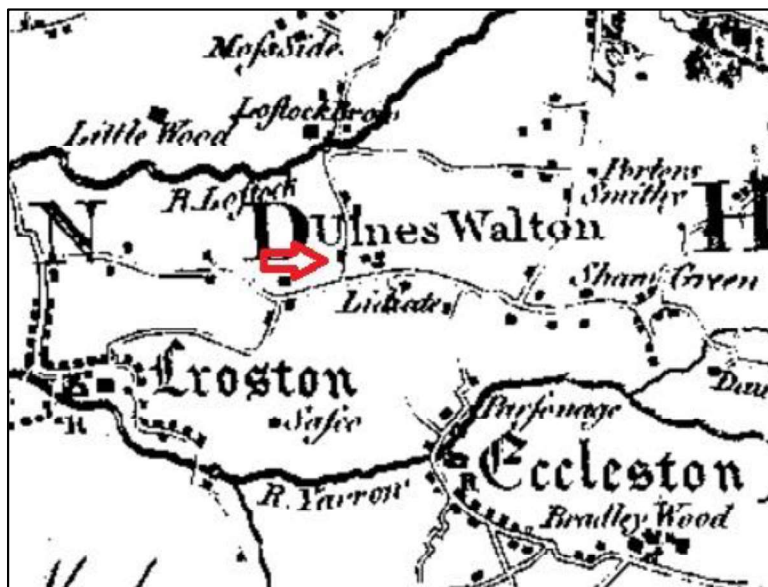
Figure 3 Extract from Yates' 1786 Map of Lancashire.

- 3.2.1. Yates' map of 1786 shows a structure on the map which is probably the site of the farmstead, but the scale and cartographic conventions on that map do not allow the identification of individual buildings on the site.

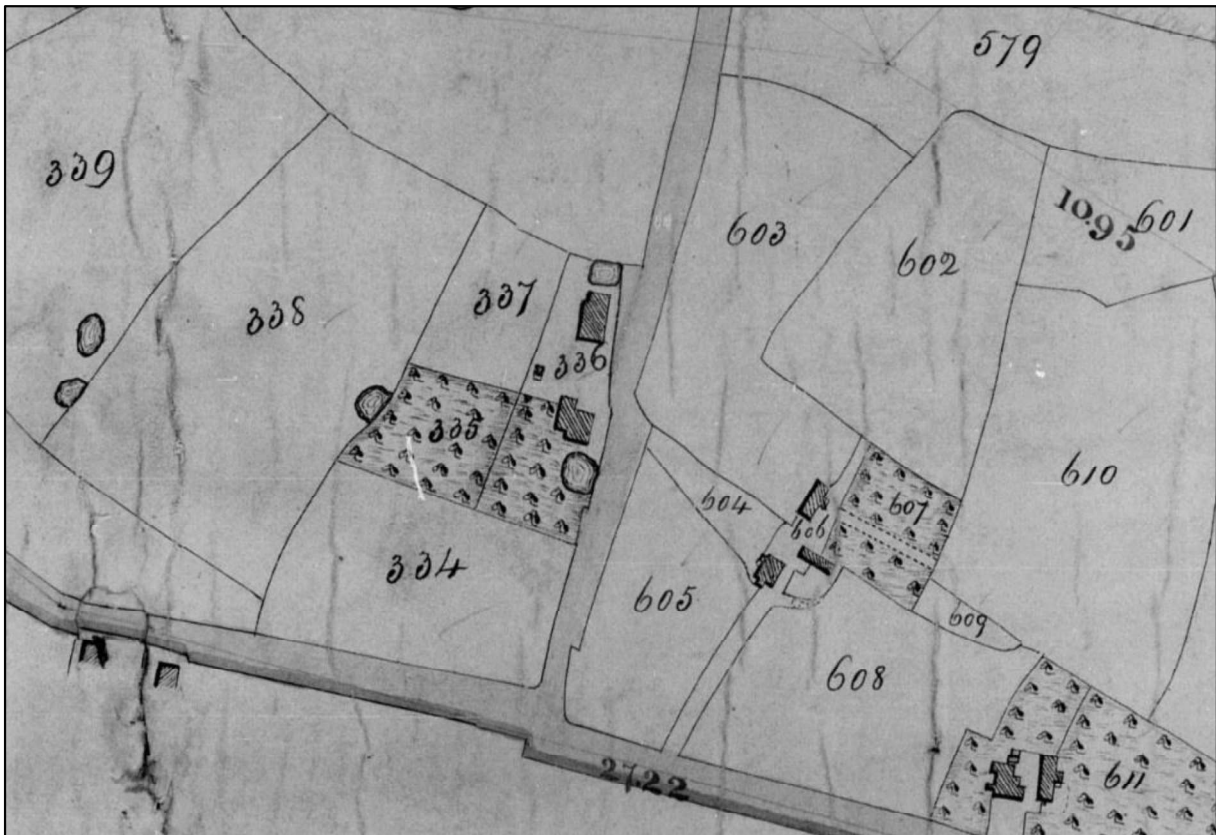
Figure 4 1837 Tithe map of Roecroft Farm.

- 3.2.2. The first map to show Roecroft Farm in detail is 1837 Tithe map of Ulnes Walton. The farm buildings comprise of the main farmhouse with a garden to the south and a large barn to the north. There is a pond at the north boundary of the plot and a little outbuilding close to the west boundary. The barn is depicted as a rectangular building

with a shippon at the north end. The farm occupies plot 336, in the Tithe apportionment described as ‘House Barn and Yard’ and owned by Edward Lister and Others & George Johnson Wainwright & Tryphosa Wiatt and Others, heirs of The Late James Longworth Esquire. It was occupied by Humphrey Moon. The Tithe Schedule also shows Humphrey Moon in occupation of the following plots:

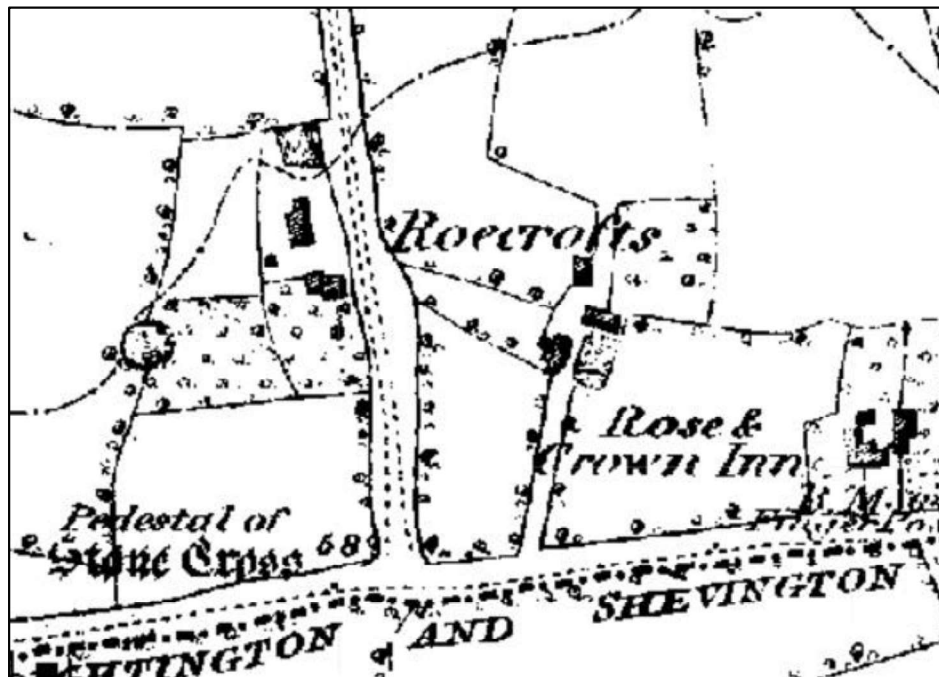
Figure 5 Extract from 1849 OS map.

- 3.2.3. The farmstead is depicted as 'Roecrofts' and remains relatively unchanged since 1837 mapping.

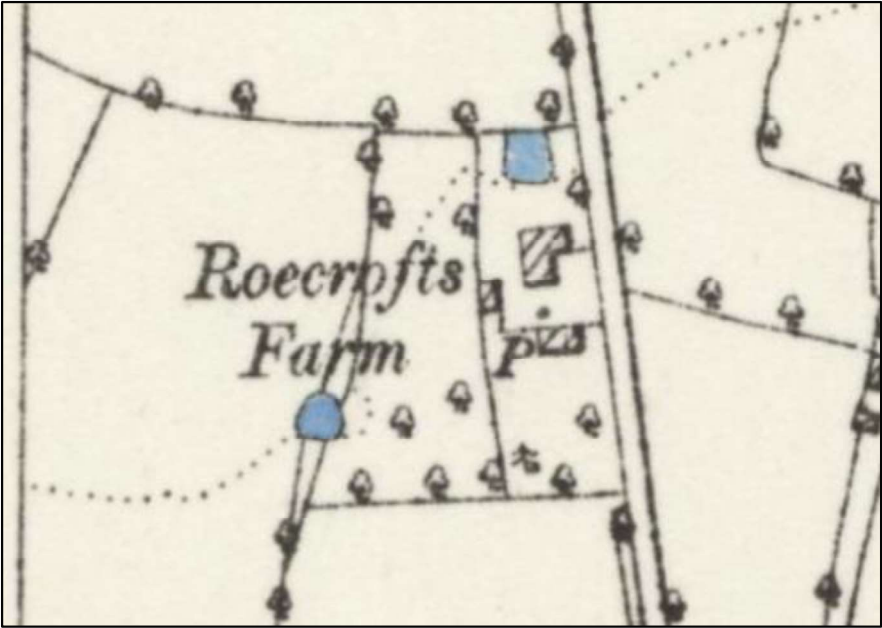
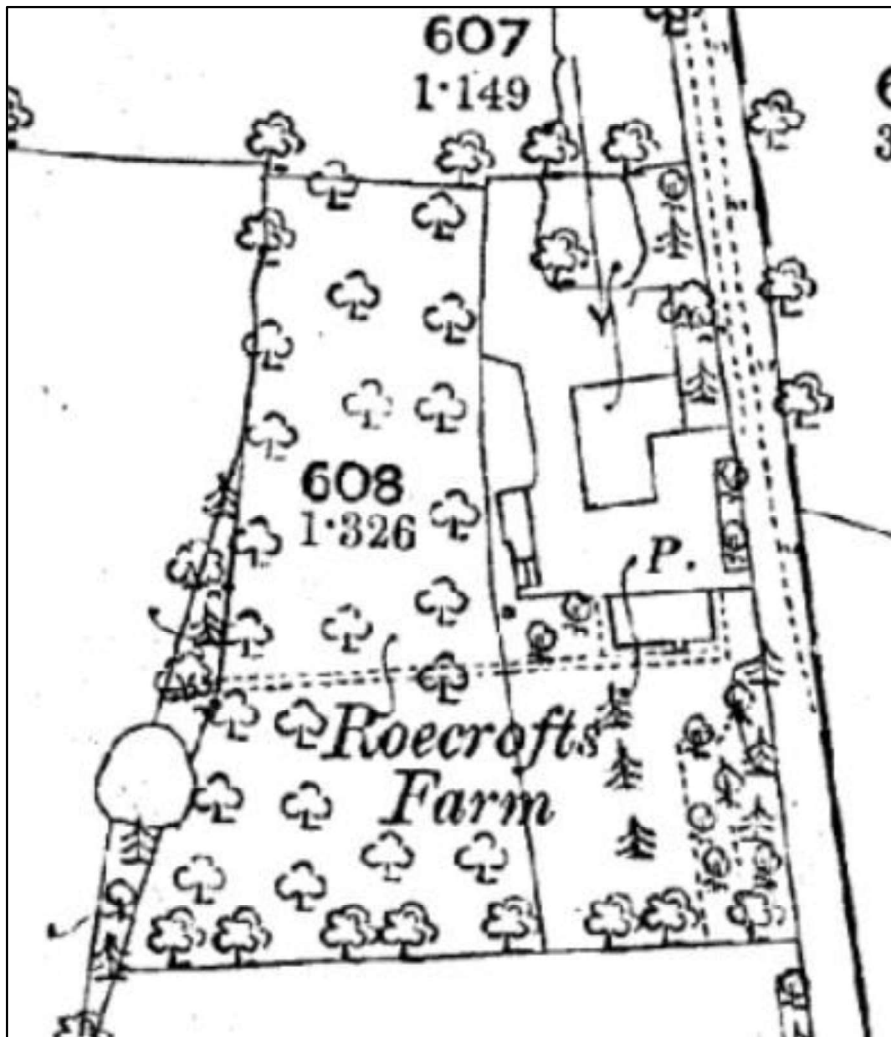
Figure 6 Extract from 1894 OS map.

Figure 7 Extract from the 1894 OS map.

- 3.2.4. The 1894 6" to one mile and 25" to one mile Ordnance Survey maps shows relatively few alterations to the site of Roecroft Farm. An outshut has been added to the north end of the east side of the barn.

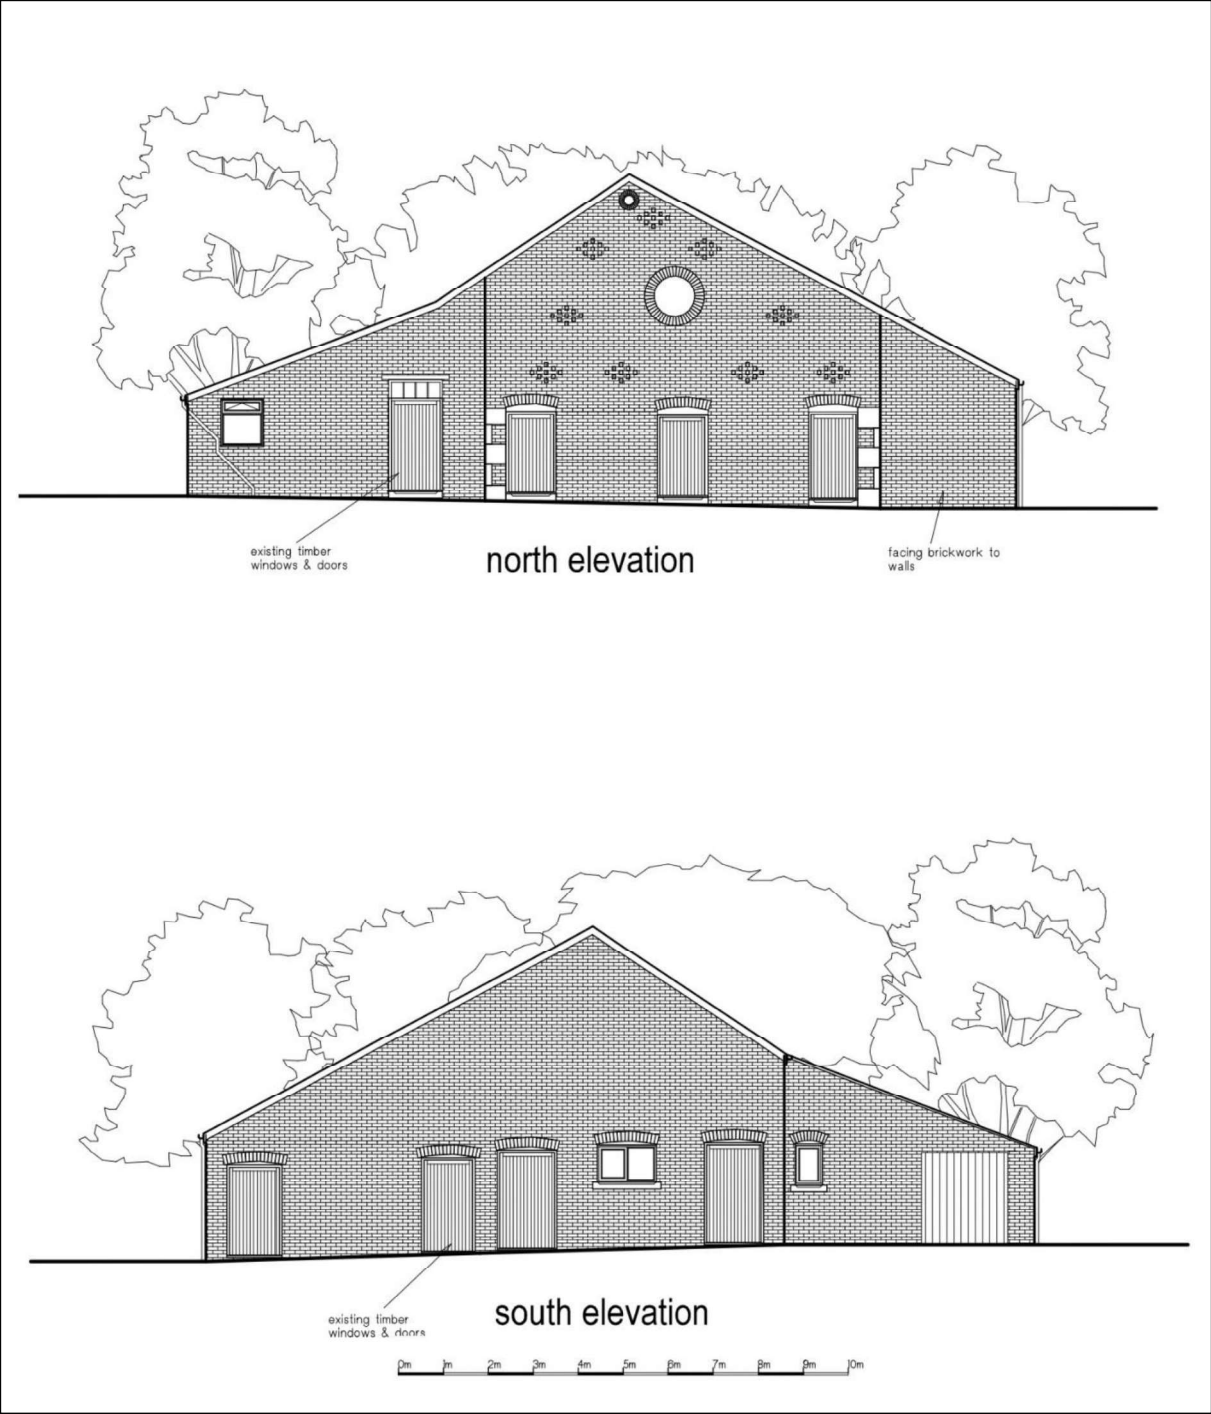
Figure 13 North and south elevations of the barn (Building 7) (produced by Warwick Consultancy Ltd).

**South elevation** is asymmetrical and comprises of the elevation of the main barn and an outshut to the west. The barn wall has two symmetrical doors with brick arches and centrally placed two-light window, also with a brick arch and a stone sill. This part of the elevation is of red brick laid in common bond and comprises of inserting course of headers every six courses. There is a large ventilation slot below the apex of the gable. The difference in colour of the brickwork at the top of the gable may suggest that the lower part of the elevation has been repointed with white lime mortar.

The central part of the elevation remains unaltered and comprises of three symmetrically placed timber framed doors leading into the shippon. The door on the east has a timber facade under a brick arch. In the other two doors the façade detail is missing exposing the brickwork underneath. A large pitching eye serviced a hayloft, with a brick surround and timber sliding weather door and there is an owl hole below the apex of the north gable (Plate 11). Above the doors there are eight rectangular diaper pattern ventilation slits placed irregularly around the pitching eye. There is a modern light fitting to the left of the pitching eye. The brickwork is laid irregular common bond, with large sandstone quoins on both sides up to the height of the door arches.

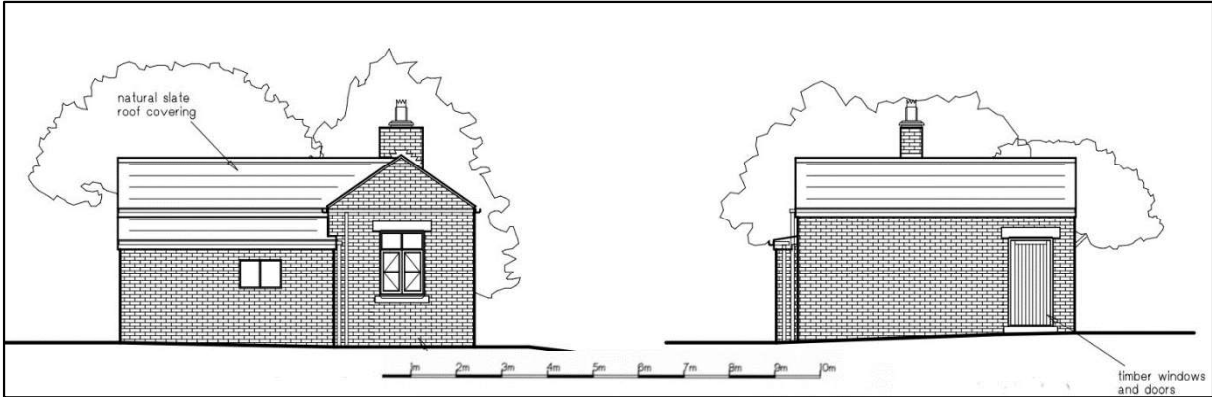
Figure 18 West and south elevations of the cottage (Building 2) (produced by Warwick Consultancy Ltd).

The west elevation comprises of the end of a gable with a single timber-framed six-light window. The modern outshut to the south is of red brick with a single two-light window. The rainwater goods are a modern replacement.

The south elevation (Plate 48) has only one timber door with sandstone sill and lintel.
