Barn at Dansons Farm, Staynall Lane, Hambleton, Lancashire

Historic Building Investigation and Recording

January 2021

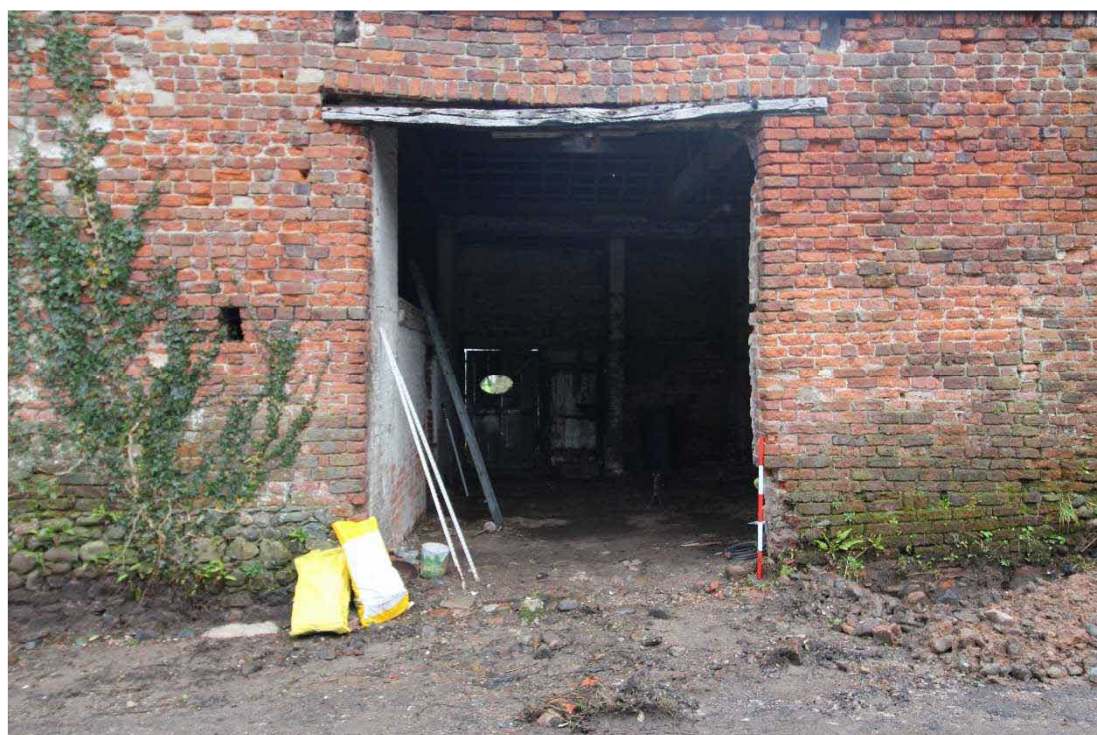
Plate 9: Western entrance to Barn, with small aperture to left, facing east with 1m scale

- 3.2.5 At the opposing end of the elevation and towards the base of the wall there lay a ventilation loop, formed by omitting a series of headers to produce a diamond pattern (Plate 11). Notably, it was the only ventilation loop on this elevation, although a small vertical aperture was also noted to the north of the cart entrance at mid-height (Plate 9).

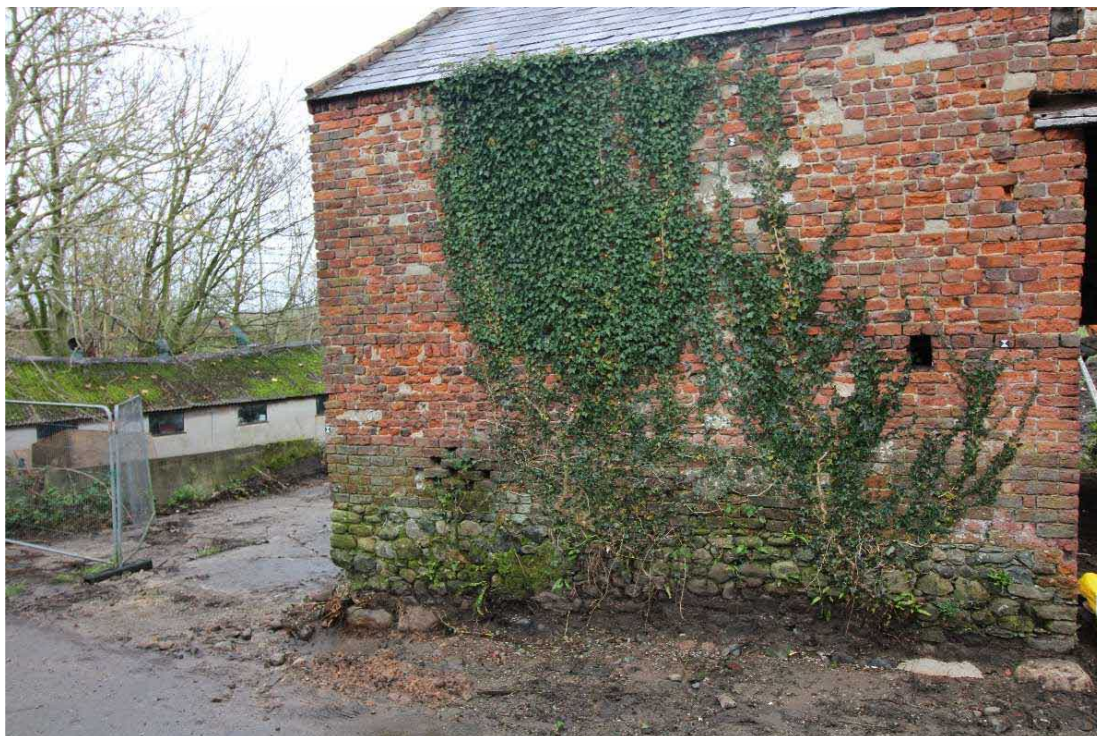
Plate 12: Cobble construction of lower wall, with secondary phase above partially obscured by vegetation, facing north-east

- 3.2.6 Close inspection of the wall's construction revealed that at least two and possibly three phases of rebuilding had taken place. The most obvious of these was the use of cobble stones for the construction of the barn's lower portion (Plate 12). Although this feature was confined to the north of the cart entrance, to the south it was evident that cobbles had also been employed in the building's foundation. The second phase had been raised upon the cobble base in hand-made brick, typically between 60-65mm thick and featuring large pebble inclusions. To the north of the cart entrance this phase extended to mid-height and was topped along much of its length by a soldier course, although the wall was partially obscured by vegetation (Plate 12). This phase of construction was also identified to the south of the cart entrance, although immediately to the south of this entrance it reached a height of just 1.5m, before stepping up to mid-height with a vertical joint and continuing across the remainder of the elevation (Plate 13).

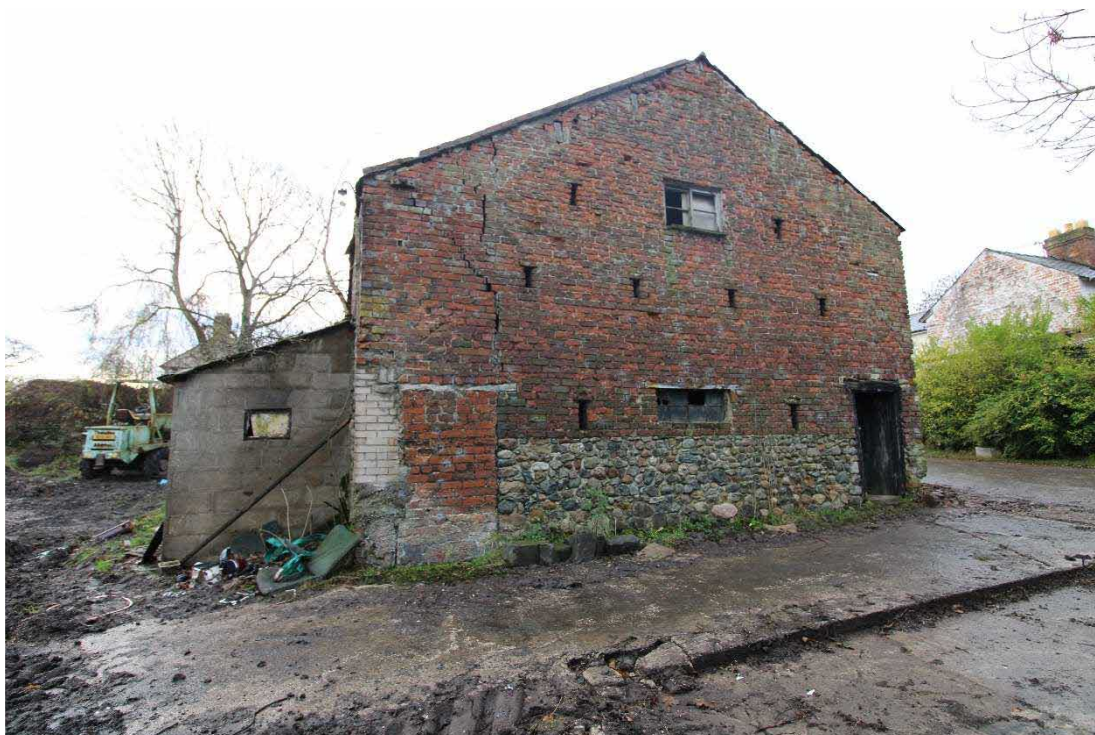
Plate 14: Northern gable elevation, facing south-west

- 3.2.8 The northern gable elevation revealed a similar constructional phase to the western elevation, with two phases of hand-made brick resting upon a cobbled foundation and lower wall (Plate 14). At its western end it had a single width doorway fitted with timber surrounds and a door of narrow timber boards (Plate 15). On the jamb of this door, the initials AW had been cut prior to the application of a coat of black paint (Plate 16). The disposition of the coursing and character of the brick suggested this was an original opening and it was matched at the eastern end of the elevation by a similar opening. This latter doorway also had a timber lintel, but the opening had been blocked in hand-made red brick of later nineteenth century character (Plate 17). The eastern jamb of this doorway had been rebuilt using a modern buff coloured brickwork during works to stabilize the north-eastern corner of the barn following structural movement.

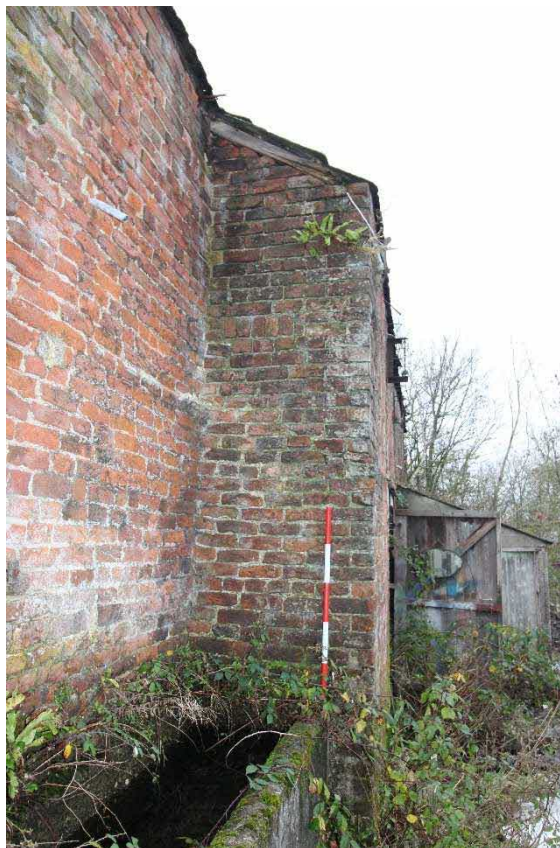
Plate 26: Scar of roof line on south-facing return wall. Facing north with 1m scale

- 3.2.16 The southern third of the elevation featured a single doorway at its southern end, fitted with a timber lintel, although the frame and door itself had been lost (Plate 25). To the north of this door, a concrete water cistern had been fitted against the base of the wall, extending up to the return wall of the barn's wider section (Plate 26).

- 3.2.17 Evidence for phasing on this elevation was less clear, in part due to the presence of the lean-to structure at the northern end, but the variation in lime mortar and character of the brick remained, with a mid-height soldier course observed to the south of the double-width doors (Plate 21). The clearest evidence, however, lay on the return wall between the narrower southern third of the elevation and the remaining northern two-thirds, where the earlier roof line was again visible as a construction joint (Plate 26).

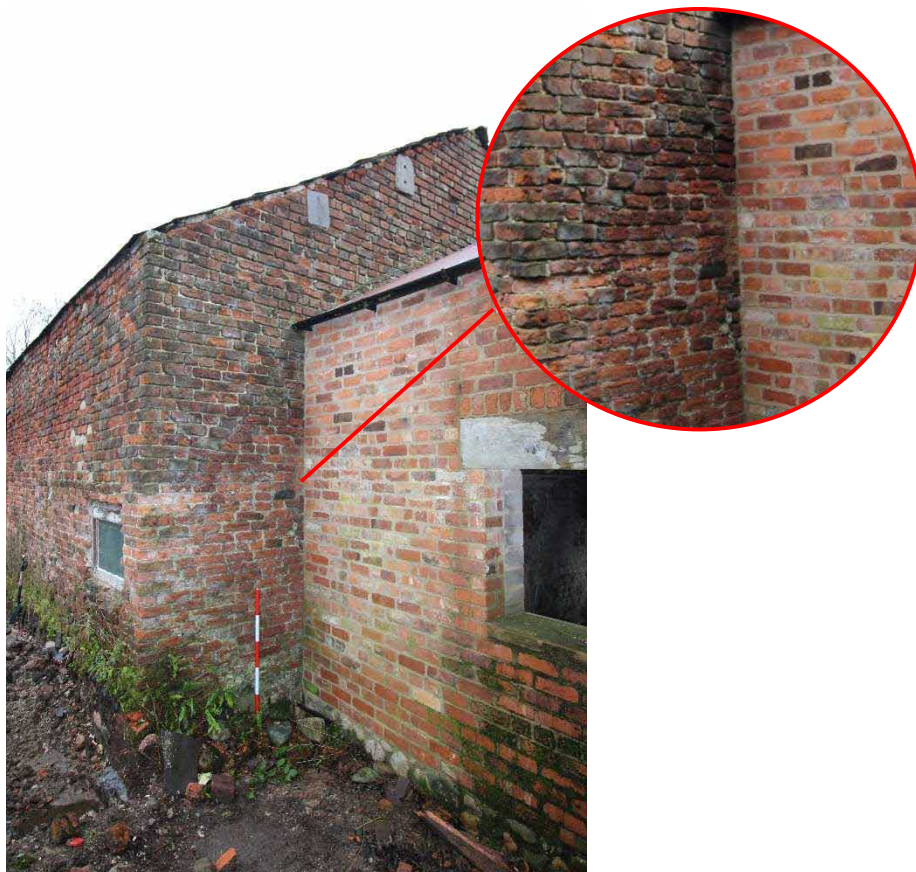
Plate 27: Southern gable elevation, showing fossilized pitch of original roof line. Facing north-east with 1m scale

- 3.2.18 The southern elevation was partially obscured by the later southern extension, but its western side was still visible for inspection. It appeared to be wholly of brick above foundation level, but the change between the two phases of brick work was also well-defined here as a diagonal roof line, fossilizing the pitch of the earlier roof in the present wall. A pair of slates had been attached to the wall beneath the eaves presumably to protect the exposed ends of each roof purlin (Plate 27).

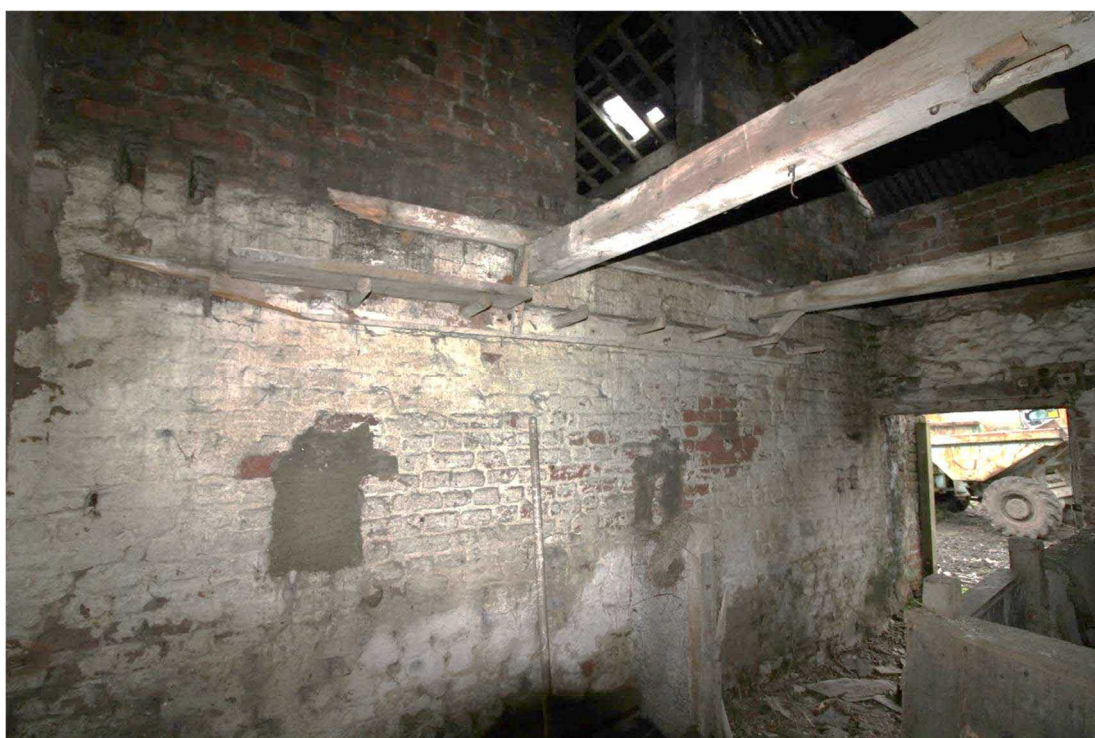
Plate 28: Southern gable of Barn, now enclosed by Southern Extension. Note blocked pairs of ventilation loops and timber peg board at mid height. Facing north-east

- 3.5.2 The rebuilt western wall of the room had been left as exposed blockwork (Plate 53), but the lower halves of the northern and eastern walls had been lime-washed leaving exposed brick above. The southern wall had been lime-washed to full height, but the upper half had been discoloured by dirt and dust (Plate 54). A pair of lateral timber joists extended from the southern wall to the northern wall to provide the necessary structural support for a floored loft space, but the floor itself had been removed (Plate 54). Just below these joists on the northern wall there was a row of seven timber pegs set into a horizontal mounting board (Plate 28).

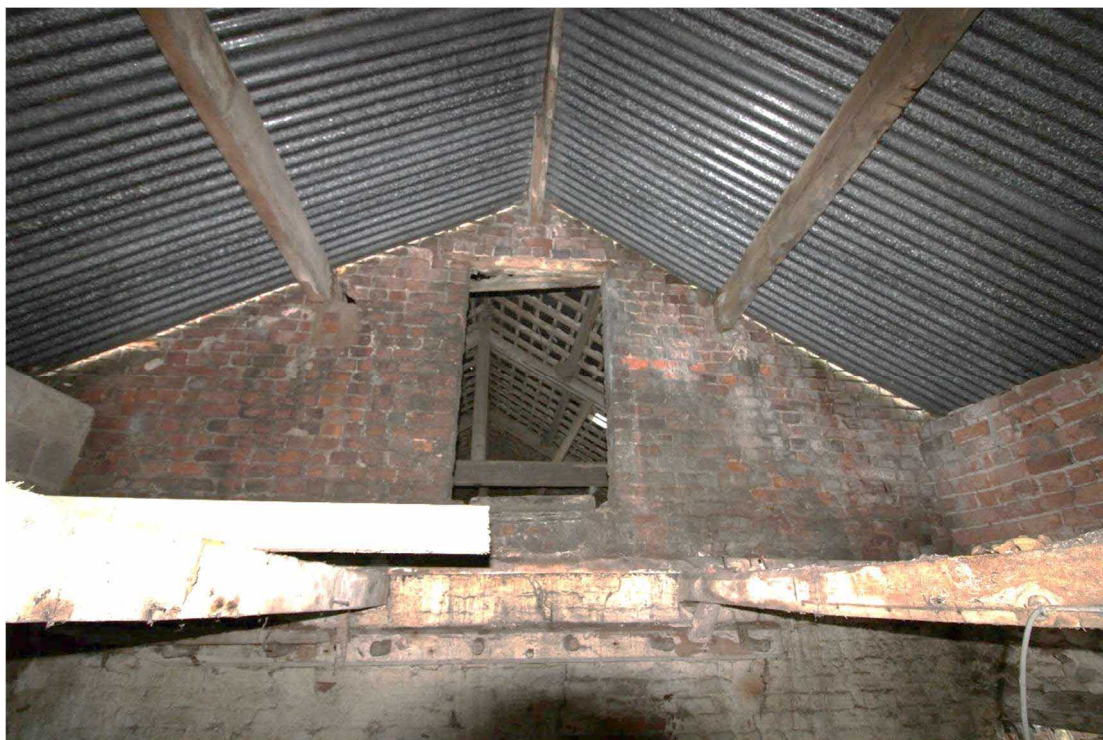
Plate 29: Loading door at centre of southern gable. Facing north

- 3.2.19 An inspection of the remainder of this elevation from the interior of the southern extension revealed a series of narrow vertical ventilation loops arranged in pairs and over four tiers (Plate 28). The loops had been blocked but were similar in form to those discussed on the northern gable elevation and were probably of a contemporary phase. The lower portion of this wall had been coated in thick white paint following its enclosure within the later extension and there was a first-floor loading doorway at the centre of the elevation with the uppermost blocked ventilation loop above its centre (Plate 29).

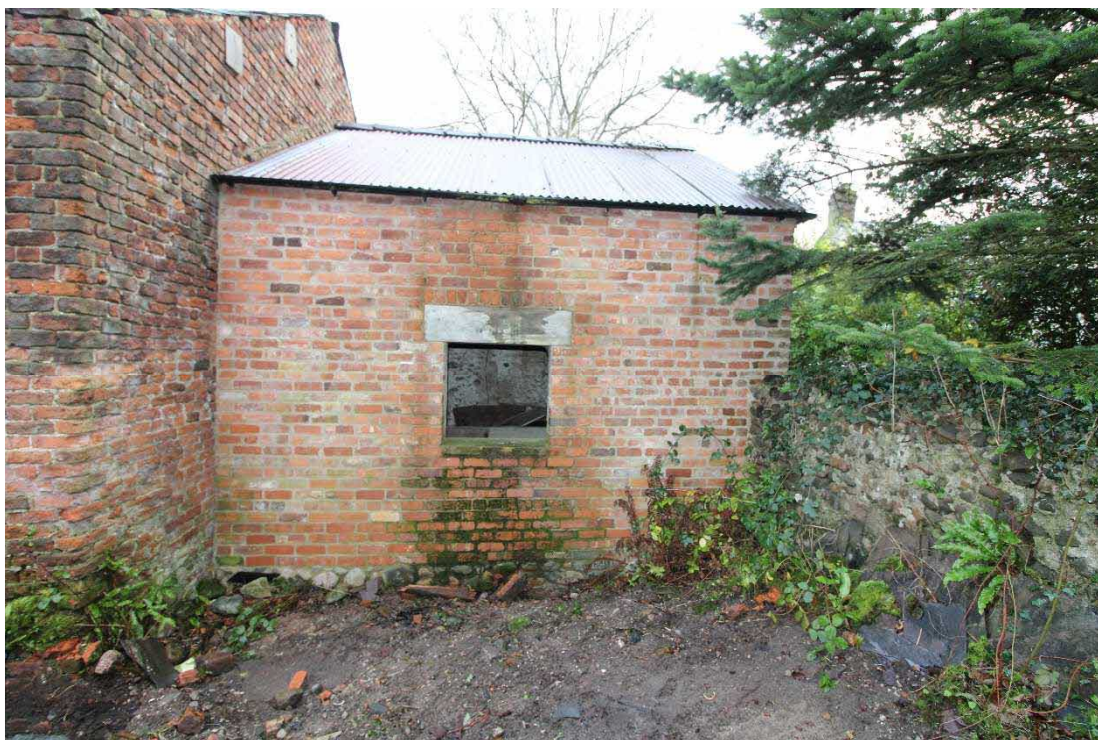
Plate 30: Western elevation of Southern extension, facing east

- 3.3.1 The southern extension was a multi-phase gabled structure with a corrugated sheet roof that abutted the southern gable of the main barn (Plate 30). Its western wall had been recently rebuilt, with a red brick outer skin facing an internal wall raised in concrete blockwork. At the base of the elevation a cobble foundation indicated that the present wall had probably been a rebuild of an earlier wall on the same footprint.

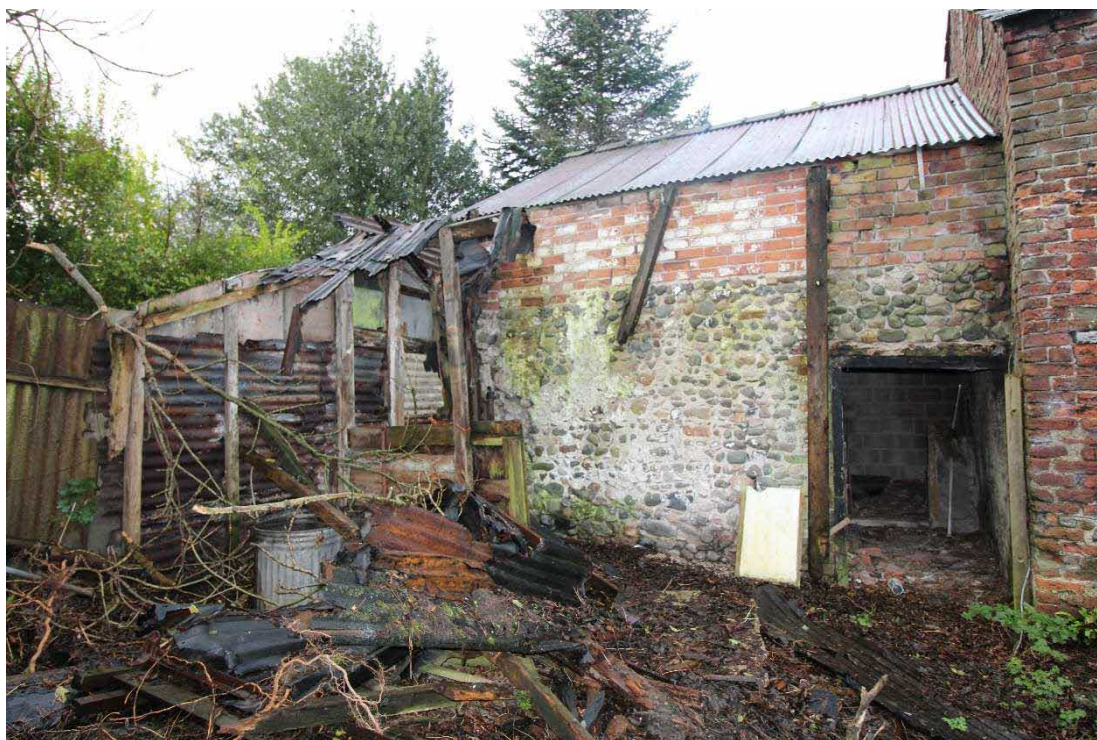
Plate 32: Eastern elevation of Southern extension, facing west

- 3.3.4 The lower three-quarters of the eastern elevation was also constructed in cobbles, with an additional ten courses of red brick bringing it to eaves height (Plate 32). This wall had an entrance at its northern end, plainly built at a width that could accommodate cattle and was fitted with timber surrounds, but its door did not survive.

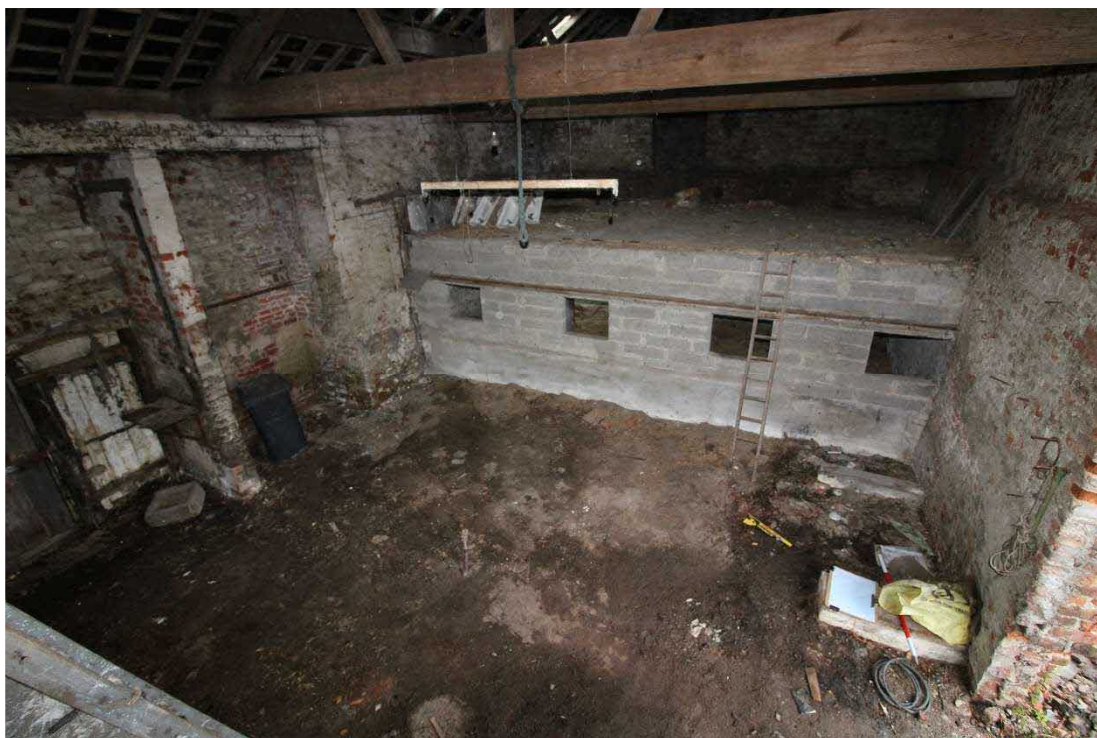
Plates 40: Threshing floor, looking south

- 3.4.7 The threshing floor at the centre of the barn was a large undivided space accessible from either of the double-width openings to the east and west (Plate 40). Its exposed brick walls had been lime-washed and the floor, while covered in loose soil, revealed elements of a cobbled surface beneath.

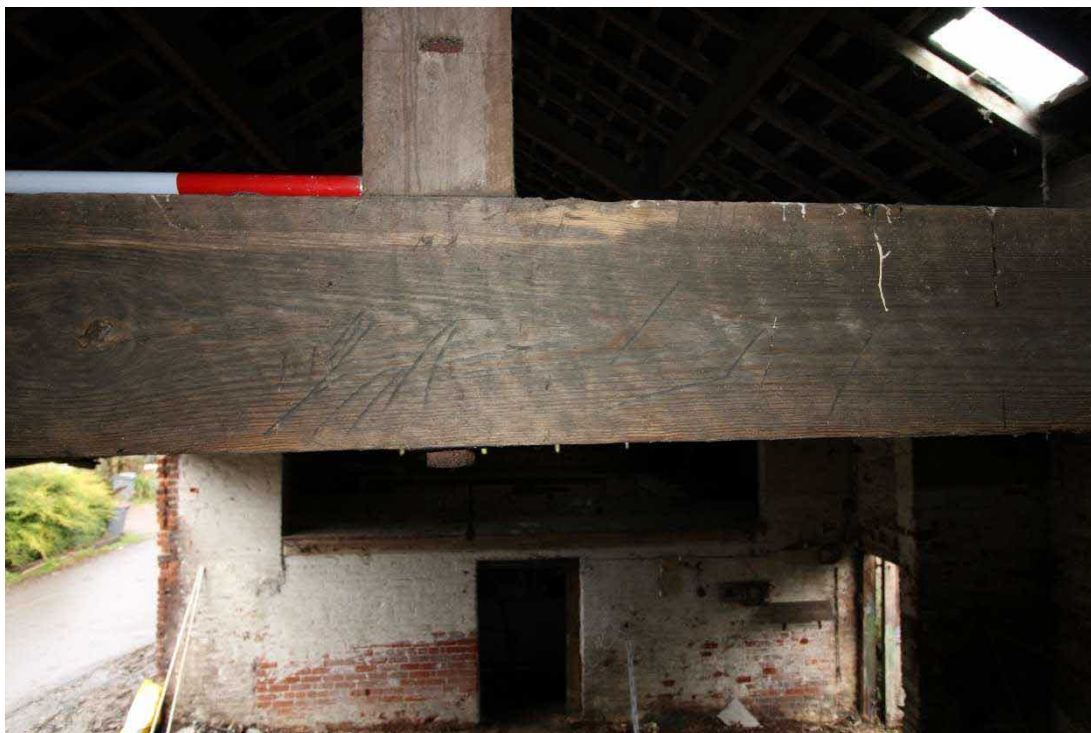
Plate 50: Baltic shipping marks on southern face of south truss, facing north with 0.2m scale

- 3.4.13 The barn's slate roof was supported at each end by its gable walls and three intermediate king post trusses to form three roughly-equal structural bays and a fourth larger bay at the northern end. The king post was bolted to the tie beam via a threaded bolt from beneath and had a raking strut rising from the upper face of the tie beam to a joint on the underside of each principal rafter (Plate 48). The purlins were trenched into the backs of the principal rafters upon which rested the common rafters, with the battens attached to the rear of these in turn.
- 3.4.14 All of the timbers were of sawn soft wood and close examination of the trusses revealed assembly marks on the northern faces inscribed using a system of roman numerals (Plate 49). In addition, the characteristic sweeping lines known as Baltic shipping marks were observed on several of the tie beams (Plate 50).
