Hubbard Conservation

Introduction and methodology.

Victoria Hubbard MSc of Hubbard Conservation has been commissioned to write this Heritage Impact Assessment on behalf Mr and Mrs Holdsworth in relation to the Listed Building Consent application for proposed works to No. 36 New Street.

The proposal seeks to demolish and replace the C21 modern extension, replace the rooflight and roofing slates. Internal alterations including new stud partition at first floor, damp proofing and repairs to stone flooring at Lower Ground Floor level. (See Report 2 for the Impact Assessment):

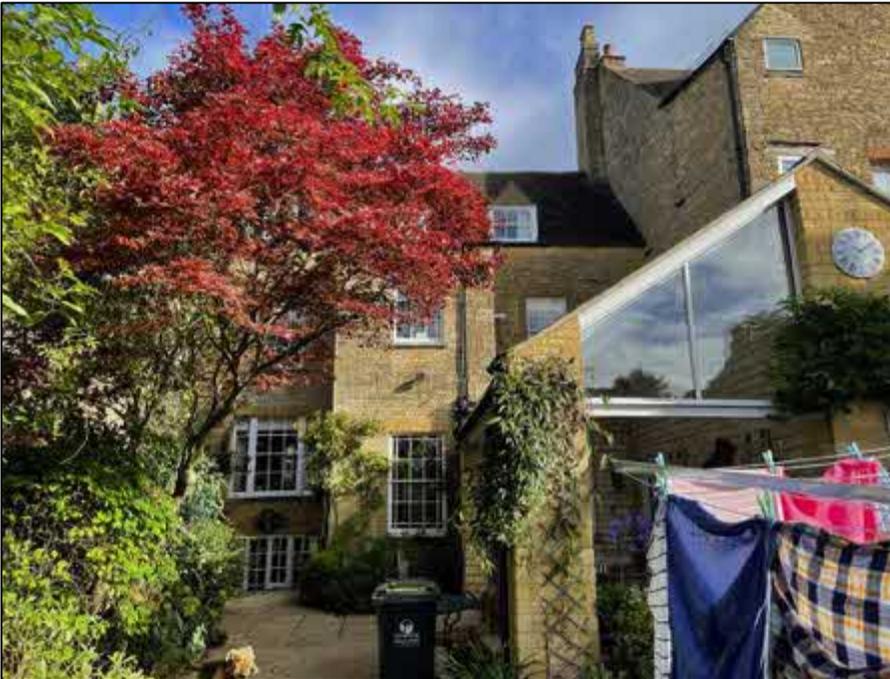
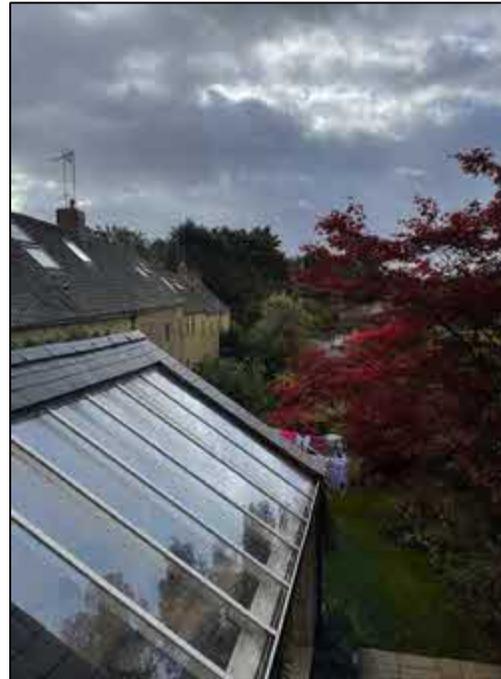
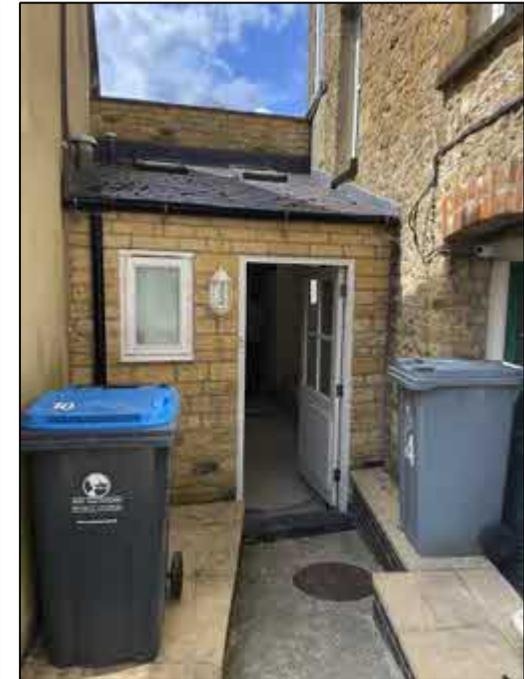
The central three-storey rear range and the small single storey kitchen disrupt the otherwise even rear elevation of the main range. The kitchen range is partially hidden from view by the c2013 rear extension and verandah. The extension is coeval to the east extension that replaced a former garage (Fig. 6). The main range comprises coursed random rubble, and the central range exhibits more squared and coursed stone with ashlar quoins. As the range rises to first floor level the quoins appear better defined suggesting the range was raised.

Beginning the description at the west bay, there are windows to all four-levels (Fig. 7). The lower ground floor window comprises 3-lights within a dressed limestone surround, slightly narrower in character to those above, with an integral lintel, which might be earlier in character when compared to those above. Timber casements are set within the stone surround, the central of which has an opening sash. There is a ventilation pane to the east-light.

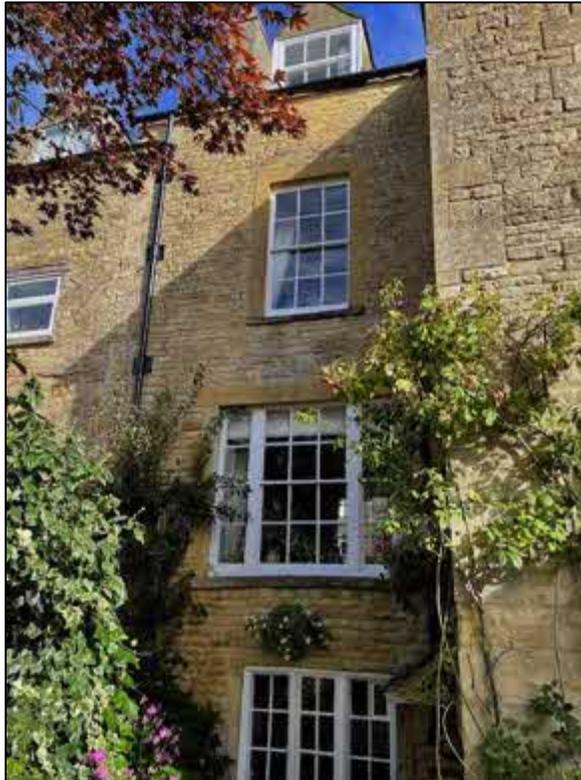
Above the lower ground floor is the ground floor window comprising timber tripartite of 6/6 central sash flanked by 2/2; absent of horns. The ashlar stone surround has a lintel extending slightly beyond the jambs, and a stone cill. Above this is the first floor window 6/6 sash windows, again absent of horns, set within a plain ashlar surround with narrow stone cill, which appears to be echoed at the eastern bay. At second floor level is a gabled dormer window (one of three) comprising modern timber 3/3 sash window with rendered cheeks and façade under concrete plain tile covering; echoed at the eastern bay. The central dormer comprises a smaller scale timber casement window, with a flat roof presumably with rendered cheeks.

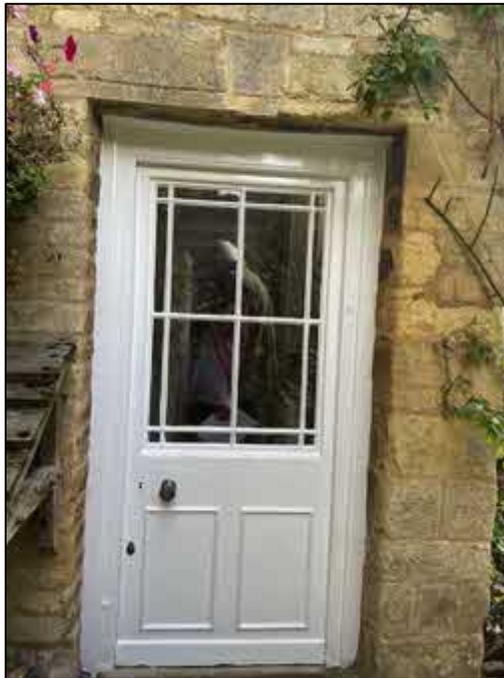
A western doorway provides access into the rear range from the garden. The flanking walls exhibit different characters; coursed rubble to the north and squared and dressed to the south. The timber-door itself comprises four-glass panes with margin lights (coeval to the ground floor window) and two –panels below set in timber architrave, underneath a dressed stone lintel with keystone wedge (Fig. 9).

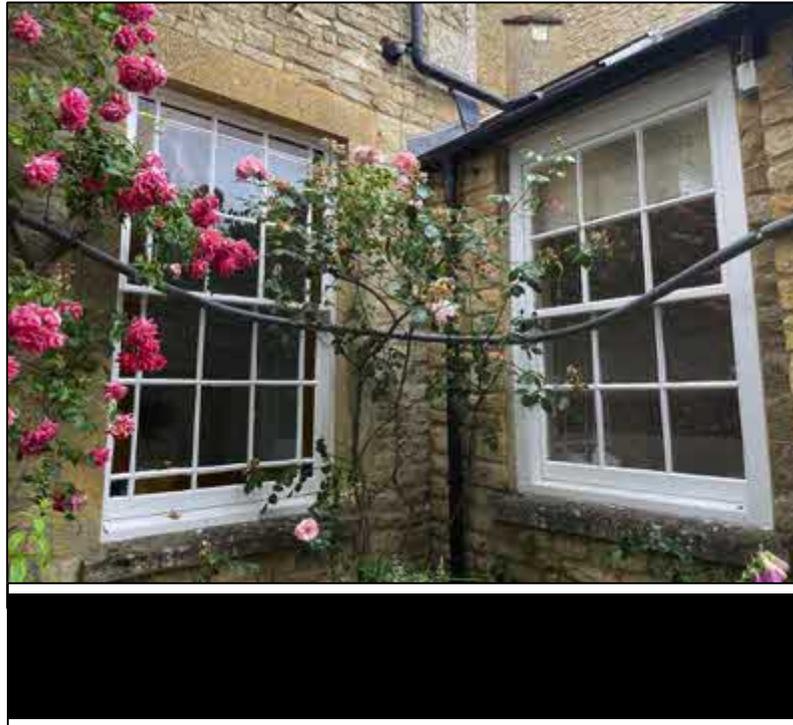
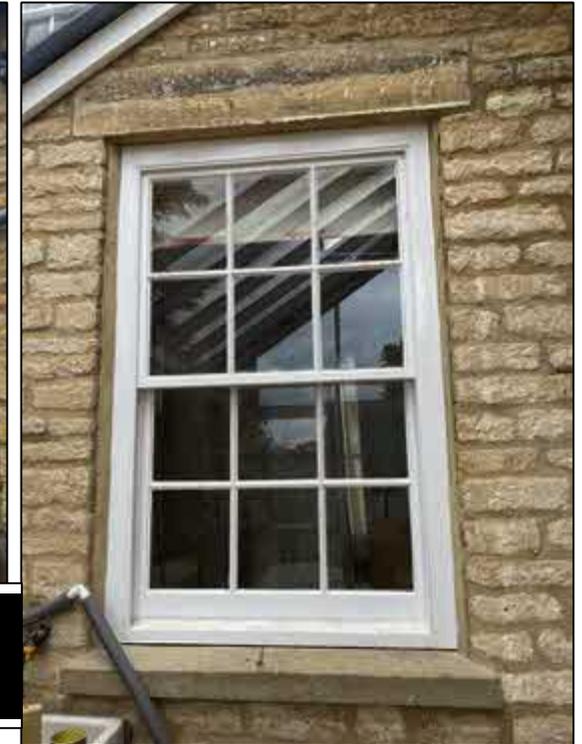
coursed roughly-squared limestone rubble with a grey tiled roof and roof light to the western pitch. There are 6/6 sash windows to both the west and south elevations (which appear to be modern replacements); the southern of which has a stone lintel and a concrete cill, and the western window has a stone cill. This might suggest that the southern window is secondary (Fig. 10). There is a door to the southeast side leading into the c2013 extension and the former garage area to the east (Fig. 6).

The c2013 extension has been constructed off of the southern kitchen wall. The roof is continuous covering the kitchen and extension with a fully glazed section spanning the open verandah. There is a flue raising from a presumed former chimneystack. The construction is block-work clad in modern stone. There are modern double doors to the southern gable (Fig. 11).

G6 and G7 were both constructed c2013 principally from Thermalite blockwork, some brick and stone cladding. G7 is an open-sided verandah (Figs. 6, 8 & 11).

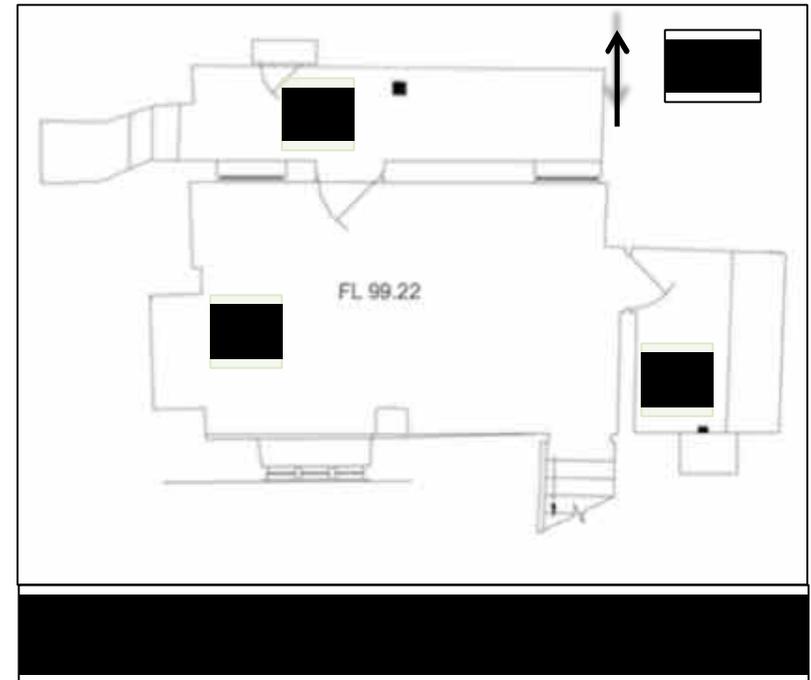
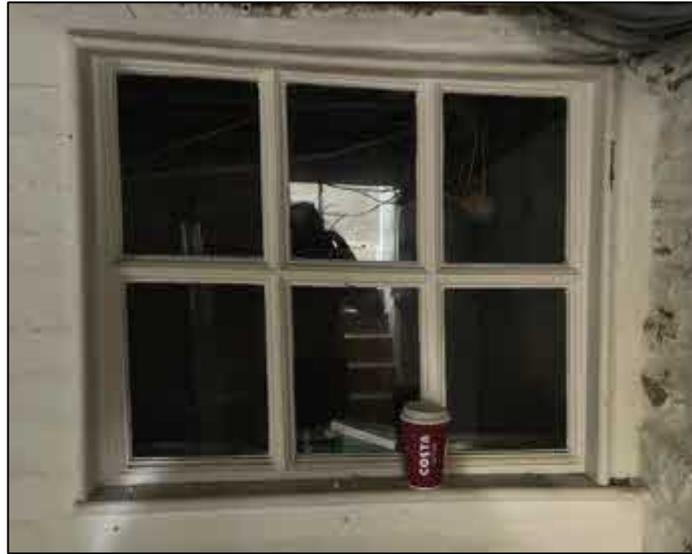
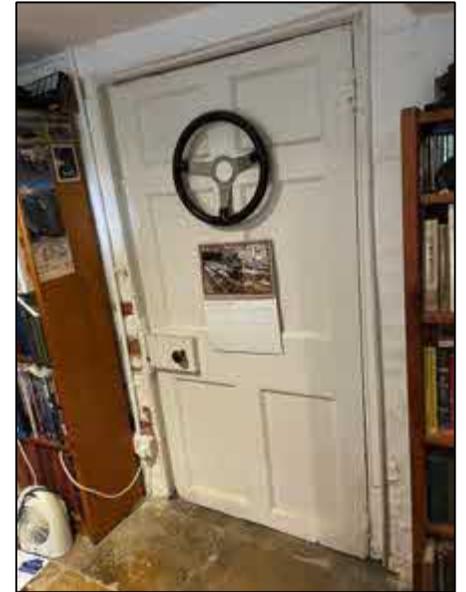
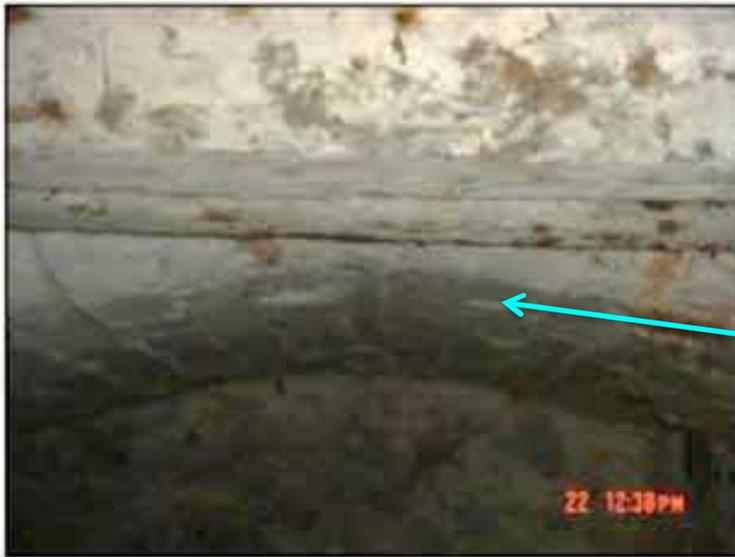
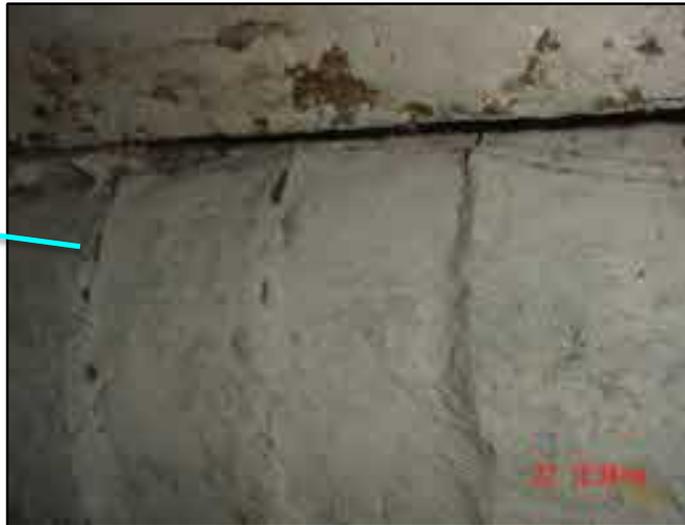
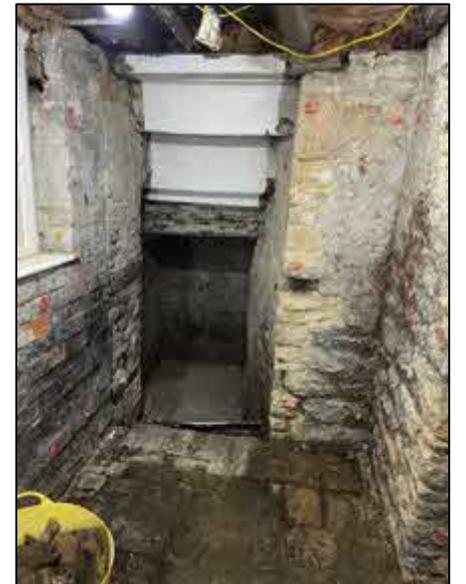
The lower ground floor primarily comprises one room (C2), which has been partitioned to form a passage to the north leading to a short corridor into the cellar of No. 38 (C1). There is a larder to its east (C3). Access is gained via the stairs in the rear range (G4).

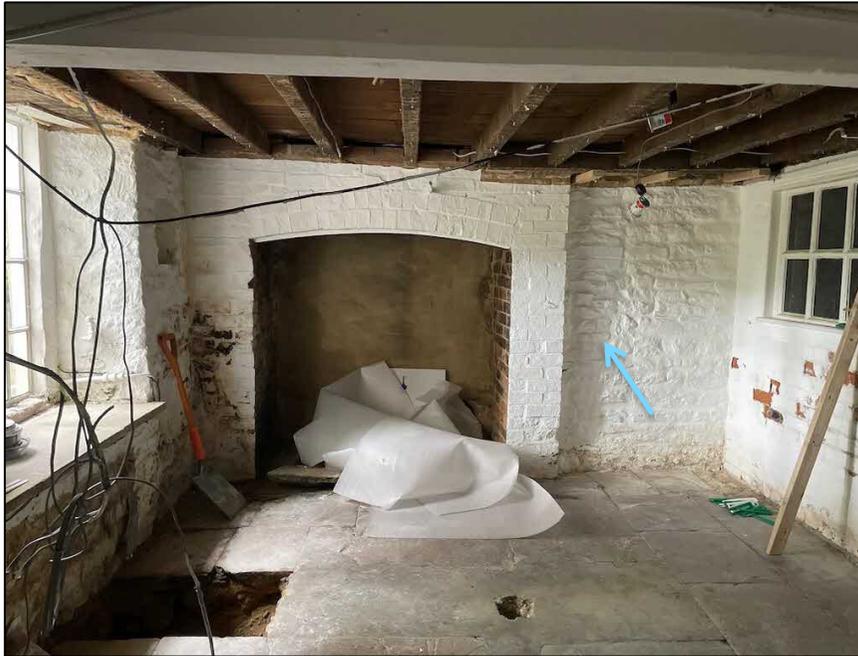
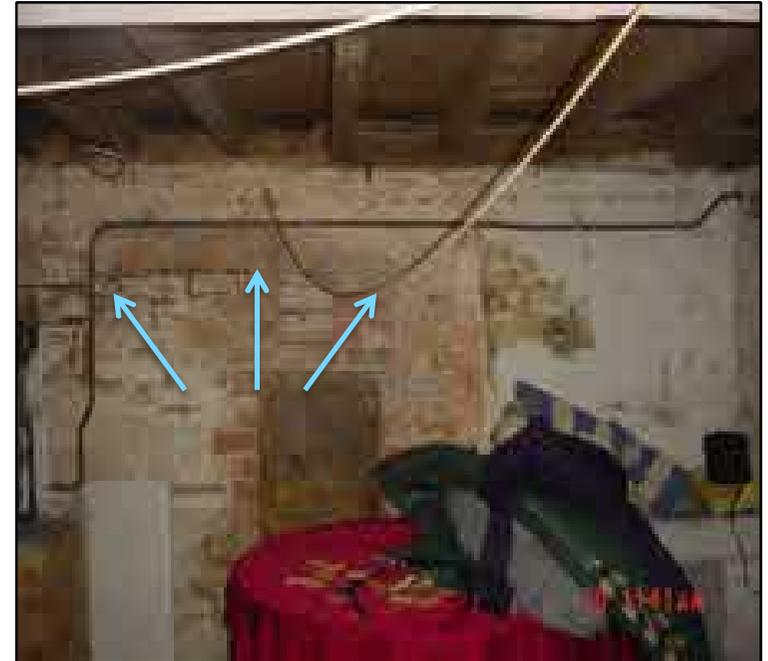
C2 is dominated by a large fireplace in the west wall. When the property was first surveyed in 2012, the void was bricked-up (Fig. 14) and had a small door¹¹. The segmental arch remained distinguishable (Fig. 14). There is a hint of disruption to the stonework to the right of the right-hand side jamb, possibly suggesting a degree of rebuilding or possibly reduction from a larger earlier fireplace. To the left of the fireplace is another shallow candle niche.

The fireplace principally comprises brick surround and cheeks (stone to the rear) with a segmental double-header lintel. The left jamb/cheek appears to have earlier bricks than the opposing jamb.

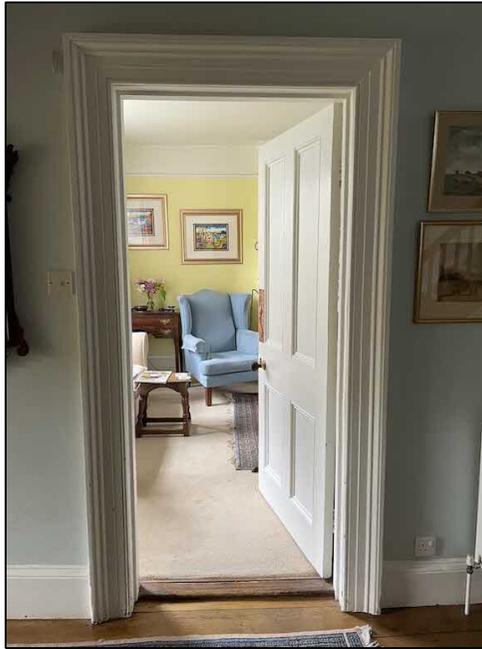
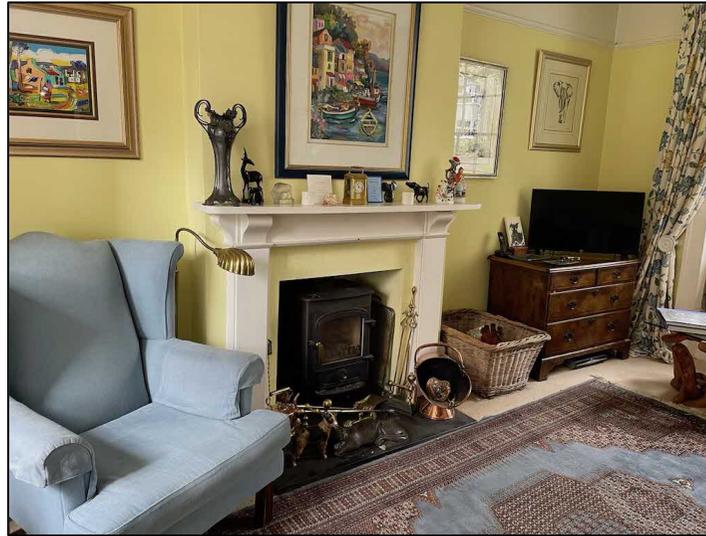
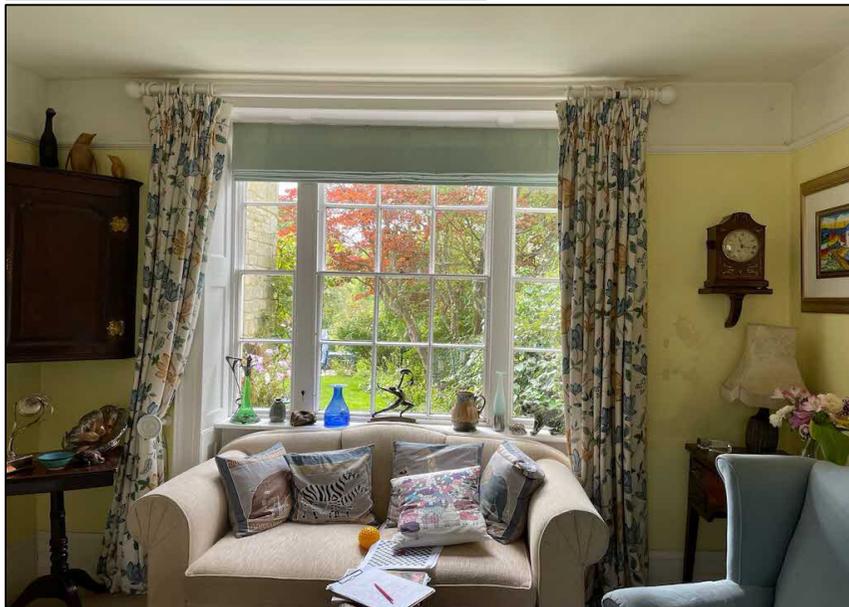
G2 is the principal entrance hall and staircase to all floors. G2 provides opposing access into G1 and G3, as well as G4 (Fig. 19).

The front (north) six-paneled door (hung from HL hinges) provides entrance from the street. Above the door is a 4-light fanlight. To the east of the door is a cupboard with a basket-arch underneath the stairs. The dogleg stairs provides access to every-floor and comprises closed string with a surprisingly simple handrail and stick-balusters.

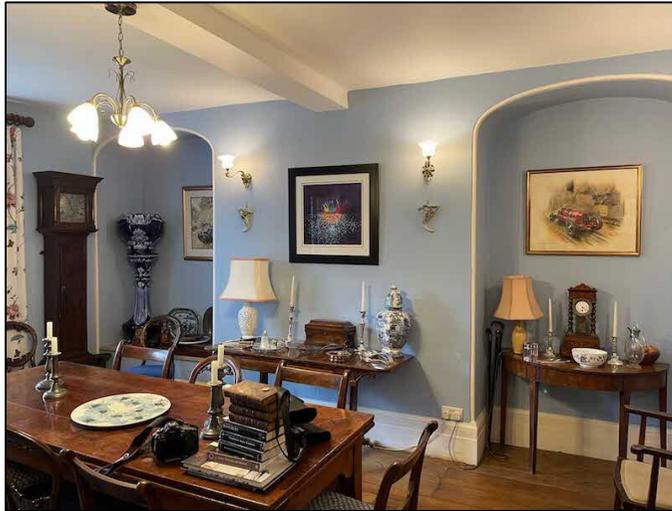
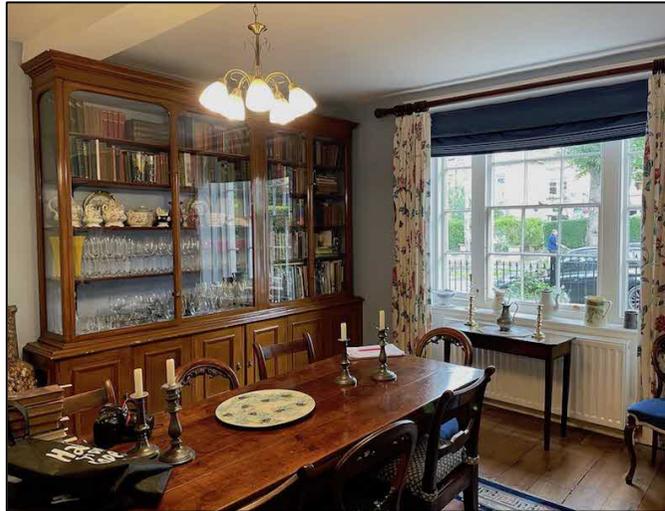
G4 is entered via a basket-arch doorway; at this point the floorboards and stairs change to pine. The pine 6-panelled door hangs awkwardly above the stairs when open. The secondarily timber taking the form of a slender jamb to receive the door-latch suggests the whole door arrangement is secondary.

There are five pine steps descending from G2, which reach a short landing (pine floor boards) providing access into G5, and to a similar number of pine-stairs providing access into the cellar. The closed-string banister has turned balusters and ramped mahogany handrail, which turn and curve downwards through 180 degrees. The basket arch above the cellar doorway has the same character to that above the entrance into G4 (as seen from G2), and likely similar (thus coeval) to the alcoves in G3.

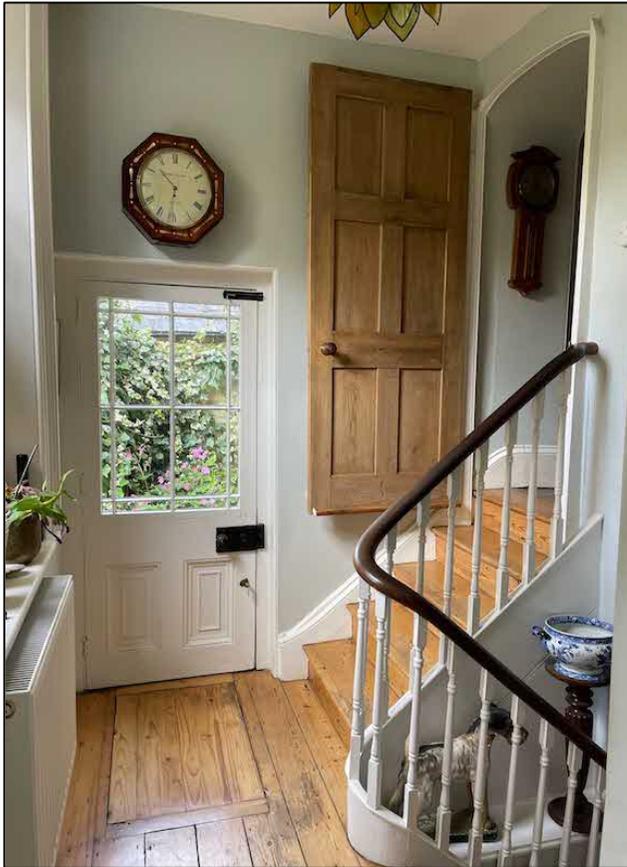
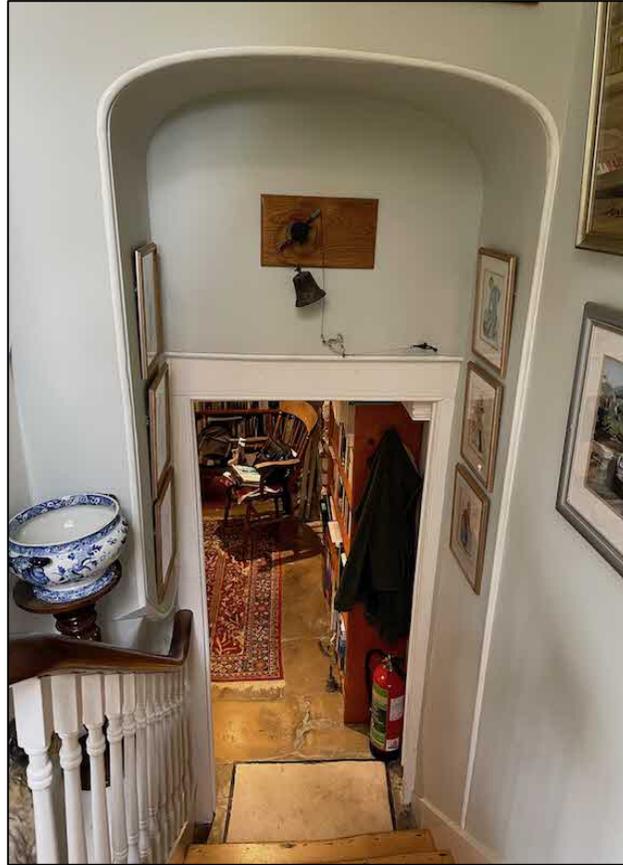
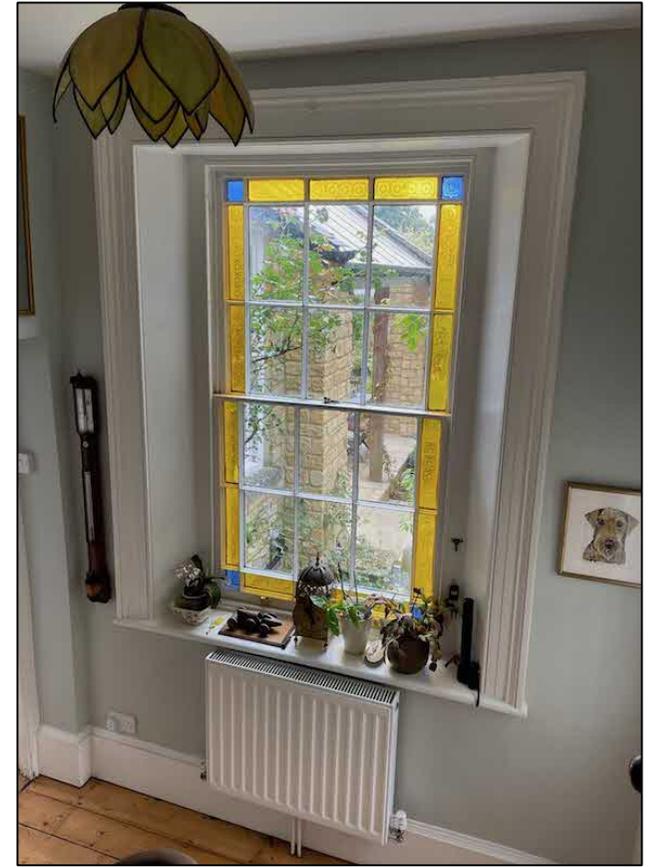
Based on the fabric evidence, it appears that G5 was added after the ground floor of the rear range was constructed. Unlike the doorways in the cellar and G2, the entrance into G5 is simple and plain: no architrave (just a door-frame) or arch (Fig. 21). The floorboards are pine, similar in character to those in G4). G5 is a fairly featureless room. The southern wall appears to have a recess for a cooking range, although any chimneystack/flue rising from the ridge has long since disappeared, and has been replaced with a modern exhaust/flue. The jambs comprise squared and dressed stone. This small gabled room has a roof light to the west slope and has timber corbels underneath the wall plates.

Based on the fabric evidence it seems likely that the western window opening is primary but the southern is secondary. Both windows appear to be modern replacements (Fig. 10). There is a southeast doorway into G7.

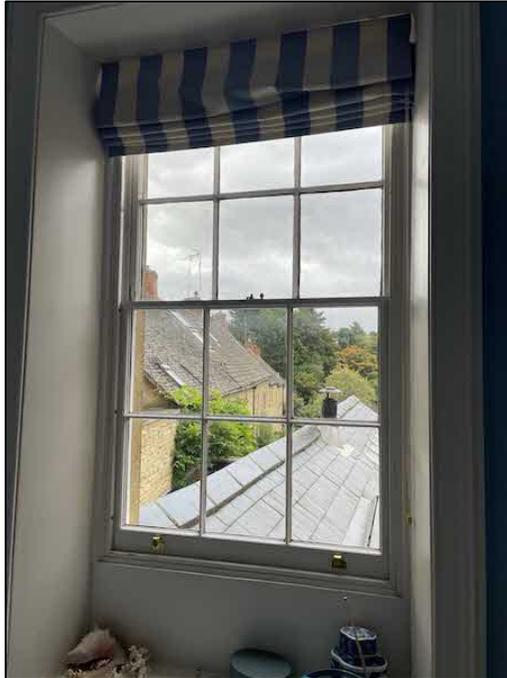
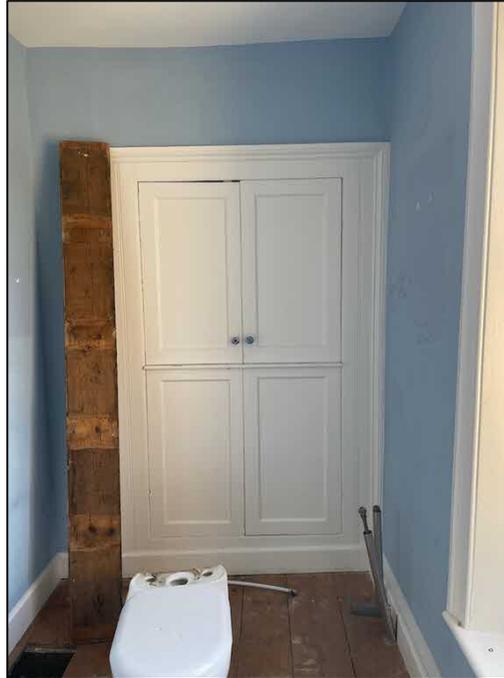
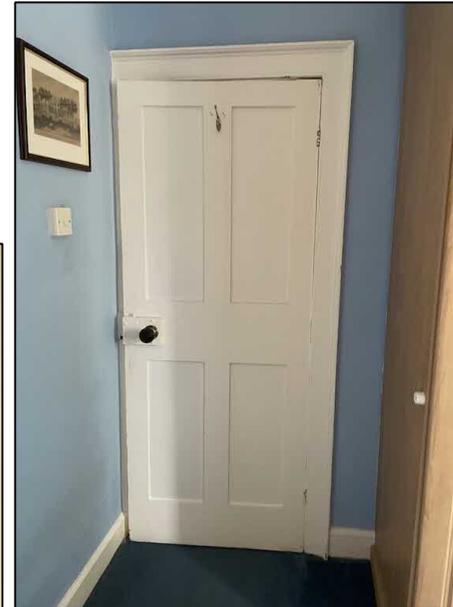
F3a is lit by another 6/6 sash window with fine glazing bars. This example has splayed reveals within a moulded architrave with a window seat: no obvious sign of shutters (Fig. 28).

In the southeast corner of the room, there is a cupboard set within architrave, with two sets of paneled-double doors (fielded on the inside). There are two modern MDF¹⁷ shelves inside the top cupboard. The top doors are hung from modern hinges (Fig. 28).

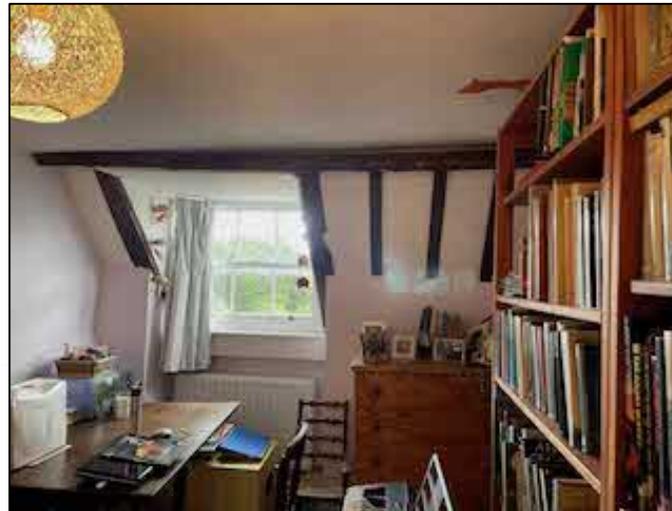
S1 is the western of the principal rooms. The room would have been heated from the hearth in the western wall. To the right (north) of this is the blocked doorway into No. 38. The room is lit by the modern 3/3 sash window set within the south facing dormer window (Fig. 30).

The room would have been heated from the hearth in the eastern wall. To the right (north) of this is a cupboard with a 2-paneled pine door hung from strap hinges ²¹. The room is lit by the modern 3/3 sash window with sidelights set within the south facing dormer window (Fig. 30).

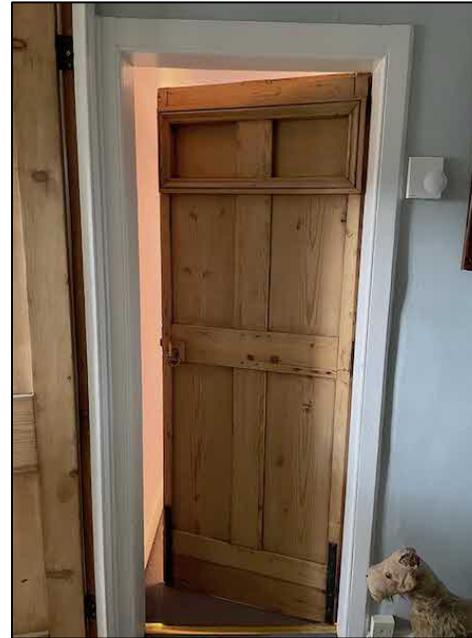
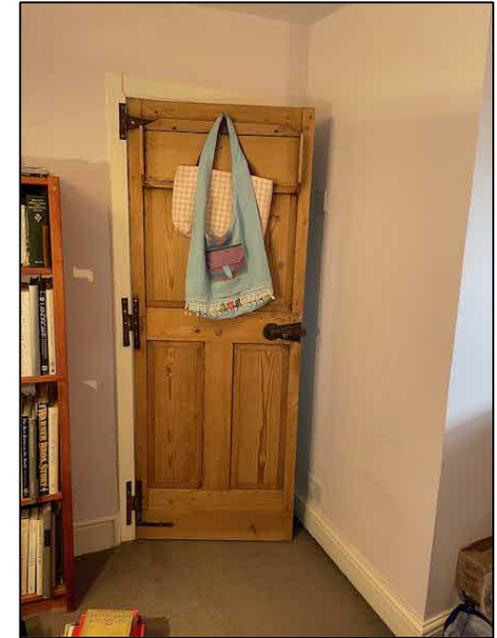
The door between S1 and S2 is interesting. On first inspection the door appears to comprise 6-panels, however, it would appear that the door is an adapted 4-fielded paneled door, with the top section of the upper panels adapted to provide a non-glazed window section and/or ventilation or draft hatch. There is a border/frame to the outer side of the door and a hinged hatch to the inside. The door is hung from; an H, and HL, and a strap hinge. There is a metal spring latch with back-plate to the inside of the door (Fig. 31).

Popularity for 4-panelled doors grew during the late C18¹⁸. Use of the spring latch, again became popular during the C18¹⁹ continuing to be used up until the Regency period¹⁹. H and HL hinges were freely available from the second half of the C17 and early C18, although the simple, plain versions such as those attached to the door in question are most likely to date to the C18²⁰.

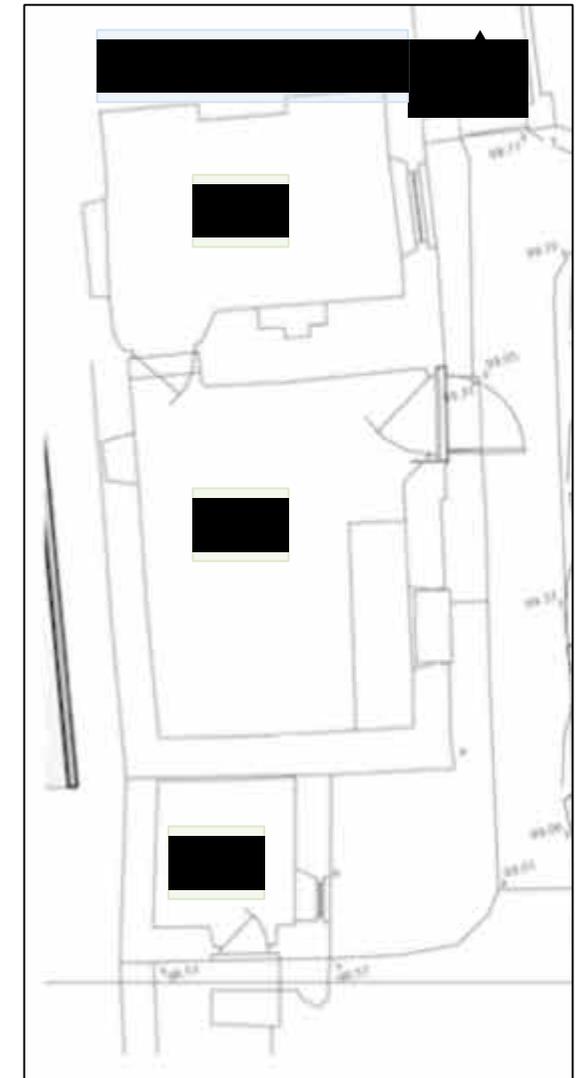
External detail: Comprising rubble limestone with random coursing; the gabled roof above A2 comprises clay tiles with a finial inserted into the punultimate ridge tile as a secondary measure at the south. There is a capped-stone chimneystack at the north end. Above A1 the roof alters pitch and covering with a blue/grey slate roof, continuous above the rear range of No. 38. To the south of A2 is a small outbuilding, likely a former outdoor privy, constructed from randomly coursed limestone rubble with 'some' quoins to the southeast corner, underneath a hipped blue/grey slate roof. Its western wall is on a line with the west wall of A2 and A3; forming the boundary between No. 36 (and No. 38) with No. 40 New Street (Figs. 34 & 35).

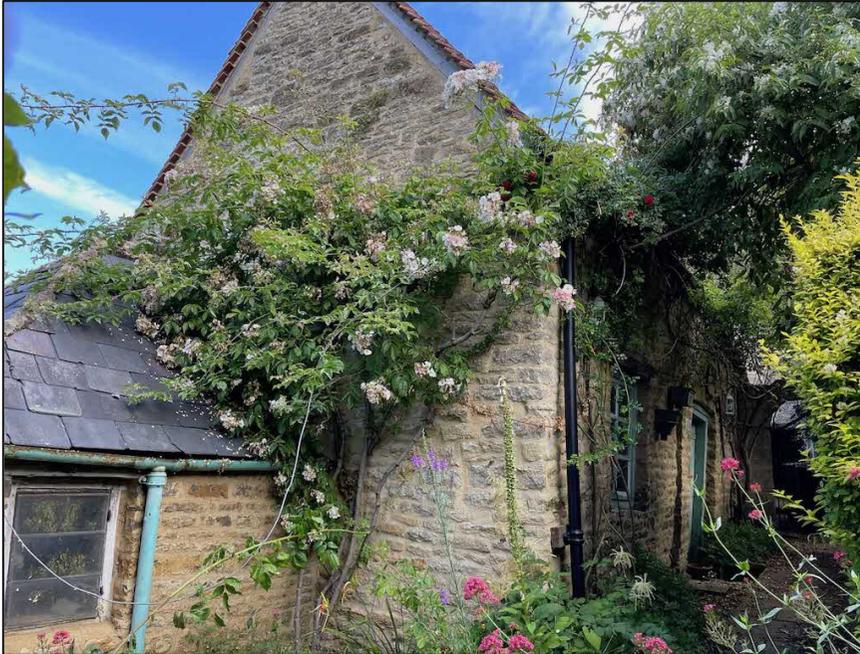
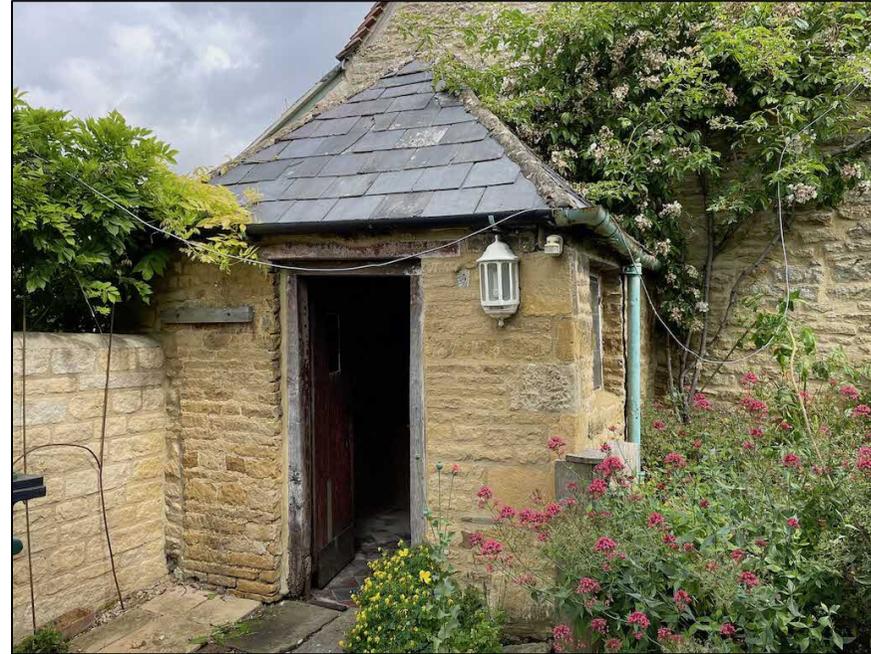
There is a small blocked window to the rear (west) of A2 and a larger window in A1 (Fig. 35).

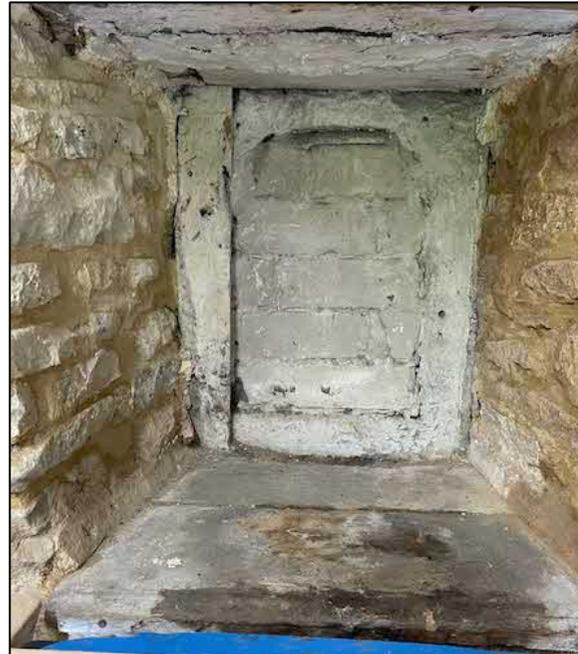
The door between A1 and A2 has 4-panels. There is a small arched headed stone window in the rear wall, (likely primary and early). This has been infilled and blocked with brick. The rear wall is deep, highlighted by the wide planks used as a window cill (Fig. 37).

As mentioned previously, there are an array of straight joints and scars, which do not appear to be echoed externally. There is a hefty transverse ceiling beam below a modern mezzanine floor. The room is lit by the 6-pane timber casement window.
