**TWYNEHAM HOUSE,
UPPER CLATFORD, HAMPSHIRE
SP11 7PS**

Heritage Statement

October 2021

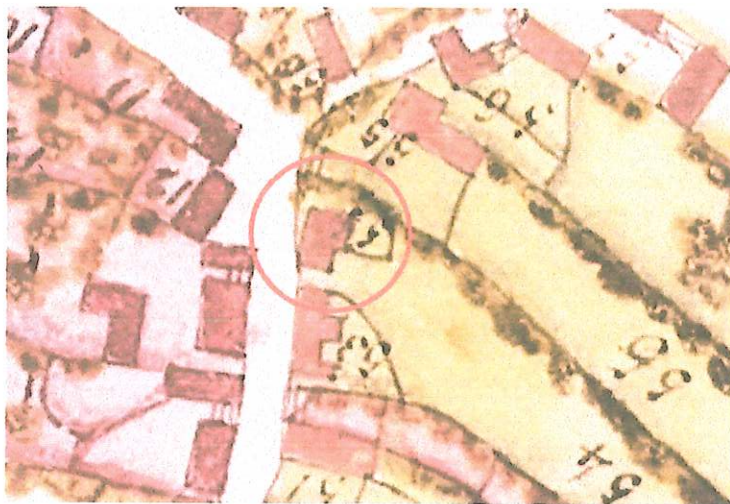
Figure 1
Map of the Manor of
Upper Clatford, 1733
© HRO 117M93/1

- 2.1 The earliest map consulted for this assessment is a Map of the Manor of Upper Clatford of 1733 (Figure 1). This map shows a detached building on the site of Twyneham House, the building having a deeper northern half than the southern part. At this date Watery Lane did not lie immediately south of the Twyneham House plot.

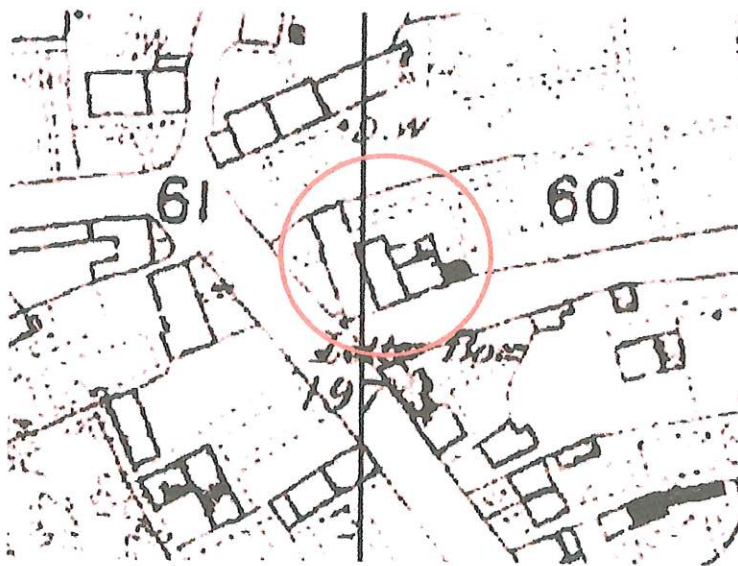
Figure 3
Ordnance Survey 1st
edition 25" map, 1873.
© Ordnance Survey/
Landmark

- 2.3 The Ordnance Survey 1st edition 25" map of 1873 shows that an addition parallel to the earlier range had been added to the rear but not running the full length of the original range, and that there was a further smaller block behind this (Figure 3). This arrangement remained largely unchanged in 1896 (Figure 4). By 1910 there had been some further alteration to the rear – the smaller rear block had been demolished and a new block added further to the north (approximately where the present single-storey block now stands).

- 5.3 The historic maps show that there was a degree of alteration to the rear part of the house in the period between 1896 and 1910 with the removal of a block set against the south boundary and its replacement with a new block set further to the north. Whilst the historic mapping does not indicate any major change to the front or rear ranges, the fabric of the building does suggest that there was a greater level of change than is revealed by the mapping. The use of stretcher bond brickwork for the rear range and the facing of the south elevation of the front range would suggest a date later than 1873. The brickwork, together with the late 19th/early 20th century windows to the rear range, provide evidence to suggest that the rear range was rebuilt c.1900. The remodelling at this time appears to have extended into the earlier part of the house given that the same form of door is used within both phases of the building. It is possible that this remodelling relates to the end of the use of the building as a grocer's shop.

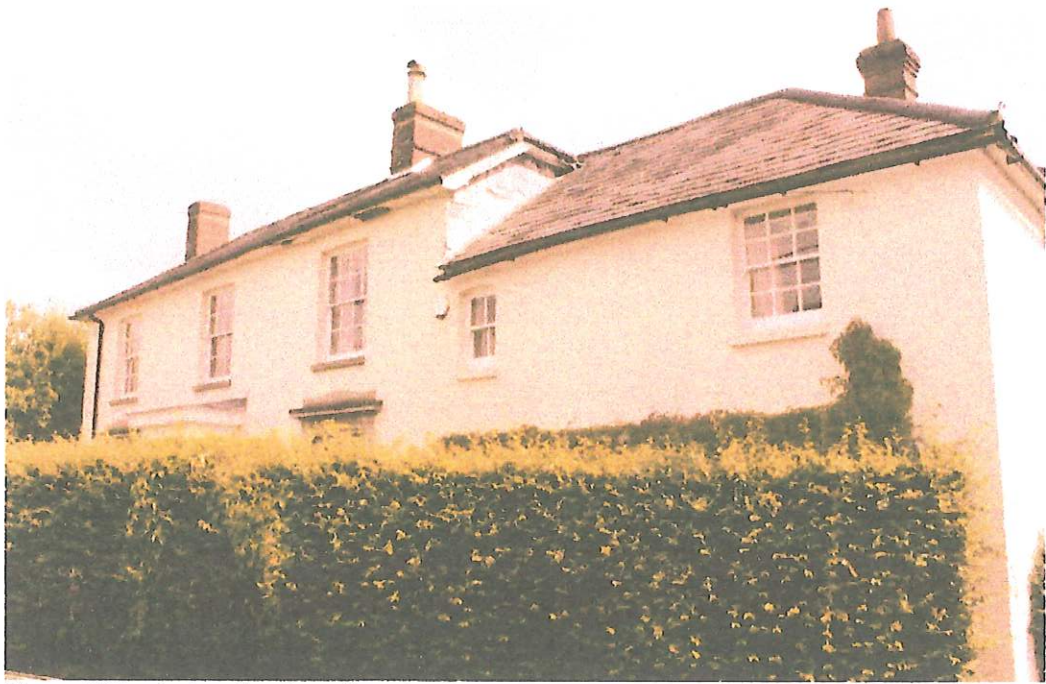
Figure 5 Front elevation from the street.

- 3.1 Twyneham House presents a symmetrical three bay elevation to the street with hornless eight-over-eight sashes at first floor level and to either side of the central door (Figure 5). The windows at ground floor level have cement rendered surrounds and cills with hoods over and the door has a rectangular fanlight with heavy Tuscan columns supporting a flat hood (Figures 6 and 7). The brickwork to this elevation is laid in Flemish bond, the brickwork being painted with a cement rendered plinth. The slate roof is hipped to the north and half-hipped to the south end. There is a stack to the north gable and a ridge stack between the central and southern bays. Attached to the south end is a lower two-storey range under a hipped slate roof with, on its front elevation a small two-over-two sash with decorative horns and a six-over-six sash, also with horns at first floor level. The brickwork of this extension is also laid in Flemish bond and has queen closers where it abuts the main block of the house to the north. There is a rendered string course at storey height with a four-panel door and two, two-over-two sashes with cement rendered surrounds.

5.8 Undoubtedly, the primary element of Twyneham House which was identified as having architectural interest is the three-bay principal element of the front range which, as the list description suggests, is likely to have been built around 1840. The architectural features of this front elevation; the window surrounds and heavily detailed Tuscan porch are typical of the period and it is considered that the architectural interest of this front elevation is medium. The rear elevation of the main block of the house represents a different character to the front, this elevation being of more vernacular form with the use of banded brick and flint. The element has been harmed through the addition of the single-storey extension and the alteration to the large three-light window at first floor level. This element of the exterior of the house has a slightly reduced level of architectural interest – probably being at the lower end of medium. The c.1900 element to the rear constructed in stretcher bond brickwork has limited architectural interest and, whilst it obviously represents a phase in the development of the building, architecturally this element has little which could be described as being of 'special' interest. At best, the architectural interest of this element of the house is at the low end of medium.

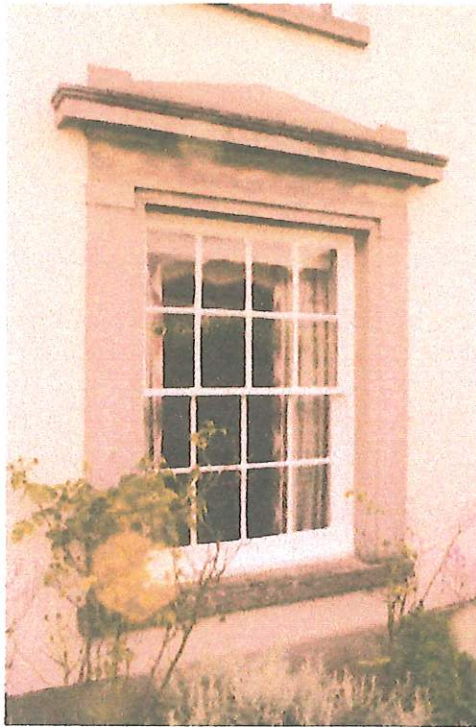
Figure 6 Detail of window surrounds to front elevation.

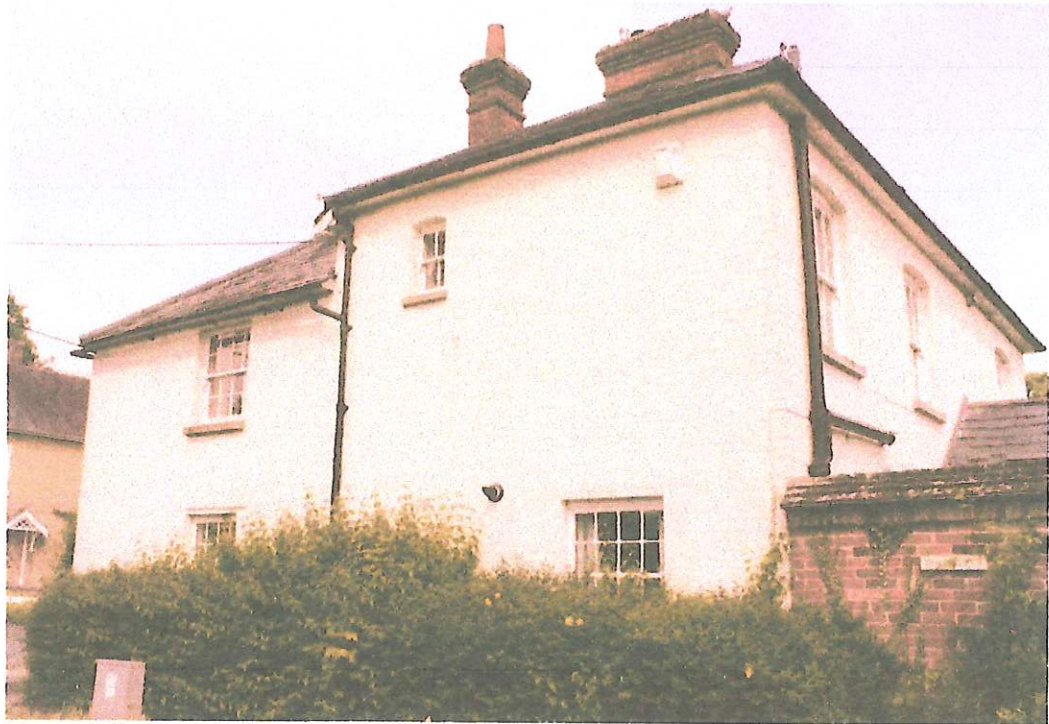
Figure 8 South elevation.

The south gable presents two elements: the lower two-storey hipped roof section to the left with eight-over-eight sashes at first and ground floor levels (Figure 8). At the south-west corner, the brickwork is keyed-in to the brickwork of the front elevation in blocks of three courses and the brickwork is laid in stretcher bond indicating a major rebuild or re-facing. The element to the right of the south elevation is a slightly taller two-storey block, also with a hipped slate roof with a large brick stack set just back from the top of the hip. This element is also of painted brick which is also laid in stretcher bond with the occasional use of header

brick. The brickwork appears to run straight through to the left-hand part of this elevation. At first floor level there is a small two-over-two sash with horns and at ground floor level a further eight-over-eight sash.

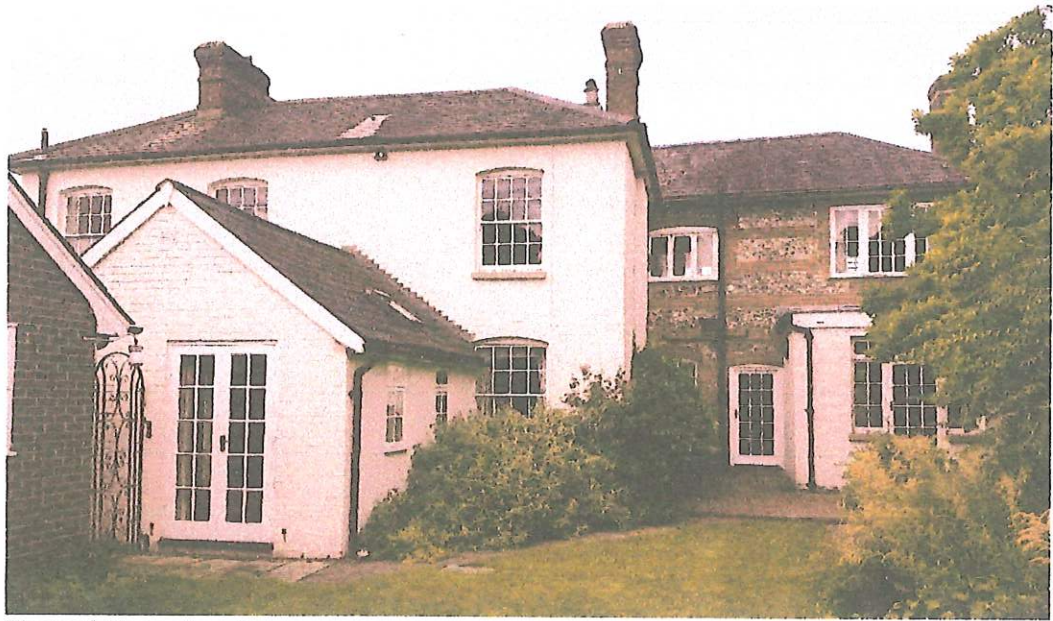
Figure 9 Rear elevation.

- 3.3 The rear elevation of the main block of the house is constructed in flint with brick bands (Figure 9). At ground floor level is a modern door from the entrance hall with a four-over-four sash under a segmental brick arch of two rows of header bricks and a concrete sill to the left of the door. Above is a three-light casement, also under a segmental brick arch of one row of header bricks on edge and one row laid flat. Extending off the drawing room is a single-storey painted brick extension with a shallow pitched lead roof. Some of the bricks have clear wire markings. Above this is the modern three-light casement of the northern bedroom with a row of header bricks above and clearly rebuilt brickwork to the sides.

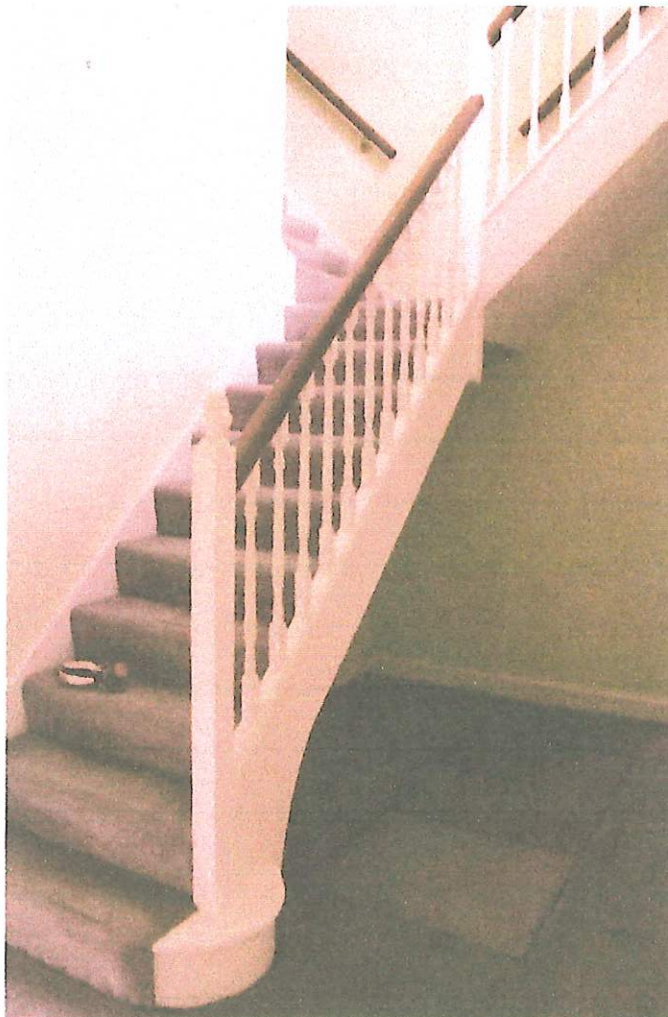
Figure 11
Staircase.

- 3.7 The three-panel front door gives access to an entrance hall and staircase. The modern closed string stair has turned balusters and a mahogany handrail with square newel post with an acorn finial (Figure 11). Within the floor to the west of the staircase is an access to cellar steps. To the left part of the hallway there is short corridor to a modern 15-pane glazed door to the rear garden and a cloakroom which has a vertical board ledged door hung on old strap hinges but which has been faced on the hall side with a sheet of modern boarding and applied mouldings creating four panels. The hallway has a modern coving to the ceiling.

- 5.4 The house was also subject to a phase of alteration in the mid-20th century. At this period the staircase was replaced with the present stair, presumably in a new position leaving the steps to the cellar accessed from a hatch in the hall floor whereas they would be expected to be positioned beneath the main flight. The remodelling of the layout at first floor level was also probably undertaken at this date with the insertion of the corridor within the main range to give access from the stair to the rooms within the front and rear ranges. The small window in the south elevation of the rear range (within the bathroom) would appear to have either served a corridor in the rear range or a WC – either way, there seems to have been change to the plan in this part of the building.

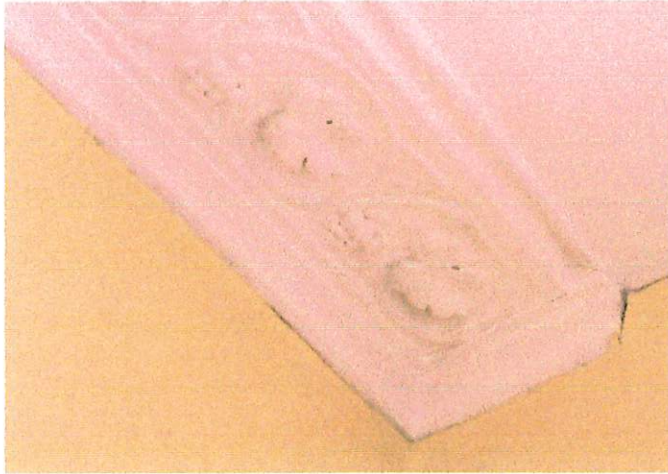
- 3.8 To the north of the entrance hall is the drawing room. This room has a modern reproduction fireplace with marble slips but retains a 19th century cast-iron raised grate and black marble hearth. The room has a decorative cornice to the ceiling of vine leaves and bunches of grapes (Figure 12). The cornice does not run along the line of the original east wall where there is now down stand, the wall having been largely removed to open the room into a modern extension. Whilst the inner moulding of the cornice turns at the corner, the outer moulding runs up to this return closing the design which suggests that the cornice did not originally run along the east wall. The window to the front has slim Grecian moulded glazing bars. The door is of four panels with a decorative moulding. The architrave moulding consists of a roll with an ogee. The skirting board has a simple roll moulding. Within the modern extension to the rear there is a modern 15-pane glazed door with six pane side lights, a three-light top light over the door and two-light windows above side lights.

Figure 12
Detail of the cornice at the north-east corner of the drawing room. The inner moulding continuing to the east wall suggests that the cornice originally stopped at this corner and did not return along the east wall.

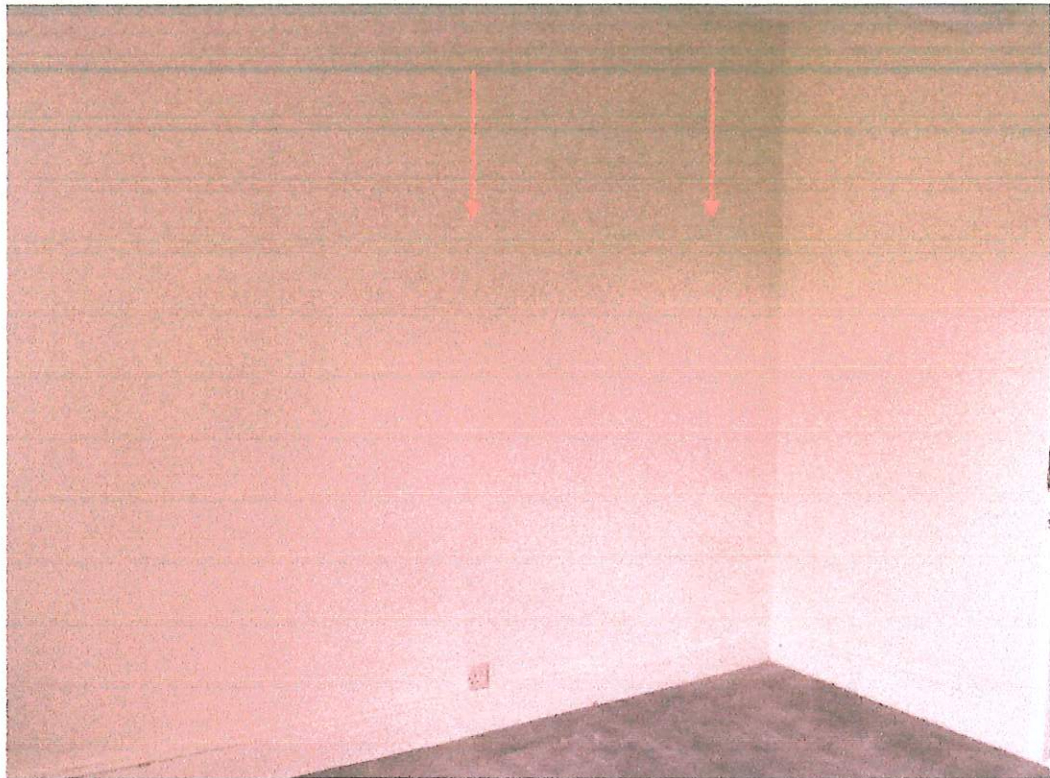
Figure 13 Blocked door visible in the south wall of the rear reception room.

- 6.4 Internally, it is proposed to form a door opening between the kitchen and the sitting room, both within the c.1900 element of the house. This opening will unblock a former doorway, evidence for which is clearly visible in the sitting room (see Figure 13, above). This minor change will not impact historic fabric of significance and will not harm the designated heritage asset.
