Lime Kiln Farm, Coddtenham, Suffolk

Ecological Impact Assessment

Date: 13th August 2023

Ref: 1850

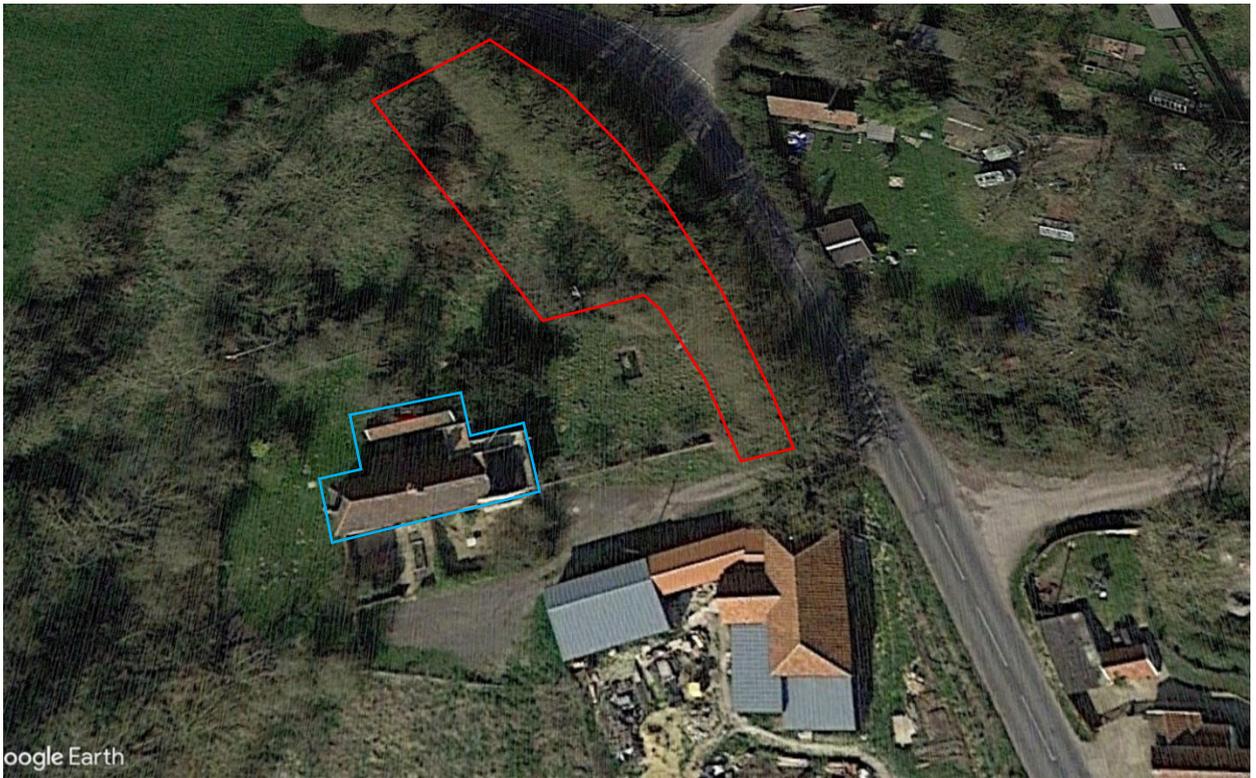
Fig 2: Building location plan, with farmhouse and shed outlined in blue, and location of proposed new shed with access outlined in red. Aerial sourced from Google Earth Pro

- 3.5 The survey area was limited to the land within the red line boundary as shown in Figure 2, plus land immediately adjacent and within the potential Zone of Influence.

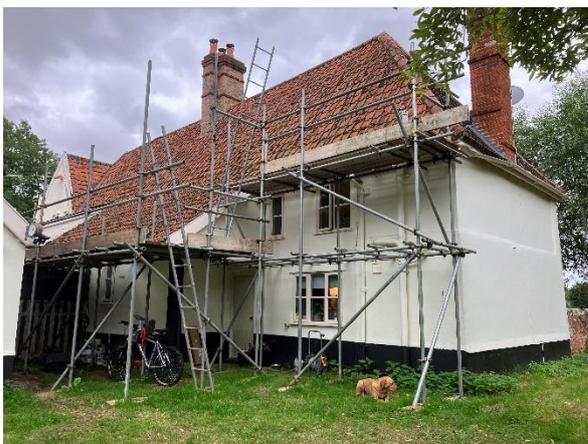
- 4.12 Lime Kiln farmhouse comprises two semi-detached two storey cottages, one of which is currently inhabited, whilst the other has been stripped internally back to brickwork and beams. The external walls are rendered, with a proportion of the south eastern (front) half of the house currently missing render. Door and window frames are wooden, and closely fitting.

Photo 1: North western facades of farmhouse

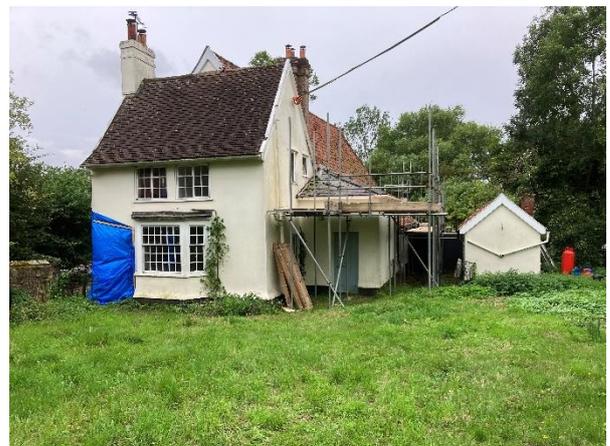
Photo 2: Eastern facades of farmhouse and rear shed

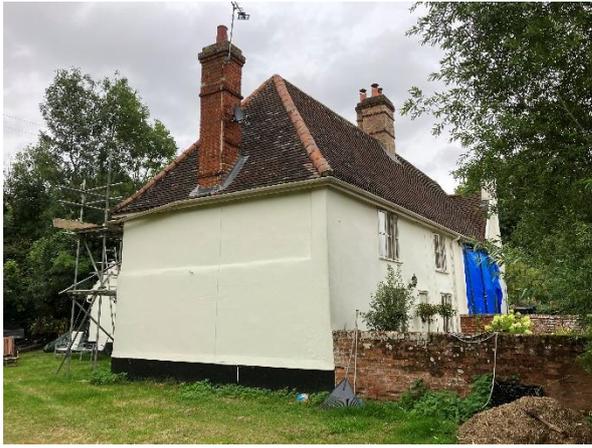
Photo 3: South western facades of farmhouse

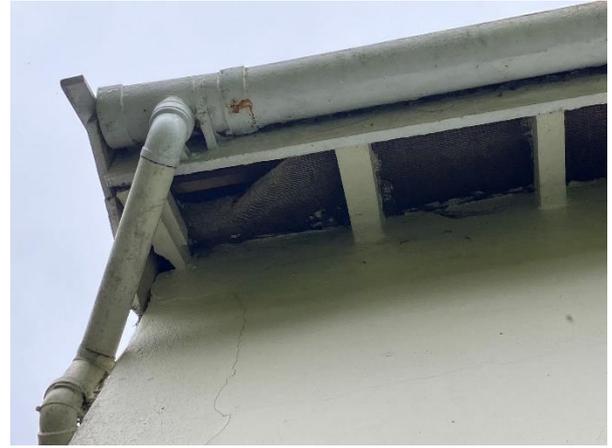
- 4.15 Potential access for birds and bats into the roof on all facades was also noted around the eaves, however no bat droppings were recorded on the white rendered walls beneath.

Photo 4: Potential bat and bird access point around eaves of farmhouse

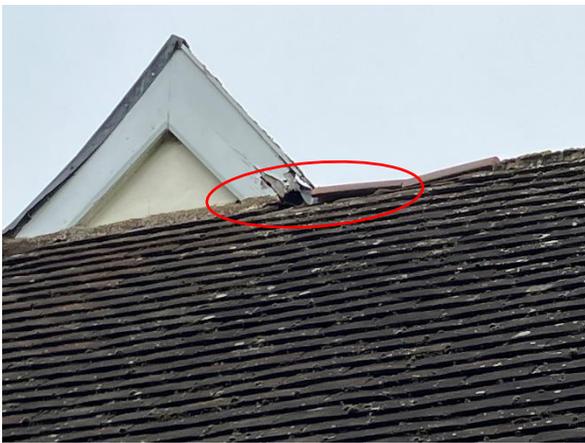
- 4.14 The southern, eastern and western facades of the roof appear to have been relatively recently re-roofed (within the last 10-20 years), with closely fitting peg tiles, well fitted lead flashing around chimneys and wooden soffits in reasonably good condition. The peg tiles have been lined internally with a breathable roofing membrane, which has been extended up and over the ridge beam by around 200mm. Otherwise the northern side of the roof is unlined, and covered with poorly fitting clay pantiles. Numerous potential access points into the roof were noted on this façade, beneath the pantiles, beneath loose ridge tiles, around poorly fitting lead flashing, and around partially rotten wooden soffits and barge boards. Most of the northern side of the roof also extends down to single storey height to cover a small rear extension.

Photo 5: Potential bat access points around ridge and rotten soffits on eastern façade of farmhouse

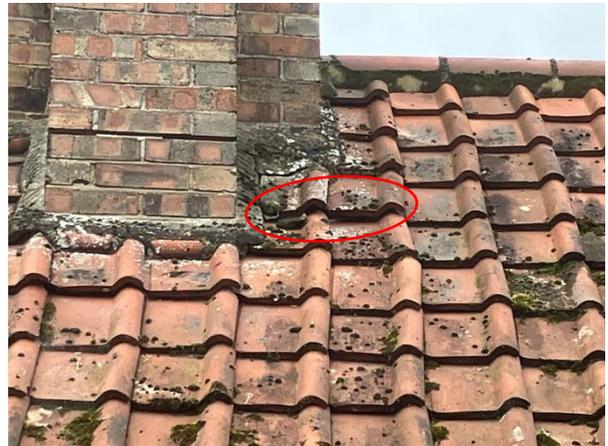
Photo 6: Gaps beneath tiles around chimney base on northern façade of farmhouse

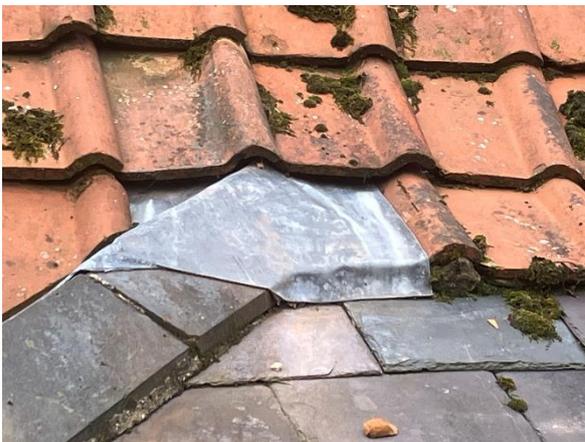
Photo 7: Gaps around tiles and lead flashing on northern façade of farmhouse

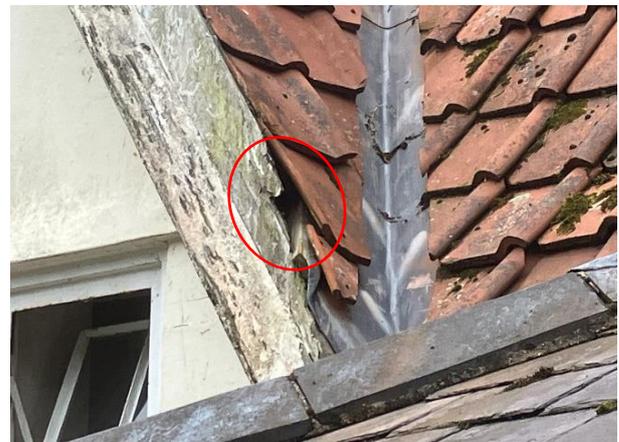
Photo 8: Gaps between tiles and rotten barge boards on northern façade of farmhouse

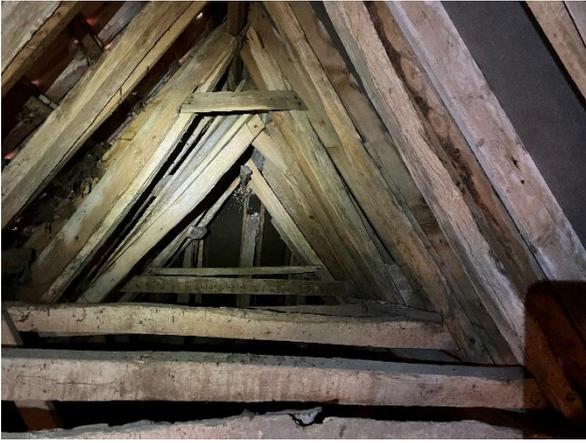
- 4.16 Only the eastern half of the roof space was accessible for inspection, running from a large, central chimney breast across to the hipped eastern end. The floor is covered with thick fibreglass insulation, which did not appear to have been disturbed for a significant period of time. Across the insulation were various large collections of bat droppings, of various ages from fully disintegrated and dusty, to old grey intact droppings, to dark fresh droppings.

Photo 9: Internal view of eastern loft space (western side thought to be a mirror image, but inaccessible due to excessively small loft hatch)

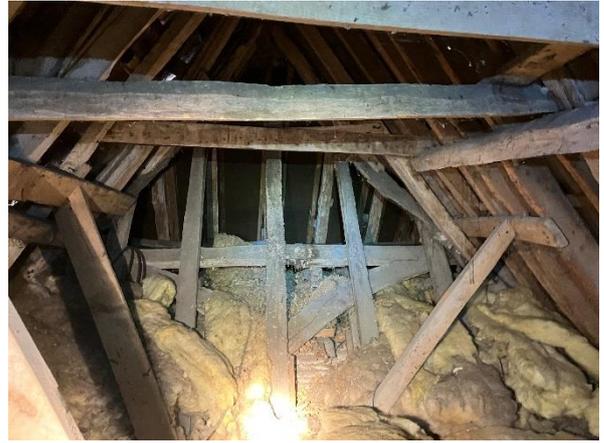
Photo 10: Eastern end of loft space, where floor is raised

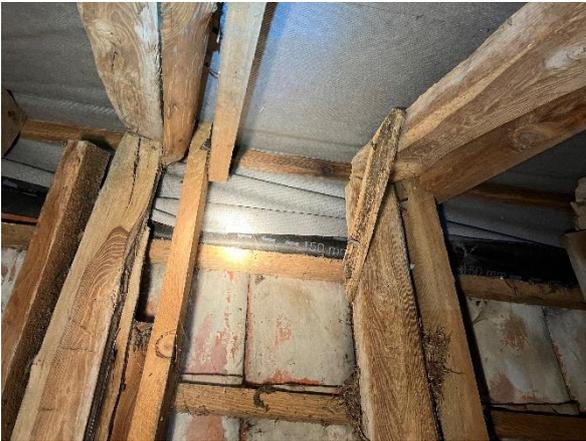
Photo 11: Ridge area of loft space, with breathable membrane running over ridge and c.200m down northern side of roof

- 5.9 Only traditional Type 1F bitumen felt will be used to line the northern façade of the roof, and not a breathable membrane due to the potential for bats to become entangled in loosened fibres of breathable membranes. A breathable membrane has already been used across the southern façade of the roof, but since no alterations are proposed to this or the eastern and western facades, this membrane will remain insitu. Due to the apparent loosening of the fibres already, it is recommended that the internal sides of the breathable membrane are at least partially relined with Type 1F felt in the areas most used by bats i.e. c.200mm down from the ridge beam. This will prevent bats inside the loft roosting against the breathable membrane, and will reduce the likelihood of bats further loosening the fibres and becoming entangled. It is noted however, that this is not the responsibility of the current home owner to do this, and it will effectively result in an enhancement of the current conditions inside the roost.

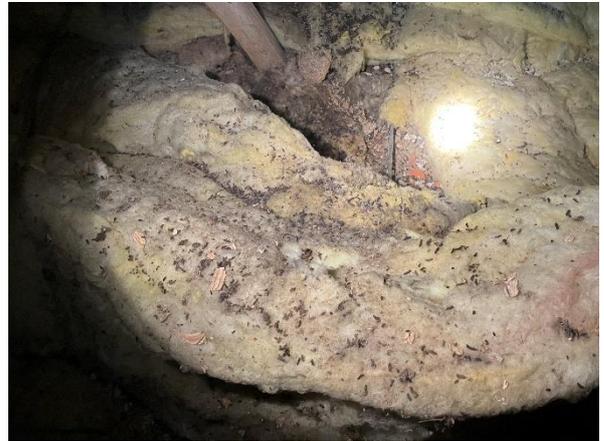
Photo 12: Collections of bat droppings of varying age beneath ridge – fully disintegrated, dry and dull, and dark and shiny

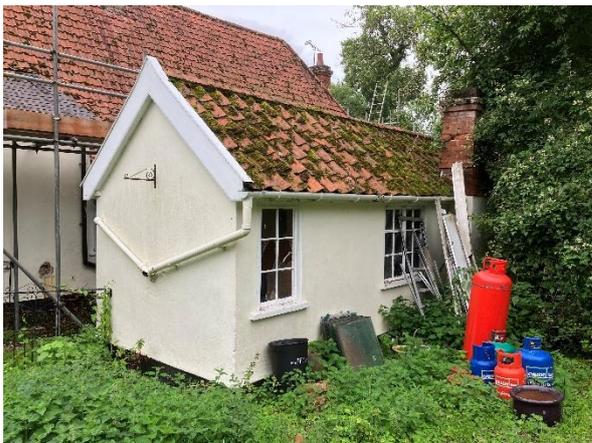
- 4.17 Immediately adjacent to the northern rear wall of the house is a long, narrow, single storey brick and render storage shed. Roof beams are closely fitting, and are covered with black bitumen felt and clay pantiles. The tiles are well fitted, with numerous holes and tears in the felt beneath. No evidence of the presence of bats was recorded internally or externally on this building.

Photo 13: North eastern facades of rear shed

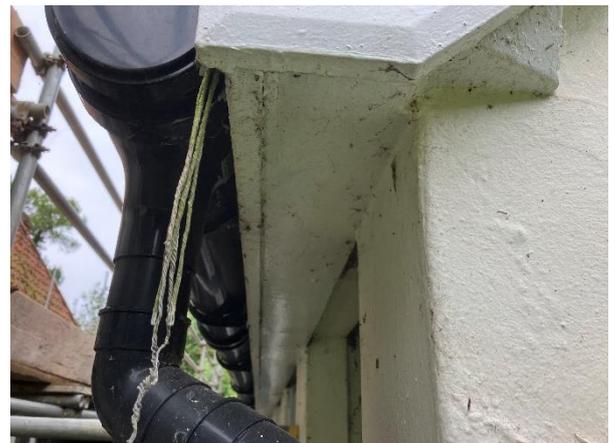
Photo 14: Closely fitting soffits and barge board of rear shed

4.24 Tiles across the northern shed are closely fitted, soffits and barge boards are in very good condition, and the shed itself is shaded by the immediately adjacent house. This building is assessed as being of negligible suitability for roosting bats.

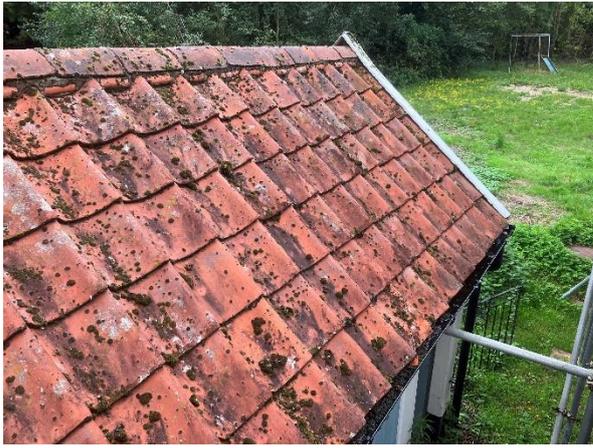
Photo 15: Closely fitting tiles of rear shed

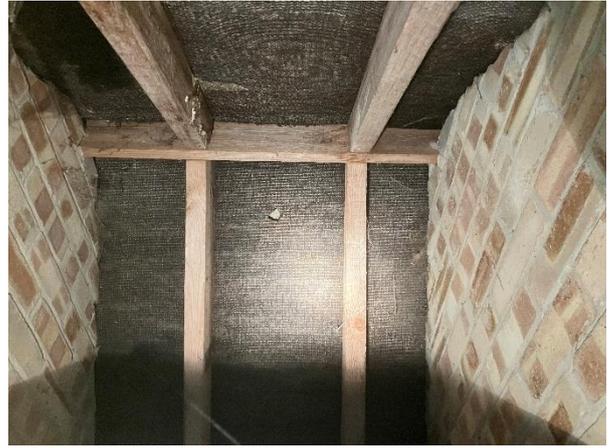
Photo 16: Internal view of rear shed

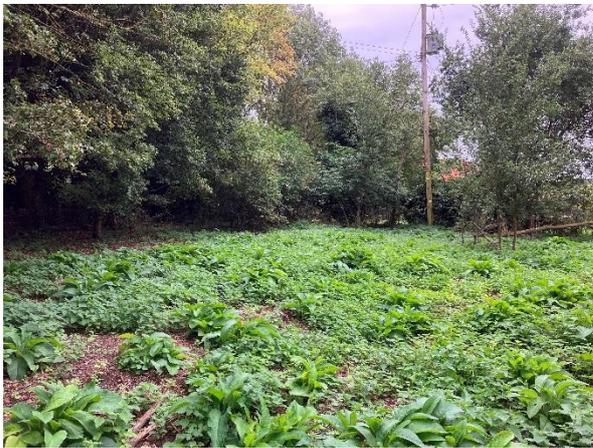
Photo 17: Proposed location of new storage shed

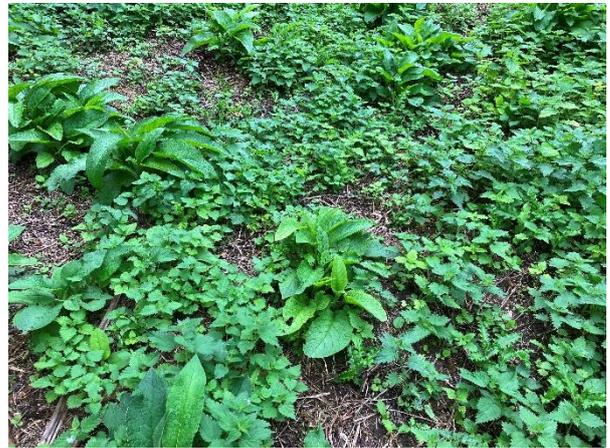
Photo 18: Typical vegetation cover across location of new storage shed

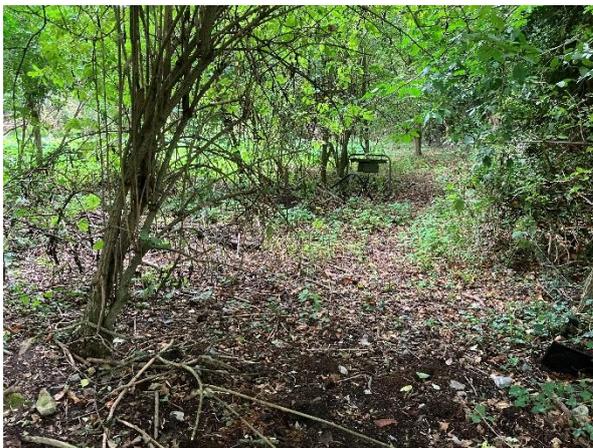
Photo 19: Small stand of leggy elder located along northern half of proposed new access route

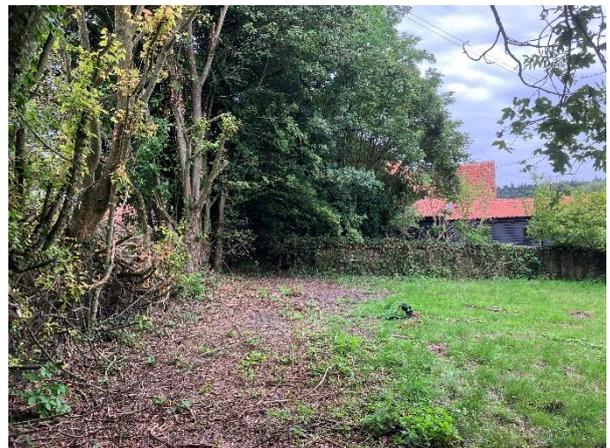
Photo 20: Bare earth and sparse vegetation along southern half of proposed new access route

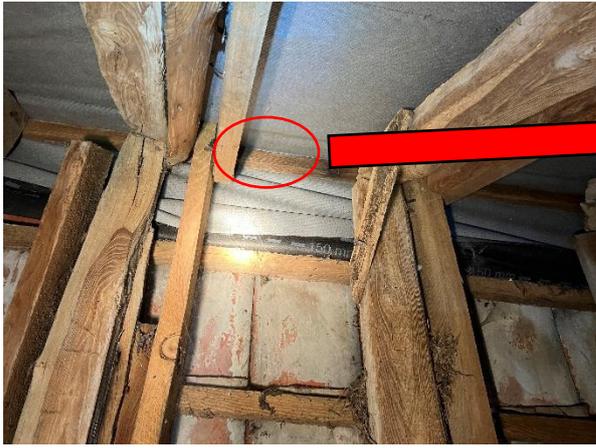
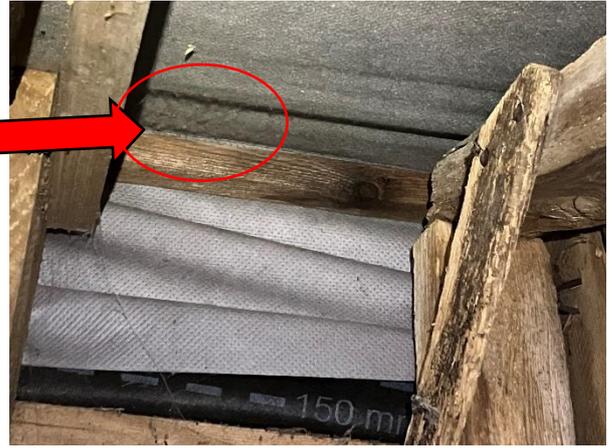
- 4.22 As indicated by the various locations of bat droppings beneath the ridge area, the bats appear to be roosting in a number of positions along the ridge beam, however one particular area was noted close to the central roof chimney stack where the roof membrane fibres have been noticeably pulled and worn – see photographs 21 and 22 overleaf.

Photo 21: Red circle - likely favoured location of roosting brown long-eared bats

Photo 22: Likely location of roosting bats indicated by piling and pulling of roof membrane fibres

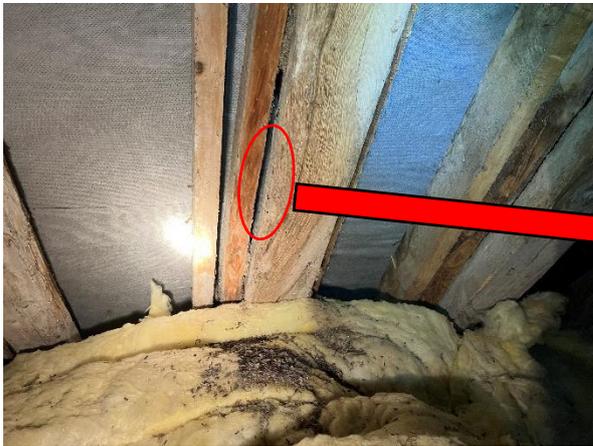
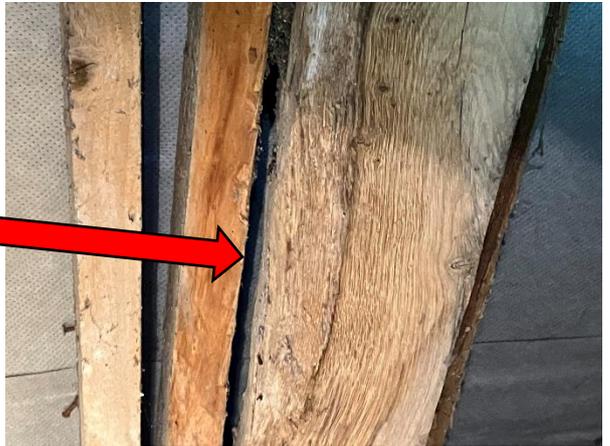
- 4.23 A second obvious roosting location was noted along the southern façade of the roof, in a low crevice created between two rafters. An estimated 2-300 droppings of various ages were recorded on the fibreglass insulation immediately below. See photos 23 and 24 overleaf.

Photo 23: Red circle - likely favoured location of roosting brown long-eared bats

Photo 24: Likely location of roosting bats indicated by piling and pulling of roof membrane fibres

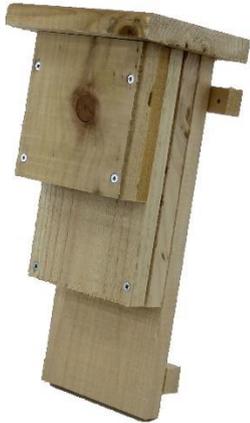
Wooden Kent Bat Box

Made of thick, untreated wood with two vertical cavities. Based on a design by the Kent Bat Group

- 6.1 **2 no. wooden Kent bat boxes** will be fixed to the new storage shed – one on the south western wall and one on the north western wall – to provide a variety of roosting conditions for crevice dwelling bats. Each box will be located at least 3m high, and well away from all sources of artificial lighting. The recommended box type is shown below.

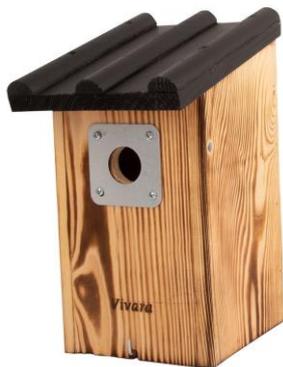
'Travis' style wooden nest box with 32mm diameter hole and predator-proof metal plate.

- 6.2 **3 no. bird boxes suitable for house sparrows** will be fixed to the northern or eastern elevation of the new storage shed, at a height of 2-4m. The boxes will be positioned as close as possible (at least within 300mm) of one another. The boxes will each have a 32mm diameter access hole (suitable for use by house sparrows).

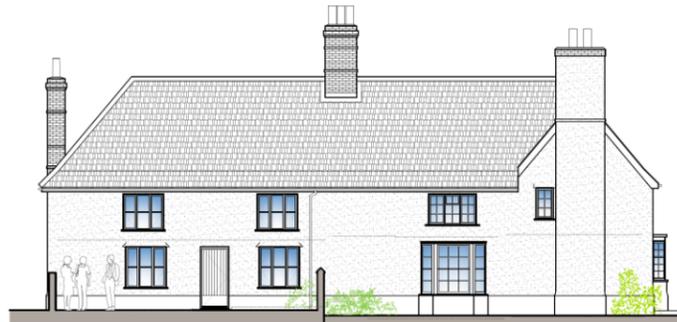
proposed south-east elevation 1:100

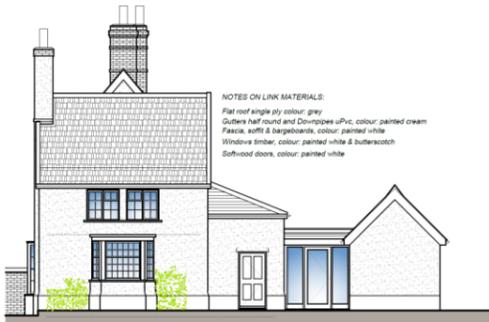
proposed north-east elevation 1:100

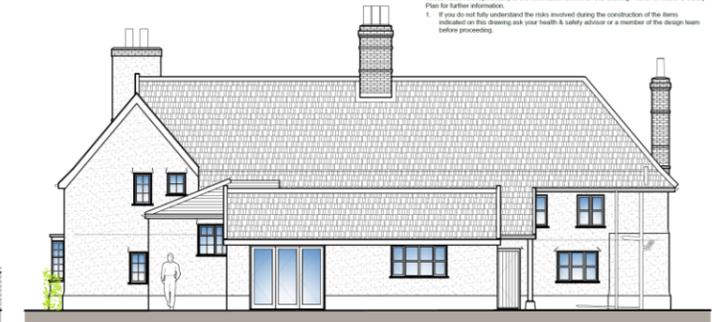
proposed north-west elevation 1:100

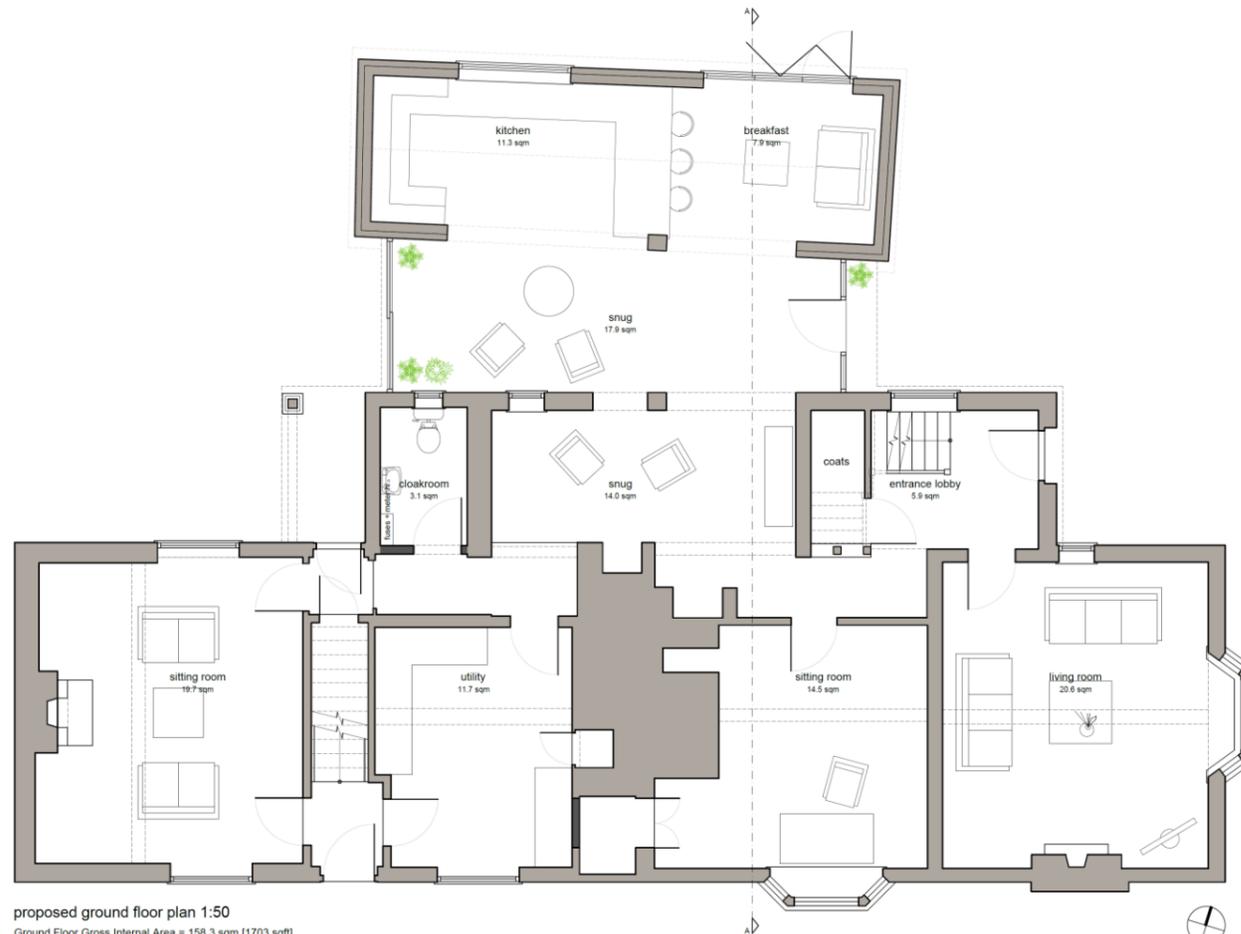
proposed ground floor plan 1:50
 Ground Floor Gross Internal Area = 158.3 sqm [1703 sqft]
 Total Gross Internal Area = 254.4 sqm [2737 sqft]

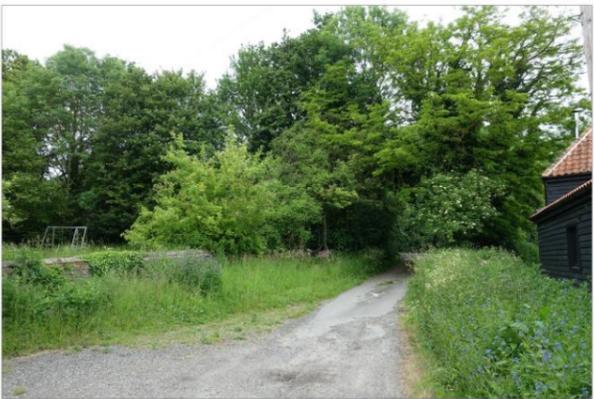
View looking Northeast towards entrance showing 1.5m high garden wall, 3.5m section to be removed as indicated on block plan
