Whitmore Dairy Cottage, Ashill, Devon

Bat Survey and Assessment

For Mr Perry Waddams

20th July 2023

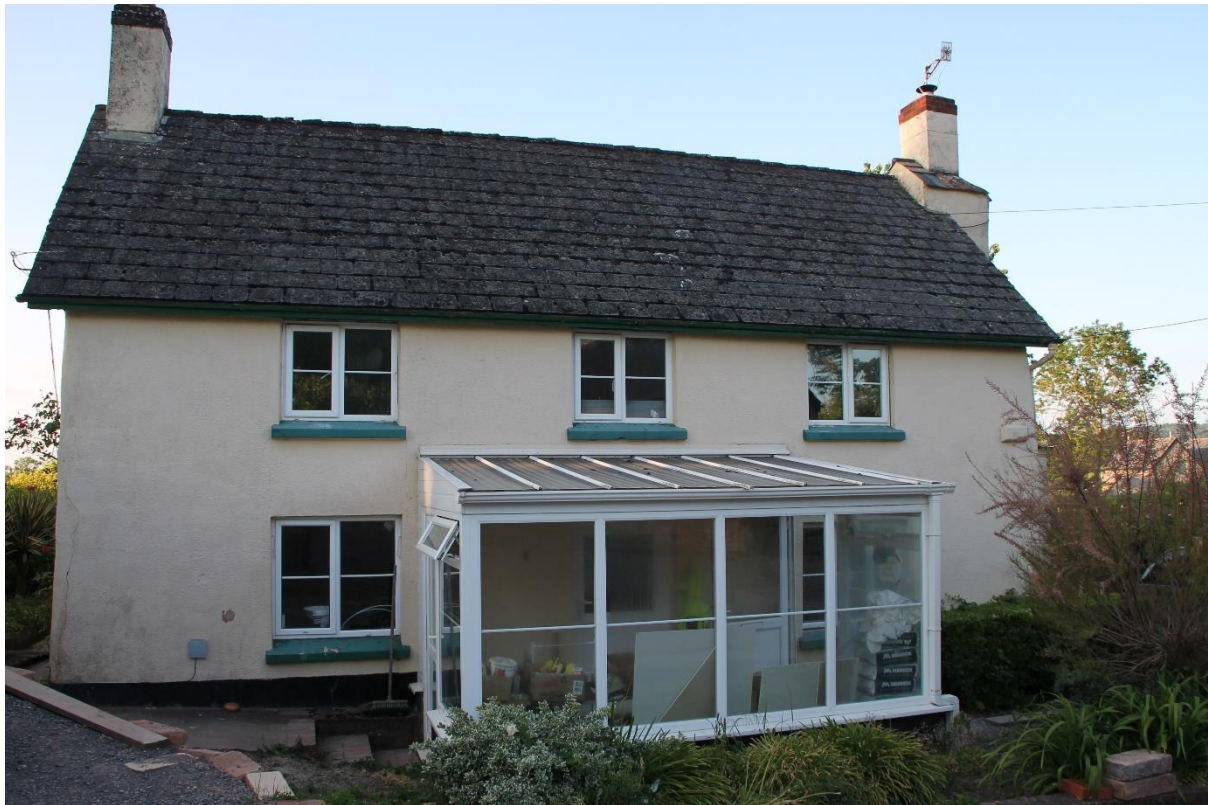
Photograph 1: showing a view of the target building

The target building is a two storey detached residential property constructed from traditional stone with an external render that has been painted. The roof is multi-pitched and is covered with slate tiles, and at the rear of the property there is a large two-storey extension with a flat roof covered with bitumen roofing felt.

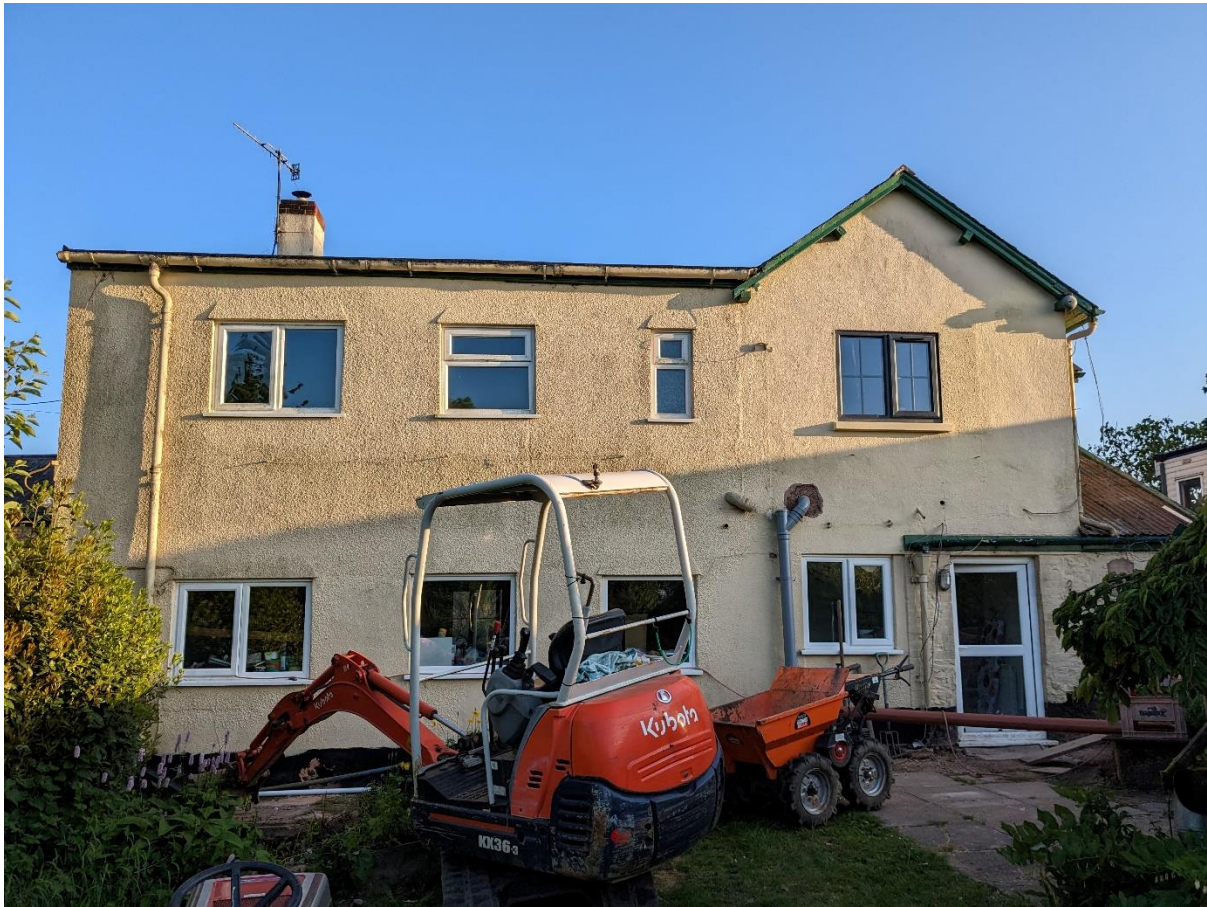
Photograph 2: showing a view of the rear of the target building

Externally the walls of the building were found to be in a good condition with no cracks or crevices where bats could gain access for roosting. Some water damage was noted on the external walls; however, they were found to be dry at the time of the survey.

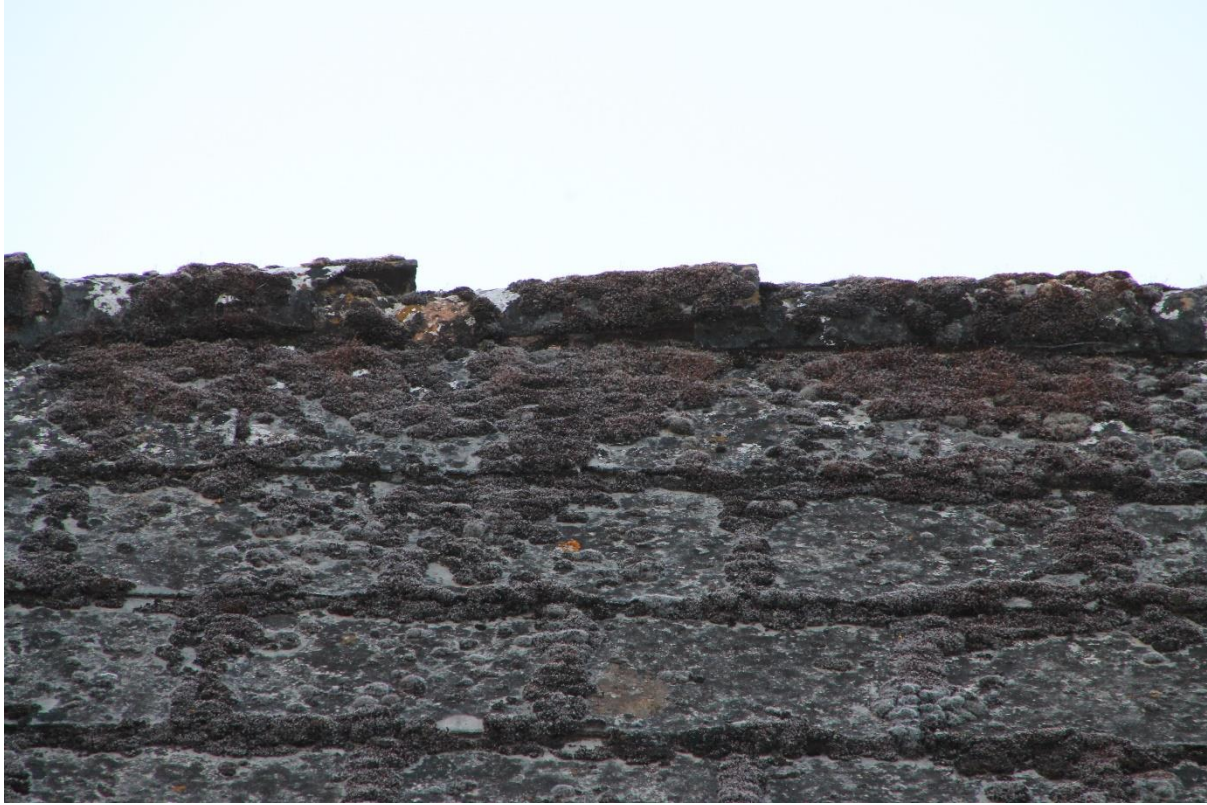
The external roof structure of the building was found to be in a good condition with no loose, lifted or missing tiles. Some evidence of moss was noted to be present on the roof indicating that it is wet and this may reduce the suitability for bats that require dry and stable conditions for roosting.

Externally no evidence of bat activity was found in the target building during the physical inspection.

Photograph 3: showing the external roof structure

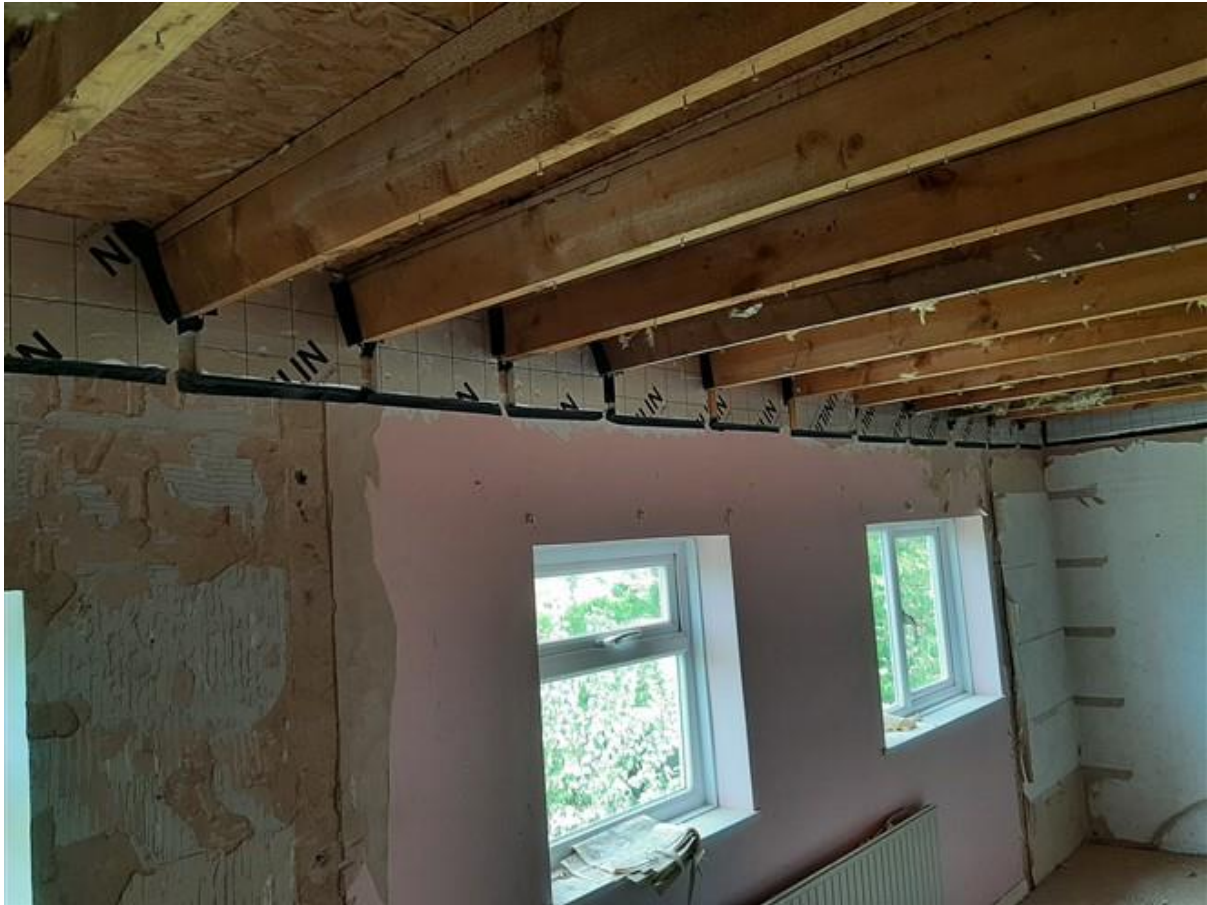
Internally the building is undergoing renovations and it is understood that evidence of bats (droppings) was identified (by the owner) when a plasterboard ceiling was removed from the extension to the rear of the property.

Following the discovery of these bat droppings, an inspection was made by an ecology consultancy where it was assessed that bats had been using the area behind the fascia to the rear of the property (where they may have gained access to the top of the wall), although no bats were found. Droppings were assessed as being from pipistrelle bats and the owner was advised to internally enclose the area along the northern and eastern elevations, to prevent bats from entering the living space. It is understood that this has been undertaken using Celotex insulation.

During the survey undertaken by Ellendale Environmental no evidence of bats was found in this part of the building and no evidence of bats was found on the external areas of the building, indicating that it is no longer used by bats.

Photograph 4: showing the area where evidence of bats was found (by the owner/previous ecologist)

It is therefore advised that precautionary working methods are undertaken during the renovation of the building, including:

- A suitably experienced and licenced ecologist will be available to attend site on a regular basis throughout the construction period to ensure all environmental mitigation relevant to the project is delivered;
- Site personnel will be made aware of the potential presence of bats through a toolbox talk;
- Any dangers within the site likely to affect bats will be identified and measures undertaken to minimise any such risk, i.e., lighting;
- If a bat is found, or the presence of bats is suspected, all work must stop immediately, and a licensed bat worker must be contacted for advice;
- Bats must not be handled under any circumstances; and
- The ecologist will assess a potential roost space (if identified/found) and inform NE of the proposed actions to be undertaken.

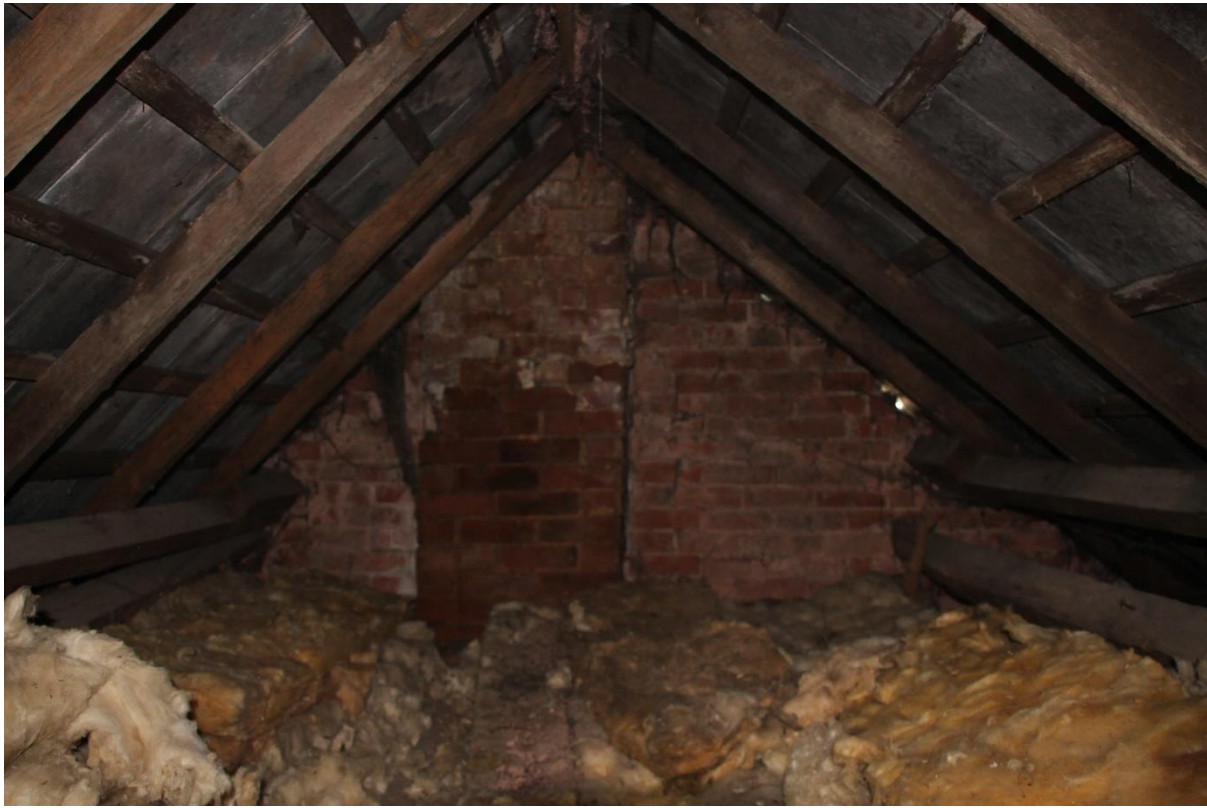
The loft space of the building is constructed from a traditional timber frame covered by a single layer of slate tiles. No felt liner was present under the slate tiles; however, the loft was well insulated with fiberglass loft insulation. A few old bat droppings were noted to be present within the loft space and these were found to be hard and grey. No recent bat droppings (i.e., 2023) were found. It was noted within the loft space that several gaps had been repaired to ensure the roof remained watertight and in a good condition.

A few cobwebs were noted to be present along the ridge of the building and some water damage was noted along the chimney area.

Photograph 5: showing an internal view of the loft space

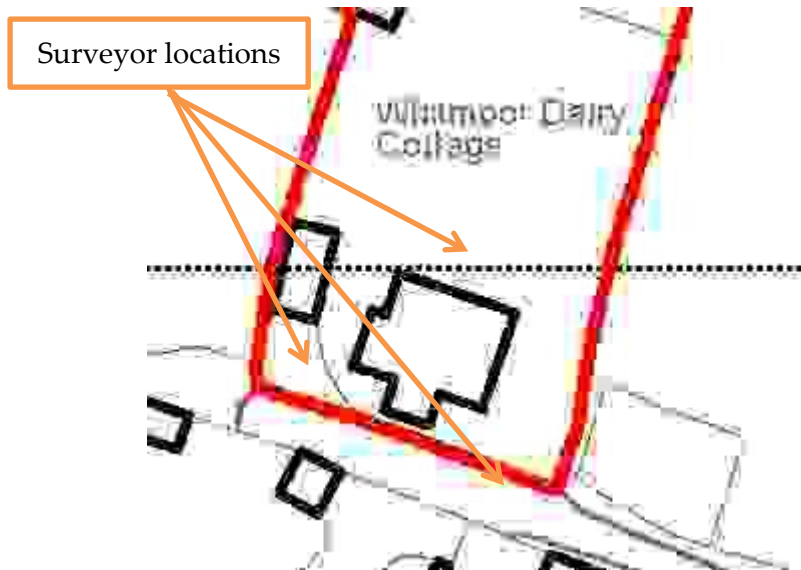
Each surveyor was located in a static position to cover all aspects of the target building during the activity survey.

Figure 2: Surveyor locations
