Ground Investigation Report

Proposed Redevelopment

Lanwades Park, Kentford, Newmarket

Site: Lanwades Park, Kentford, Newmarket
Document Title: Ground Investigation Report
Document no.: STU5875-R01 Rev B
Date: February 2023
Client: Lochailort Investments Limited
Issuing office: Soiltechnics Ltd
Cedar Barn, White Lodge, Walgrave, Northampton. NN6 9PY
Tel: 01604 781 877 E-mail: mail@soiltechnics.net

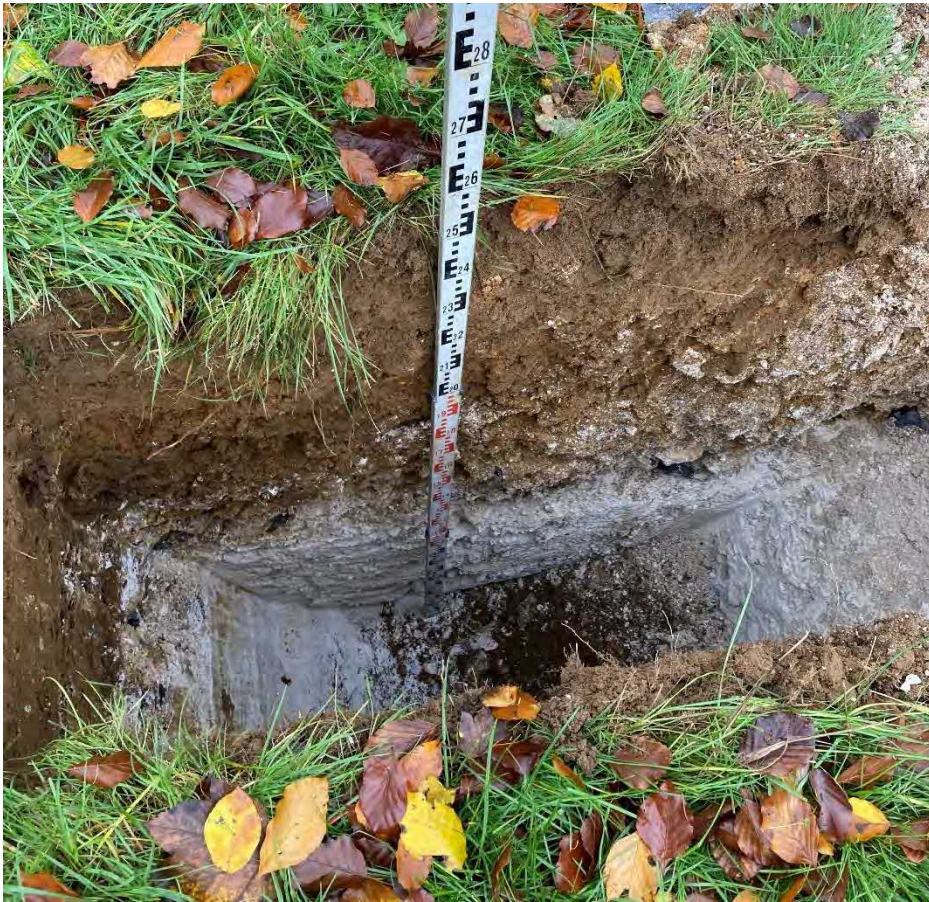
Figure 6-1: Topsoil within TP15

6.2.1 Topsoil was encountered in all exploratory holes, with the exception of HP02, HP03 and TP04. The base of the unit varied between 0.1m and 1.0m thick. The Topsoil comprises dark brown, gravelly, sandy clay with gravel consisting of flint.

6.2.2 A typical photograph of topsoil deposits encountered is presented below.

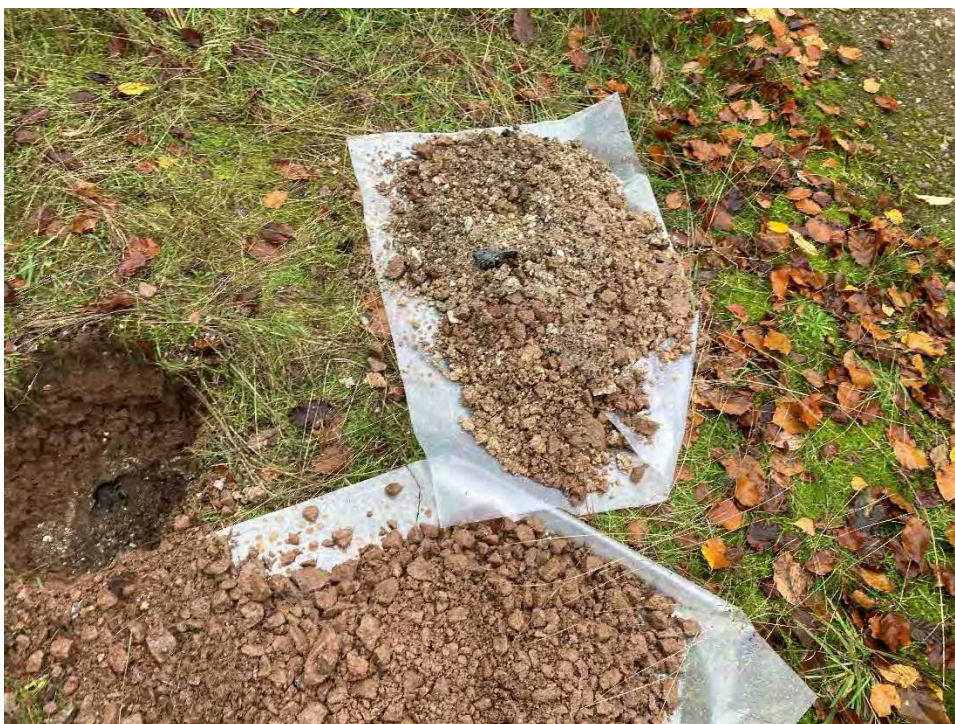
Figure 6-2: Made Ground in HP03

- 6.3.2 Made Ground is variable but generally comprises grey and light brown, slightly sandy to sandy, clayey gravel or gravelly, slightly clayey sand and light brown and light grey, slightly sandy, slightly gravelly clay. Gravels consist of chalk, flint, brick, clinker, concrete and sandstone. Occasional wood and fabric are present in the cohesive deposits in TP04 to the north of the incinerator building. Staining and a strong hydrocarbon odour were also noted between 0.6m and 1.20m in this area.

- 6.3.3 Photographs of the Made Ground encountered are presented below.

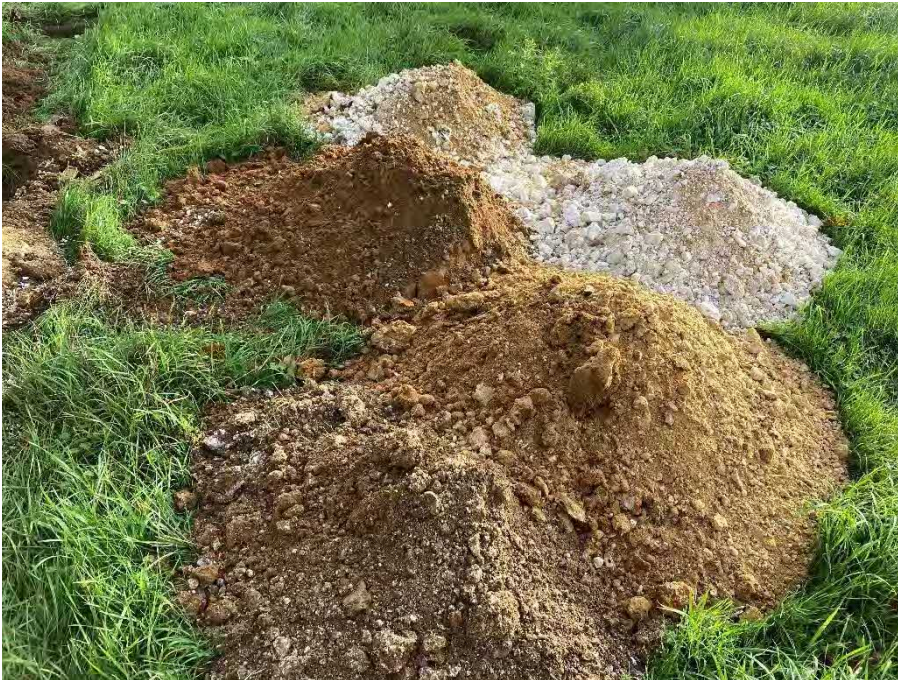
Figure 6-5 Quaternary Deposits taken from TP14.

- 6.4.3 Such deposits are likely to be part of the Lowestoft Formation, though the variability and locally low strength provides some doubt, with such deposits also reminiscent of alluvial and/or Head deposits and as such have been given the more generic term of Quaternary Deposits.

6.4.4 A typical photograph of the Quaternary Deposits encountered is presented below.

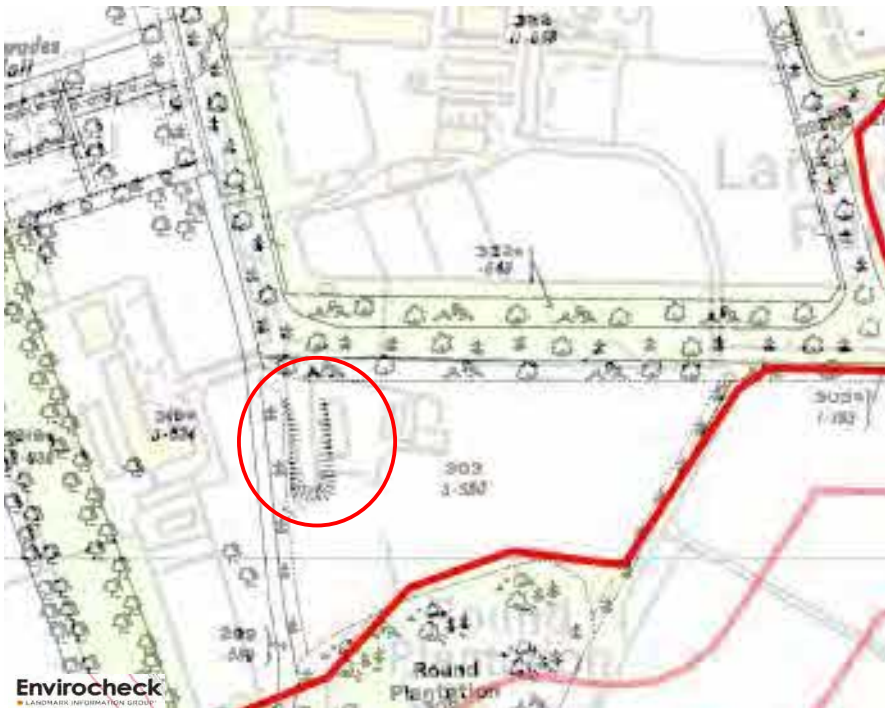
Figure 7-1: Mapping overlays from 1926 and 2006 showing existing layout and location of former quarry

- 7.4.2 Based on historical maps, a backfilled quarry is likely to be present on site as indicated by the red circle on Figure 7-1. This area lies below an existing building and access way and investigations have not been undertaken in this location at this time. This is likely to be an area of deep Made Ground and may require further investigation depending on development proposals. Again, a piled foundation solution may be required in this area should buildings be proposed over the former quarry.

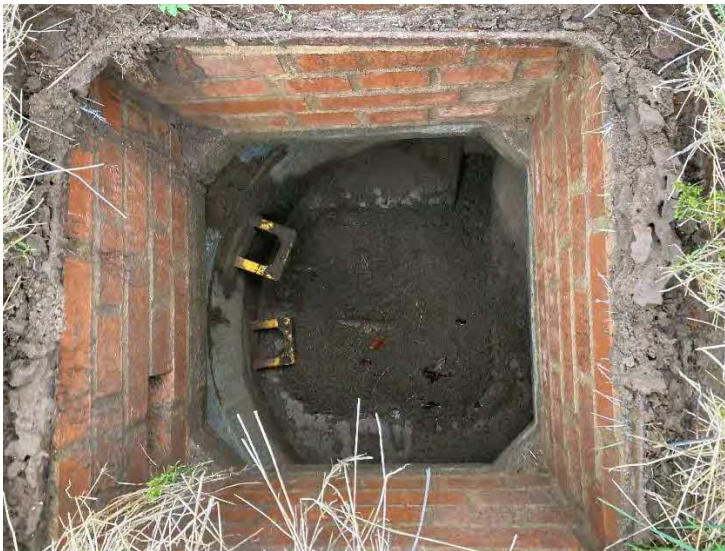
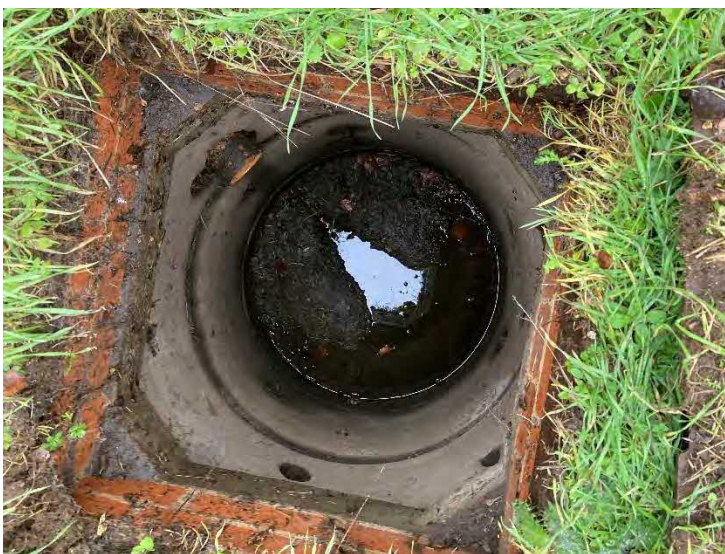
Figure 8-1: View of existing drainage

8.10.1 Based on the site reconnaissance, it was considered likely that any biohazard waste would likely be predominantly present in drainage at the site. On this basis, during fieldwork, manhole covers down gradient of the main site were lifted to assess the presence of any obvious silts or sludge material that could potentially indicate waste products within the drainage.

8.10.2 Some drainage runs appeared to be clear although others included some soils/silts. No sampling or testing was undertaken due to possible risk to personnel. Further assessment of the materials within the drainage system may be required.

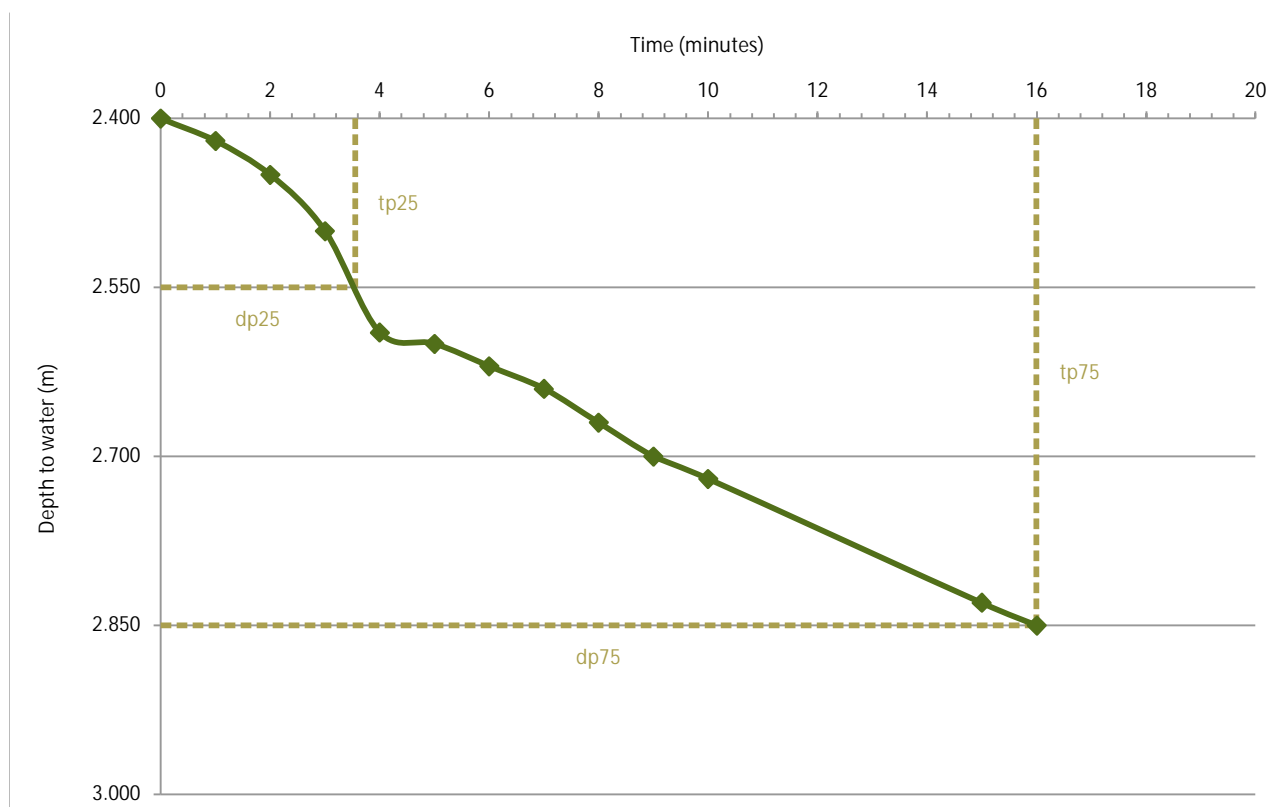
Location	Cycle	Test date	Dimensions (m)
TP01	1	21/11/2022	0.70m x 3.80m

Depth at start of test (m)	Groundwater observations (at time of excavation)
2.4	No groundwater encountered.

$$f = \frac{V_{p75-25}}{a_{p50} \times t_{p75-25}}$$

V_{p75-25} Effective storage volume of water between 75% (dp75) and 25% (dp25) effective depth	0.798	m ³
a_{p50} Internal surface area up to 50% effective depth and including the base	5	m ²
$t_{p75} - t_{p25}$ Time for the water level to fall from 75% to 25% effective depth	747	s
f Soil infiltration rate	1.99E-04	m/s

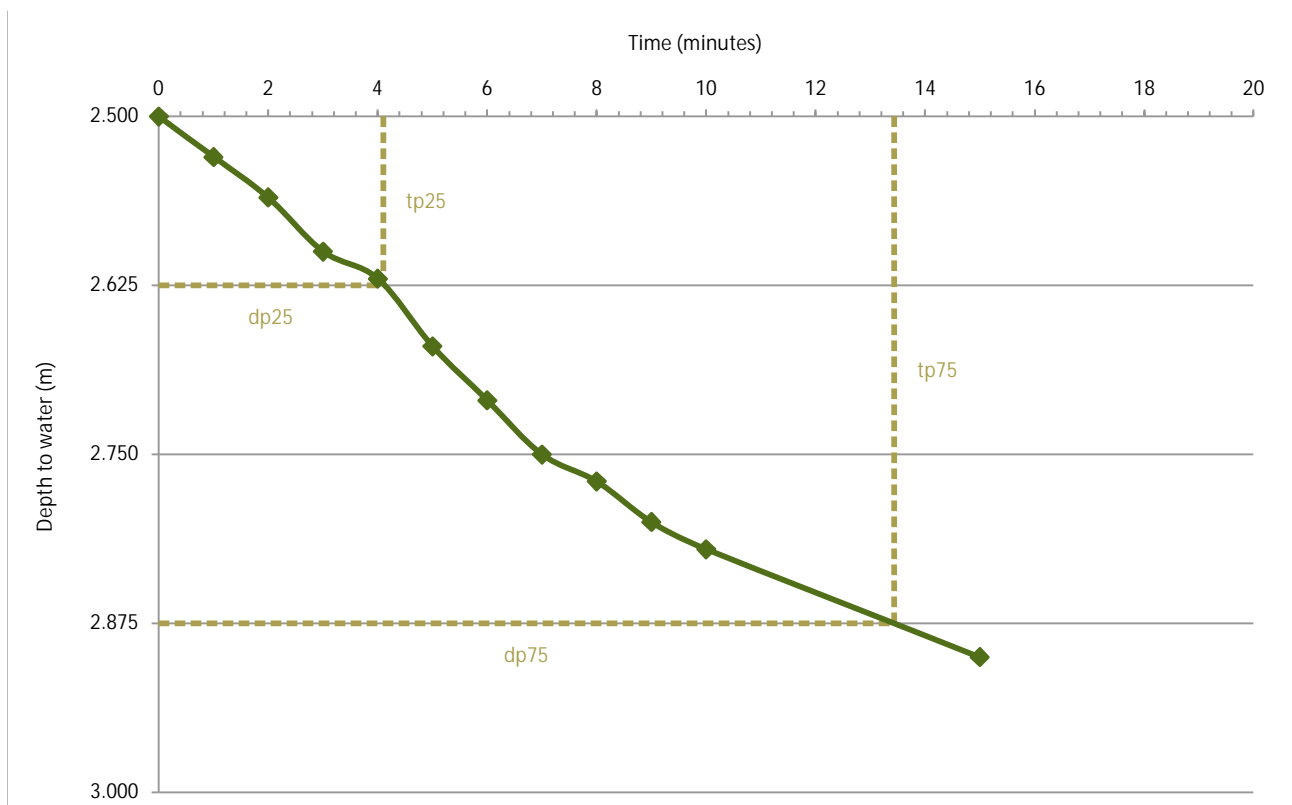
Location	Cycle	Test date	Dimensions (m)
TP01	2	21/11/2022	0.70m x 3.80m

Depth at start of test (m)	Groundwater observations (at time of excavation)
2.5	No groundwater encountered.

V_{p75-25}	0.665	m^3
Effective storage volume of water between 75% (dp75) and 25% (dp25) effective depth		
a_{p50}	5	m^2
Internal surface area up to 50% effective depth and including the base		
t_{p75-25}	560	s
Time for the water level to fall from 75% to 25% effective depth		
f	2.42E-04	m/s
Soil infiltration rate

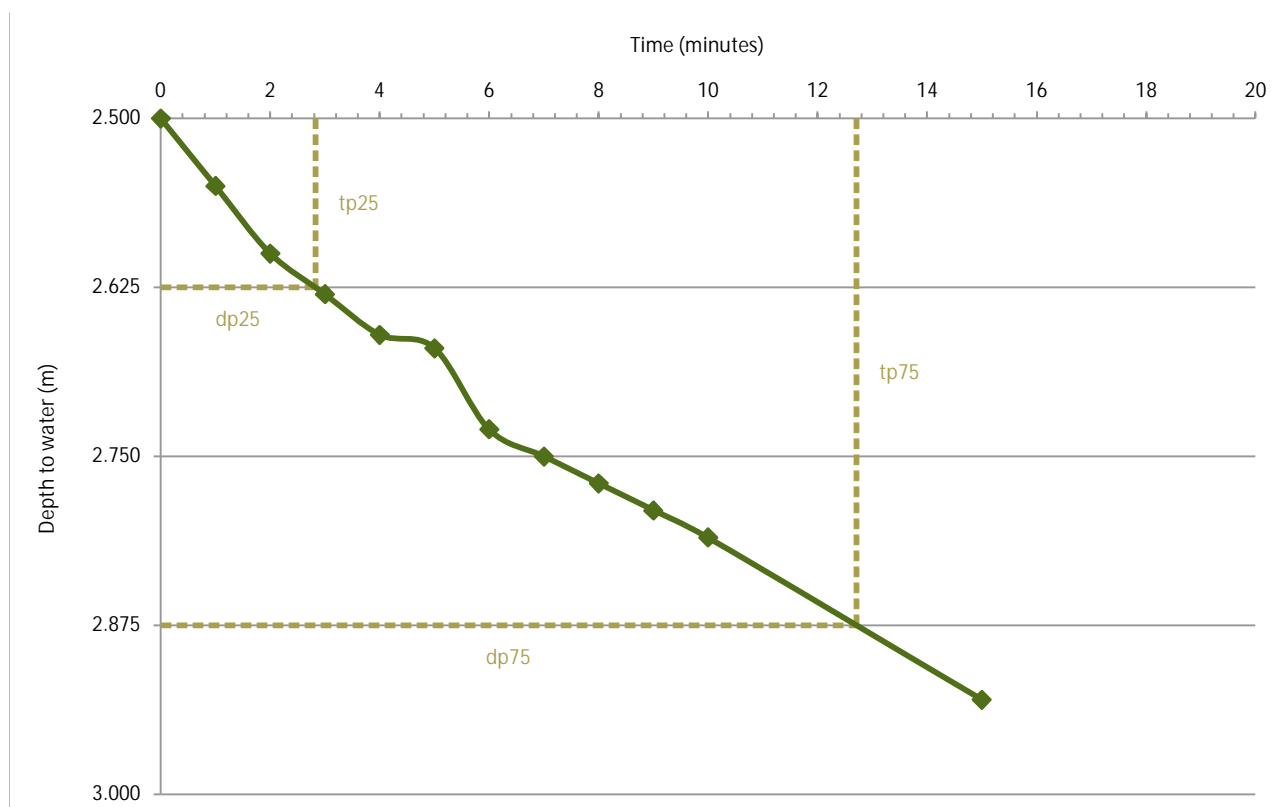
Location	Cycle	Test date	Dimensions (m)
TP01	3	21/11/2022	0.70m x 3.80m

Depth at start of test (m)	Groundwater observations (at time of excavation)
2.5	No groundwater encountered.

V_{p75-25}	0.665	m^3
Effective storage volume of water between 75% (dp75) and 25% (dp25) effective depth		
a_{p50}	5	m^2
Internal surface area up to 50% effective depth and including the base		
$t_{p75} - t_{p25}$	593	s
Time for the water level to fall from 75% to 25% effective depth		
f	2.29E-04	m/s
Soil infiltration rate
