# Townley Primary School: Tree Survey, Impact Assessment & Outline Method Statement

Prepared for: Jeakins Weir

May 2023

2317-WWA-ZZ-XX-RP-L-601-PL01

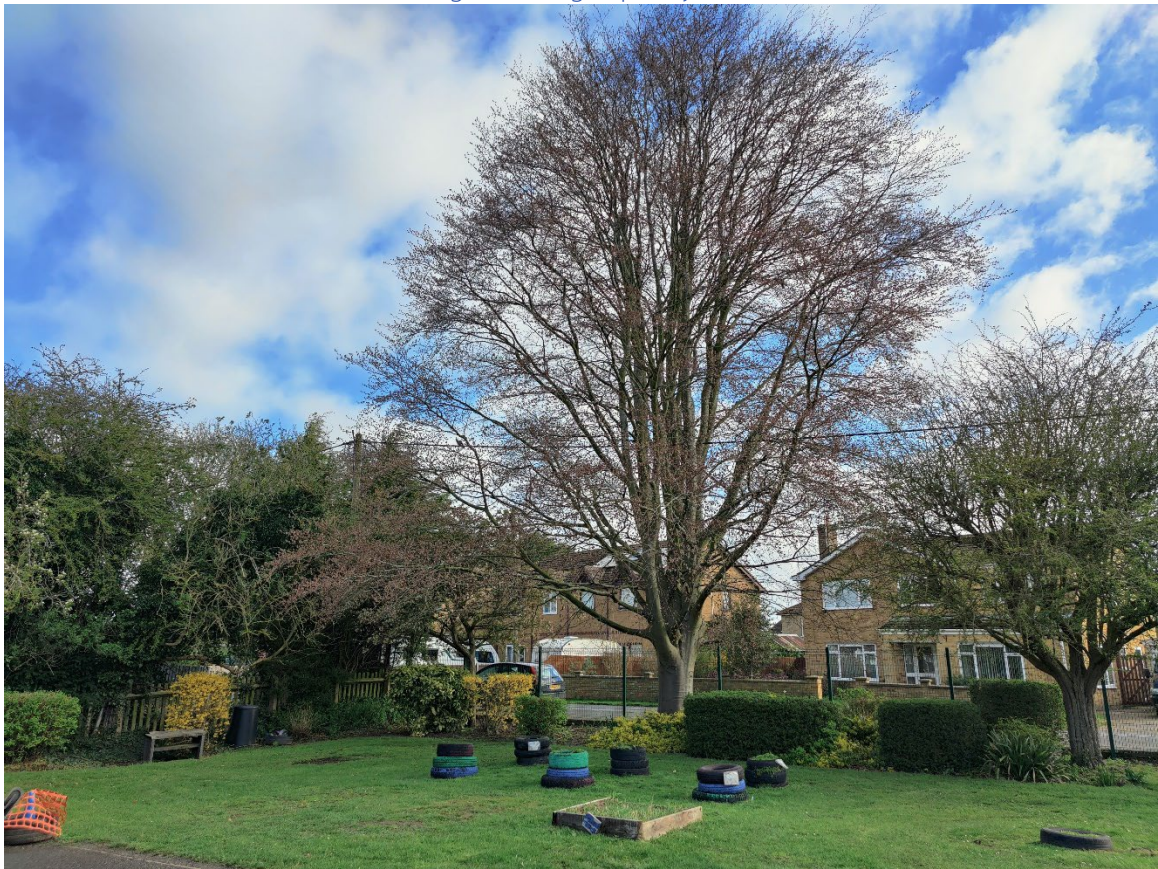
Figure 2: T01, T02 and T03 on frontage with road. T02 is the large beech in the centre, graded high quality.

- 5.5 The other 5 surveyed trees are of low quality. They should not be regarded as a constraint on development. It may be appropriate to plan their replacement as part of any scheme of landscaping forming part of the development plan.
- 5.6 Photos of the 2 grade A trees T02 and T12 are in Figures 2 and 3 below.

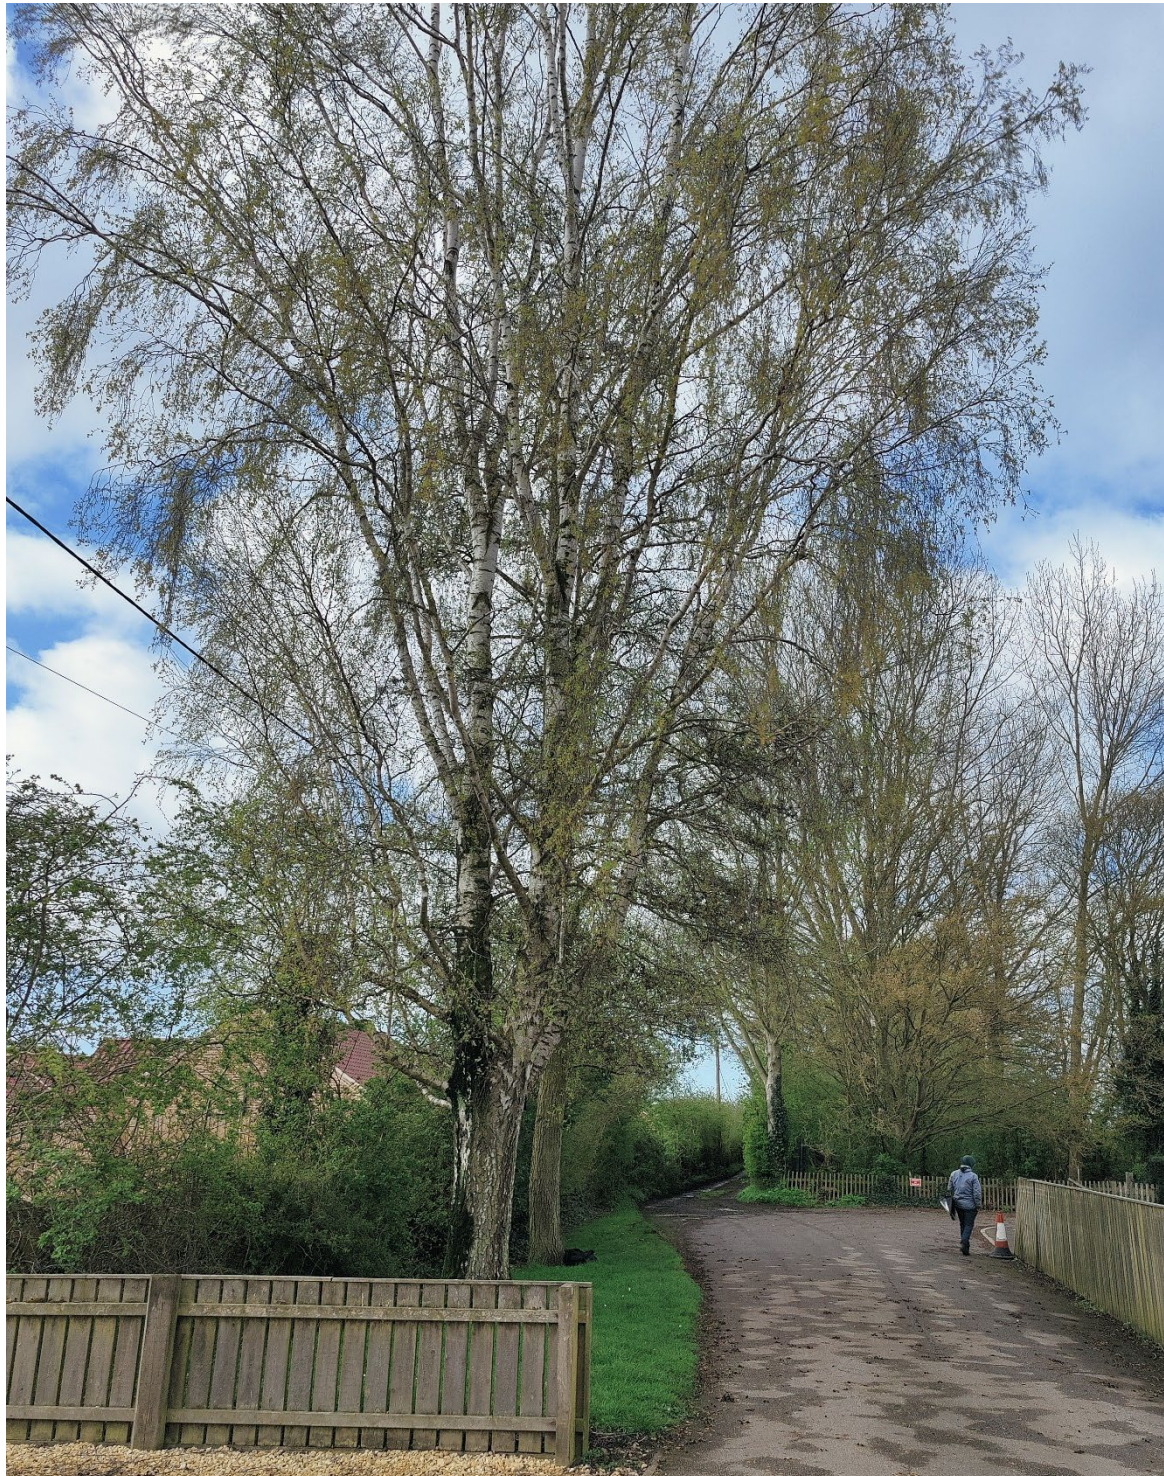
Figure 3: T12, a high-quality mature silver birch on the eastern boundary of the site.

- 7.4.1 The height above ground of the canopy of high-quality birch T12 will need to be checked immediately before work starts. It may be necessary to prune part of the canopy which overhangs the access drive along the eastern boundary in order to prevent damage when the relocatable classroom is removed. The canopy is currently 3m above the drive (see Figure 3) but it will droop lower when the tree is in full leaf. The amount of pruning needed will not cause harm if done competently as set out in the outline method statement.

- 8.5.1 The site will be walked with a suitably competent and experienced arboricultural contractor before work starts to agree whether any access pruning is needed, in particular to silver birch T12. The amount of such pruning is expected to be minor.
- 8.5.2 All pruning work will be carried out in accordance with British Standard BS 3998:2010 *Tree Work: Recommendations* and in accordance with current best practice. A competent tree surgery contractor will be used for the work. Bird's nests are very unlikely in any of the pruned parts of these trees, but this will be checked before work starts.

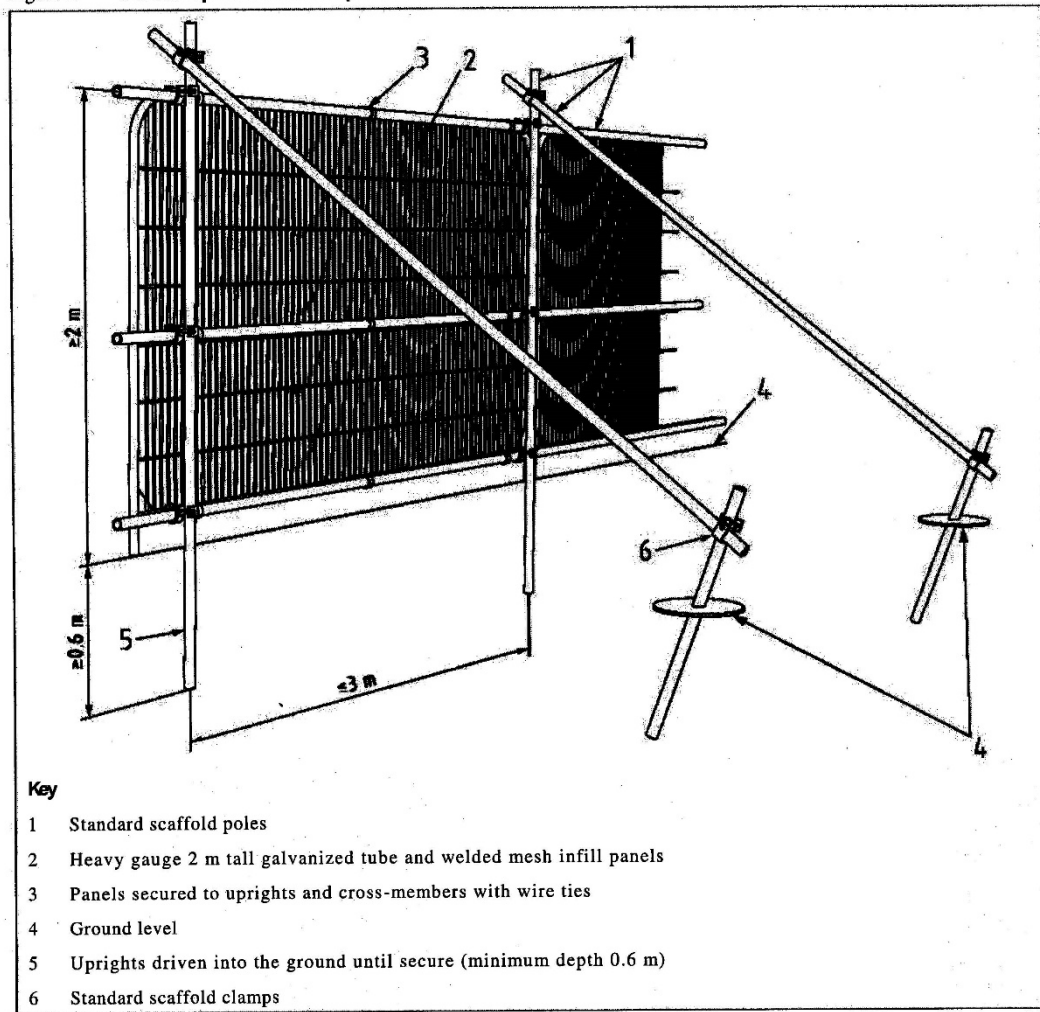
Figure 8: BS5837 suitable protective fencing (soft ground)

- 8.6.1 The contractor will erect protective fencing at the start of work on site. The position of the fencing is shown on plan 2317-WWA-DD-L-0702-PL01. The fencing will be of the types described in BS5837:2012 (see Figures 8 and 9 for illustrations). It will remain in position until the end of construction work.

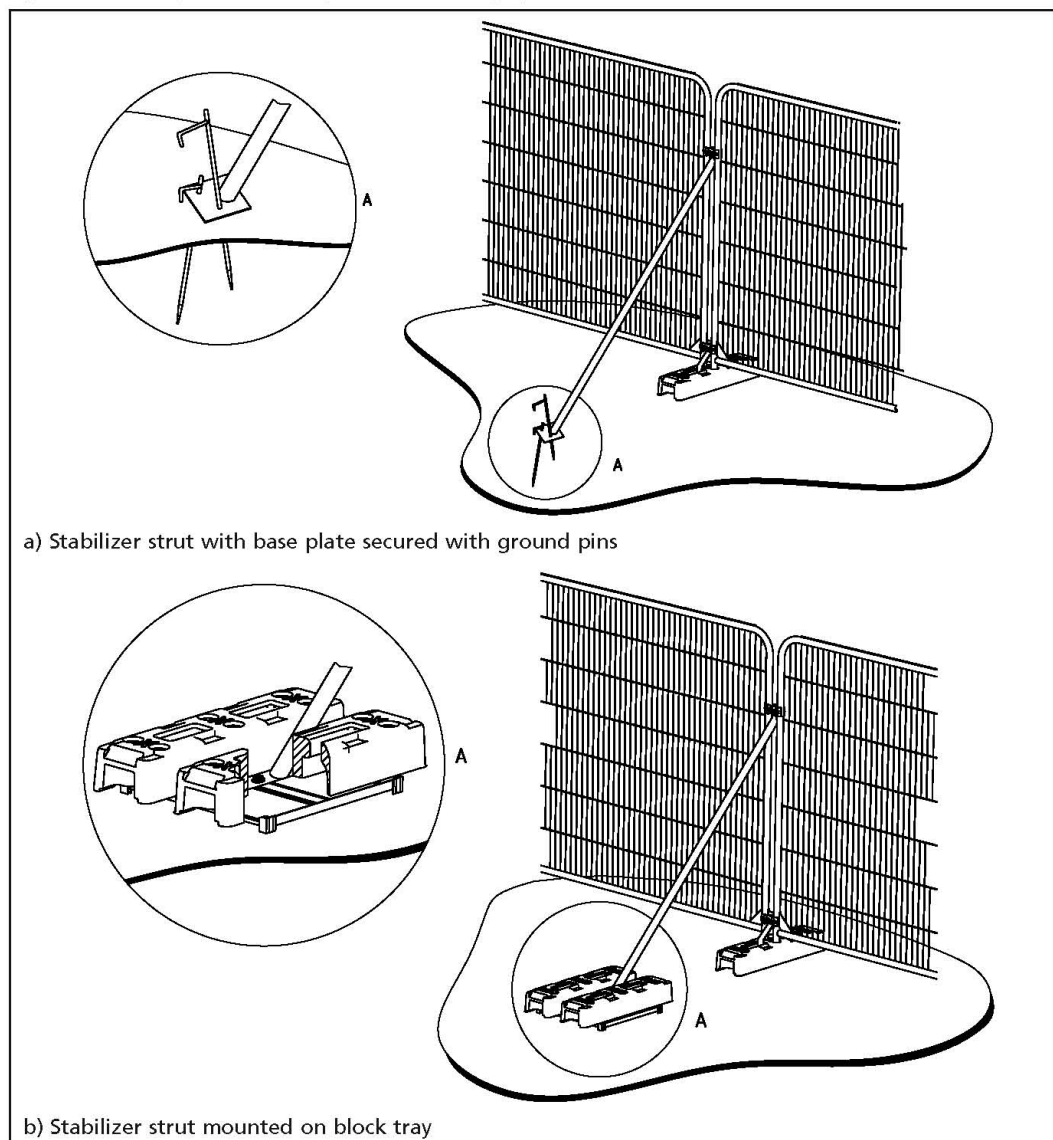
Figure 9: BS5837 suitable protective fencing (paved ground)
