Ground Investigation Report

Proposed Redevelopment

Lanwades Park, Kentford, Newmarket

Site: Lanwades Park, Kentford, Newmarket
Document Title: Ground Investigation Report
Document no.: STU5875-R01 Rev B
Date: February 2023
Client: Lochailort Investments Limited
Issuing office: Soiltechnics Ltd
Cedar Barn, White Lodge, Walgrave, Northampton. NN6 9PY
Tel: 01604 781 877 E-mail: mail@soiltechnics.net

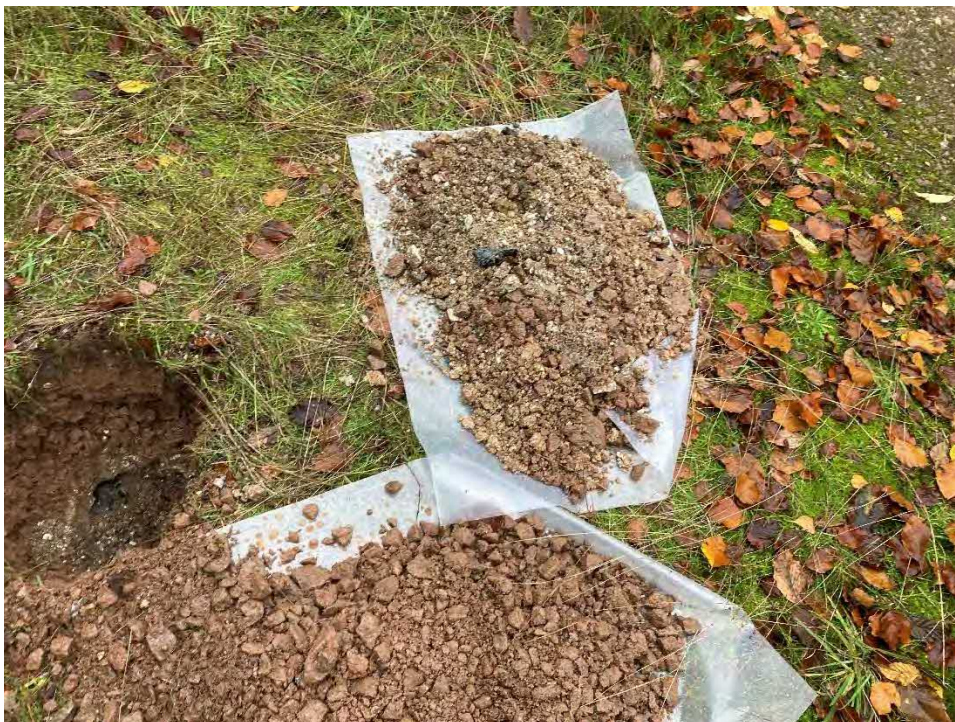
Figure 6-2: Made Ground in HP03

- 6.3.2 Made Ground is variable but generally comprises grey and light brown, slightly sandy to sandy, clayey gravel or gravelly, slightly clayey sand and light brown and light grey, slightly sandy, slightly gravelly clay. Gravels consist of chalk, flint, brick, clinker, concrete and sandstone. Occasional wood and fabric are present in the cohesive deposits in TP04 to the north of the incinerator building. Staining and a strong hydrocarbon odour were also noted between 0.6m and 1.20m in this area.

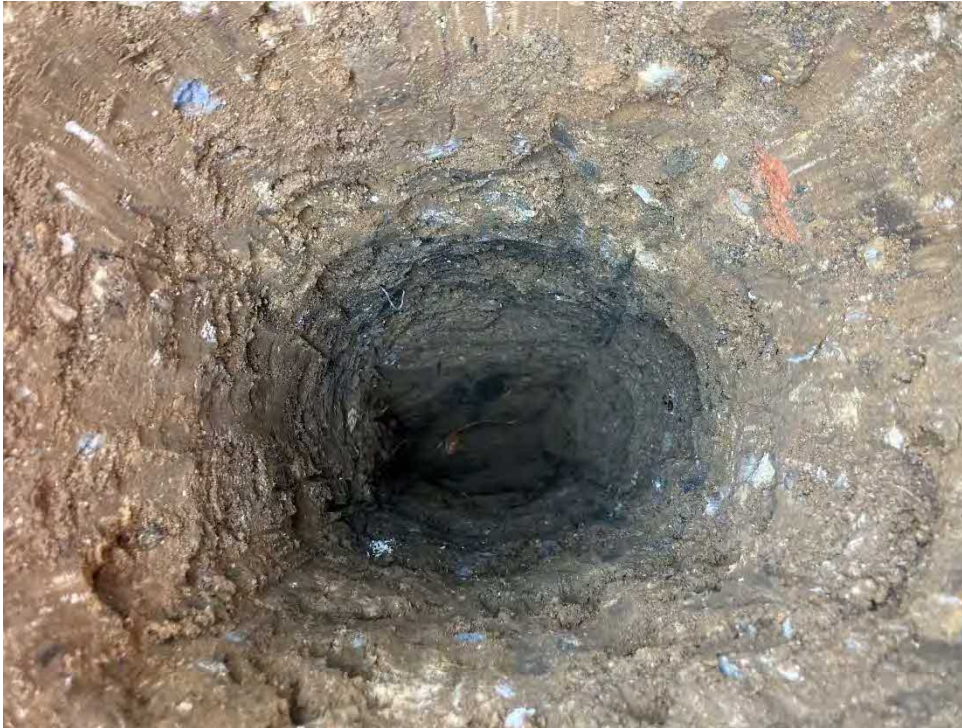
Figure 6-4: Made Ground in HP09 (raised/bunded area to the northeast)

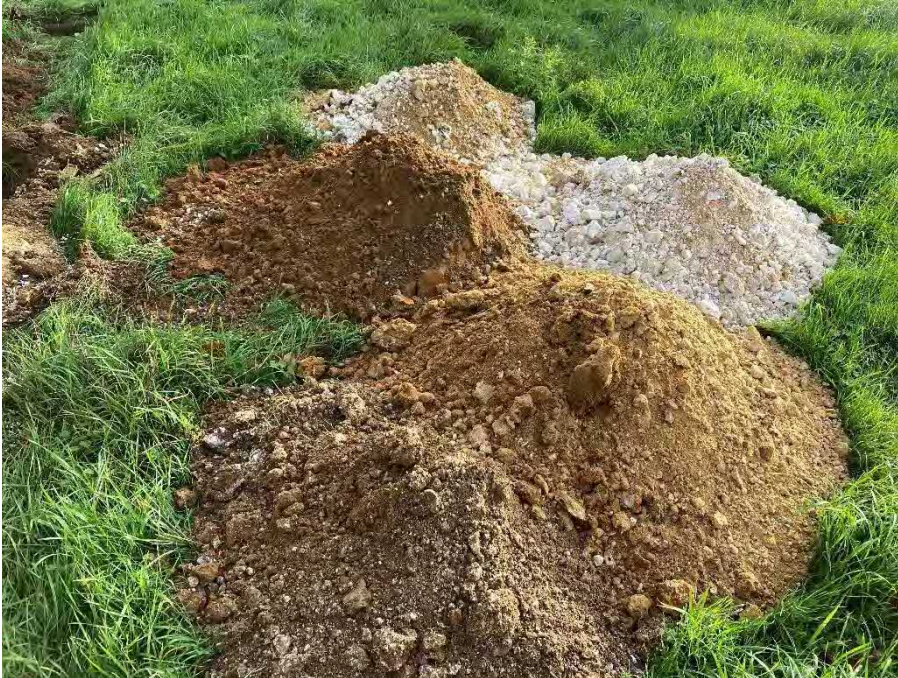
Figure 6-5 Quaternary Deposits taken from TP14.

- 6.4.3 Such deposits are likely to be part of the Lowestoft Formation, though the variability and locally low strength provides some doubt, with such deposits also reminiscent of alluvial and/or Head deposits and as such have been given the more generic term of Quaternary Deposits.

6.4.4 A typical photograph of the Quaternary Deposits encountered is presented below.

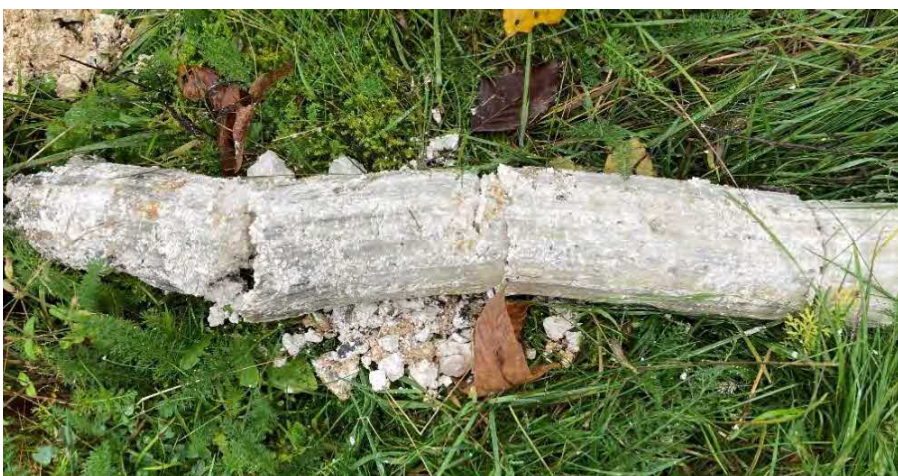
Figure 6-6: Chalk – Grade Dm from WS03

6.5.2 Generally, the Chalk Formation comprised structureless chalk composed of sandy gravel with varying concentrations of clay (Grade Dc). Gravels were weak to moderately weak, low to medium density and varied in colour from light brown to white. Occasional to frequent flint gravels were also present. In two boreholes, the Chalk comprised a gravelly sandy clay (Grade Dm). However, SPTs refused at the base of the boreholes suggesting more competent Grade Dc soils below.

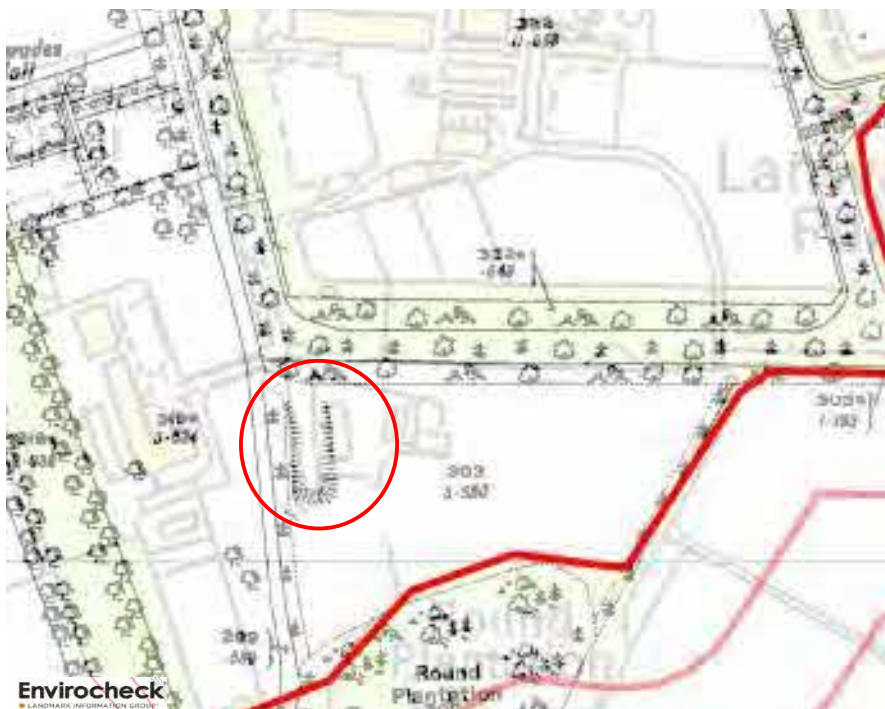
- 7.4.2 Based on historical maps, a backfilled quarry is likely to be present on site as indicated by the red circle on Figure 7-1. This area lies below an existing building and access way and investigations have not been undertaken in this location at this time. This is likely to be an area of deep Made Ground and may require further investigation depending on development proposals. Again, a piled foundation solution may be required in this area should buildings be proposed over the former quarry.

Figure 7-1: Mapping overlays from 1926 and 2006 showing existing layout and location of former quarry
