**BAT SURVEY AND  
RISK ASSESSMENT  
FOR 22, LOW GREEN  
GAINFORD**

Veronica Howard, BSc (Hons), PhD, MCIEEM  
August 2023

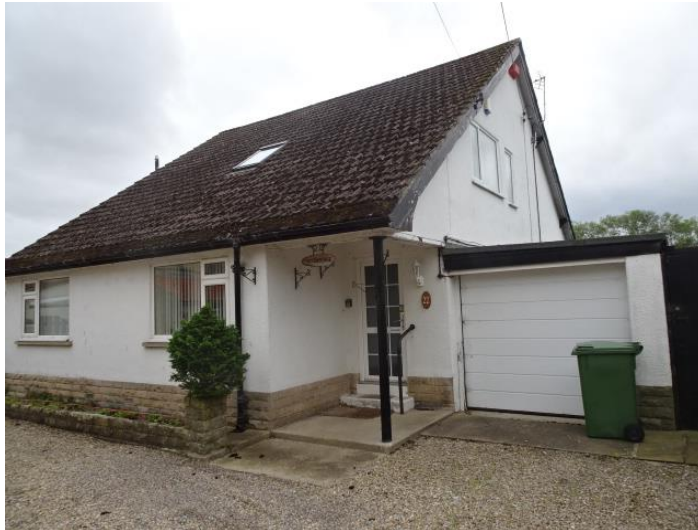
Front elevation

- 1.4 The building is in an excellent state of repair with no cracks or crevices in the exterior walls and the wall tops are sealed. The roof is also in a good state of repair and no potential access points were found into the loft space as the roof is lined. (The assessment of the state of repair only relates to the potential for the building to be used as a bat roost or hibernation site).

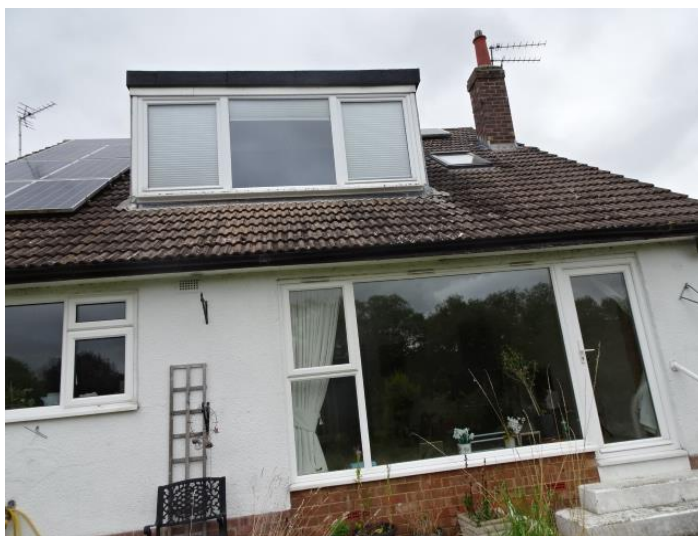
Rear elevation facing onto the river

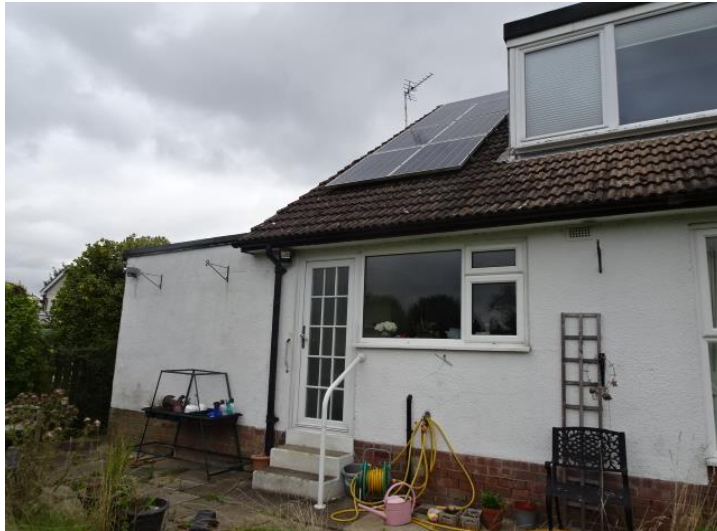
Rear elevation

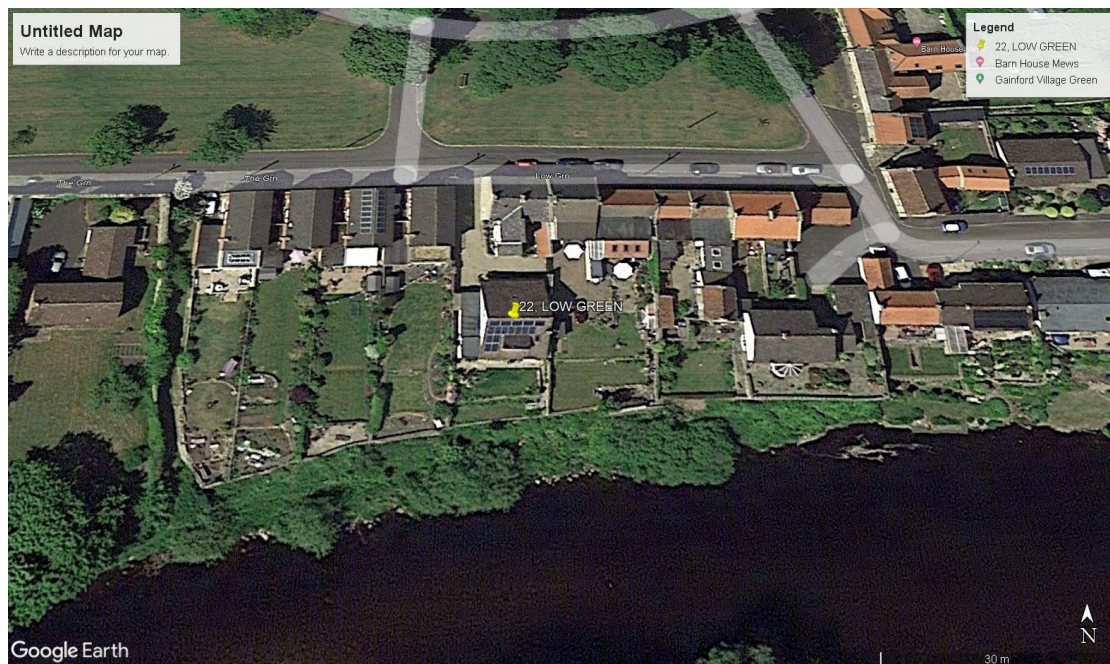
#### Surrounding Habitat (See aerial photo below)

- 1.5 The building is located close to the village green with the rear of the property facing onto the River Tees. There are further dwelling houses on either side. There are a large number of mature trees on village green and further trees along the river corridor.

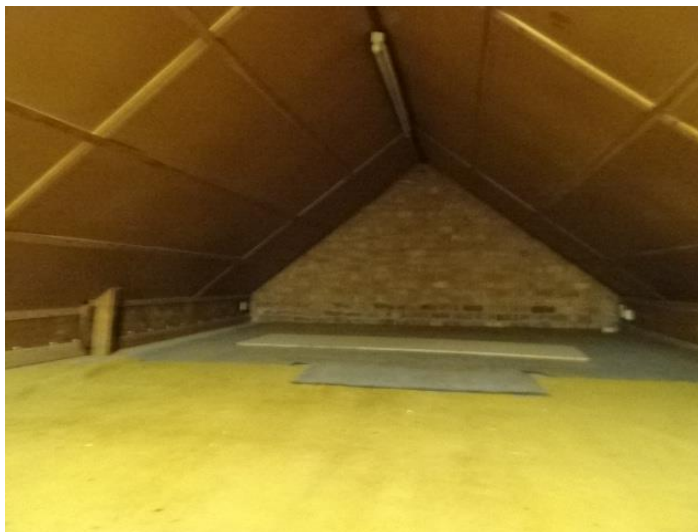
- 2.3.1 No signs of bats were found and no potential roost sites were found in the exterior walls of the bungalow or the garage and there were no signs of bats in the loft space.
- 2.3.2 The exterior walls are in a good state of repair with cracks or crevices in the render or at the wall tops. No gaps were found around the window or door frames. No gaps could be seen under the pantiles and there is no potential access into the loft space as it is lined (see below)

- b) All roofing materials from the bungalow and garage will be removed with care. Particular care will be taken when removing the pantiles as there is a very small chance a bat or bats could be roosting beneath them.

a) All roofing materials that need to be removed must be removed carefully by hand. Special care should be taken when removing the pantiles and roof lining as there is a very small chance that bats could potentially roost beneath them.
