## Phase II Ground Investigation

Land Adjacent to Coppice Inn, Lanner

10 October 2018

Wheal Jane Consultancy

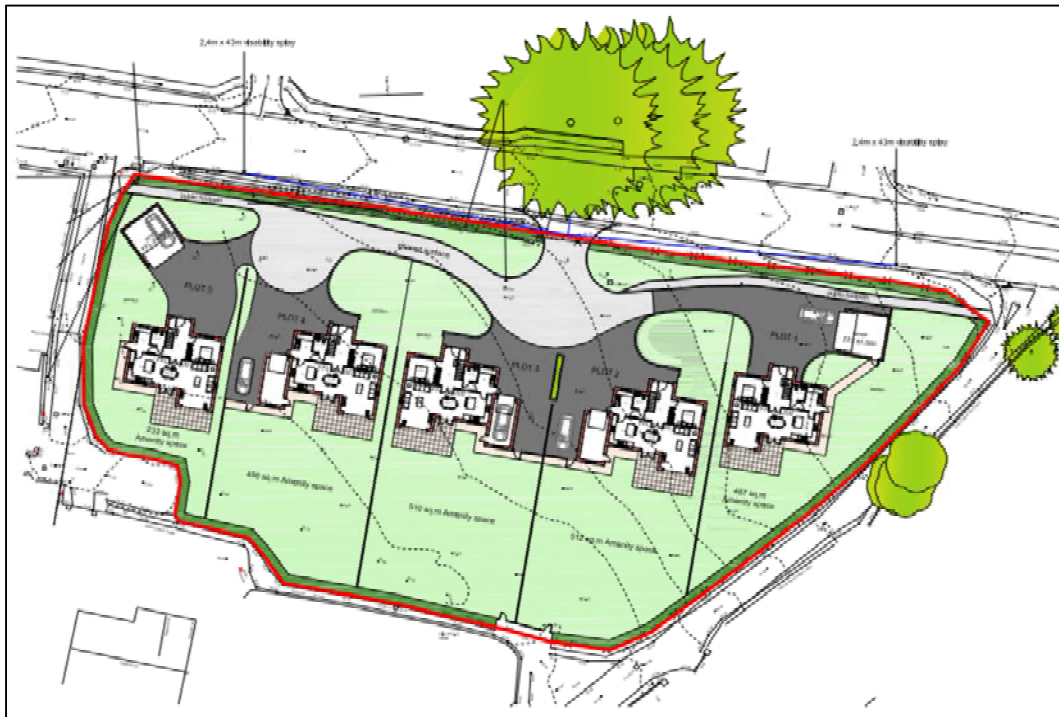
Figure 2.3. The proposed development. (Supplied by SPS Architectural, Drawing number: 0248 SP A.)

2.3.1 It is proposed to construct five dwellings and associated works to include formation of new access. Further information can be found under planning application number PA18/00405.

2.3.2 An outline plan for the proposed development can be seen in Figure 2.3.

- 5.2.4 On this basis, it is considered that a piled foundation solution is appropriate, with end-bearing piles driven through the Made Ground and Alluvium and socketed in the underlying Mylor Slate Formation at depths of 4.50m to 5.50m.

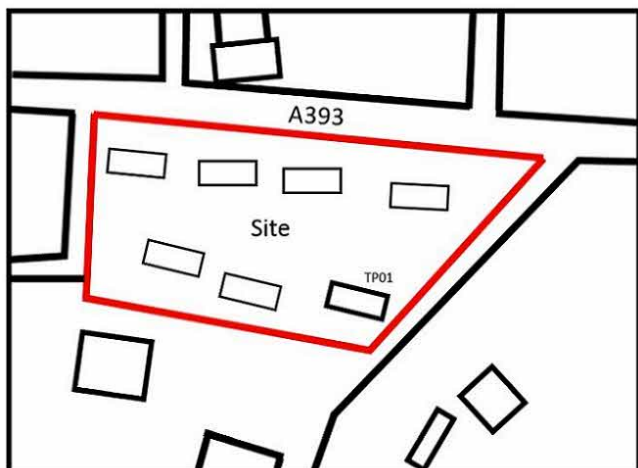
1.80	ES4			82.10	(0.20)	MADE GROUND: Grey sandy CLAY. Sand is fine to coarse.	[Cross-hatch pattern]
2.00-3.00	B5				1.90	MADE GROUND: Brown gravelly CLAY. Gravel is angular to subangular, fine to coarse of ceramic, mudstone, brick and glass.	[Cross-hatch pattern]

2.50	D6				(1.30)		
				80.80	3.20	Complete at 3.20m

No groundwater encountered.  
Sides unstable.

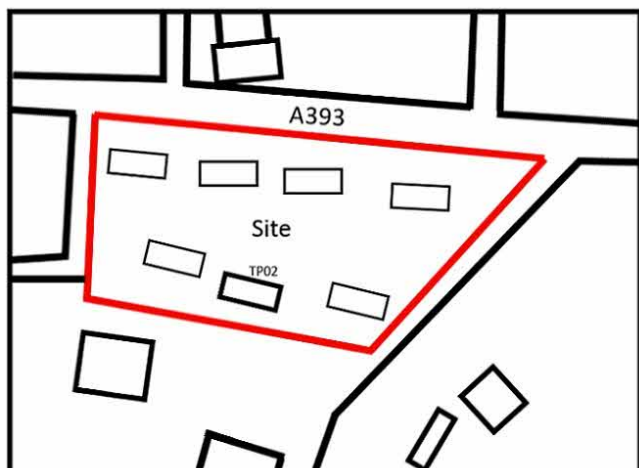
Depth (m)	Sample / Tests	Water Depth (m)	Field Records	Level (mOD)	Depth (m) (Thickness)	Description	Legend
0.00-0.40	B1				(0.45)	MADE GROUND: Grass over brown sandy angular to subangular, fine to coarse GRAVEL of mudstone, glass, brick and plastic. Sand is fine to coarse. Rare boulders of granite (Up to 550mm).	[Cross-hatched pattern]
0.50	ES2			83.55	0.45	MADE GROUND: Dark brown sandy angular to subangular, fine to coarse GRAVEL of mudstone, glass, brick, timber and ceramic. Sand is fine to coarse.	
1.60	ES3			82.80	1.20	MADE GROUND: Brown clayey, gravelly fine to coarse SAND. Gravel is angular to subangular, fine to coarse of brick, glass, plastic and mudstone.	
2.00-3.00	B4				(1.90)		
2.70	ES5			80.90	3.10	Complete at 3.10m

No groundwater encountered.  
Sides unstable.

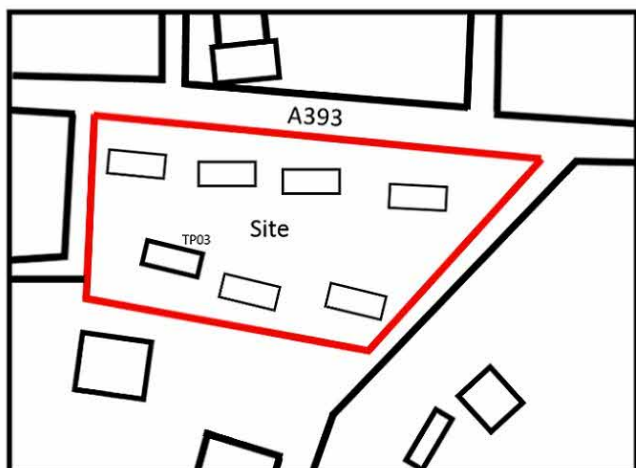
Depth (m)	Sample / Tests	Water Depth (m)	Field Records	Level (mOD)	Depth (m) (Thickness)	Description	Legend
0.00-0.50	B1					MADE GROUND: Orangish brown clayey angular to subangular, fine to coarse GRAVEL of mudstone, charcoal, ceramic, metal and brick.	[Cross-hatched pattern]
0.20	ES2			83.50	0.50	MADE GROUND: Dark brown sandy angular to subangular, fine to coarse GRAVEL of mudstone, glass, brick, timber and ceramic. Sand is fine to coarse.	
1.50	ES3			82.40	1.60	MADE GROUND: Greyish brown gravelly CLAY. Gravel is angular to subangular, fine to coarse of mudstone, glass, plastic and ceramic.	
2.10	ES4				(1.70)		
2.50-3.00	B5						
3.00	D6		Water strike(1) at 3.30m.	80.70	3.30	Complete at 3.30m	[Symbol]

Sides unstable.  
Groundwater encountered at 3.30m.

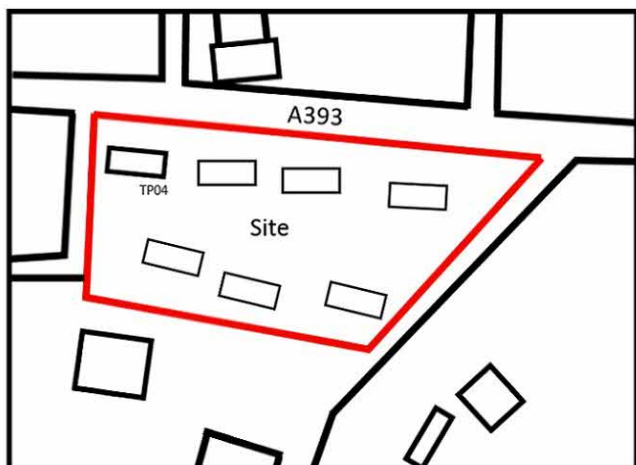
Depth (m)	Sample / Tests	Water Depth (m)	Field Records	Level (mOD)	Depth (m) (Thickness)	Description	Legend
0.10	ES1			84.58	(0.42) 0.42	MADE GROUND: Grass over brown sandy angular to subangular, fine to coarse GRAVEL of mudstone, glass, brick and plastic. Sand is fine to coarse.	[Cross-hatched pattern]
0.50-1.00 0.60	B2 ES3				(1.38)	MADE GROUND: Dark brown clayey, sandy angular to subangular, fine to coarse GRAVEL of granite, mudstone, metal, plastic, ceramic and brick. Organic odour.	
2.00 2.00 2.00-2.50	D6 ES4 B5			83.20	1.80 (1.30)	MADE GROUND: Brown sandy, gravelly CLAY. Gravel is angular to subangular, fine to coarse of mudstone, ceramic, brick and plastic. Sand is fine to coarse.	
			Water strike(1) at 3.10m.	81.90	3.10	Complete at 3.10m	[Empty]

Groundwater encountered at 3.10m.  
Sides unstable.

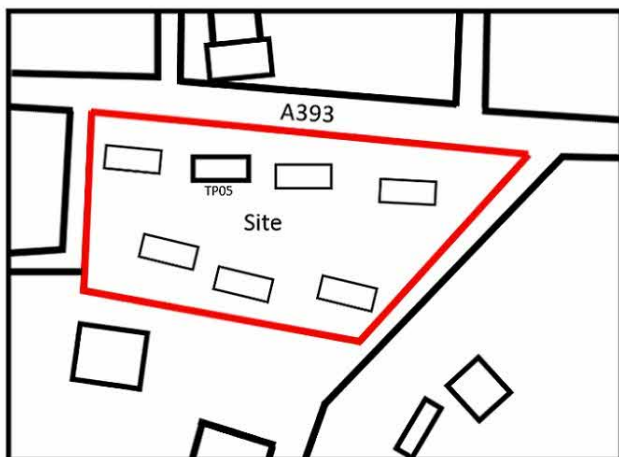
Scale (approx) 1:50	Logged By BH	Figure No. 19490.TP05
------------------------	-----------------	--------------------------

Depth (m)	Sample / Tests	Water Depth (m)	Field Records	Level (mOD)	Depth (m) (Thickness)	Description	Legend
0.40	ES1			83.55	(0.45) 0.45	MADE GROUND: Grass over brown sandy angular to subangular, fine to coarse GRAVEL of mudstone, glass, brick and plastic. Sand is fine to coarse.	[Cross-hatched pattern]
1.20	ES3			82.60	(0.95) 1.40	MADE GROUND: Dark brown clayey, gravelly, fine to coarse SAND. Gravel is angular to subangular, fine to coarse of mudstone, brick, concrete, ceramic and plastic. Sand is fine to coarse.	
1.50-2.00	B2		Water strike(1) at 3.10m.	80.50	(2.10) 3.50	MADE GROUND: Orangish brown sandy angular to subangular, fine to coarse GRAVEL of mudstone, brick, ceramic, metal and plastic. Sand is fine to coarse.	
						Complete at 3.50m

**Remarks**  
Sides unstable.  
Groundwater encountered at 3.10m.

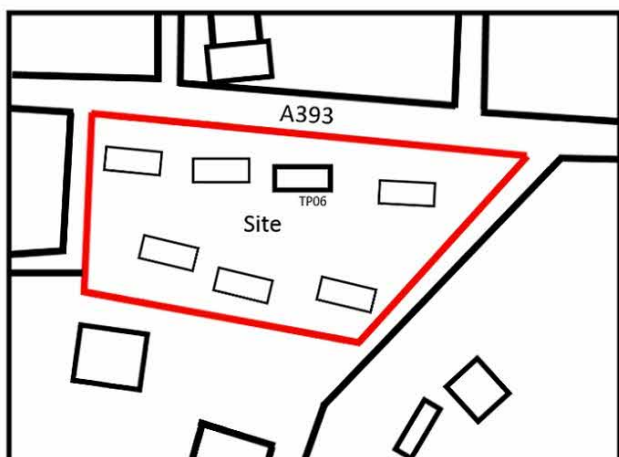
Depth (m)	Sample / Tests	Water Depth (m)	Field Records	Level (mOD)	Depth (m) (Thickness)	Description	Legend
0.30	ES1			82.65	0.35	MADE GROUND: Grass over brown sandy angular to subangular, fine to coarse GRAVEL of mudstone, glass, brick and plastic. Sand is fine to coarse.	[Cross-hatch pattern]
1.30	ES2				(1.35)	MADE GROUND: Orangish brown clayey gravelly fine to coarse SAND. Gravel is angular to subangular, fine to coarse of mudstone, brick, metal and plastic.	[Cross-hatch pattern]
1.70-2.00	B3 ES4 D5			81.30	1.70	Grey sandy CLAY. Sand is fine to coarse.	[Dotted pattern]
1.80					(1.80)		[Dotted pattern]
2.00				79.50	3.50	Complete at 3.50m	[Dotted pattern]

No groundwater encountered.  
Sides unstable.

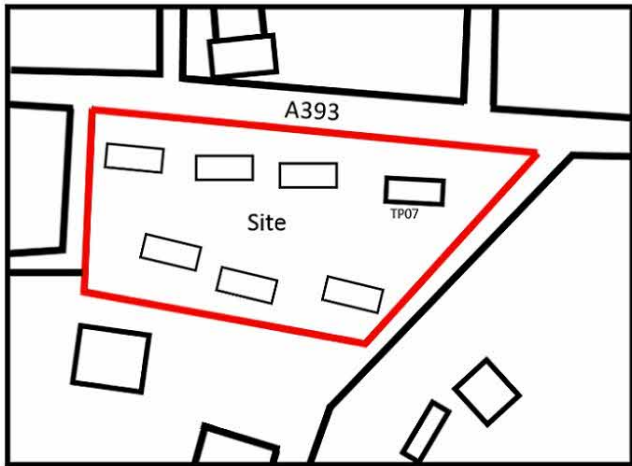
<b>Scale (approx)</b> 1:50	<b>Logged By</b> BH	<b>Figure No.</b> 19490.TP07
-------------------------------	------------------------	---------------------------------

Depth (m)	Sample / Tests	Water Depth (m)	Field Records	Level (mOD)	Depth (m) (Thickness)	Description	Legend
0.20	ES1			80.70	(0.30) 0.30	MADE GROUND: Grass over brown sandy angular to subangular, fine to coarse GRAVEL of mudstone, glass, brick and plastic. Sand is fine to coarse.	
1.30	ES2			79.80	(0.90)	MADE GROUND: Dark brown sandy angular to subangular, fine to coarse GRAVEL of mudstone, glass, brick, timber and ceramic. Sand is fine to coarse.	
1.50	D4			79.60	(1.20) (0.20)	Black sandy CLAY. Sand is fine to coarse. Organic odour.	
1.50-2.50	B3				(1.30)	Grey sandy CLAY. Sand is fine to coarse.	
2.80	ES5		Water strike(1) at 2.10m.	78.30	2.70	Greyish brown clayey angular to subangular, fine to coarse GRAVEL of mudstone.	
2.80-3.50	B6			77.50	(0.80) 3.50	Complete at 3.50m

Groundwater encountered at 2.10m.  
Sides unstable.

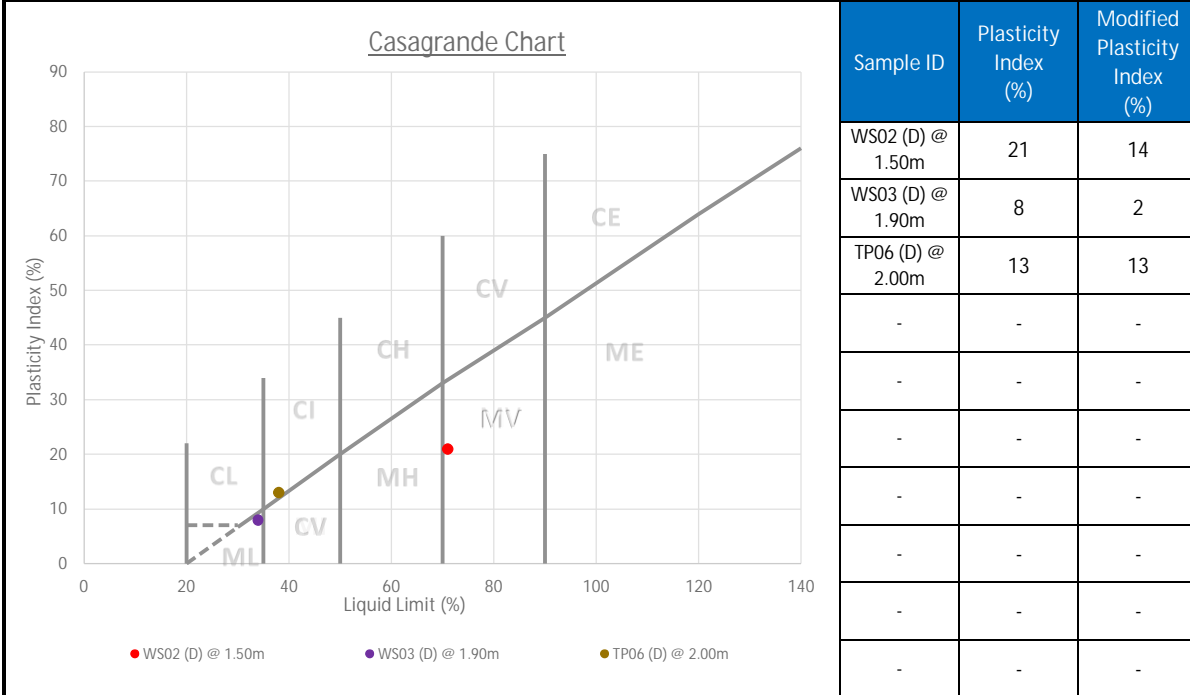
The Modified Plasticity Index ( $I'_p$ ) is defined as the Plasticity Index ( $I_p$ ) of the soil multiplied by the percentage of particles less than  $425\mu\text{m}$ .  
ie.  $I'_p \times \% \text{ less than } 425\mu\text{m} / 100\%$
