3 Ladywell, Wroughton

Bat & Bird Scoping Report

Date: July 2023

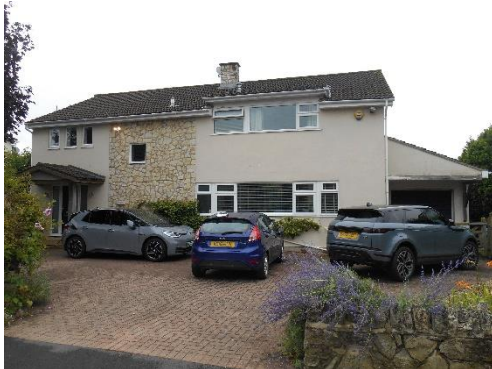
Plate 1: 3 Ladywell Northern Aspect

3 Ladywell was a detached, two-storey residential property that was constructed in 1960's (Plates 1 – 4). More recently, a two-storey extension has been added to the east of the building. Two single-storey extensions were located to the south. The exterior walls were rendered and included a stone façade in the north; the walls were in a good condition, lacking any cracks or crevices that could be exploited by bats. Intact double-glazed doors and windows were present throughout. Intact wooden soffit boxes were flush with the wall tops. The main roof was pitched and clad in pan tiles; the roof was in a good condition lacking any raised, slipped or missing tiles. One of the single-storey extensions included a sloping roof with pan tiles whilst the other was flat and covered in bitumastic felt. No external roost features were noted.

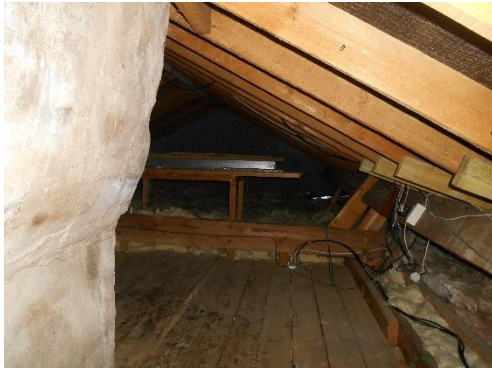
Plate 5: Loft Space 1

Loft Space 1 was in the original house and measured c. 15 m (L) x 6 m (W) x 1.5 m (H) (Plate 5). The roof was lined with bitumen felt and supported by a sealed wooden frame. A rendered chimney stack was located centrally. The gable walls were constructed from block. The floor was partly boarded and partly covered in fibreglass insulation. No signs of bats were recorded.

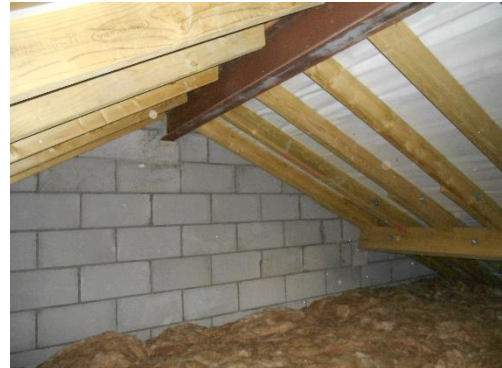
Plate 6: Loft Space 2

Loft Space 2 was in the two-storey extension and measured c. 6 m (L) x 5 m (W) x 1.5 m (H) (Plate 6). The roof was lined with breathable roof membrane and supported by a sealed wooden frame. The gable walls were constructed from block. The floor was covered in fibreglass insulation. No signs of bats were recorded.
